**THE INCIDENT REPORT IS IN RESPECT OF THE INVESTIGATION INTO THE CAUSE(S) OF A SERIOUS INCIDENT INVOLVING A BAE 146 – RJ85 AIRCRAFT, ZS-SSH, AFTER TAKE-OFF FROM OR TAMBO INTERNATIONAL AERODROME (FAJS) ON 12 NOVEMBER 2011.**

Issued by Aircraft Accident and Incident Investigation Division (AIID)

South African Civil Aviation Authority (SACAA)

February 2013

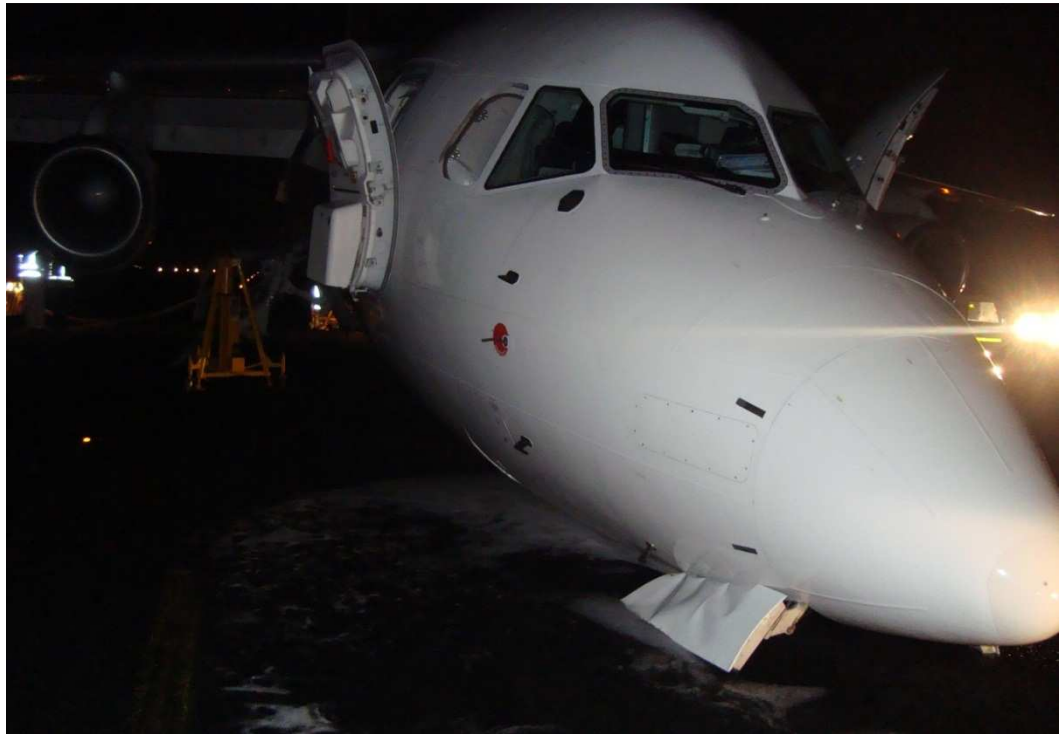
- 1.3.1 The aircraft sustained damage to the nose lower area and nose landing gear doors.

Figure 1, shows the BAE 146-RJ85 aircraft on the runway with the nose landing gear in the retracted position.

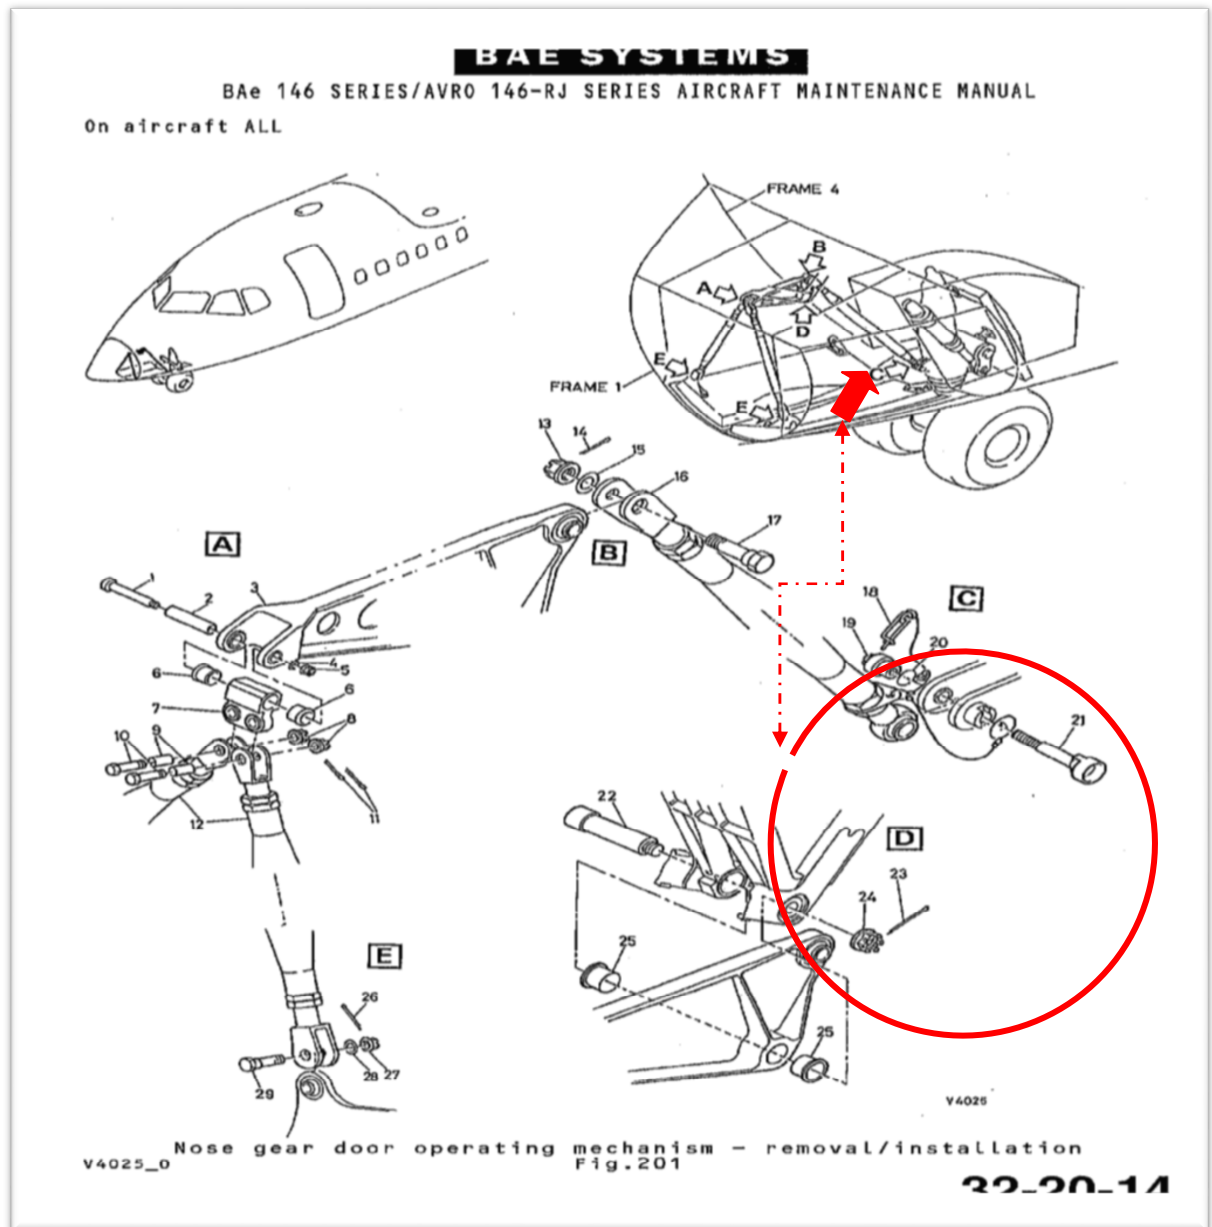
(See below figure 201, nose gear door operation – removal/installation diagram)

According to the Aircraft Maintenance Manual (AMM), Chapter 32-20-14 the following is required when opening the doors. *“Remove clip (18), thumb (19) and ring (20) from pin (21). Remove pin (21). Allow doors to open”.*

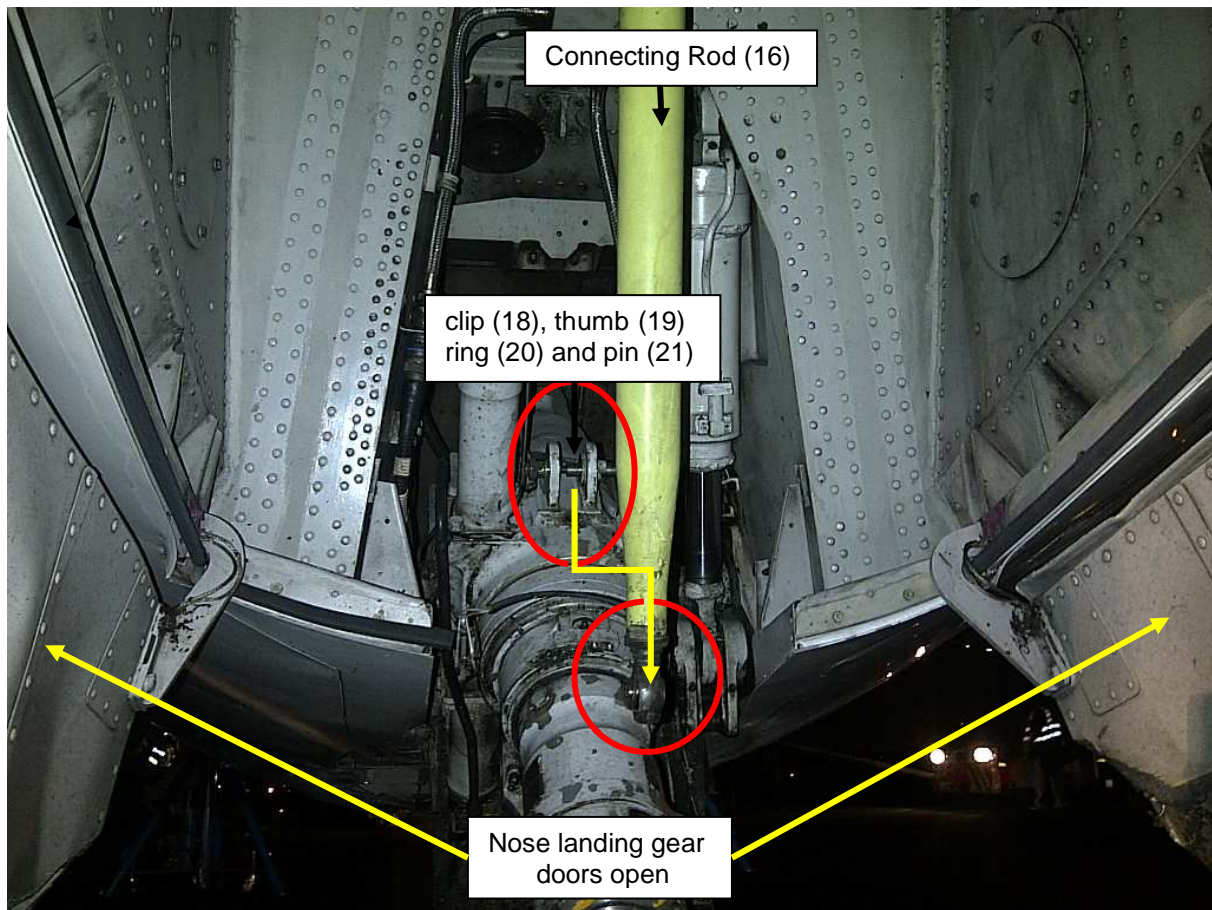
opened the nose landing gear doors by disconnecting the nose landing gear operating rod for the NDT contractor to gain access to the upper part of the forward face of the main fitting. The aircraft maintenance mechanic then left the aircraft and went back to the hangar in order to attend a shift hand-over meeting with the night shift crew supervisor. After completing the non-destructive testing inspection, the NDT contractor contacted the night shift crew chief/supervisor and informed him that the NDT task was carried out. The aircraft was left unattended due to the fact that there were other maintenance tasks still outstanding on the aircraft. The aircraft was to be towed to the hangar for further maintenance to be carried out.

(See below picture, showing nose landing gear doors removal/opening)

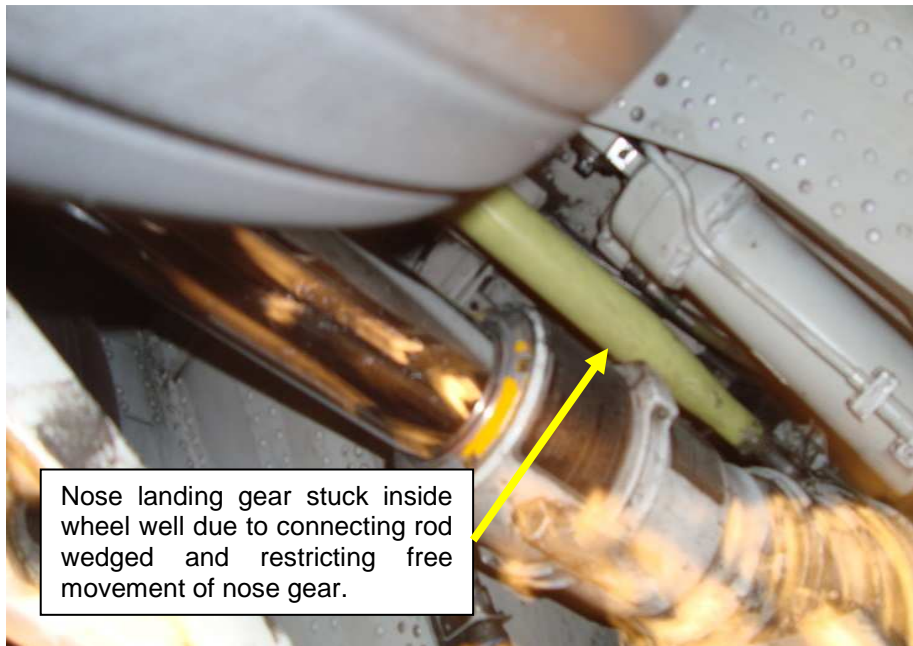
**Photo showing nose landing gear connecting rod (16) wedged inside the nose landing gear wheel well)**

1.6.14 According to available evidence the aircraft maintenance mechanic who opened the nose landing gear doors and left the connecting rod disconnected, did not make an entry in the aircraft technical logbook or on maintenance documentation to indicate that the nose landing gear doors were opened by disconnecting the rod inside the nose landing gear doors. There was also no maintenance in progress identification warning on the nose landing gear doors.

- 3.2.1 The nose landing gear failed to extend after the undercarriage was selected to the down position.
- 3.2.1. The nose landing gear doors were opened by an aircraft maintenance mechanic by disconnecting the nose landing gear door operating rod at the lower attachment point for NDT inspection to be carried out. The operating rod in question was not reconnected back to normal, causing the operating rod to become stuck (wedged) into a position which restricted the nose landing gear not to extend and lock down.

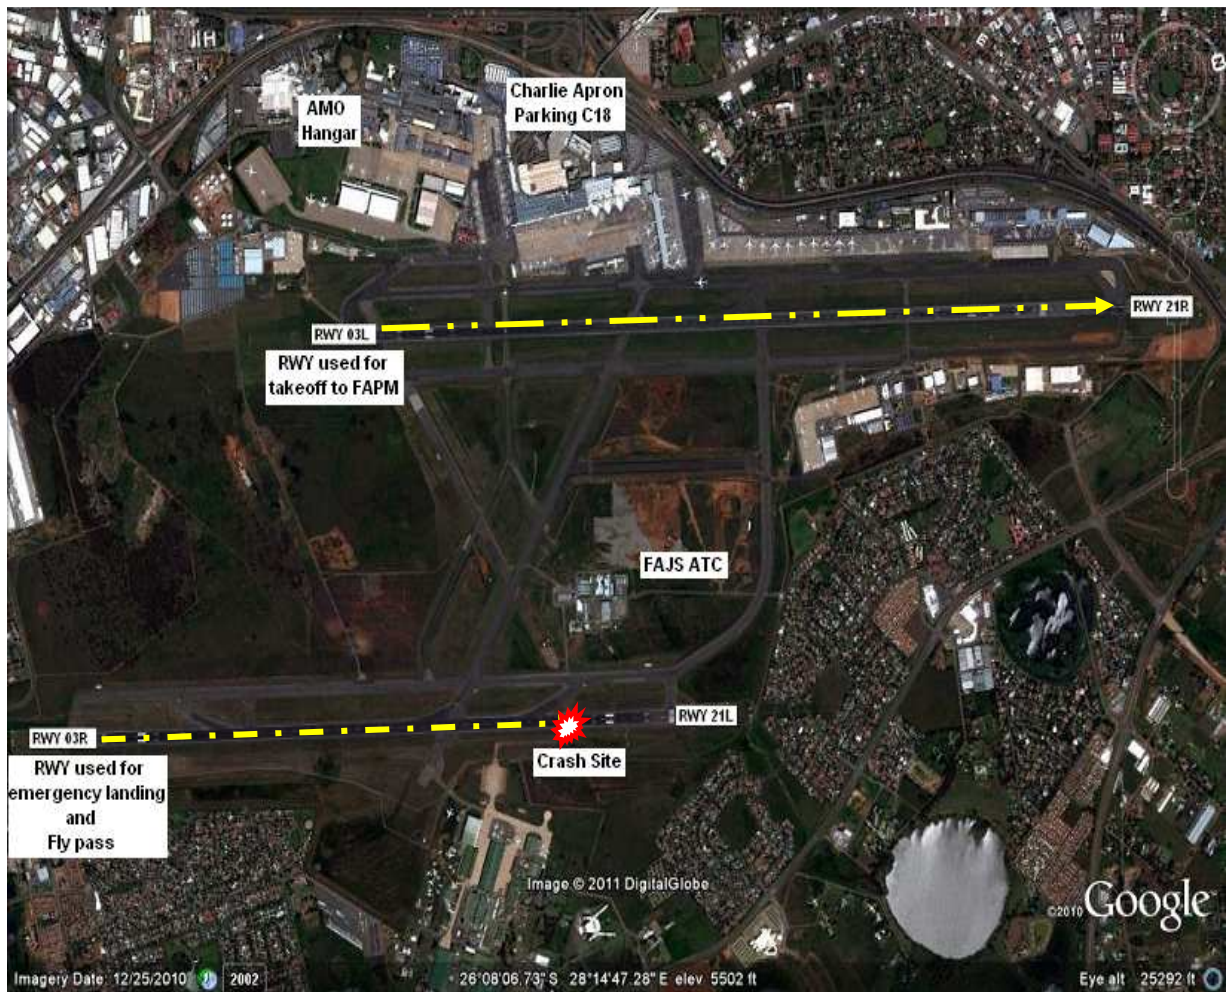
1.13.1 The aircraft was committed to an emergency landing onto Runway 03R at FAJS with the nose landing gear in an unsafe condition and not extended. The left and right hand main landing gears were fully extended and locked down and touched down first on the runway with the nose of the aircraft in a slight nose up attitude. The nose of the aircraft eventually lowered and scraped onto the runway surface for approximately 200 metres before the aircraft came to rest approximately 2500m from the threshold of Runway 03R.

Figure showing aircraft took off from Runway 03L at FAJS and emergency landing onto Runway 03R
