AIRCRAFT ACCIDENT REPORT AND EXECUTIVE SUMMARY

Reference:	CA18/2/3/8994	
Aircraft Registration	ZS-HHW	Date of Accident	20 December 2011		Time of Accident	0750Z	
Type of Aircraft	Bell 206B		Type of Operation	Private			
Pilot-in-command Licence Type	Private (Helicopter)		Age	52	Licence Valid	Yes	
Pilot-in-command Flying Experience	Total Flying Hours		Unknown		Hours on Type	Unknown	
Last point of departure	Wonderboom aerodrome (FAWB) (Gauteng province).						
Next point of intended landing	Bakubung bush lodge (North West province).						
Location of the accident site with reference to easily defined geographical points (GPS readings if possible)							
Near the foot of Sun City mountain at GPS position determined to be South 25° 21.411' East 027° 05.407'.							
Meteorological Information	Dew point 12°C: Temperature 27°C: Surface Wind @ 05 knots: Visibility, Good.						
Number of people on board	1 + 0	No. of people injured	0	No. of people killed	1

AIRCRAFT ACCIDENT REPORT

Name of Owner/Operator : Evening Star Trading 579 (PTY) LTD
Manufacturer : Bell Helicopter Textron
Model : Bell 206B
Nationality : South African
Registration Marks : ZS-HHW
Place : Near the foot of Sun City Mounta

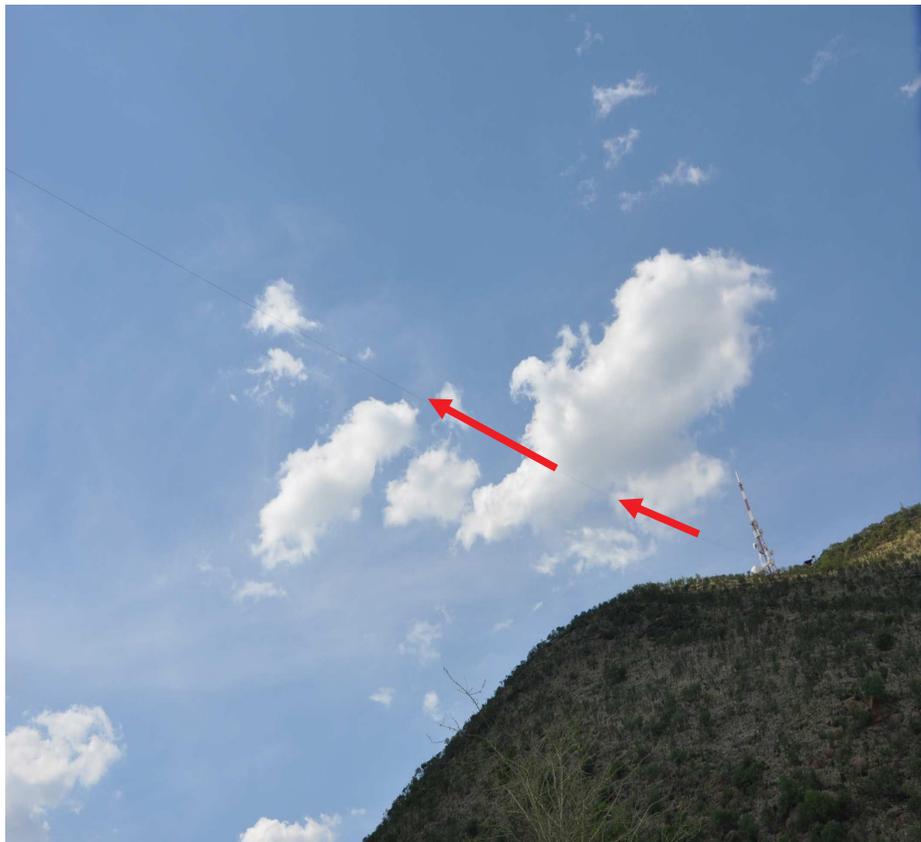
Figure 1: View of the zip line cable running from the high ground on the right of the picture.

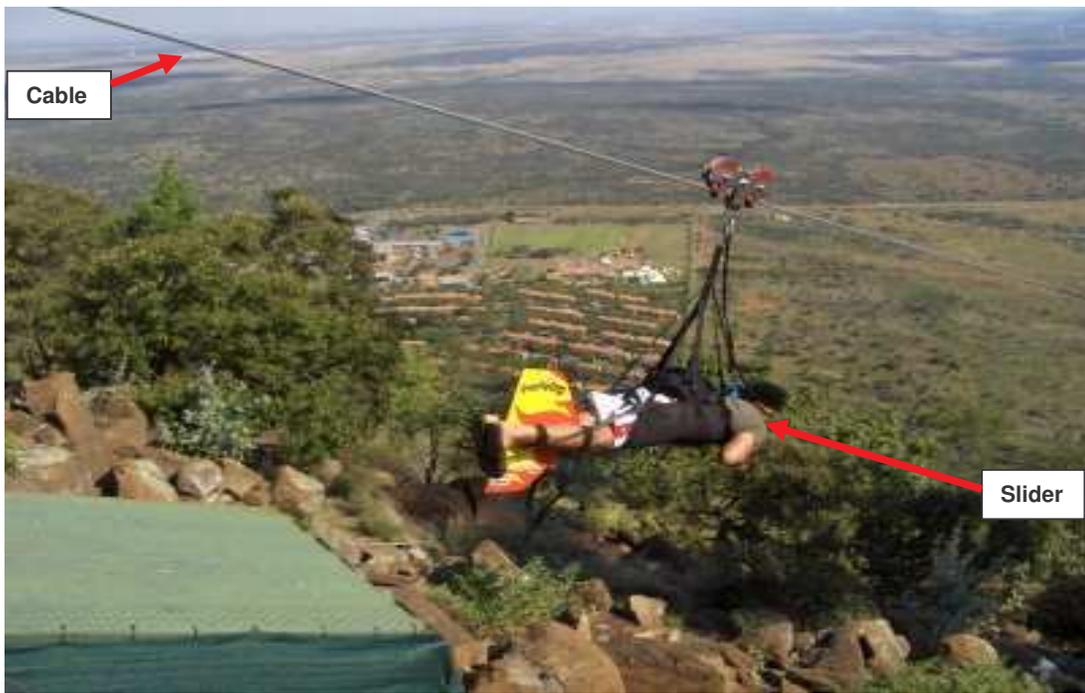
Figure 2: View of the zip slide cable spanned from the mountain top and how it operates (Photo found on internet).

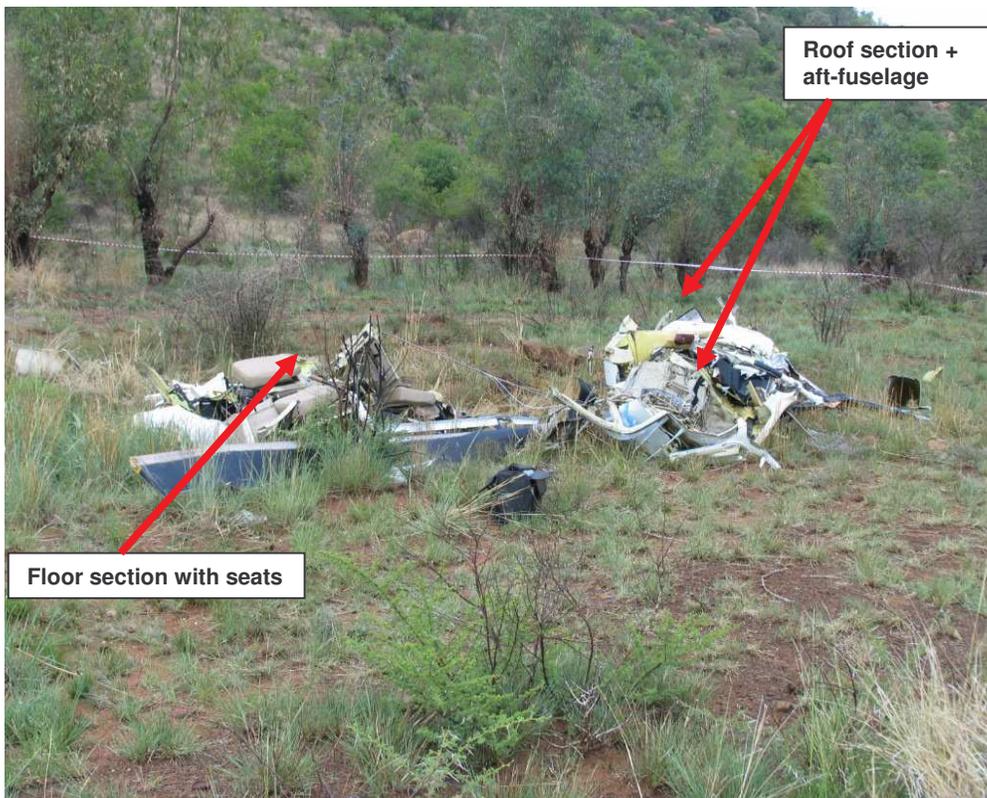
- 1.2.1 The aircraft was destroyed.

Figure 3: View of the accident site and the helicopter wreckage.

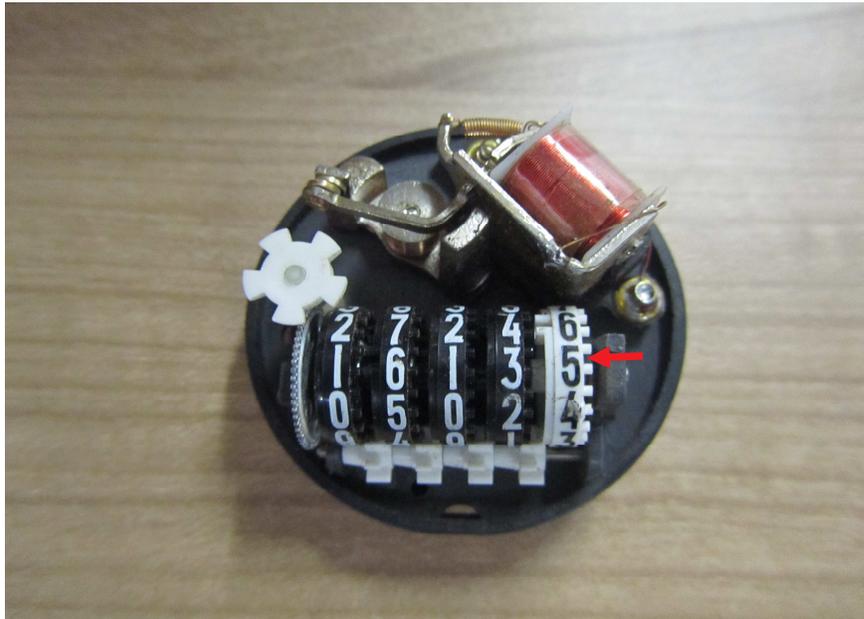
*NOTE: According to the flight folio, the last helicopter's Hobbs metre entry made at Wonderboom aerodrome (FAWB) dated 27 November 2011 was logged at 1612.6 hours and after the accident it was found to be on 1613.5 hours which meant that the helicopter had flown a total of 0.9 hours. See the Hobbs metre on figure 5 below:

Figure 5: View of the Hobbs metre as found at the accident site.

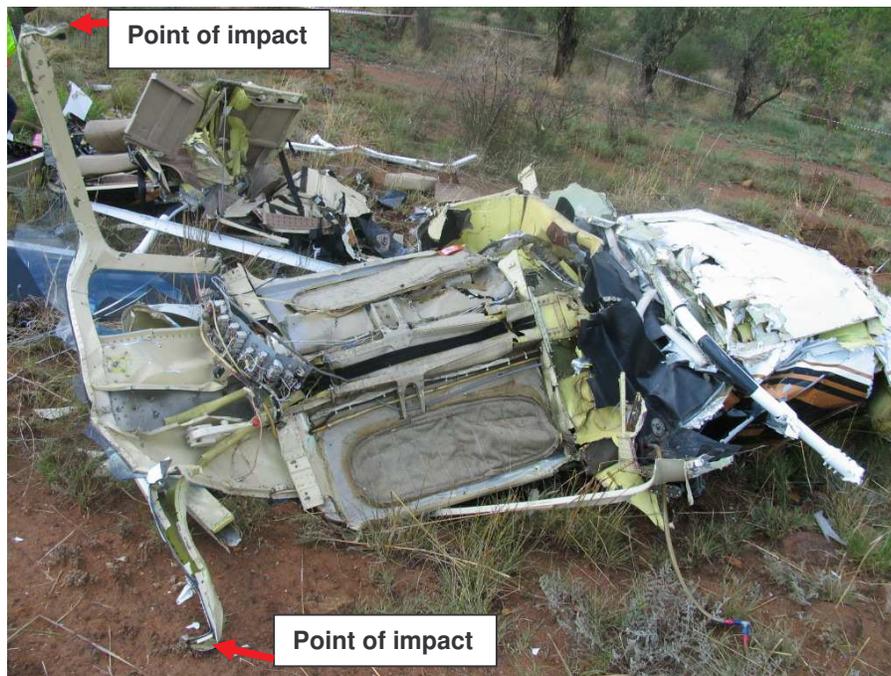
1.12.1 The accident occurred near the foot of Sun City Mountain. The helicopter was destroyed after colliding with the zip line cable spanned from the top of Sun City Mountain but the cable did not fail. On site examination of the wreckage revealed that the helicopter struck the cable on the lower wind shield as it can be seen on figure 7 below.

Figure 7: Evidence of cable impact on the helicopter's lower wind shield area.

- 2.2 The pilot was also appropriately rated and there was no indication that medical factors might have affected his performance at the time of the accident. On-site investigation and examination of the wreckage revealed that the helicopter collided with the zip line cable spanned from Sun City Mountain top on the lower windshield and was destroyed.

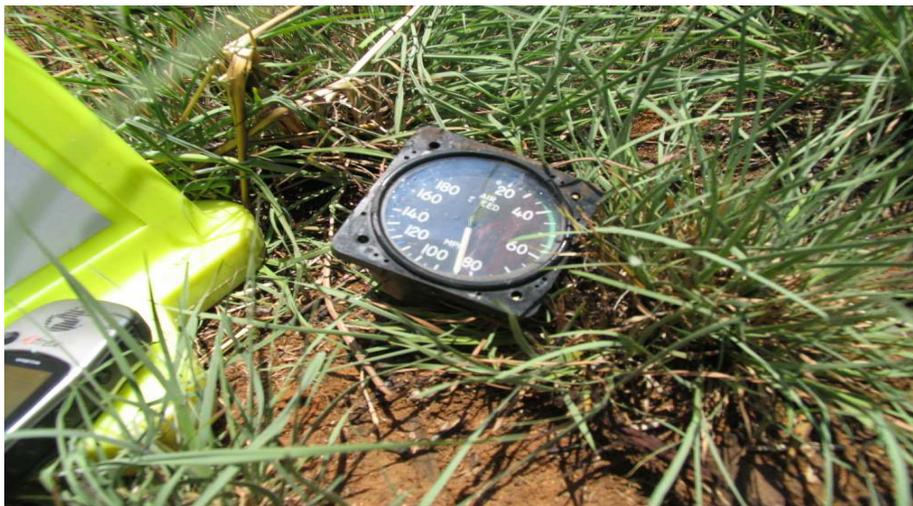
1.12.2 The tail boom was destroyed after impact with the ground and the tail rotor gear box detached from the tail rotor. The fuel tank ruptured during the impact sequence and there was evidence of fuel (Jet A1) smell at the wreckage. Examination of the engine and the main rotor (two bladed) revealed that the engine was operating normally prior the accident. All the doors detached from the helicopter and were severely damaged. The helicopter battery ruptured after impact with the ground. Although the cockpit instrument console was severely damaged airspeed indicator, which was found to have separated from the instrument panel, displayed a reading of 85 mph.

Figure 8: Airspeed indicator.
