AIRCRAFT ACCIDENT REPORT AND EXECUTIVE SUMMARY

Reference:	CA18/2/3/8999	
Aircraft Registration	ZS-NBW	Date of Accident	07 January 2012		Time of Accident	0730Z
Type of Aircraft	Cessna 150		Type of Operation		Private (Hire & Fly)	
Pilot-in-command Licence Type		Private Pilot	Age	35	Licence Valid	Yes
Pilot-in-command Flying Experience		Total Flying Hours	167.3		Hours on Type	62.4
Last point of departure		Port Elizabeth Aerodrome (FAPE), Eastern Cape				
Next point of intended landing		Port Elizabeth Aerodrome (FAPE), Eastern Cape				
Location of the accident site with reference to easily defined geographical points (GPS readings if possible)						
On Syfergat Farm, approximately 8km North of Uitenhage, Eastern Cape (GPS S33°44.651 E025°19.271)						
Meteorological Information		Fine weather conditions; Temperature: 17 °C with no cloud; Wind 060°/04kt; Visibility CAVOK.				
Number of people on board	1 + 1	No. of people injured	0	No. of people killed	2

Name of Owner/Operator : Madiba Bay School of Flight CC
Manufacturer : Cessna Aircraft Company
Model : Cessna150L
Nationality : South Africa
Registration Marks : ZS-NBW
Place : On Syfergat farm, 8km north of Uitenhage
Date : 07 January 2

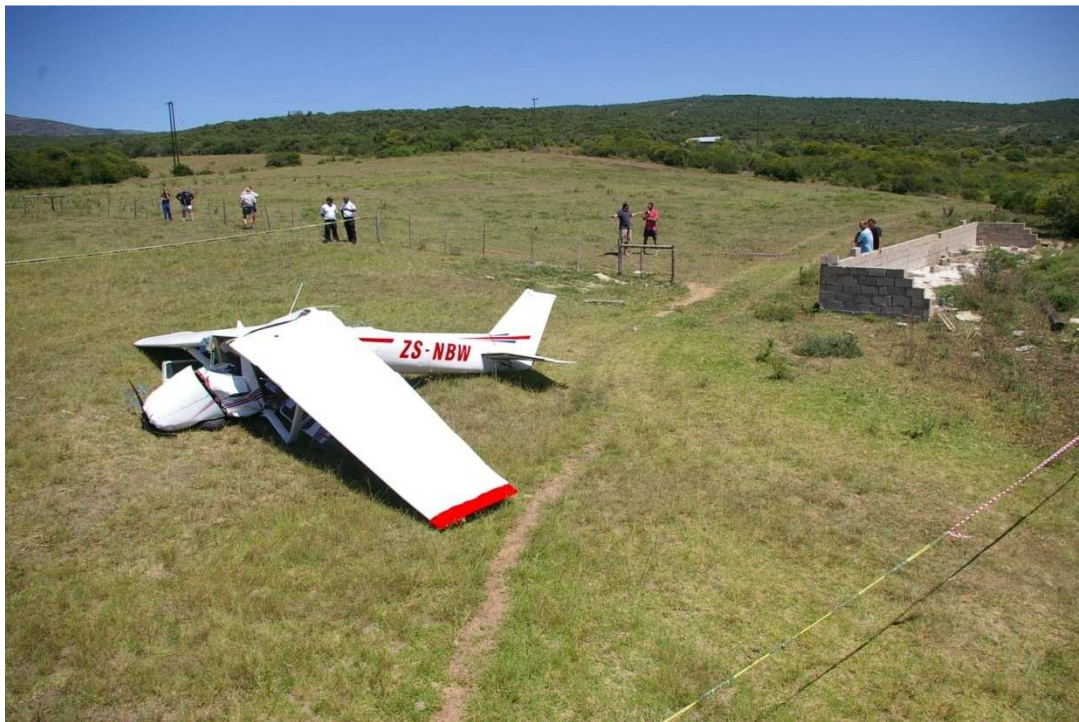
1.3.1 The aircraft was extensively damaged during the accident sequence.

Figure 2: Damage caused to the aircraft

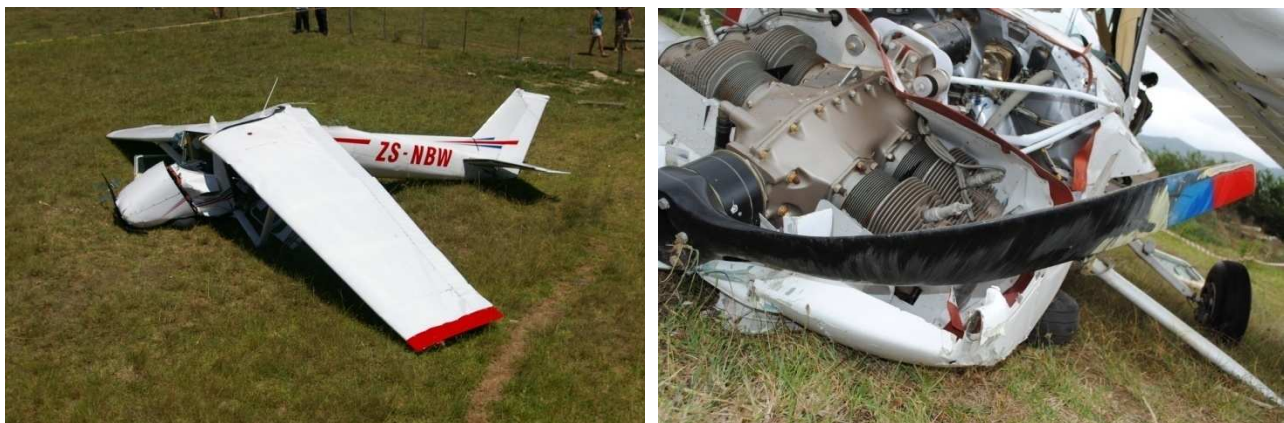
1.12.3 The witness marks on the propeller indicated that the engine was at a low/idle power setting at the time of the impact sequence. The throttle was found in the idle position and the right rudder pedal was fully depressed.

Figure 5 & 6: Damage to the aircraft, propeller blades and the wing support struts

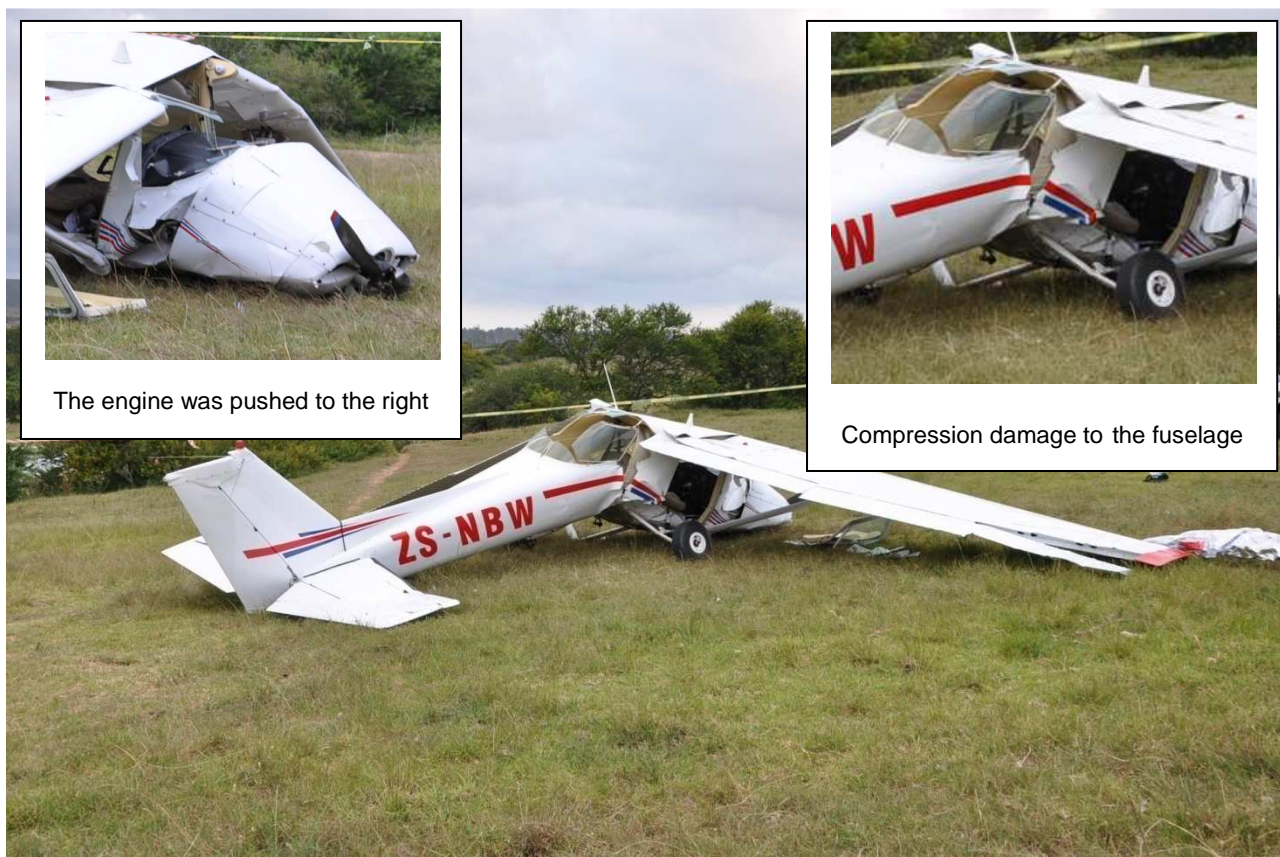
1.12.2 The aircraft sustained damage to both wings which bent downwards as a result of the impact forces. The cockpit area was substantially damaged. The nose landing gear collapsed and the main landing gear sustained damage. The rudder, horizontal stabilizer and elevators were also damaged. The trailing edge root of the left high wing exhibited compression. Compression was evident to the left side of the fuselage and to the leading edge root of the right high wing. The engine was pushed to the right, tension was evident to the trailing edge root of the right high wing and impact damage to trailing edge right wingtip.

Figure 7: Damage to the aircraft

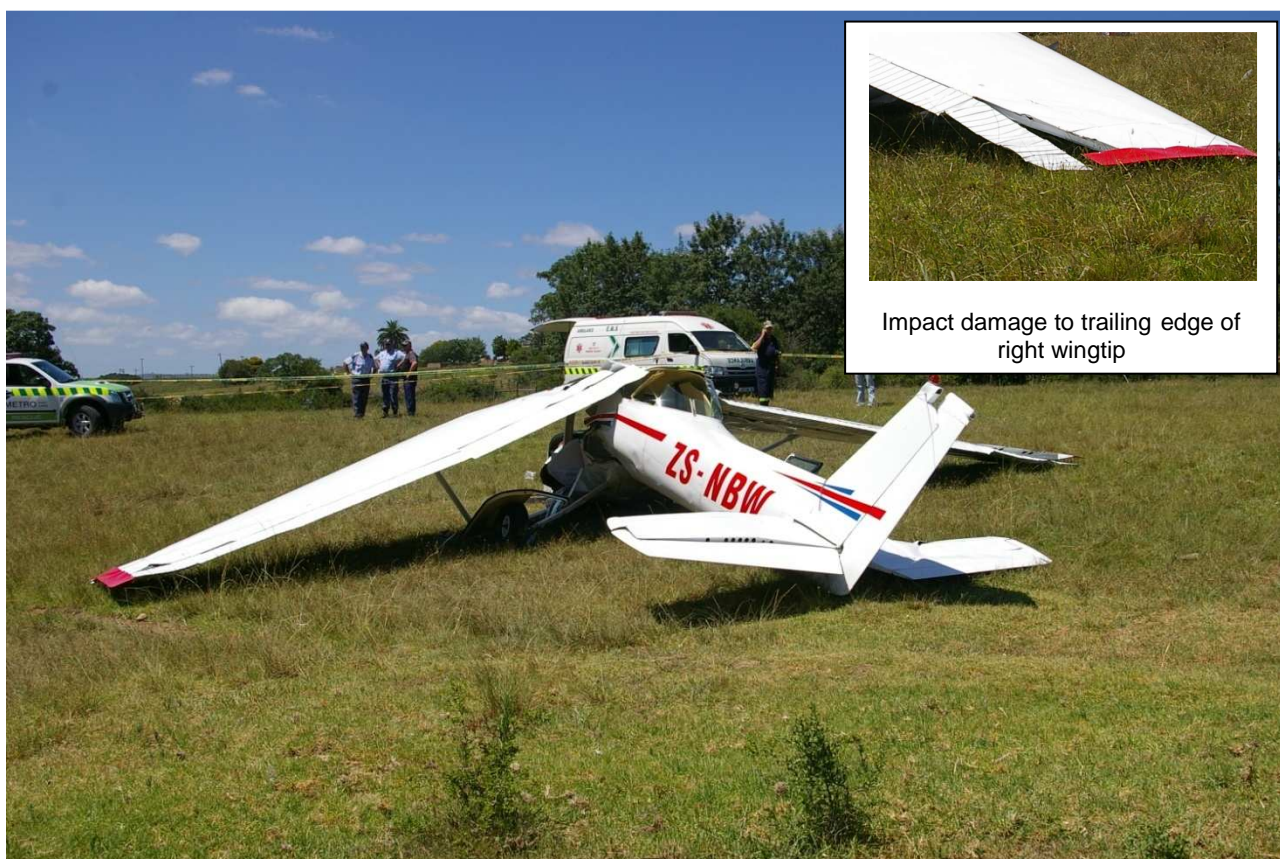
Figure 8: Damage to the aircraft

- 2.2 The wreckage pattern of the aircraft wreckage exhibited compression to the trailing edge root of the left wing, compression to the left side of the fuselage and compression to the leading edge root of the right wing. It also revealed tension to the trailing edge root of the right wing, that the engine was pushed to the right and impact damage to trailing edge of the right wingtip. The wreckage pattern is indicative of damage sustained by an aircraft in a typical left spin.

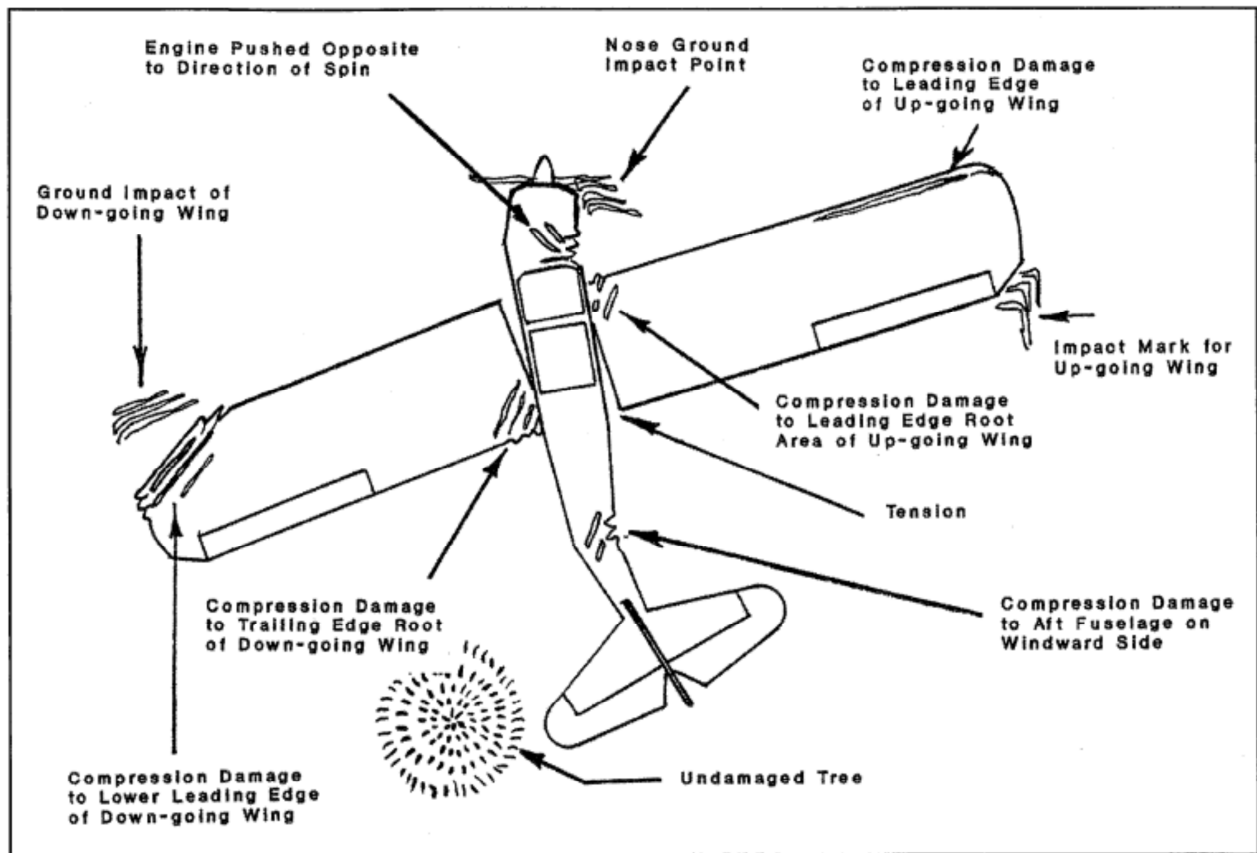
1.12.3 The damage that ZS-NBW sustained, exhibited a wreckage pattern that can be compared with a typical spinning aircraft similar to the one illustrated in Aircraft Accident Investigation Book - Second Edition by Richard H. Wood and Robert W. Sweginnis (See Figure 9).

Figure 9: Wreckage pattern of a spinning airplane
