AIRCRAFT ACCIDENT REPORT AND EXECUTIVE SUMMARY

Reference:	CA18/2/3/9011	
Aircraft Registration	ZS-NLR	Date of Accident	6 February 2012		Time of Accident	1605Z
Type of Aircraft	Dromader PZL-M18A		Type of Operation		Other Aerial Work	
Pilot-in-command Licence Type		Commercial Pilot	Age	68	Licence Valid	Yes
Pilot-in-command Flying Experience		Total Flying Hours	15 515,6		Hours on Type	1 800,0
Last point of departure		Pearly Beach aerodrome, (Western Cape province)				
Next point of intended landing		Andrew's aerodrome near Struisbaai, (Western Cape province)				
Location of the accident site with reference to easily defined geographical points (GPS readings if possible)						
Farm Duinefontein in the Overberg district (GPS position; South 34°37'24.7" East 019°28'14.1")						
Meteorological Information		Surface wind: 225°/ 3kt, Temperature: 28°C, Visibility: +10 km				
Number of people on board	1 + 0	No. of people injured	1	No. of people killed	0

AIRCRAFT ACCIDENT REPORT

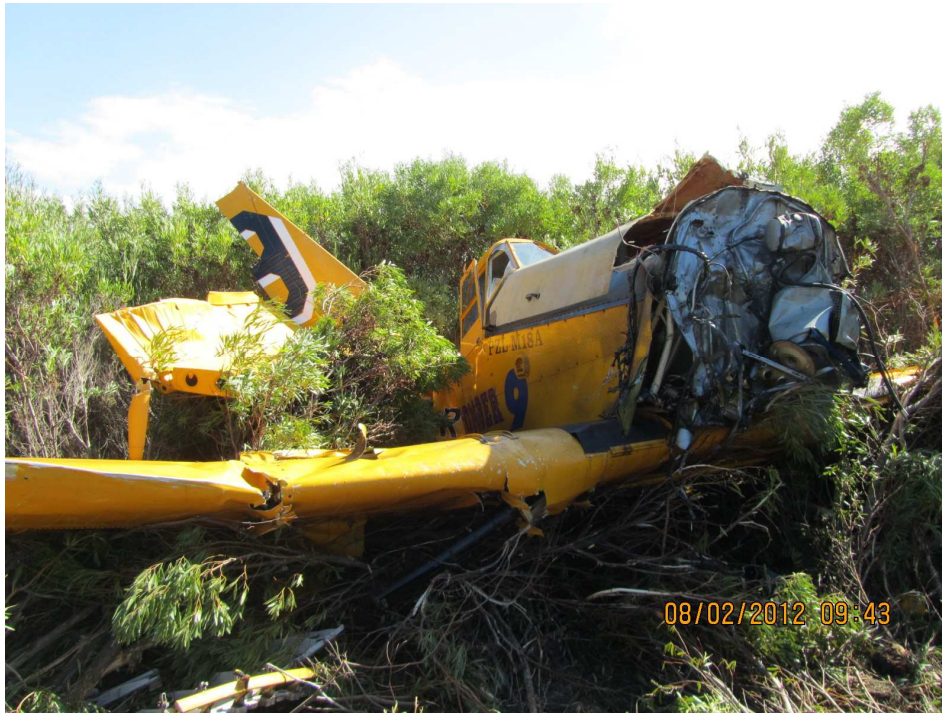
1.3.1 The aircraft was extensively damaged during the impact sequence.

Figure 1. A view of the wreckage with the engine and propeller ripped off.

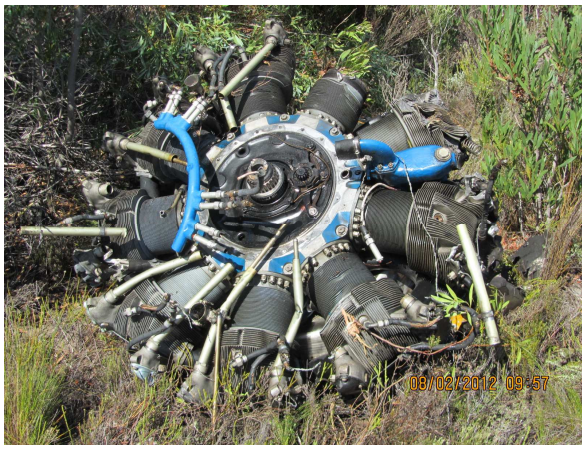
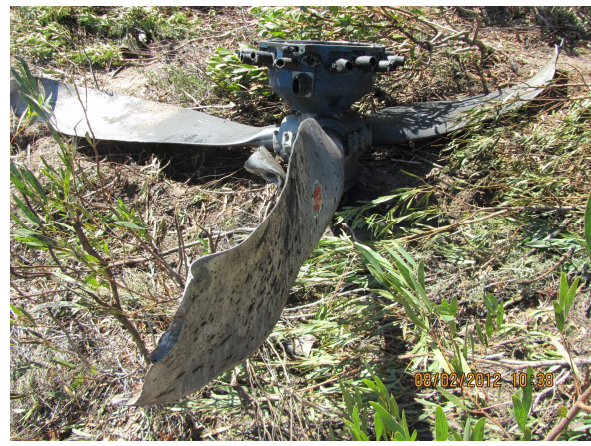
Approximately 30 m after the first point of impact the propeller struck the ground. During the impact sequence the propeller and driveshaft assembly failed and the propeller assembly separated from the engine attachment and came to rest approximately 15 m further on. The engine attachments also failed in overload mode and as a result the engine was projected in the direction of impact, coming to rest approximately 90 m further on. Several pieces of the exhaust as well as the carburettor assembly were found along the impact line in the direction the engine was projected.

Figure 5. A view of the engine and the propeller respectively.

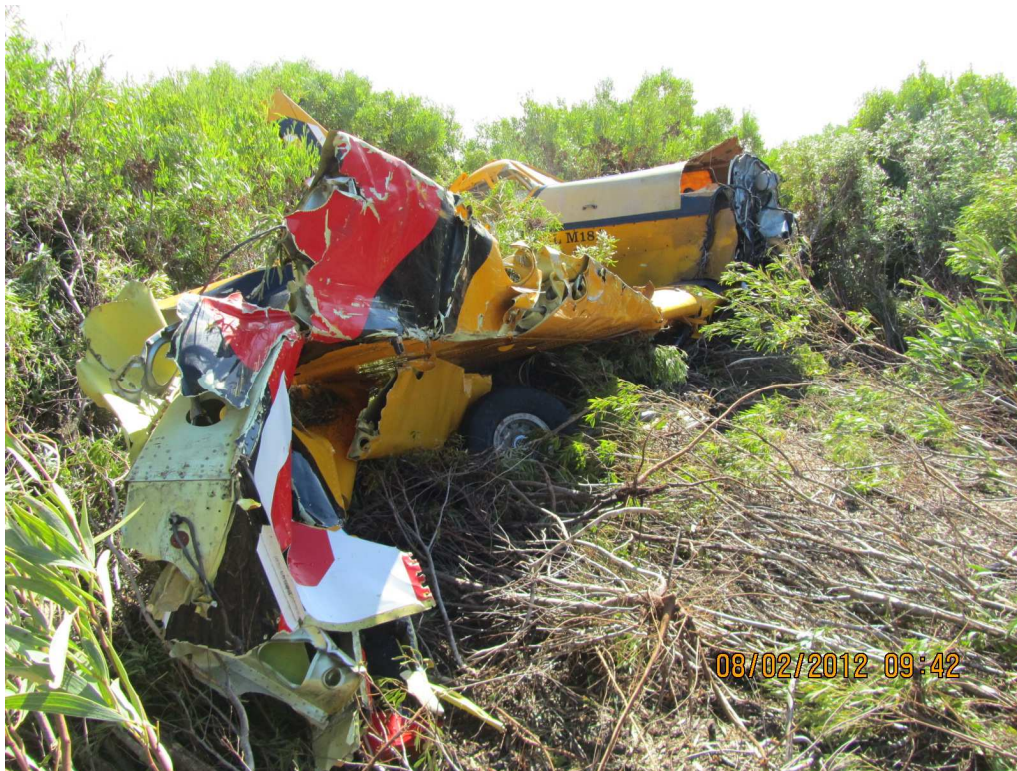
Figure 6. A photo of the right wing which was substantially deformed during the impact sequence.

1.12.3 The right wing, especially the outer section displayed evidence of ground impact and was severely deformed. Both wing structures remained attached to the airframe structure. The hopper tank which consists mainly of a glass fibre structure, located between the engine and the cockpit was found to have fractured at several places. According to the pilot, he was soaked in water that spilled from the hopper tank into the cockpit area during the impact sequence. The water in the hopper

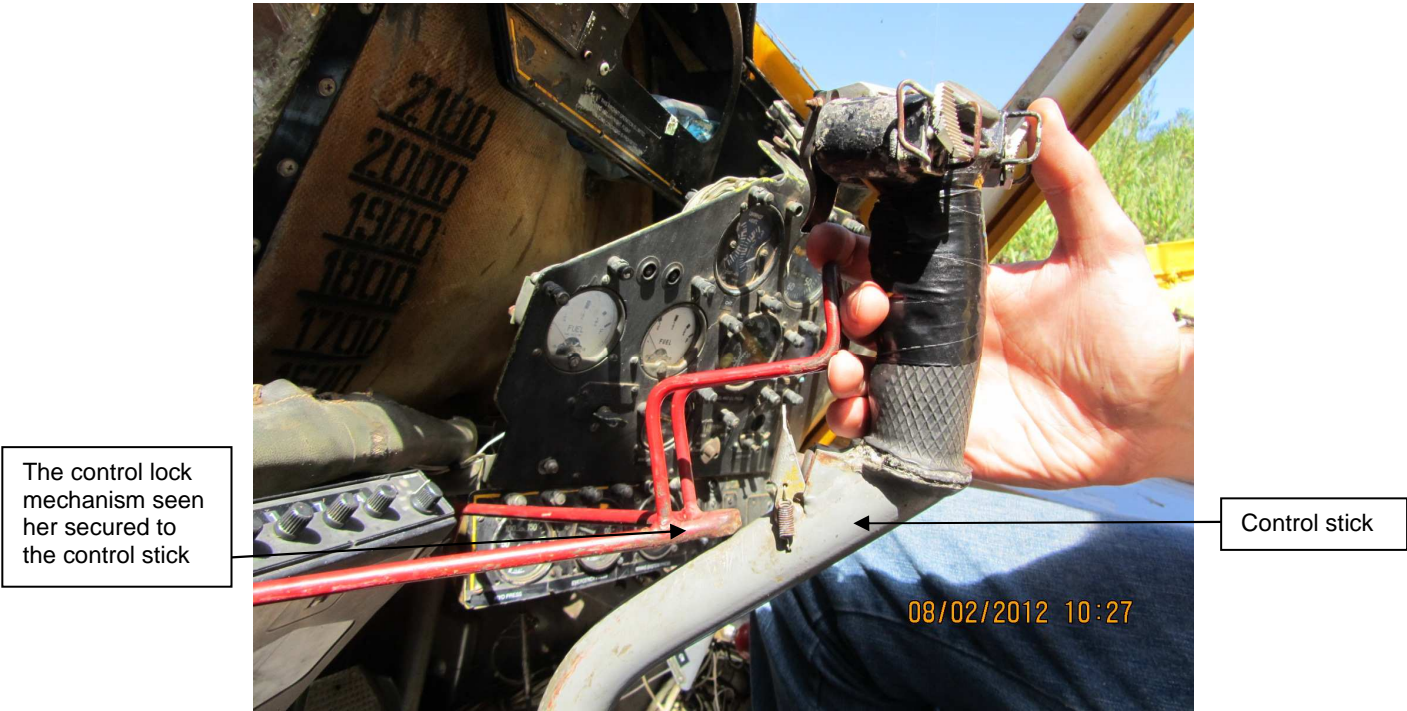
The control stick locking mechanism, which is a metal constructed device in a V-shape lock into the top of the control stick by means of a pin and a hole on the control stick (see figure 7). The locking mechanism is attached to the airframe at two pivot points, which is secured by a locking pin on either side. Once the control lock mechanism is disconnected from the control stick, the pilot/person performing the task then needs to rotate it downwards and forward, into the stowed position (see figures 8 and 9). The locking mechanism was equipped with a spring on the right-hand side. The sole purpose of the spring is to pull the locking mechanism into the stowed position and keep it there (see figure 10 for picture of the spring and it position). The spring that was secured to this mechanism showed signs of severe wear. Due to the V-shape of the locking mechanism it was possible to install a transponder unit in the lower cockpit area, which was done on this aircraft. When the mechanism is in the stowed position it was able to slide pass the transponder unit on both sides as can be seen in figure 8 and 9.

The control lock mechanism was designed with a build in safety device, to ensure the pilot remove the mechanism prior to flight. The design is such that it restricts the pilots hand and he or she is therefore unable to get proper hold of the control stick as displayed in figure 7.

Figure 7. A photo of the control stick in the locked position with the control lock mechanism secured.

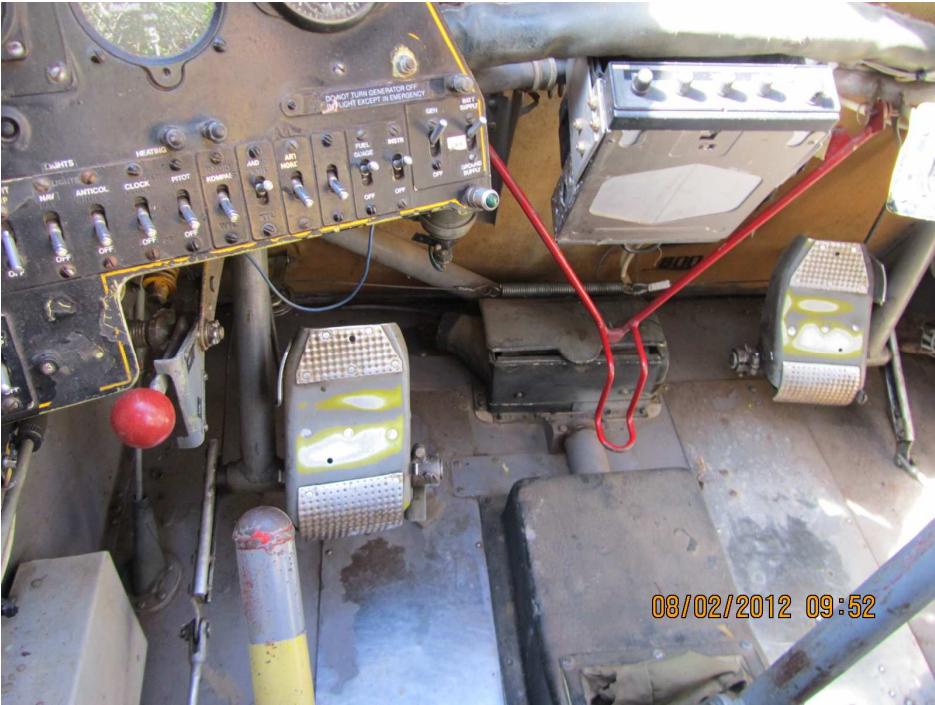
Figure 8. A photo of the control lock mechanism in the forward or “stowed” position.

The fact that the control lock mechanism was able to make contact with the control stick during flight could be attributed to the fact that the control lock mechanism was most probably not adequately secured or checked in the pre-flight once the pilot had released the device from the control stick. The absence of a proper locking device to secure the control lock mechanism should be regarded as a latent shortcoming on this aircraft.

That the SACAA Airworthiness Division issues an Emergency Service Directive that will ensure that all aircraft equipped with this kind of control lock be equipped with a proper mechanism that will ensure that once the control lock had been removed from the control stick the control lock is secured and locked in such a way that it cannot be moved unless the control lock securing mechanism has been released to allow for such movement.”

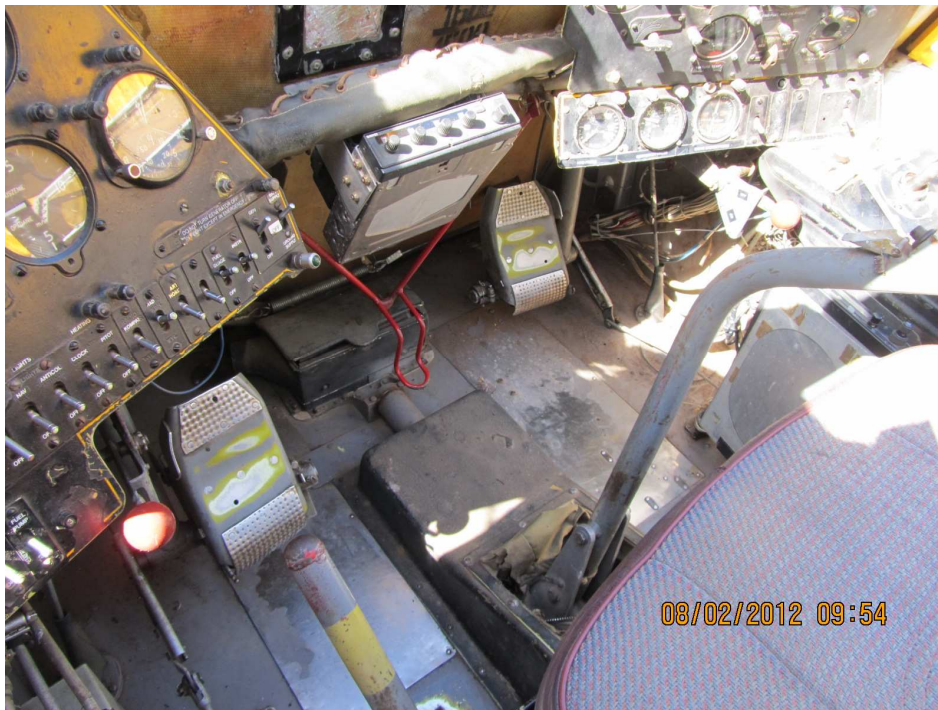
Figure 9. A photo of the control lock mechanism in the forward or “stowed” position.

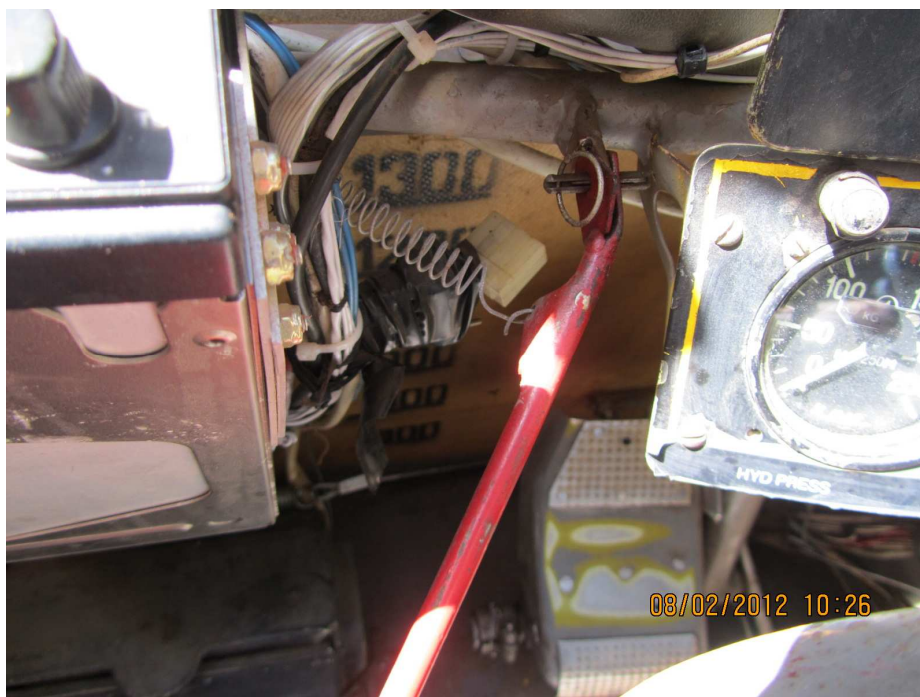
Figure 10. A photo of the control lock spring that assist in securing the device once unlocked.

On the accident aircraft the spring was installed, however, it was found to be in an advance state of wear if compared to that of a new spring. The service life of the spring in question could not be determined as it was an on conditions item. The probability remain that the spring was never replaced since the aircraft was introduced into service, as a new aircraft.

With the spring tension below standard, it is possible that the control lock mechanism could have swung/rotated backwards (towards the control stick) and made contact with the control stick at the time when the aircraft sank back onto the runway as the right main wheel made contact with the runway surface. As the lock mechanism swung/rotated backwards it was possible to jam on the side of the control stick as displayed in figure 11 on page 15 of this report, and as explained by the pilot during the on-site investigation and in a follow-up statement.

- 3.1.8 The aircraft had approximately 750 litres of fuel onboard at the time of impact.
- 3.1.9 The retaining spring that was installed on the control lock mechanism to assist in stowing the device was found to be in advance state of wear.

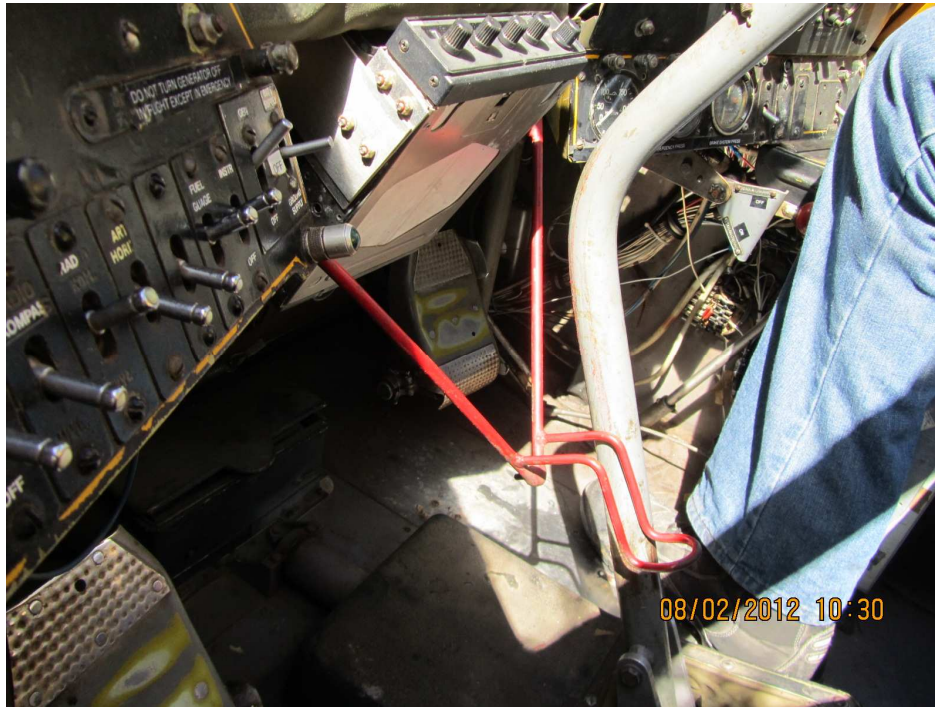
As stated by the pilot that once he looked down into the cockpit he noticed that the control lock mechanism was jammed on the left-hand side of the control stick as can be seen in the illustration in figure 11. Due to limited lateral movement on the control stick the aircraft immediately started to roll to the right after take-off. By the time the pilot made the observation, the right wing collided with indigenous vegetation and the aircraft impacted with the ground. According to the pilot from the time the aircraft became airborne until ground impact was a matter of seconds.

Figure 11. Photo of the control lock mechanism positioned on the left-hand side of the control stick.

- 3.2.1 Due to limited control stick movement in the lateral plane, induced by the control stick locking mechanism that made contact with it on take-off, the aircraft rolled to the right, followed by ground impact.
