# AIRCRAFT ACCIDENT REPORT AND EXECUTIVE SUMMARY

Reference:	CA18/2/3/9035	
<b>Aircraft Registration</b>	<b>ZU-EMR</b>	<b>Date of Accident</b>	27 April 2012		<b>Time of Accident</b>	1452Z
<b>Type of Aircraft</b>	Gyro MT-03		<b>Type of Operation</b>		Private	
<b>Pilot-in-command Licence Type</b>		Recreation Learner Pilot	<b>Age</b>	66	<b>Licence Valid</b>	Yes
<b>Pilot-in-command Flying Experience</b>		Total Flying Hours	89.3		Hours on Type	89.3
<b>Last point of departure</b>		Private strip in Fouriesburg-(Free State Province)				
<b>Next point of intended landing</b>		Tempe airfield - (Free State Province)				
<b>Location of the accident site with reference to easily defined geographical points (GPS readings if possible)</b>						
On a farm in Dealseville near R64 road GPS coordinates S28° 48,187' E 025° 50 531'						
<b>Meteorological Information</b>		Wind direction :280°;Wind speed:10knots ; Temperature: 21°C;Dew point 02°Ccloud and visibility ok (CAVOK)

## AIRCRAFT ACCIDENT REPORT

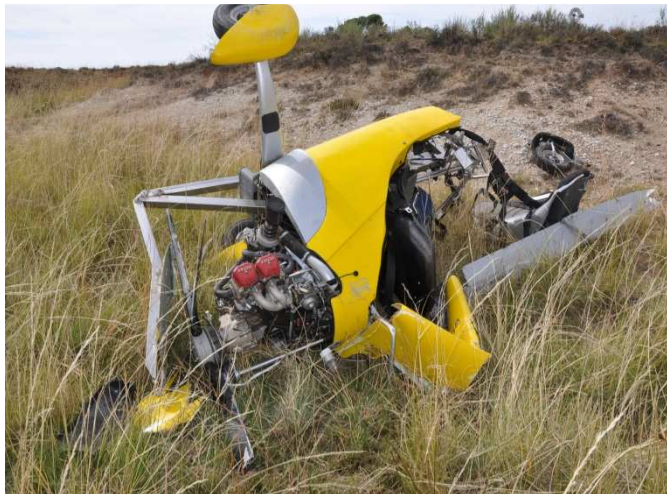
1.3.1 The aircraft was destroyed during the accident.

Figure 1: Damage to the Gyrocopter

1.12.6 The main wreckage was lying on its right hand side and the cockpit area was destroyed during the ground impact.

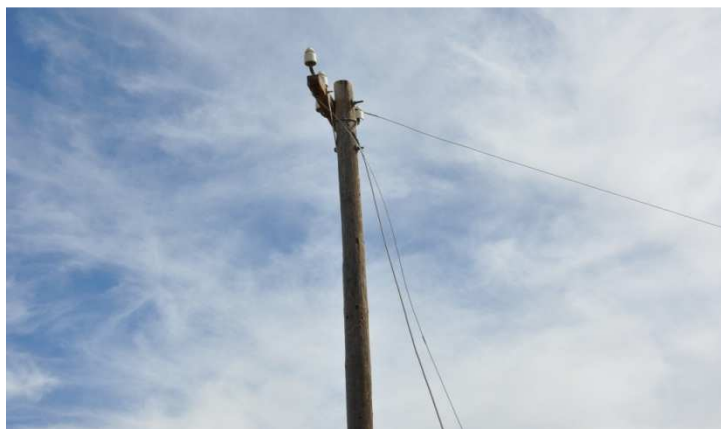
1.4.1 Other damage was caused to the telephone wire which was severed by the gyroplane as it struck the wire.

Figure 2: Damage to the telephone wires

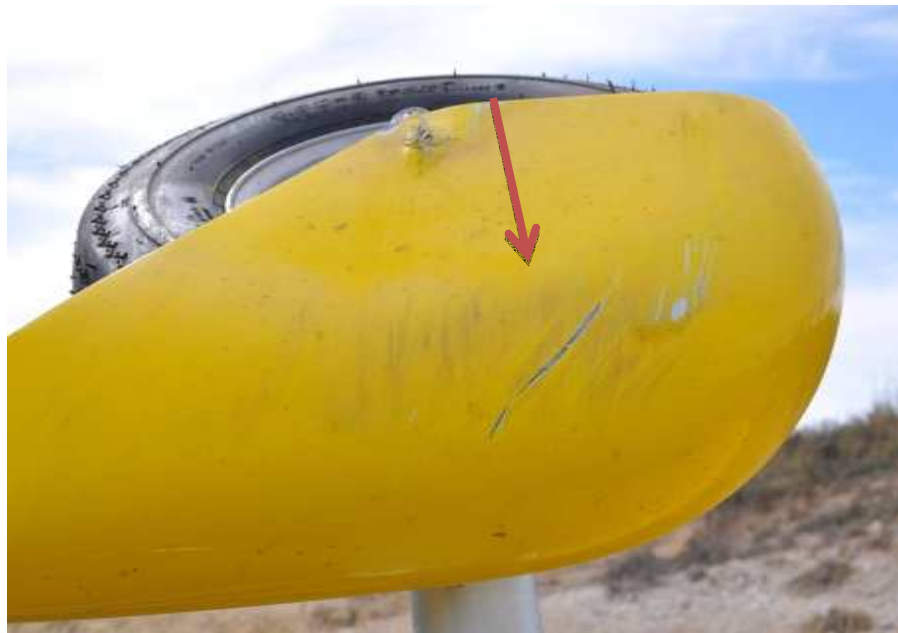
1.12.4 The spat on the left-hand main landing gear had scuff marks indicating that, that was the 1<sup>st</sup> contact with the telephone wires. This was supported by yellow paint marks from the spat on the telephone wires.

Figure 3: The wire marks on the left gear

- 2.4 The inspection of the gyroplane left landing gear revealed marks associated with the impact of a metal cable. Evidence of a broken telephone wire had the yellow marks which indicated that the left landing gear had impacted the wire.

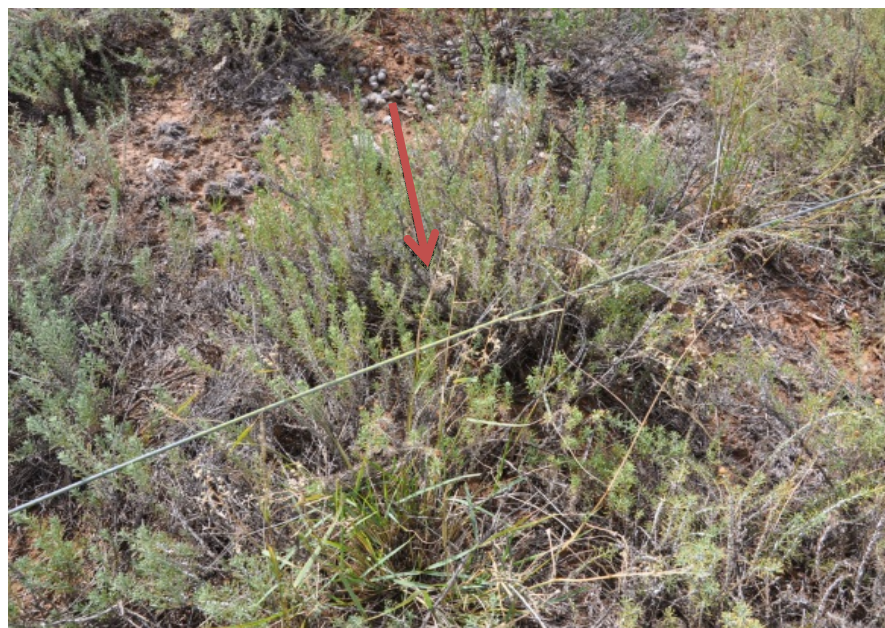
Figure 4: The yellow paint mark on the wire
