AIRCRAFT ACCIDENT REPORT AND EXECUTIVE SUMMARY

Reference:	CA18/2/3/9061	
Aircraft Registration	ZS-HIG	Date of Accident	12 July 2012		Time of Accident	1320Z
Type of Aircraft	Robinson R44 Raven I		Type of Operation	Private flight		
Pilot-in-command Licence Type		Private Pilot	Age	53	Licence Valid	Yes
Pilot-in-command Flying Experience		Total Flying Hours	770.0		Hours on Type	114.0
Last point of departure		Farm Vucht, Lephalale district (Limpopo province)				
Next point of intended landing		Game farm Africa Sand Safaris, (Limpopo province)				
Location of the accident site with reference to easily defined geographical points (GPS readings if possible)						
Game farm Africa Sand Safaris (GPS position: South 23°25.465' East 027°35.079'); elevation 2 773 feet						
Meteorological Information		Surface wind: 225/20 knots, Temperature: 20°C, Visibility: > 10 km				
Number of people on board	1 + 1	No. of people injured	1 + 1	No. of people killed	0	
Synopsis

AIRCRAFT ACCIDENT REPORT

Name of Owner : Dr. D. Kriel
Name of Operator : Private flight
Manufacturer : Robinson Helicopter Company
Model : R44 Raven I
Nationality : South African
Registration Marks : ZS-HIG
Place : Africa Sand Safaris

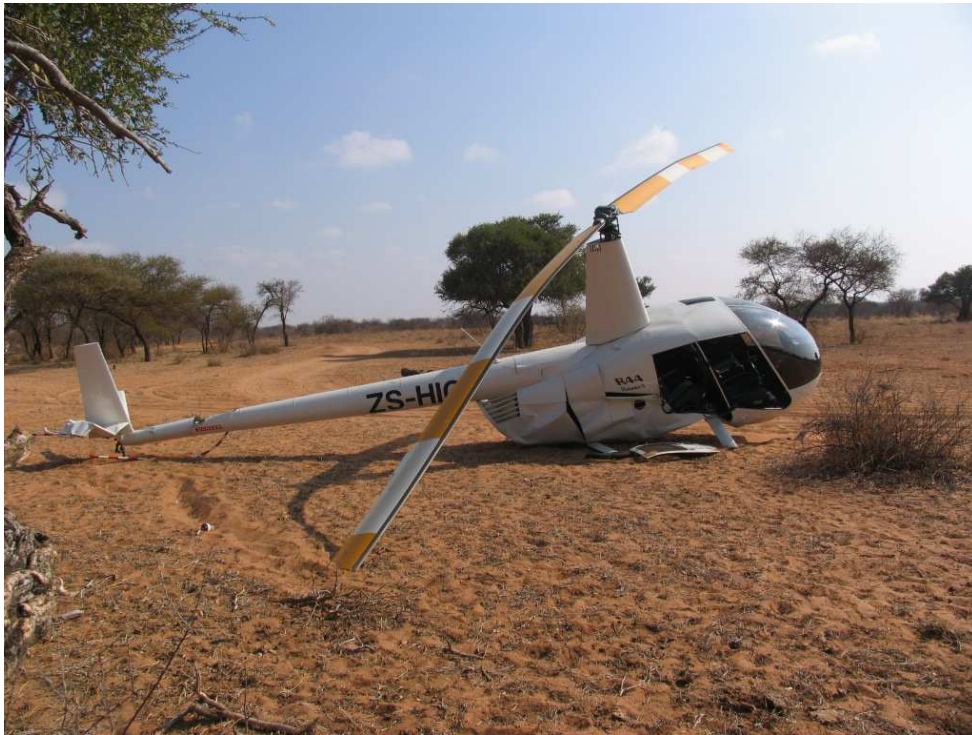
- 1.3.1 The helicopter sustained substantial damage during the impact sequence.

Figure 1. A view of the helicopter as it came to rest.

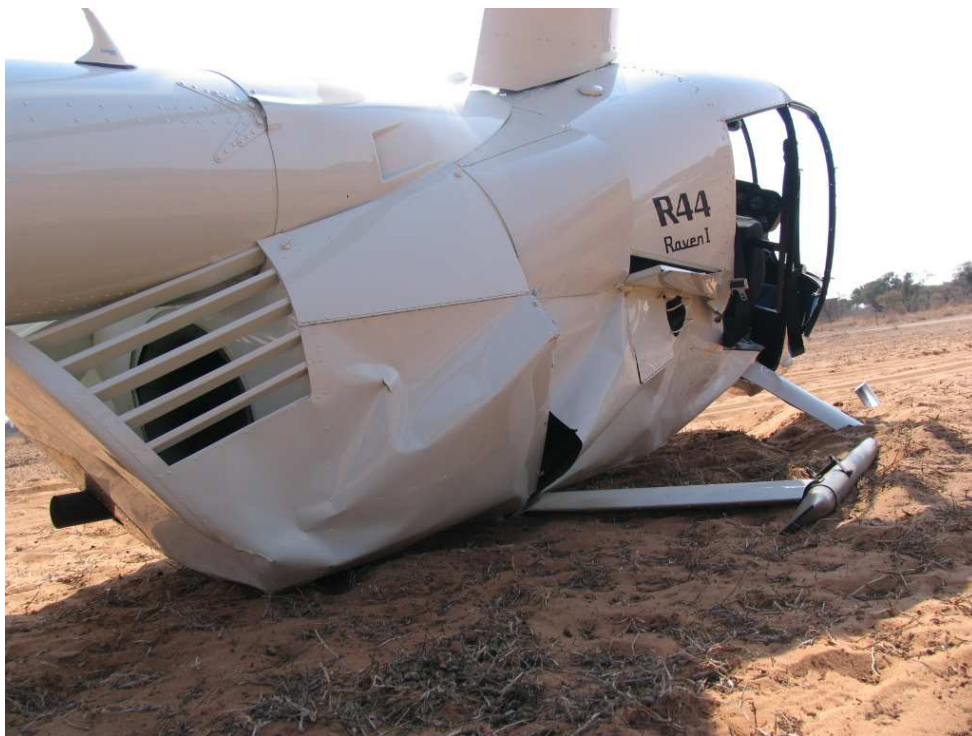
Figure 2. A view from the right aft position with the right aft skid gear flattened.

1.12.2 During the impact sequence the right aft skid gear collapsed. As the skid gear collapsed, the lower section of the vertical stabiliser also struck the ground. Due to the deformation of the fuselage, the main rotor blades struck the upper skin surface of the tail boom just aft of the strobe light installation on top of the tail boom. This caused the tail boom sheet metal structure to separate, but the tail rotor controls and tail rotor driveshaft remained secured to the tail rotor gearbox, ensuring continuity from the main drive train. Following the main rotor blade impact the tail rotor assembly rotated through 90° to the left and impact with the soft sand, leaving an imprint in the sand indicating that the rotor hub assembly was still turning at the

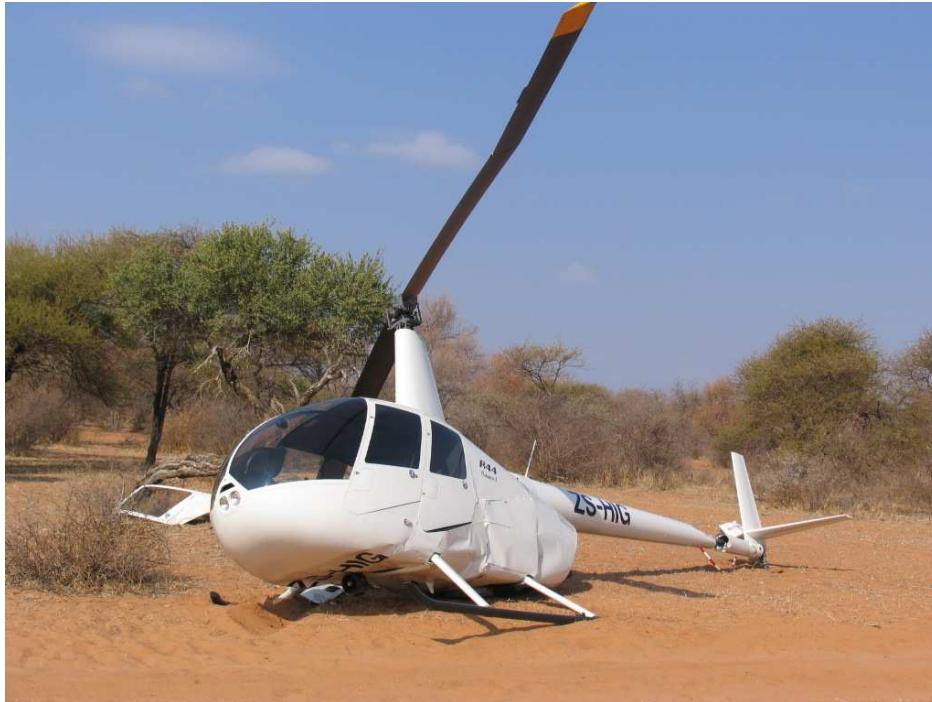
Following the collapse of the skid gear on the aft right-hand side, the wreckage came to rest at an incline, which allowed the main rotor blades to strike the tail boom and then the ground on the right-hand side of the fuselage. The engine (air filter box assembly) was in contact with the sand.

Figure 3. A view of the helicopter as it came to rest.

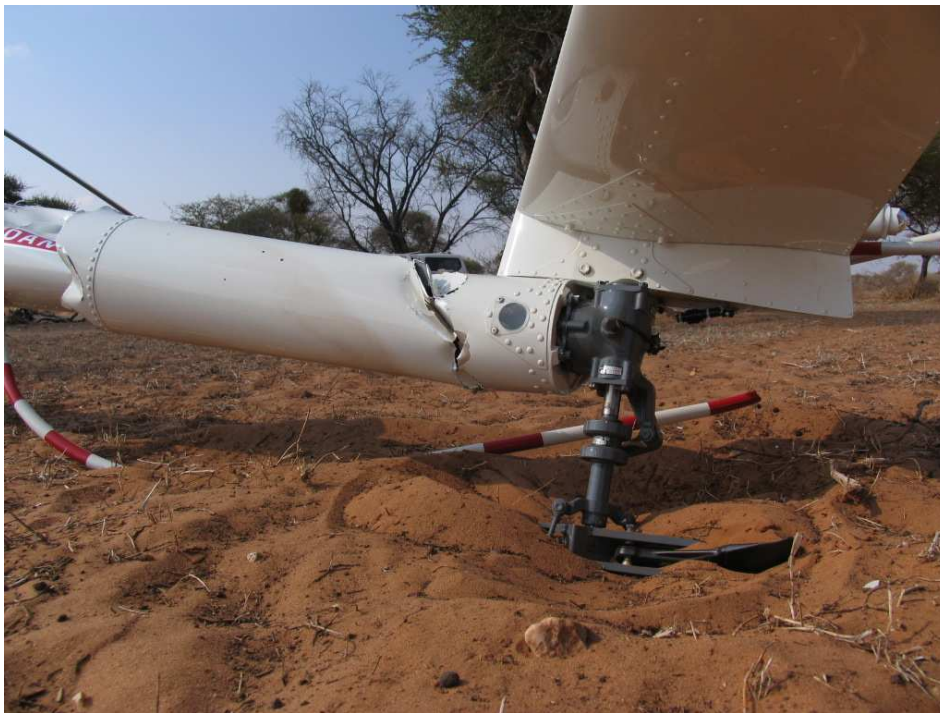
time. Both tail rotor blades were found to have separated in close proximity to the attachment to the rotor hub assembly and were found approximately 10 m away from the wreckage in the four o' clock position, with the wreckage viewed from behind.

Figure 4. A view of the tail rotor assembly with rotational evidence visible in the sand.

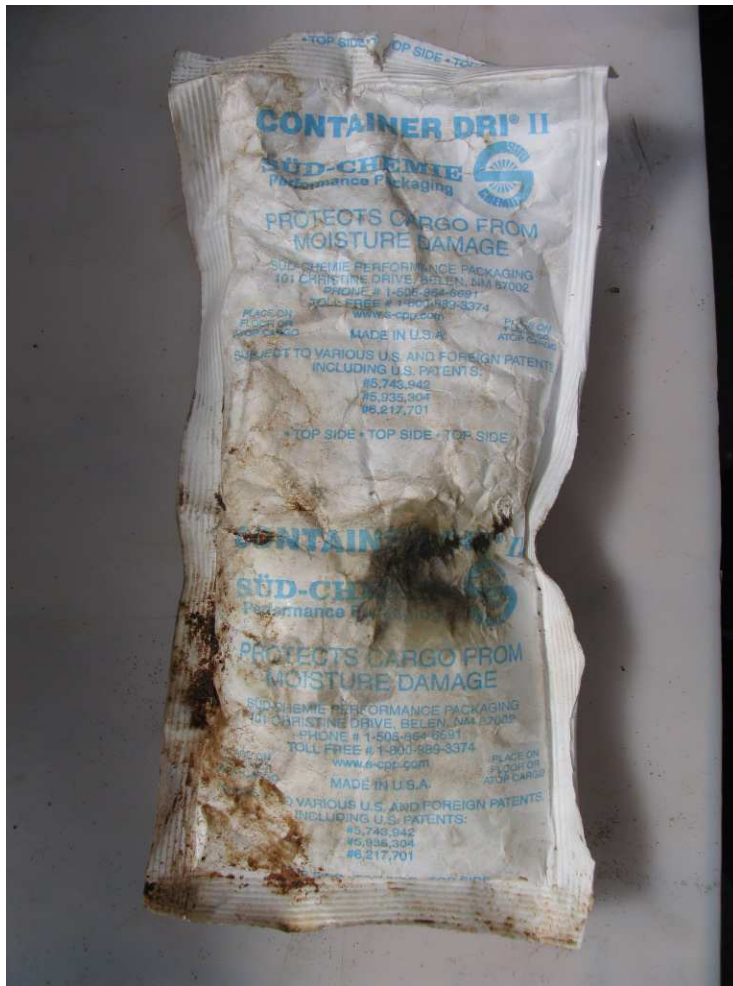
On Friday, 24 August 2012 the investigator received a call from an AMO who was requested by the helicopter owner to provide him with a quotation for a possible repair of the helicopter following the accident in question. In order to provide a detailed quotation the AMO had to make a proper assessment of the damage and in order to do so certain components, of which the engine, the air filter box and the carburettor needed to be removed. During the removal of the air filter box by an apprentice employed by the AMO a moisture absorbent bag (Container Dri II, Sud-Chemie, Performance Packaging, www.s-cpp.com, Made in U.S.A.) see figure 5 on the next page, was discovered lying in the air filter box directly under the carburettor according to a statement that was made available by the AMO. The apprentice that found the bag then notified his immediate supervisor as well as the Accountable manager, who in turn informed the investigator. The investigator then travelled to Wonderboom aerodrome to look at the evidence, which became available after the wreckage was moved several times following the accident. Several photos were taken of the bag which was still intact (no content from the bag was discharged into the engine). At the same time a borro-scope inspection was performed on the engine by an AME from an approved engine maintenance facility. The inspection displayed evidence of sand ingestion into the engine, which was also visible on a number of the spark plugs that was removed. The moisture absorbent bag, which measured 26 x 12 centimetres, was shown to the helicopter owner where after it was placed in a plastic bag and remained in the custody of the investigator.

Figure 5. A view of the moisture absorbent bag that was found by the apprentice.

Following the discovery of the moisture absorbent bag in the air filter box during disassembly of the helicopter (post accident), it is believed that if the moisture absorbent bag was in the air filter box assembly it had very little effect on the power availability of the helicopter following delivery thereof as no defects were reported to an AMO that required immediate maintenance intervention. The actual location of the bag within the air filter box assembly remains questionable, even though the apprentice that found the bag indicated it to be within the centre of the air filter unit directly below the carburettor. As indicated in correspondence with the helicopter manufacturer no such bags get placed in the air filter box, they only get placed within the air inlet hose as illustrated in this report, following inspection of a new Robinson R44 helicopter that arrived in South Africa.

4.4 On 27 August 2012 an urgent safety recommendation was forwarded to the Director of Civil Aviation for consideration after the moisture absorbent bag was located within the engine air filter box during a strip down of the helicopter following the accident.

The recommendation request that the document *“Robinson Model R44 Maintenance Manual 1.700 Special Instructions for reassembling and flight testing R44 series helicopters after crafting for export”* be amended with immediate effect, and that a checklist, which require the re-assembly crew to sign off each task should be added. Each warning label installed on the helicopter during the shipment procedure should have a clearly documented reference number to it and the person responsible for the task should be able to sign it off on the checklist. A duplicate inspection should form part of the checklist, which would require an additional column for a signature.

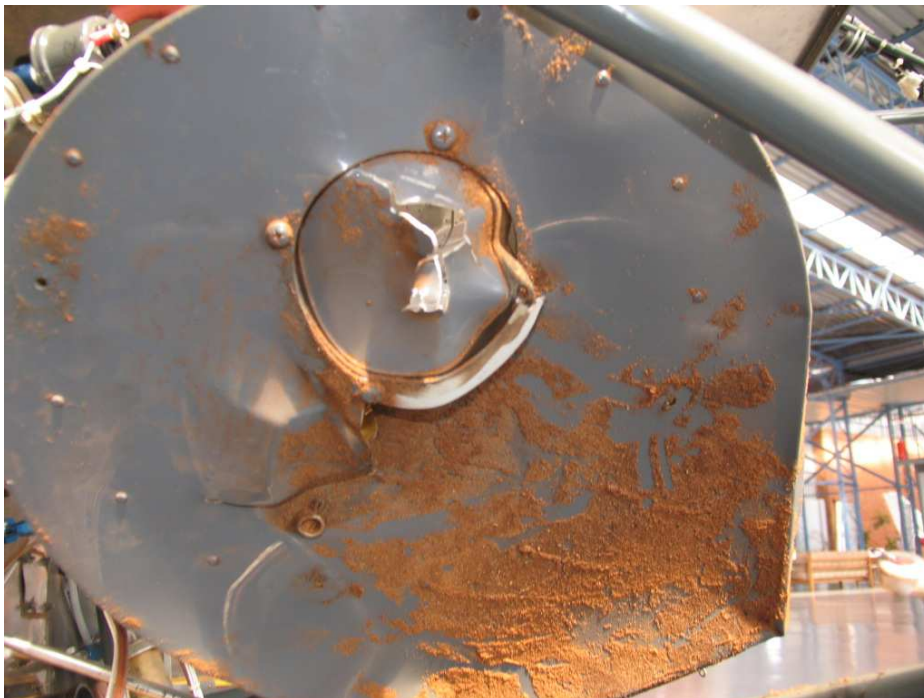
Figure 6. A view of the lower section of the air filter box which was in contact with the sand.

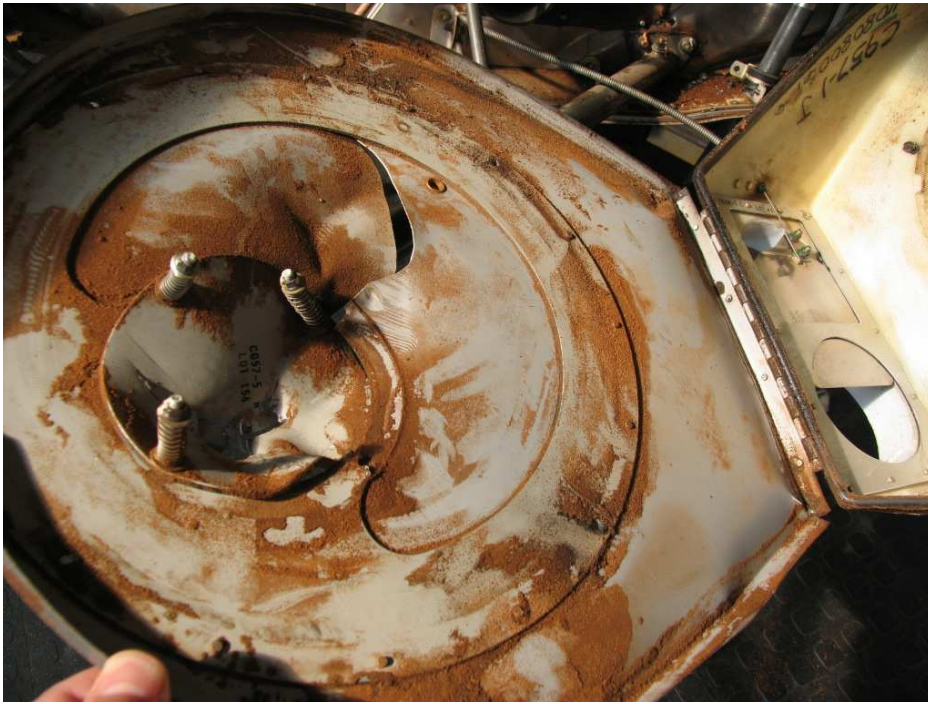
Figure 7. A view of the inside of the air filter box.

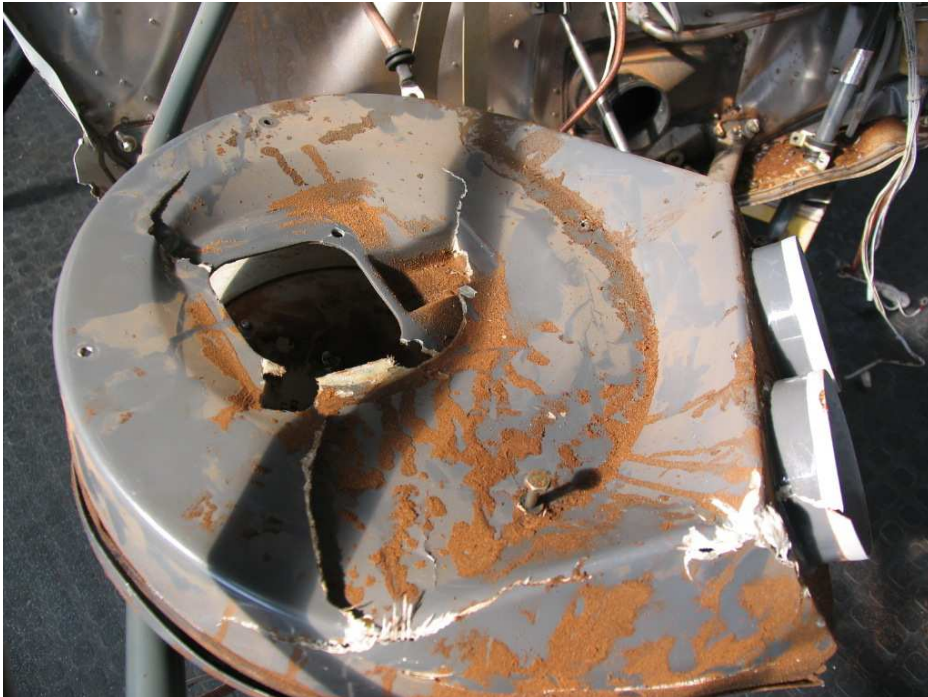
Figure 8. A view of the top of the air filter box where the carburettor gets attached to.

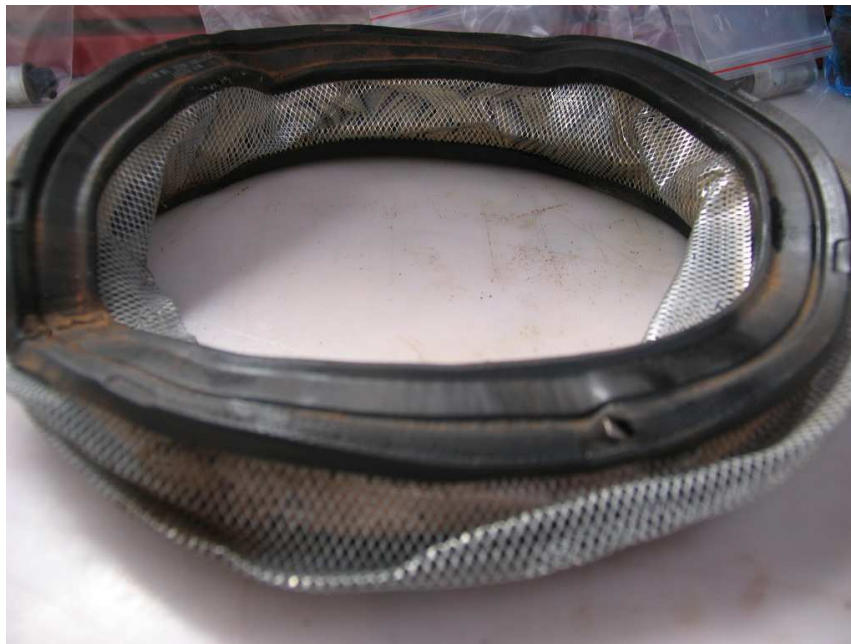
Figure 9. A view of the air filter that was in the filter box at the time of the accident.

The MPI inspection that was certified following re-assembly of the helicopter required an inspection of the air box and the alternate air door, including replacing the air filter. This task was signed off on the MPI inspection document by an Engineer and an Inspector, indicating the task was completed. It was however, ascertained during an interview with the relevant people that the air filter unit was not replaced during the MPI inspection due to the fact that the filter was still new (helicopter had only flown 4 hours with the filter installed by the time it arrived in South Africa).

- 3.1.6 The air filter was not replaced during the MPI inspection that was signed out on the aircraft after re-assembly in South Africa.
- 3.1.7 The weight and balance were found to be within the prescribed limits as stipulated in the pilot's operating handbook, with the helicopter being approximately 460 pounds below the maximum certified weight limit on impact.

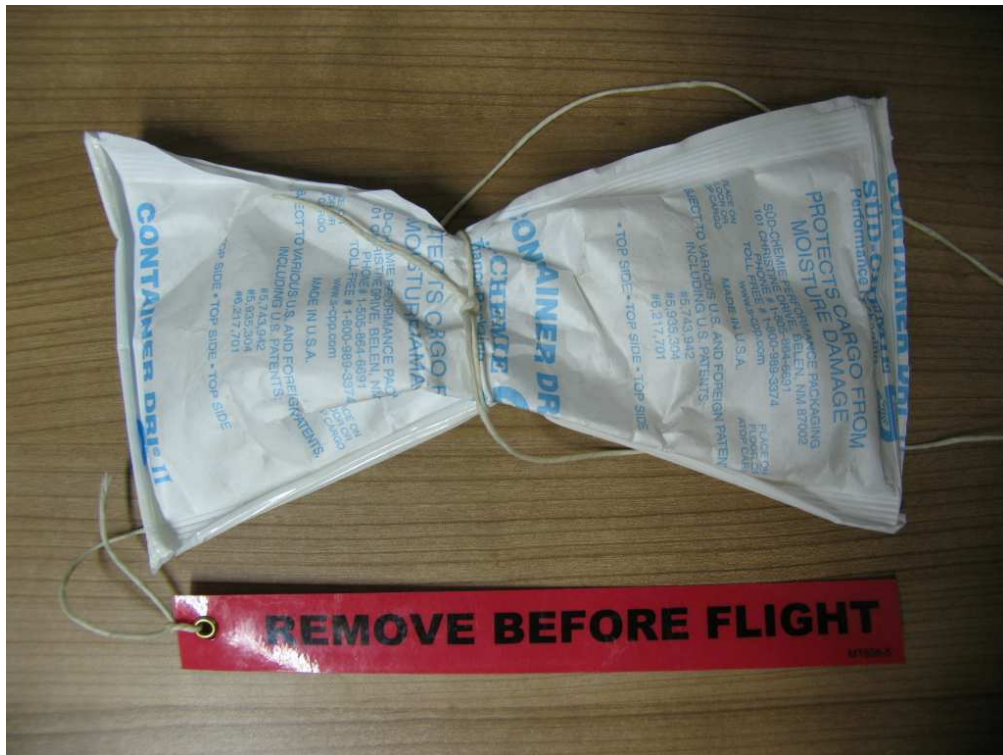
During the shipment process several moisture absorbent bags are attached to the helicopter at different locations, each bag has a warning label attached to it, which are clearly visible. The photo on the next page (figure 10) was taken of one of the moisture absorbent bags that were removed from the air inlet hose of a new helicopter that arrived in South Africa.

Figure 10. Moisture absorbent bag with the warning label attached used during shipment of a new helicopter.

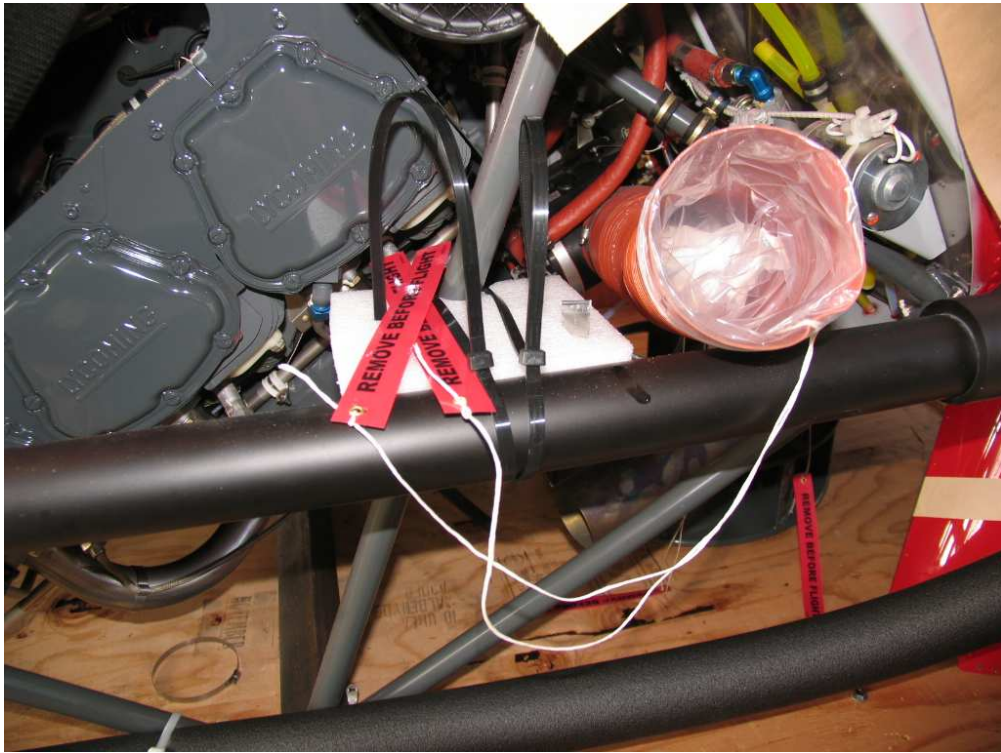
In order to better understand the shipping process and the location of the moisture absorbent bags the investigator inspected a new Robinson R44 that was delivered to a Robinson approved maintenance facility in South Africa. The new helicopter arrived in three separate wooden containers. The one container contained only the doors; the second container, the tail boom, tail rotor assembly, main rotor blades and the skid gear. The forward and centre section of the helicopter, which include the cockpit/cabin area the main rotor transmission and the engine was contained in a third container. Figure 14, on the next page display the position of the two moisture absorbent bags that was located inside the air inlet hose after opening the container. These two moisture absorbent bags had warning labels attached to them via rope as displayed in figures 14 and 15.

Figure 14. A photo of the air inlet hose with the moisture absorber bags inside with the warning labels.

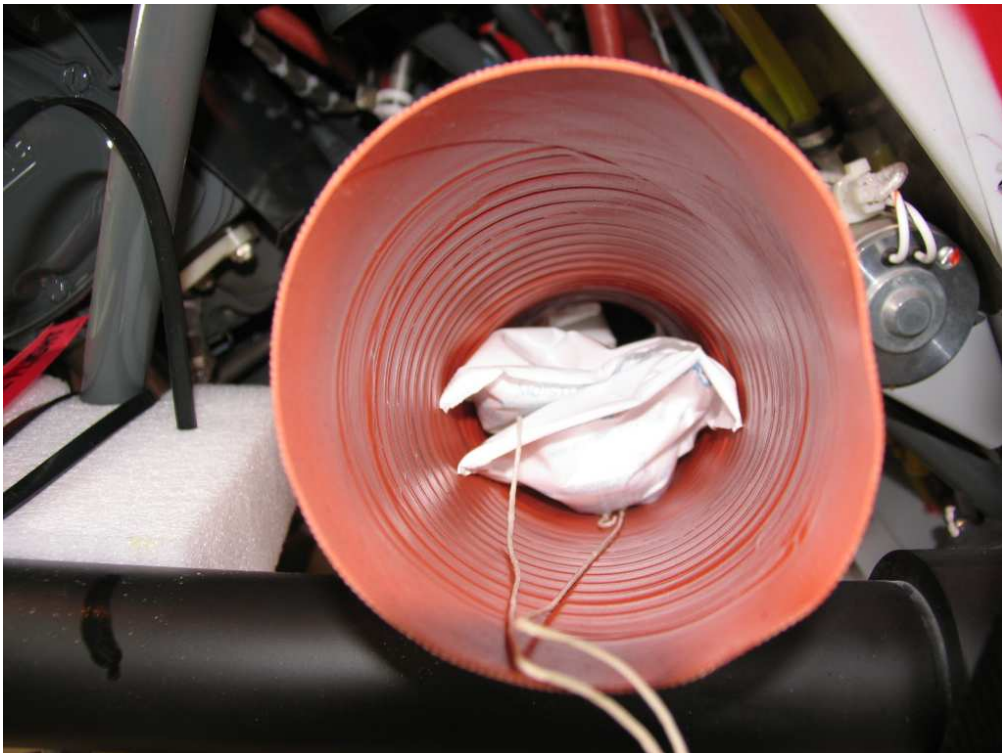
The air inlet hose, which are located on the right-hand side of the engine and connects to the air filter box had two moisture absorbent bags placed inside the air inlet hose during shipment from the factory (applicable to the new helicopter that arrived in South Africa).

Figure 15. The two moisture absorber bags visible inside the air inlet hose (ropes to the warning labels).

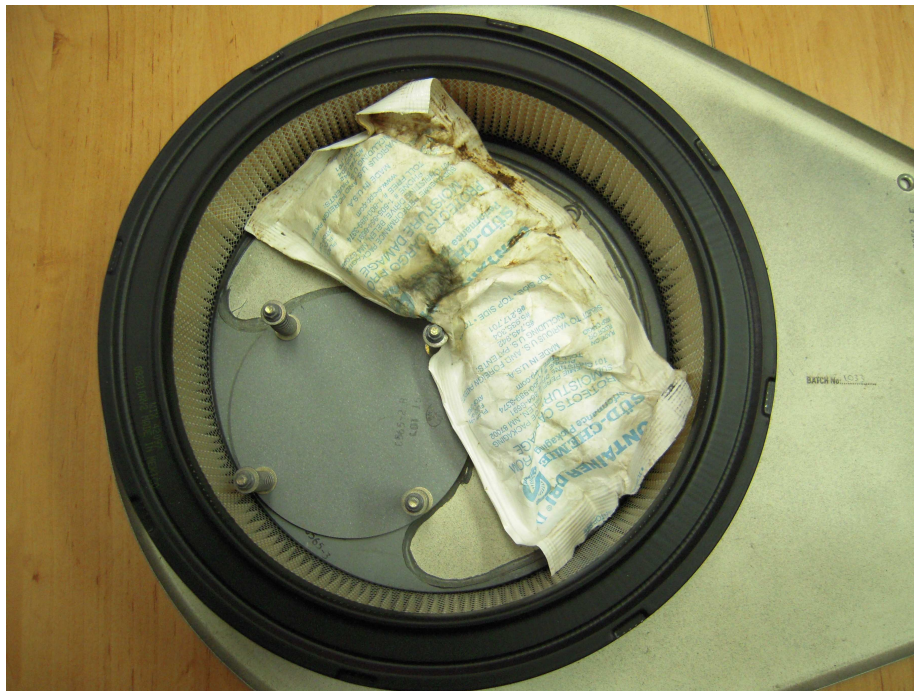
The fact that the bag was still intact (no content was discharged from it) could indicate that the bag was most probably not in the centre area of the air filter box as it most probably would have been sucked into the lower opening of the carburettor, as the suction rate of air entering the carburettor in this area are substantial. Figure 17 on the next page reflects the area covered by the moisture absorbent bag when positioned within the centre area of the air filter, which was in close proximity to the carburettor, which would have been positioned directly above the alternate air door area, at a height of approximately 6,5 cm.

Figure 17. Moisture absorbent bag within the centre of the air filter box (for illustration purposes only).

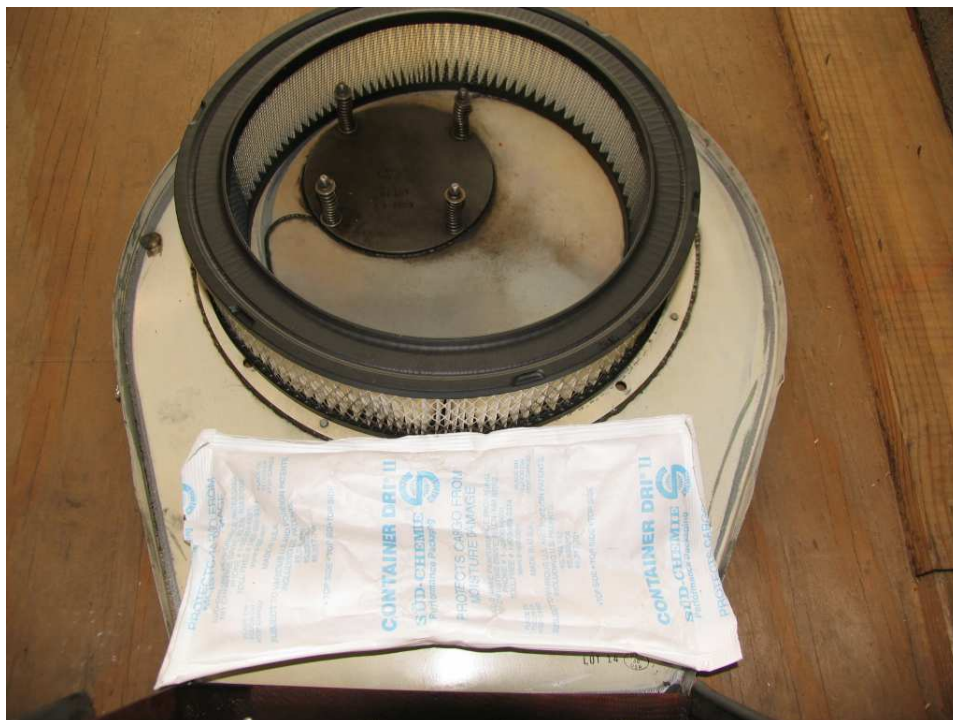
Figure 18 reflects the moisture absorbent bag to be in an alternate position within the air filter box. Should the bag have managed to migrate down the air inlet hose into the air filter box it most probably would have been located within this area of the air filter box. The actual position of the bag thereof might have been different from the illustration.

Figure 18. Moisture absorbent bag within the air filter box (for illustration purposes only).
