AIRCRAFT ACCIDENT REPORT AND EXECUTIVE SUMMARY

Reference:	CA18/2/3/9083	
Aircraft Registration	ZS-HGG	Date of Accident	19 September 2012		Time of Accident	0915Z
Type of Aircraft	Robinson 44 Raven II (Helicopter)		Type of Operation	Charter flight		
Pilot-in-command Licence Type	Commercial (H)		Age	37	Licence Valid	Valid
Pilot-in-command Flying Experience	Total Flying Hours	569.6		Hours on Type	232.7	
Last point of departure	Rand Airport FAGM - (Gauteng Province)					
Next point of intended landing	Rand Airport FAGM - (Gauteng Province)					
Location of the accident site with reference to easily defined geographical points (GPS readings if possible)						
Germiston area in bushy terrain. GPS co-ordinates: (S 26°13'41.28", E 028°7'43.23").						
Meteorological Information	Surface wind direction 240° at 07 knots, temperature 24°C, Cavok visibility					
Number of people on board	1+2	No. of people injured	1+2	No. of people killed	0	
Synopsis	<p>The pilot, accompanied by two passengers, took off from Rand Airport (FAGM) on a scenic flight to the Johannesburg central business district (CBD). The pilot suddenly heard the engine revolutions per minute (RPM) increase with a high-pitched soun

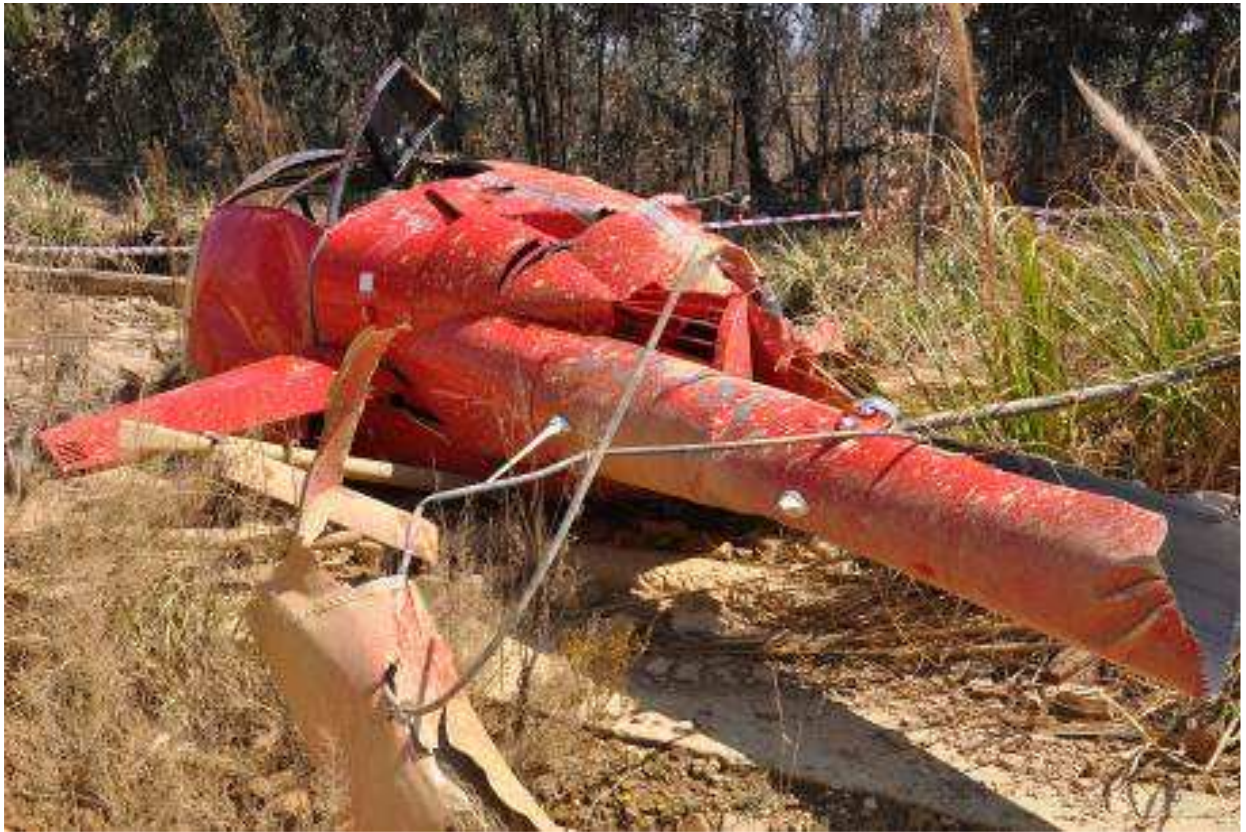
- 1.1.8 The pilot flared the helicopter in close proximity to the ground and a hard landing followed onto an old construction site. The skids broke off and helicopter rolled over onto its left side.

- 1.3.1 The helicopter sustained substantial damage during the impact sequence.

Figure 1: Main wreckage as it came to rest following impact

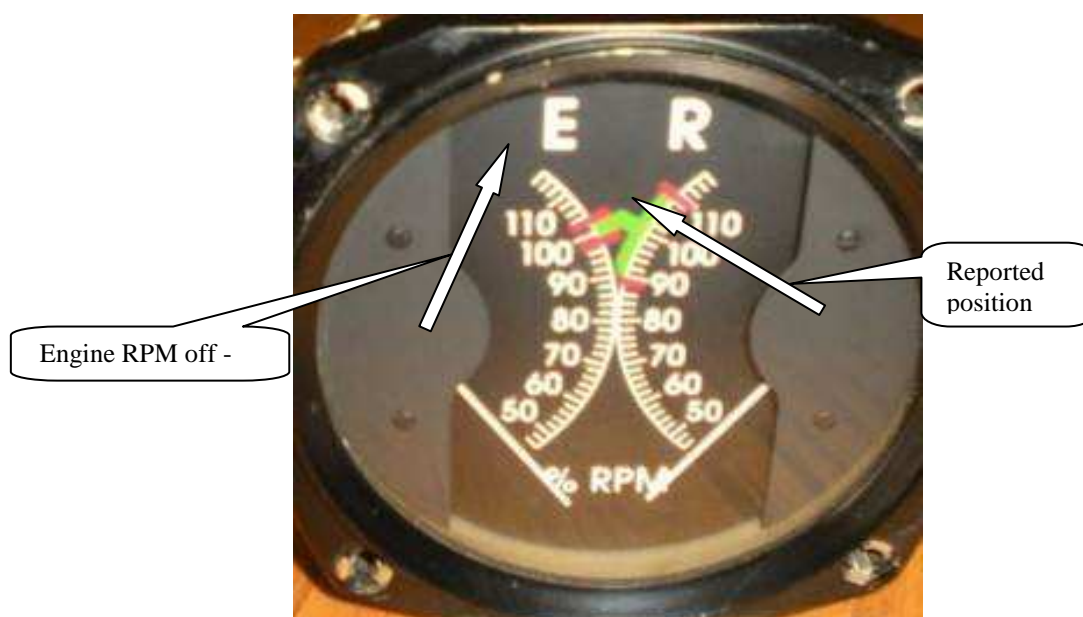
- 1.1.6 According to the pilot, at approximately 300 ft AGL he heard the engine RPM increasing. He immediately looked at the engine instrumentation (the tachometer) and noticed that the engine RPM indicator had moved off the scale and the main rotor RPM indicator was within the operating range on the scale (see figure 2).

- 1.6.1 The scale on the left (marked "E") represents engine RPM and the scale on the right (marked "R") represents main rotor RPM. The green shaded areas indicate the normal operating range for both engine and main rotor RPM.
- 1.6.2 The arrows indicate the over-speed conditions observed by the pilot prior to the accident. The engine speed needle was in the off-scale part of the scale. The rotor speed was in the green range, i.e. the normal operating ranges (see figure 2 below).

Figure 2: Tacho readings as reported by the pilot

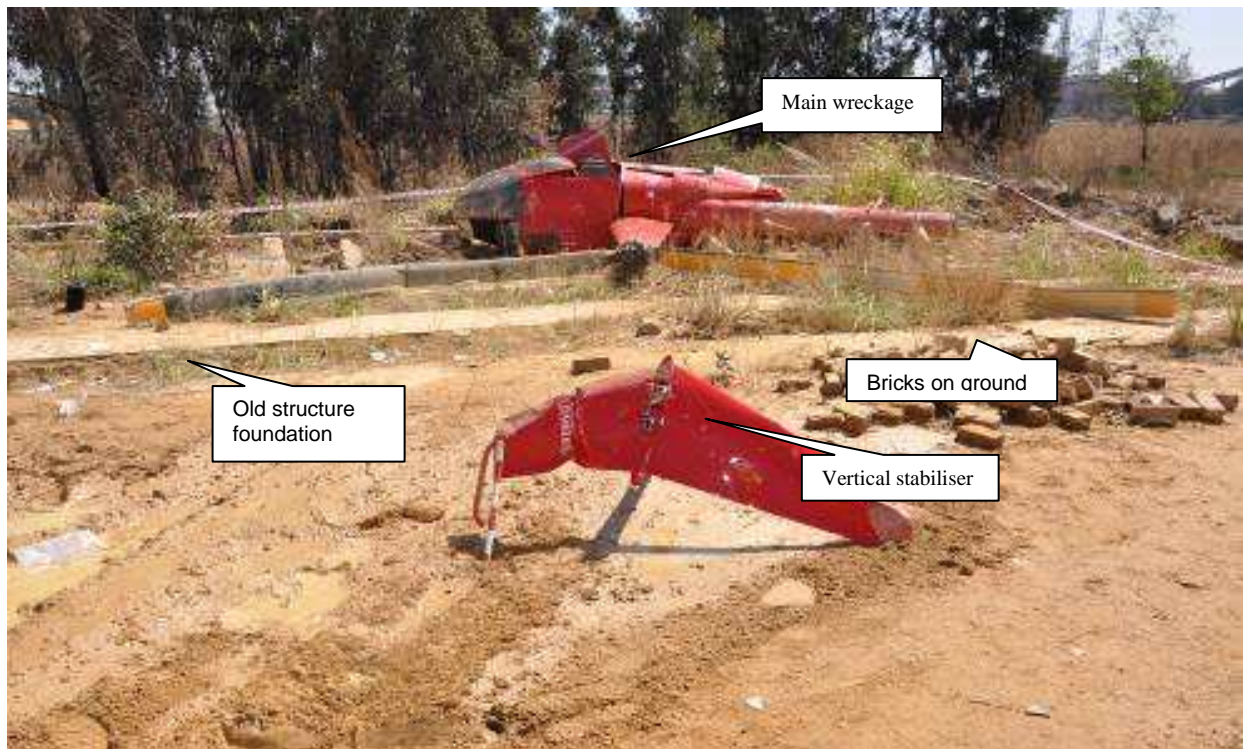
1.12.1 The impact site was 3 km from the aerodrome. The accident occurred on an old demolished construction site which was 450 m from PPC cement factory. The terrain has bricks and old foundation structure on it and is surrounded by bush. The GPS reading for the accident site is (S 26°13'41.28 ",E 028° 7'43.23").

Figure 3: View of the accident site

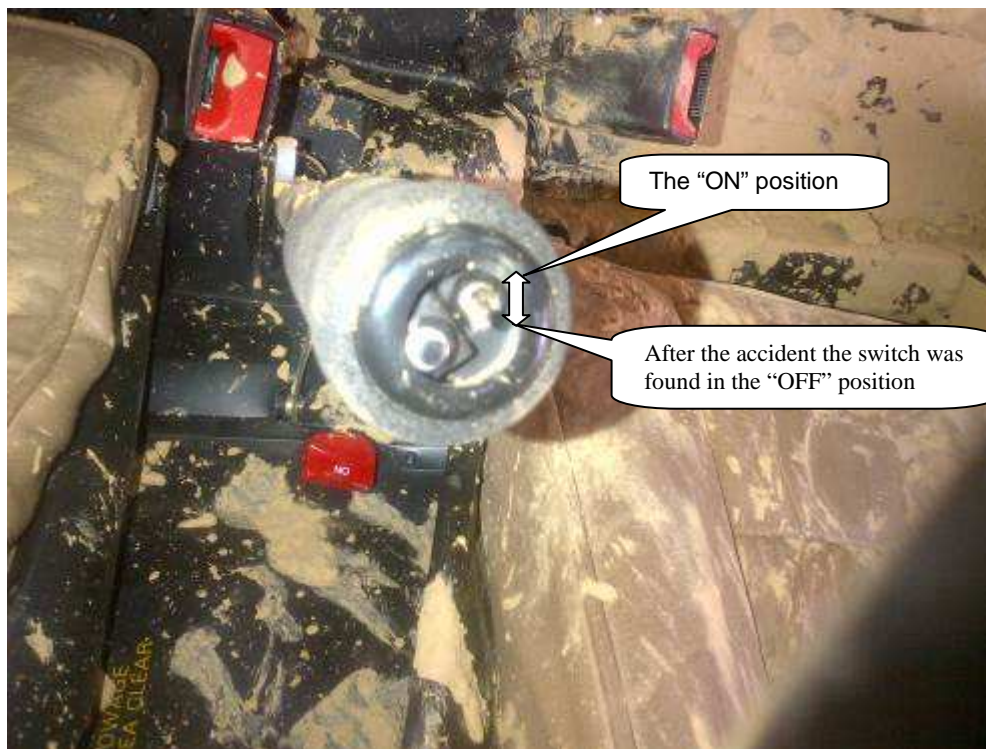
The picture below shows the position of the governor switch after the accident. The top switch is the governor switch, which is at this stage in the down position. The illustration of the position shows the operating range of the governor switch.

Figure 4: Governor Switch “ON” and “OFF” positions.

2.2 As the governor switch was found in the "OFF" position after the accident, the investigator is of the opinion that it either could have been accidentally switched off prior to the accident or it could have gone into the "OFF" position as a result of the impact. However, the pilot stated that the engine started over-speeding prior to the reduction of engine and rotor RPM. This indicates that the governor was inoperative prior to the accident.

- 3.1.10 The governor switch was found in "OFF" position and the governor control system was found serviceable during functional tests.
