AIRCRAFT ACCIDENT REPORT AND EXECUTIVE SUMMARY

Reference:	CA18/2/3/9104	
Aircraft Registration	ZS-SPI	Date of Accident	09 November 2012		Time of Accident	18:59Z
Type of Aircraft	Cessna172R		Type of Operation		Private	
Pilot-in-command Licence Type	Private		Age	24	Licence Valid	Yes
Pilot-in-command Flying Experience	Total Flying Hours		194		Hours on Type	158.3
Last point of departure		Wonderboom aerodrome (FAWB): Gauteng Province.				
Next point of intended landing		Wonderboom aerodrome (FAWB): Gauteng Province.				
Location of the accident site with reference to easily defined geographical points (GPS readings if possible)						
On the mountain at GPS coordinates determined to be (S 24° 07 6.76 E 029° 13 7 .58) at an elevation of approximately 5 940 feet above mean sea level (AMSL).						
Meteorological Information		Low clouds were observed in the vicinity of Polokwane area.				
Number of people on board	1 + 1	No. of people injured	0	No. of people killed	2

AIRCRAFT ACCIDENT REPORT

Name of Owner/Operator :Guzto Property Company
Manufacturer :Cessna Aircraft Company
Model :Cessna 172R
Nationality :South African
Registration Marks :ZS-SPI
Place :(S24°07 6.76 E 029°13 7 .58) en-rout

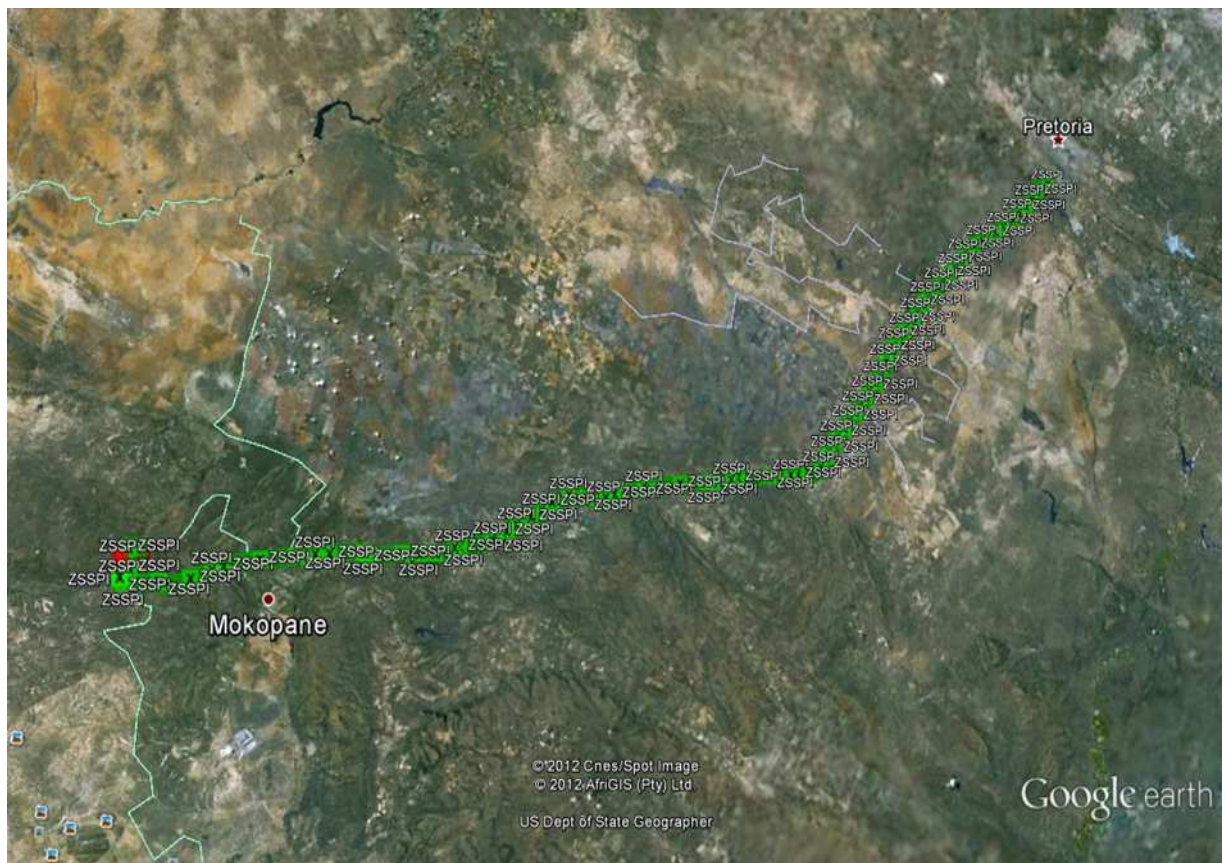
Figure 1: A radar plot of the aircraft's flight path from FAWB to accident site.

- 1.1.7 Referencing the radar image provided by ATNS, the flight path shows deviations from the intended flight plan. The pilot opted to route directly to FAPP from FAWA which was different from his flight plan which stated routing from FAWA direct to FANY then direct to FAPP for a touch and go. The initial heading selection of the aircraft from FAWA placed the aircraft approximately 4nm off track to FAPP. It is unknown if the diversion was planned prior to departure from FAWB. The correct true track to steer would have been 045° True from FAWA direct to FAPP.

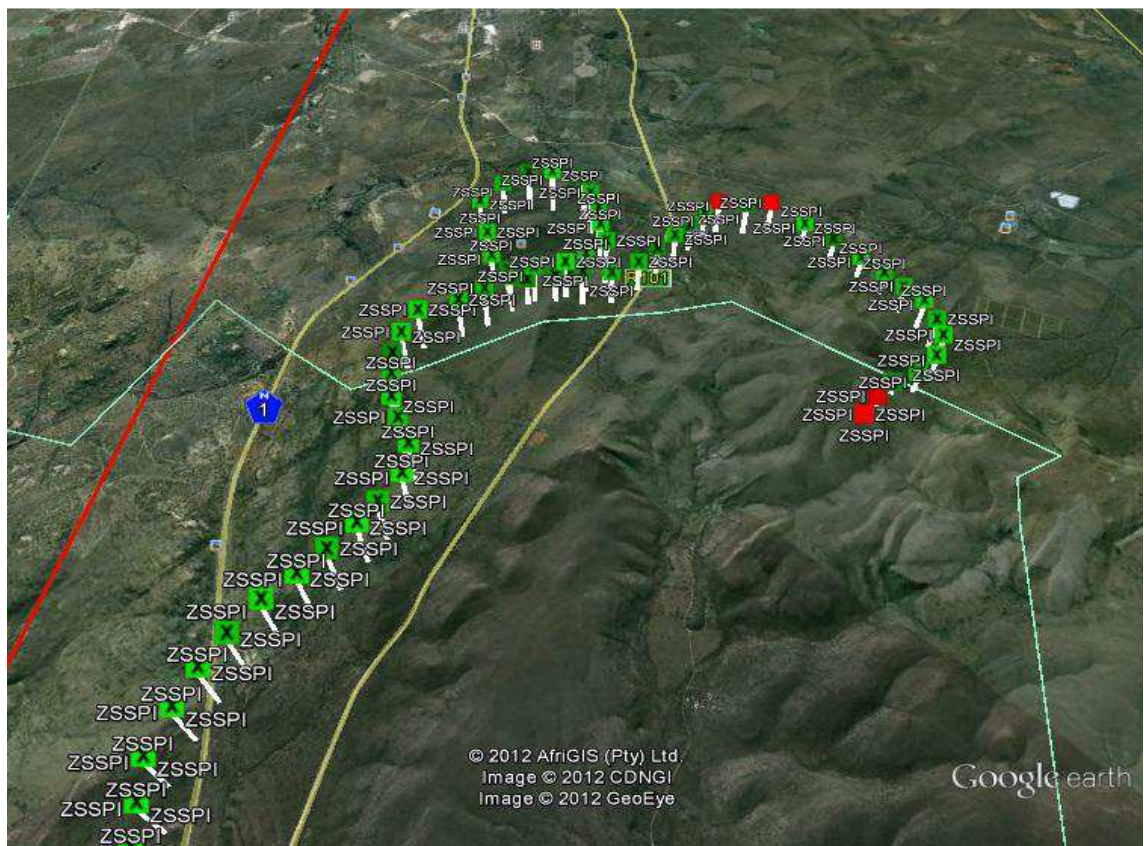
- 1.1.8 A series of incorrect heading changes by the pilot continued prior to the accident. It is possible that due to inadequate flight planning and poor estimation of a suitable track to fly the pilot positioned the aircraft directly into terrain.

Figure 2: Radar plot detailing the aircraft's flight path prior to impact.

1.1.9 The aircraft completed one left hand orbit prior to the accident. The aircraft's speed was fairly constant however a shallow rate of descent was noted on the radar plot. After completing the orbit the pilot continued to route to the right off track placing the aircraft directly into terrain. It was noted that the aircraft's speed varied between 120-150kts during this period and continued to descend. Prior to impact the aircraft regained 500ft altitude and was maintaining a cruise speed of 120kts.

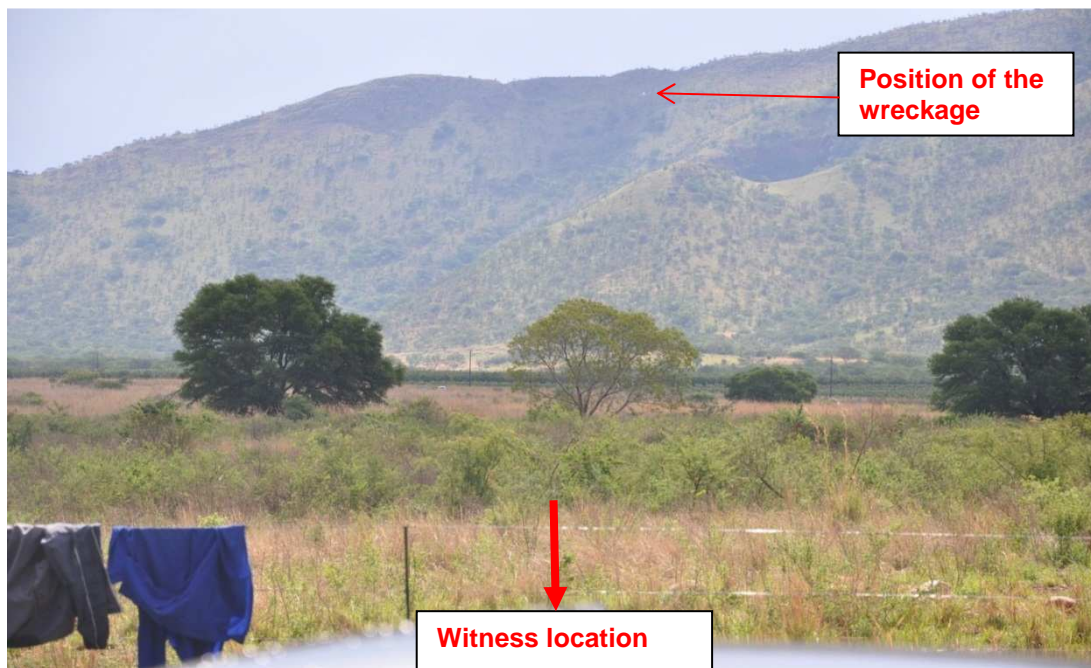
- 1.1.5 During on-site investigation a farm worker in the area informed the investigators that he observed a small single engine aircraft with flashing navigation lights routing in a South Westerly direction where after a loud explosion was heard. Post interview with a FAPP air traffic controller revealed that the pilot called telephonically at approximately 1.5 hours before departure enquiring if the runway lights would be ON at night. The controller stated the lights are ON permanently and also advised the pilot that the weather was not good at FAPP. He recommended that the pilot reconsider his flight into FAPP. The pilot made another telephone call closer to the end of the FAPP ATC shift which ended at 1800Z, he asked for an update of the weather at FAPP, which was still Visual Meteorological Conditions (VMC) but overcast at 2000 feet with visibility of 8000 metres (Visual flight rules minima according to regulation state within a control zone visibility required is 5000m and vertical distance from cloud 500 feet). FAPP tower closed for the day and the next morning when the tower reopened, they received a call from FAWB tower asking if ZS-SPI was parked at FAPP and the answer was negative.

Figure3: View of the terrain, the accident site and the location of the witness.

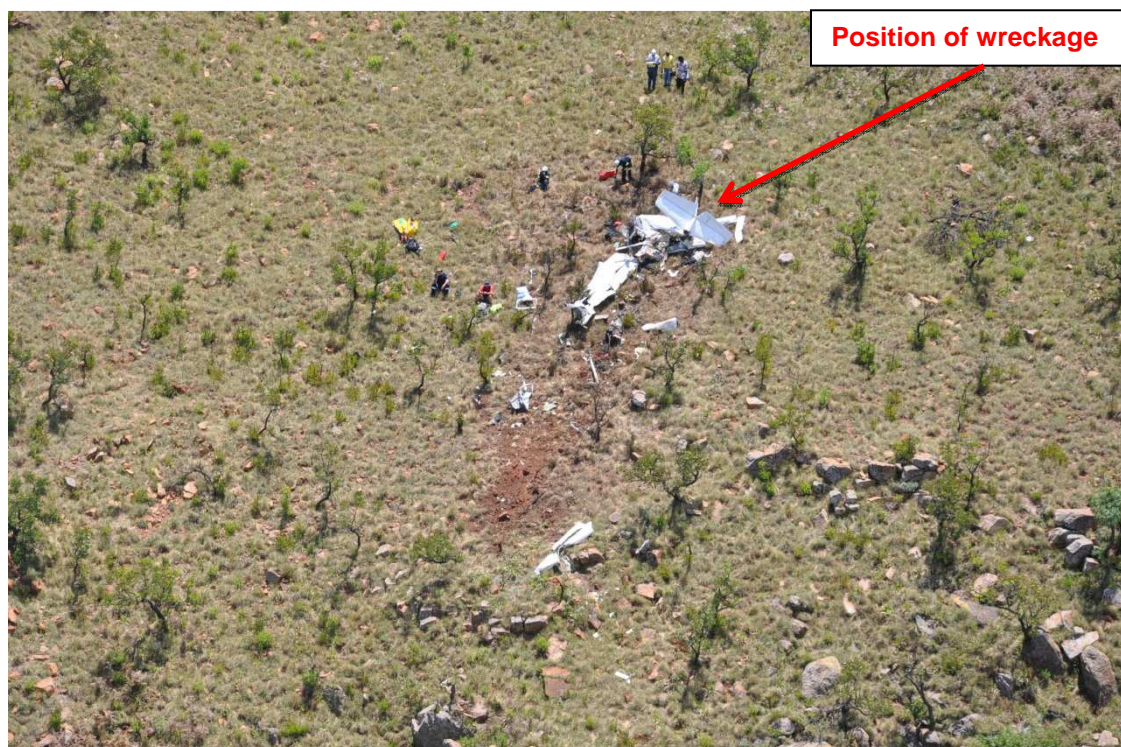
- 1.1.4 At approximately 0925Z, the search mission recommenced and the aircraft was located from the air on the mountain. The aircraft parts were scattered all over the accident site and the helicopter pilot flew closer to the site with the objective to see if there was any movement (sign of survivors), but to no avail. The SAPS helicopter pilot immediately flew back to the airport and landed uneventfully. The SAPS, SASAR and the Emergency Medical Services (EMS) team were immediately flown by the helicopter to the accident site. The helicopter landed safely on the mountain top and arriving at the accident site the aircraft was found to have been destroyed and both occupants were pronounced dead at the scene.

Figure 4: Aerial view of the wreckage.

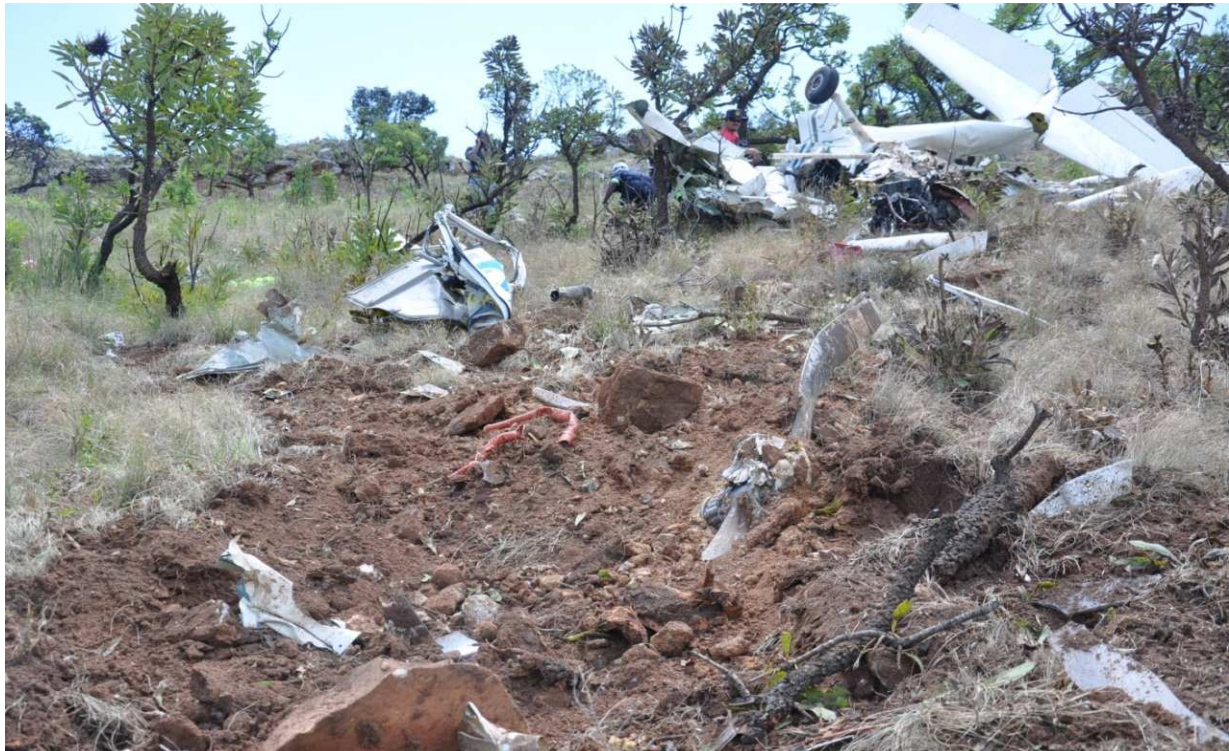
1.3.1 The aircraft was destroyed by impact during the accident sequence.

Figure 5: View of the wreckage as found at the accident site.

1.12.1 The wreckage was contained within 60 metres from the first point of impact. The compactness of the cockpit/cabin area and the high degree of damage indicated that the aircraft had impacted the mountain at a high speed. The wings, T-tail section, fuselage, including the cockpit/cabin were destroyed by impact and no fire was reported. The aircraft wind screen (perspects glass) was shattered. The aircraft wings were substantially damaged and both fuel tanks ruptured on impact. During on site investigation, the investigating team could still smell fuel, although there was rain in the area after the accident. It was also not possible to determine the position of the fuel tank selector.

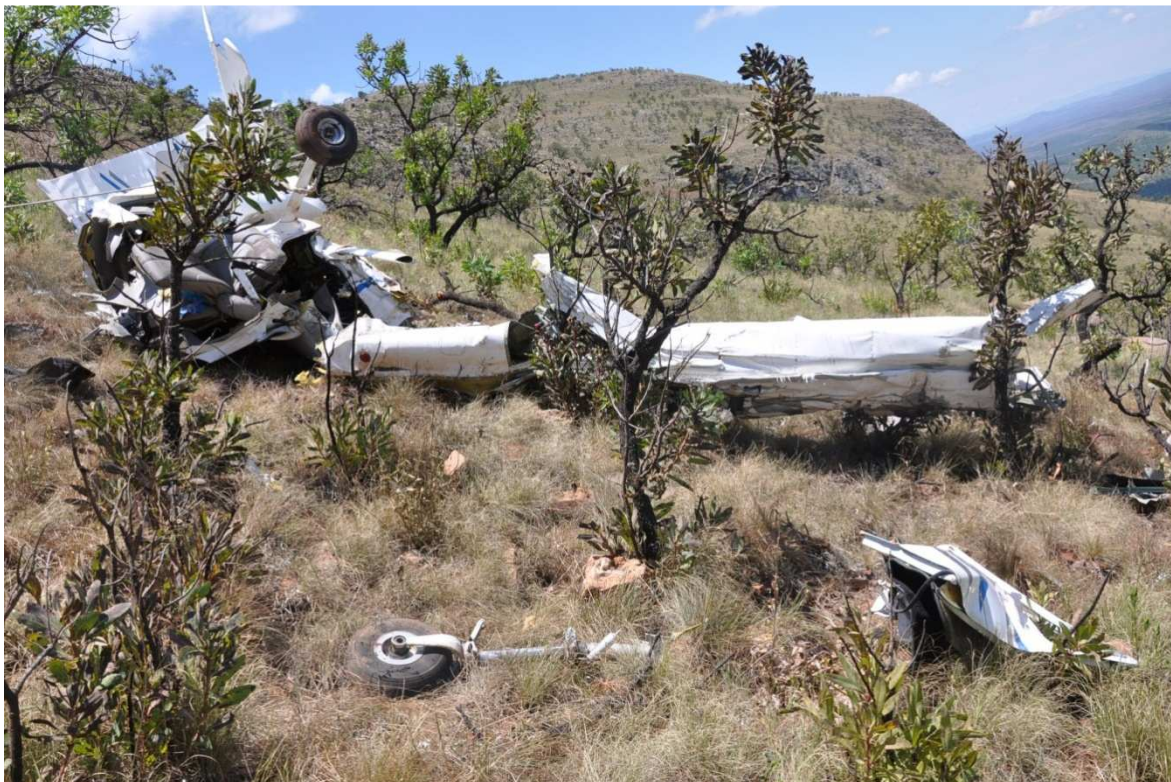
Figure 6: Side view of distribution of wreckage.

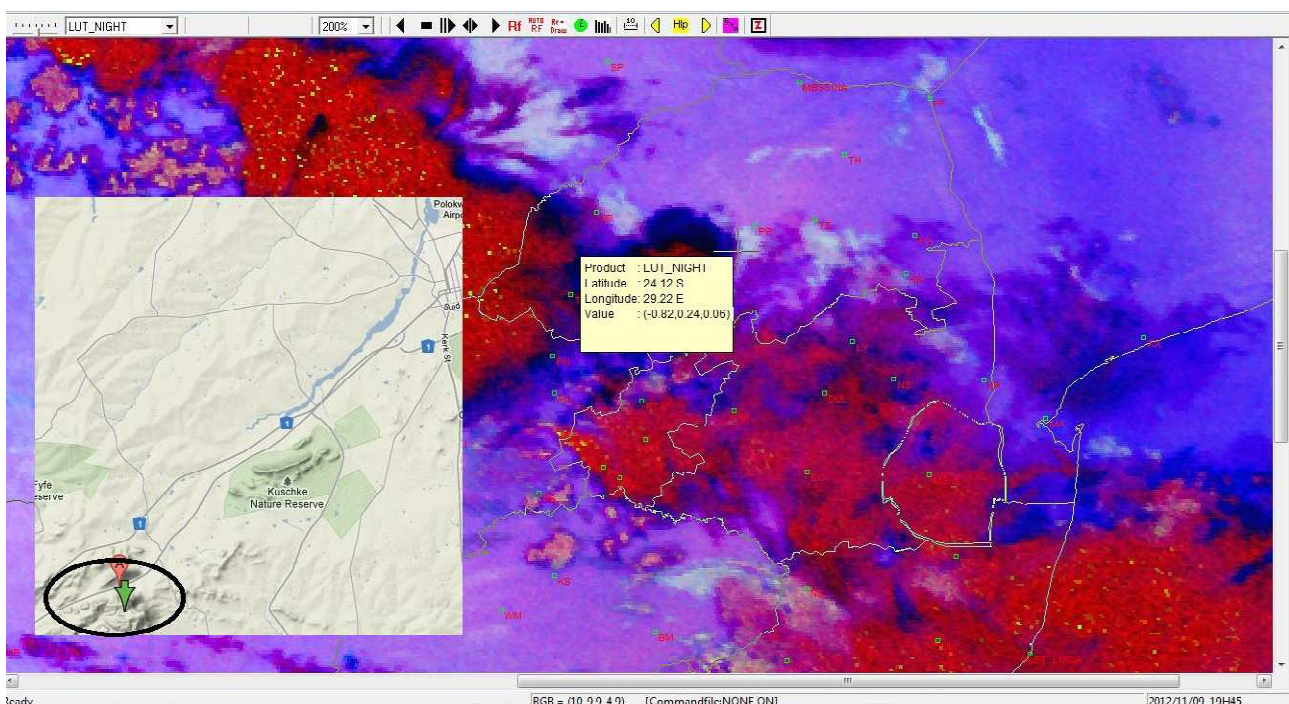
The satellite image provided in figure8, indicated Overcast low-level cloud in and around the area marked on the image and 21:00Z SIGWX chart provided indicated a forecast of scattered *low-level cloud* with base 1000ft minimum ceiling, poor visibility and *moderate low-level turbulence* in the area of the accident.

Figure 8: View of the satellite image.

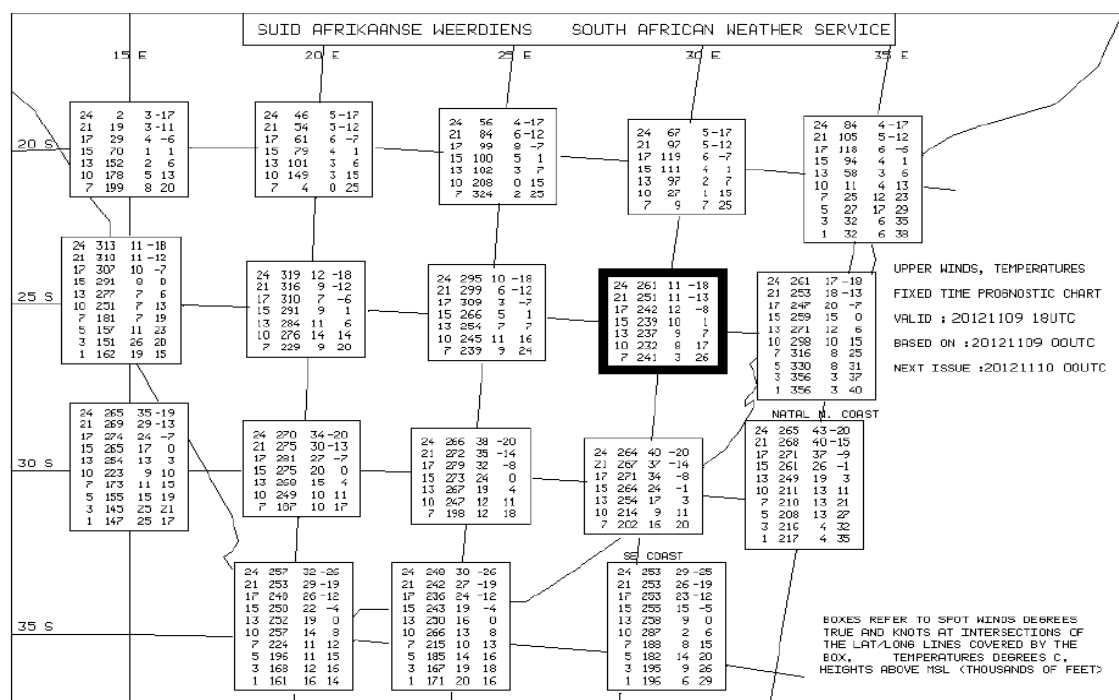
Polokwane International Airport (FAPP) 18:00Z METAR provided, indicates overcast low-level cloud at 2000ft, good visibility and light North Easterly winds. 1900Z & 2000Z AUTO METARs indicated that the dew-point depression decreased by a degree from 18:00Z to 2°C i.e. possible indication of 500ft to 1000ft cloud base drop close to the time of the accident.

Figure 9: Highlighted block indicates wind chart observation in the Polokwane area.

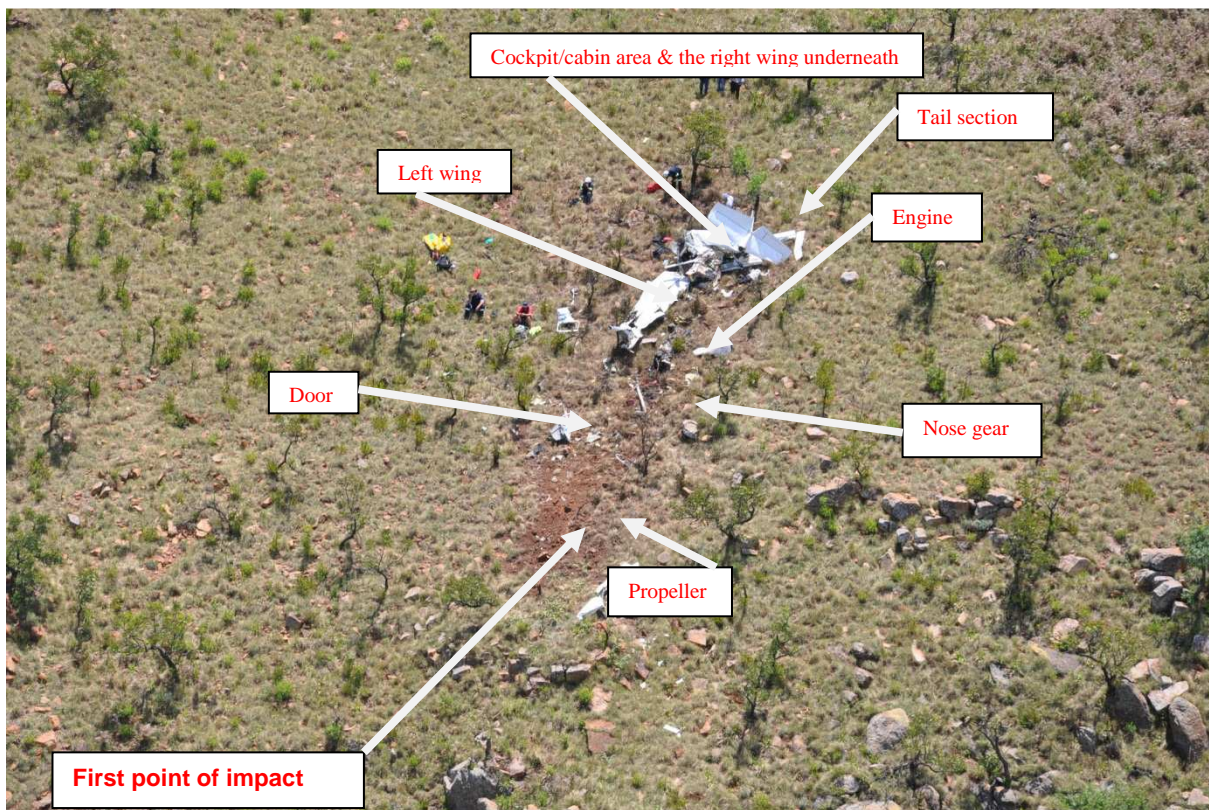
Figure 11: First point of impact and evidence of fuel spill at the accident site.

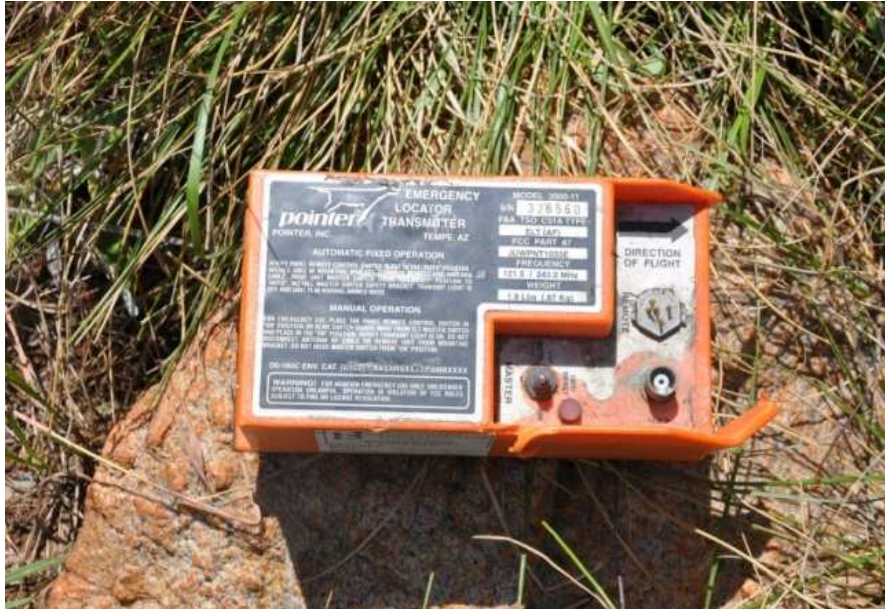
1.15.1 The accident was considered to be non-survivable due to the magnitude of the deceleration forces and the collapse of the cockpit/cabin area. The aircraft was equipped with a Pointer Emergency Locator Transmitter (ELT), model 3000-11, serial number 326560. The ELT onboard the aircraft had dislodged from its fixed mounting bracket. The Auto/On switch was however selected to the Auto position and the operation indicator light had no illumination to show that the internal inertia switch had turned the transmitter ON.

1.15.2 Functional tests by the investigators indicated that the ELT was not radiating any signal and the investigator in charge (IIC) was not advised by the South African Search and Rescue Coordination Centre of any ELT signals being received at the time of the accident. Below is the picture of the ELT after it was disconnected from the wreckage. Research will be conducted by the investigation team to conclude why the ELT was not serviceable.

Figure 12: View of the ELT after it was disconnected from the wreckage to allow a clear picture of the position of the switch as found at the accident site.

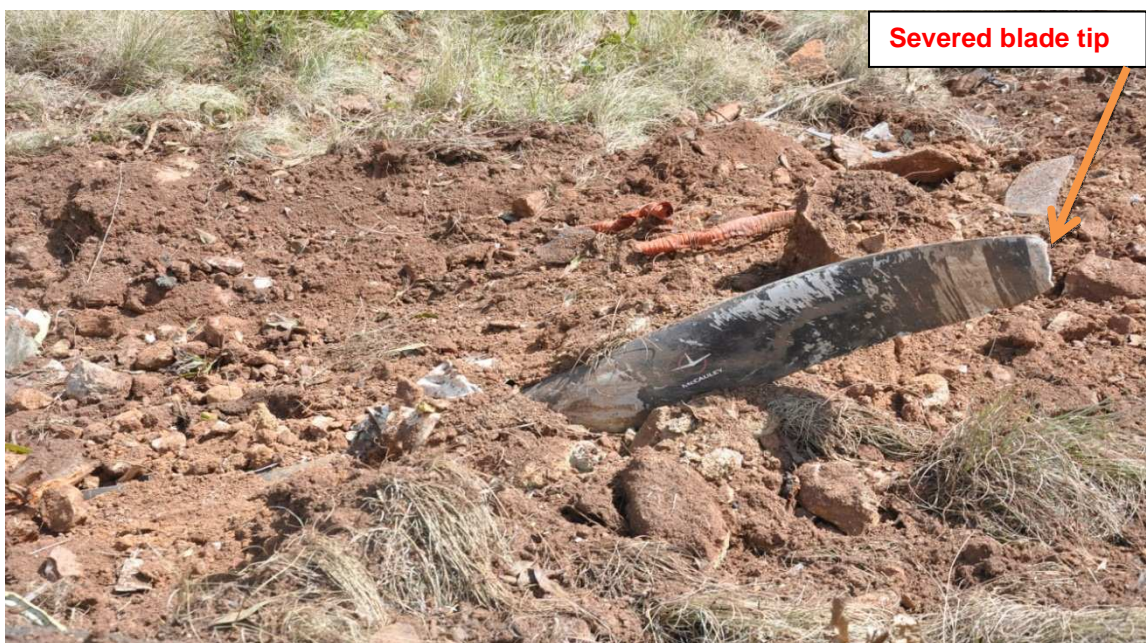
1.16.2 During the investigation, the engine was set up together with the propeller to determine the position of the propeller to the engine at the moment of impact when the propeller detached from the engine. The propeller attachment point was fractured and the blade tip was severed/ cut off after impact and that suggests that the propeller was still turning on impact however the amount of power it was producing couldn't be determined by visual inspection. See the pictures below.

Figure 14: View of the propeller as found at the accident site.

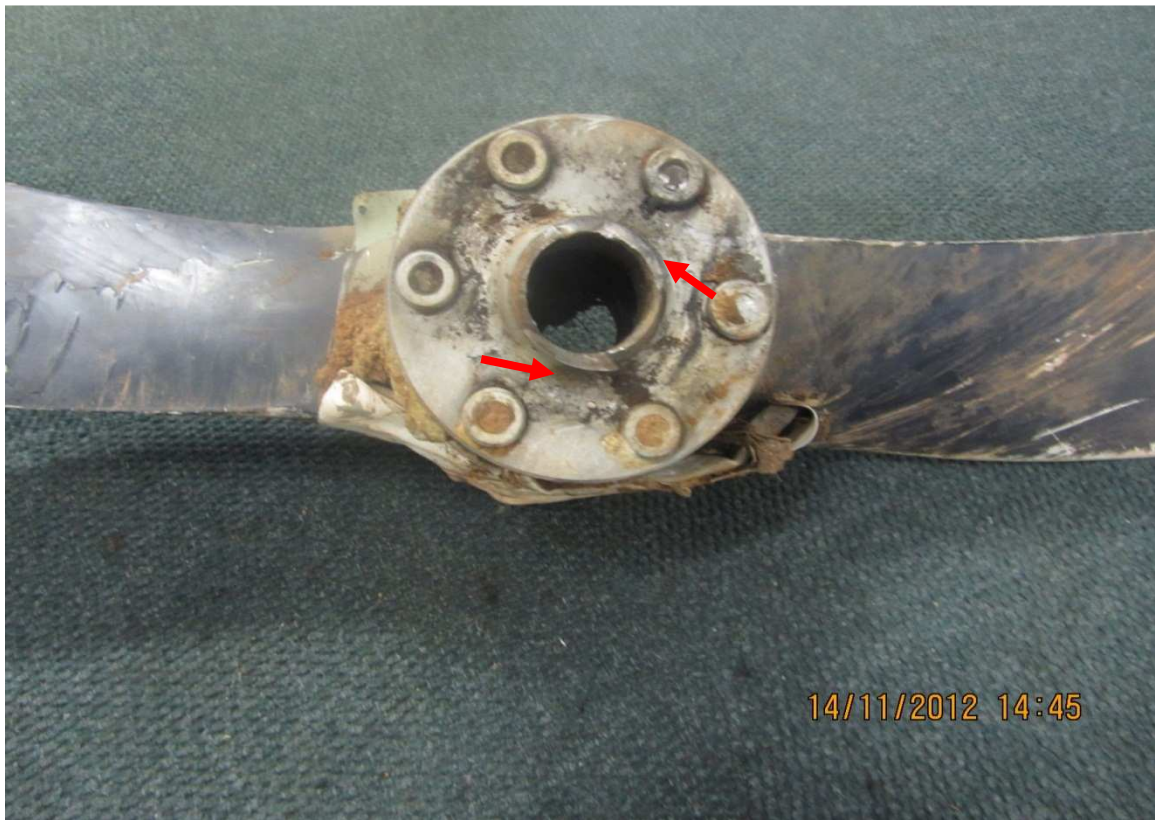
Figure 15: Closer view of the fractured propeller hub.

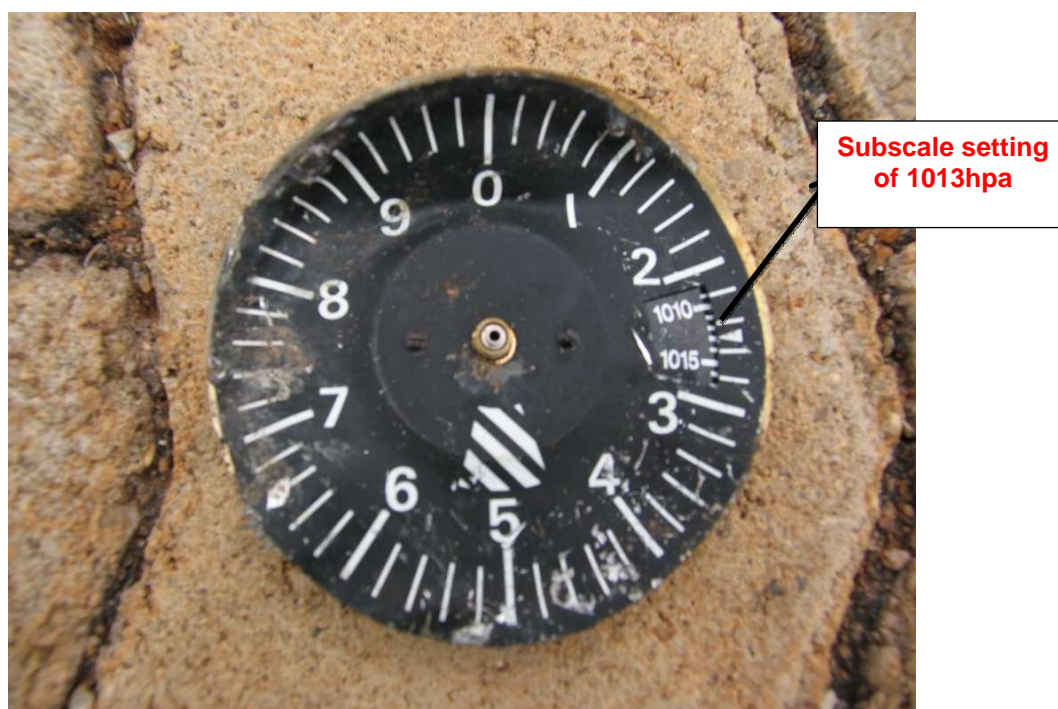
1.18.6 The altimeter recovered at the wreckage site indicated a subscale setting of 1013hpa.

Figure 17: Altimeter recovered from wreckage.

1.18.7 The local QNH at FAPP was 1018hpa. QNH was higher than standard pressure 1013.2.

1.18.8 The difference between standard pressure and QNH altitude ($1018 - 1013.2 = 144\text{ft}$).

1.18.9 QNH altitude ((last radar altitude) $6075 + 144 = 6219\text{ft}$).

1.18.10 Clearance over high ground ($6219 - 5940 = 279\text{ft}$).
