# Air Accident Investigation Sector

- Final Report -

AAIS Case N°: AIFN/0005/2013

## Unreliable Airspeed Indication

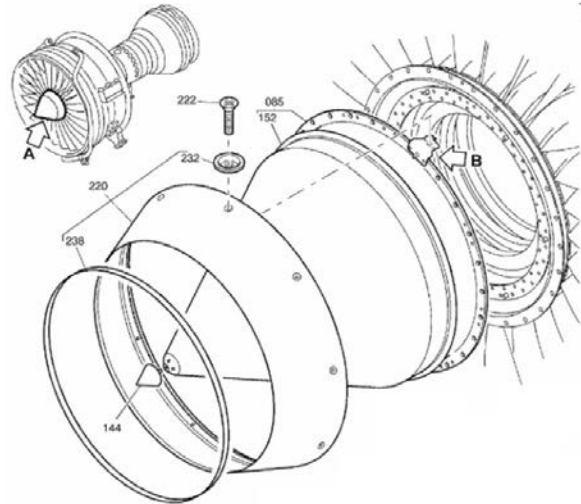
Figure 8. Air Intake Fairing/Spinner

- The spinner fairing revealed signs of lifting on 9 dimpled washers [item 232] and clearance was noted between the spinner fairing and the inlet cone.

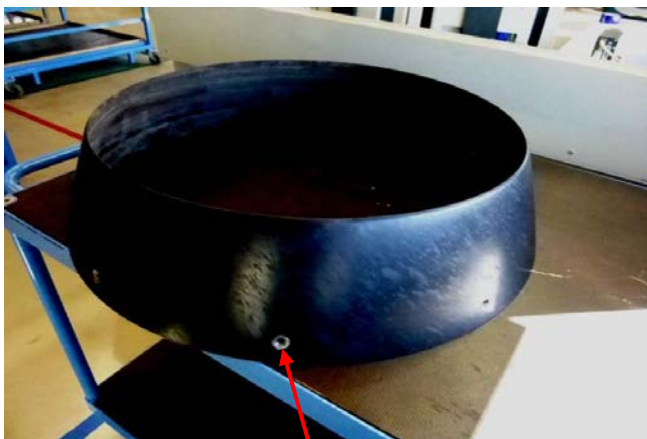
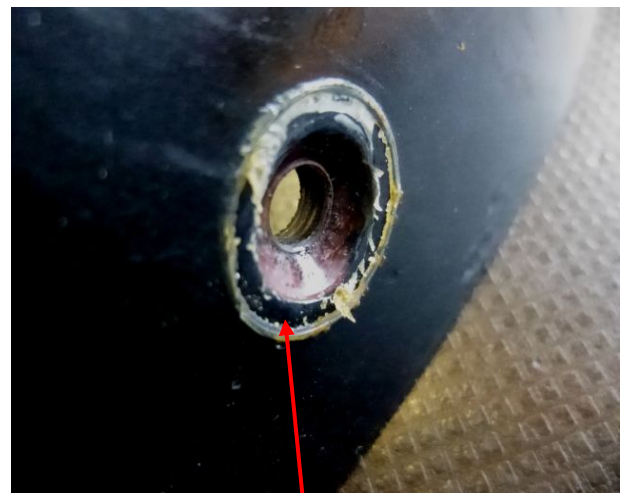
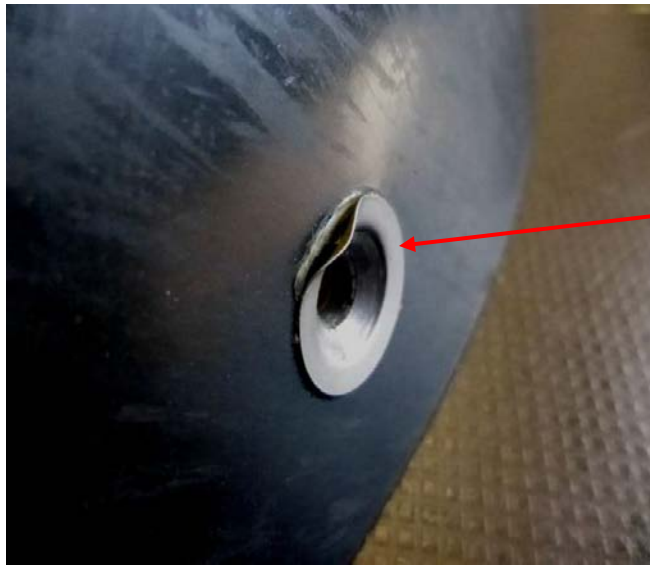
Figure 9. Washers Condition

- Three of the dimpled washers were missing and all others distorted on the Nose Cone Fairing, as shown in Figure 9.

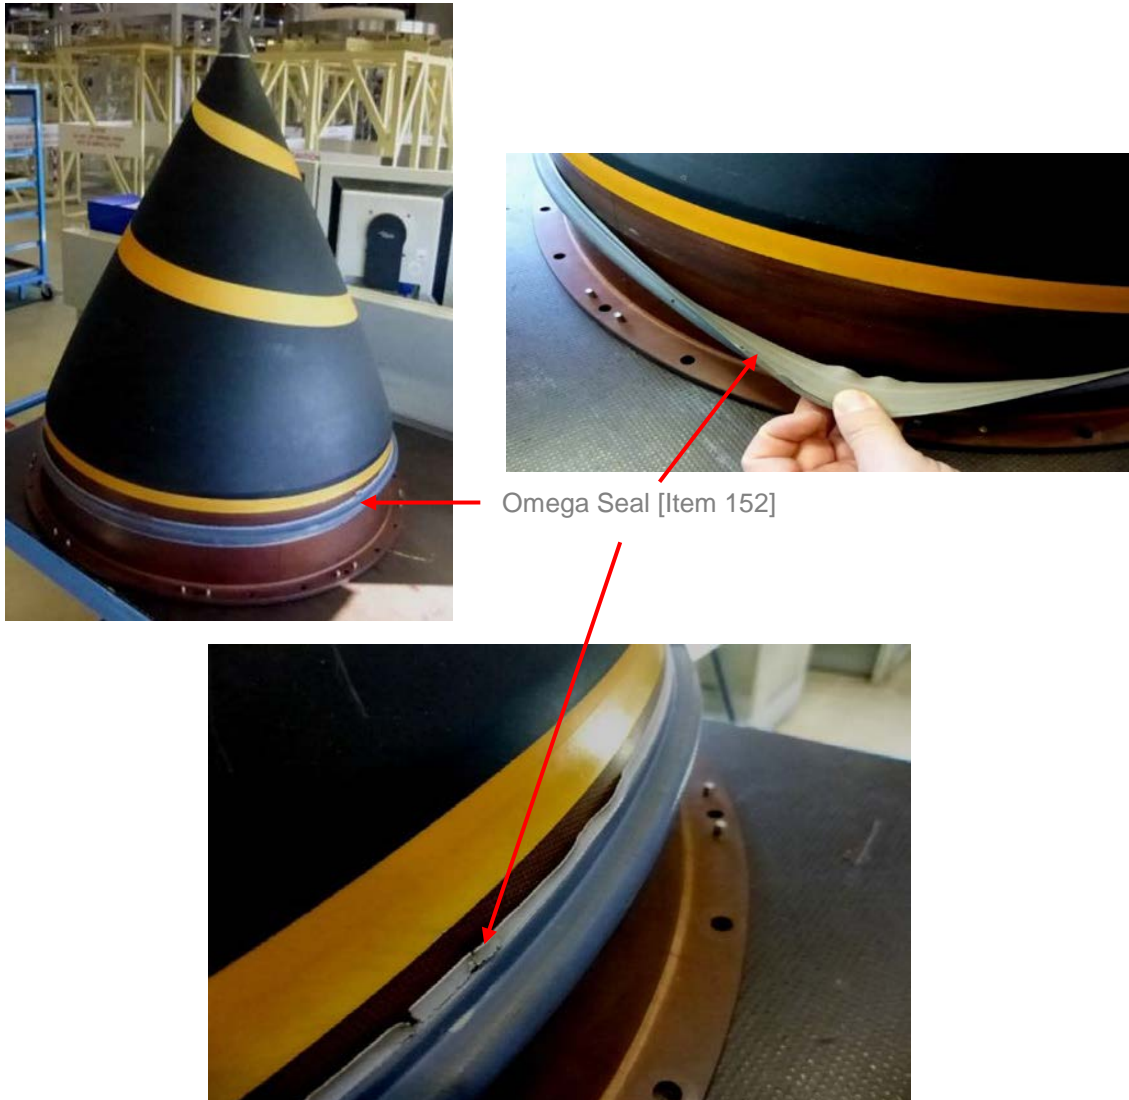
Figure 10. Omega Seal Condition

- Outer surface the omega Seal was in disband condition which made the omega seal loose on the Nose Cone, as shown in Figure 10.

Inspection of the No.2 engine revealed an Omega Seal disband. Based on the analysis of the engine manufacturer, the Investigation believes that the seal had sustained damage leaving a gap which allowed water ingress. The water or ice crystals entered and passed through the spinner fairing, and accreted under the annulus fillers creating an ice out-of-balance condition which led to the increase in N1 vibration, as shown in Figure 22. The use of engine anti-ice was apparently ineffective in dealing with the condition of the spinner fairing icing.

In Maintenance Planning Document (MPD), task 723100-R6-1 “RE-LUBRICATION OF LP COMPRESSOR BLADE ROOT COATINGS”, requested to be performed every 1200FC, requires spinner removal. At this opportunity, any damage on omega seal can be detected.

The high vibration did not cause any engine damage. The engine manufacturer is working on changes to reduce the possibility of disbanding of the Omega Seal, and is considering activities to ensure that the high vibration risk is managed to an ALARP<sup>29</sup> level.

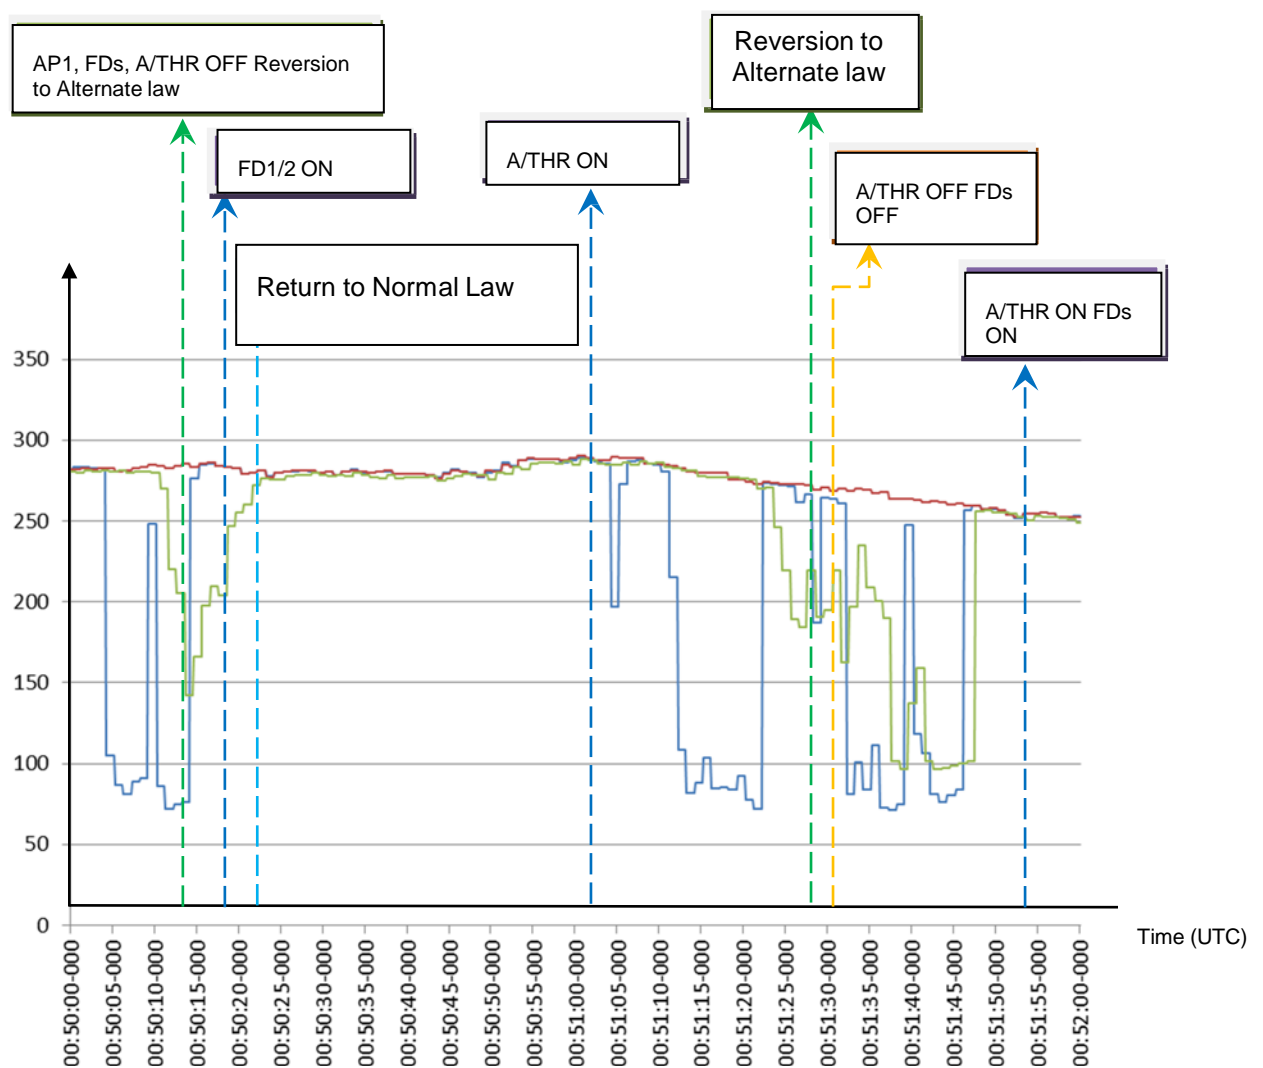
Figure 16. Flight Data Summary

Between 00:50:11 and 00:50:15, CAS1 and ISIS\_CAS (CAS3) values were out of tolerance, and all three CAS values were different, which caused the rejection of all three ADRs by the FMGEC and the FCPC.

The rejection of all three ADRs was latched by the FCPC until the end of the flight, which resulted in it becoming no longer possible to re-engage the autopilot.

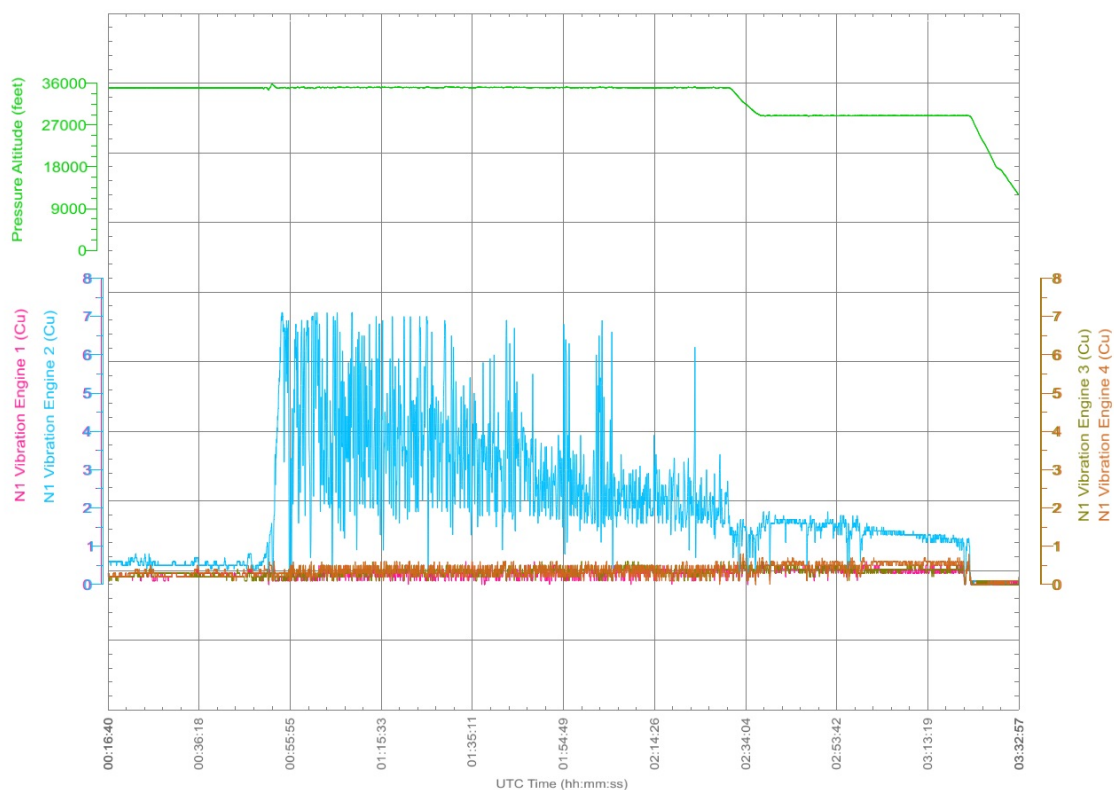
Figure 17. N1 Vibration Data on No.2 Engine

- Between 00:51:20 and 00:52:04, N1V2 increased from 0.2 CU to 1.6 CU and then returned to 0.3 CU.
- Between 00:52:16 and 00:54:13,
  - o N1V2 continuously increased from 0.3 CU to a maximum of 7.1 CU.
  - o Advisory of N1 vibration on Engine 2 became active at 00:52:59 (on the PFR at time 00:53: ADVISORY ENG2 N1 VIBRATION), when the N1V2 value was 3.8 CU.
- Between 02:30:32 and 03:22:10, the vibration started to decrease to 1.1 CU, as the Aircraft descended from FL350 to FL290.
- At 03:22:11, the vibration ceased as the Aircraft descended from FL290 to FL100.

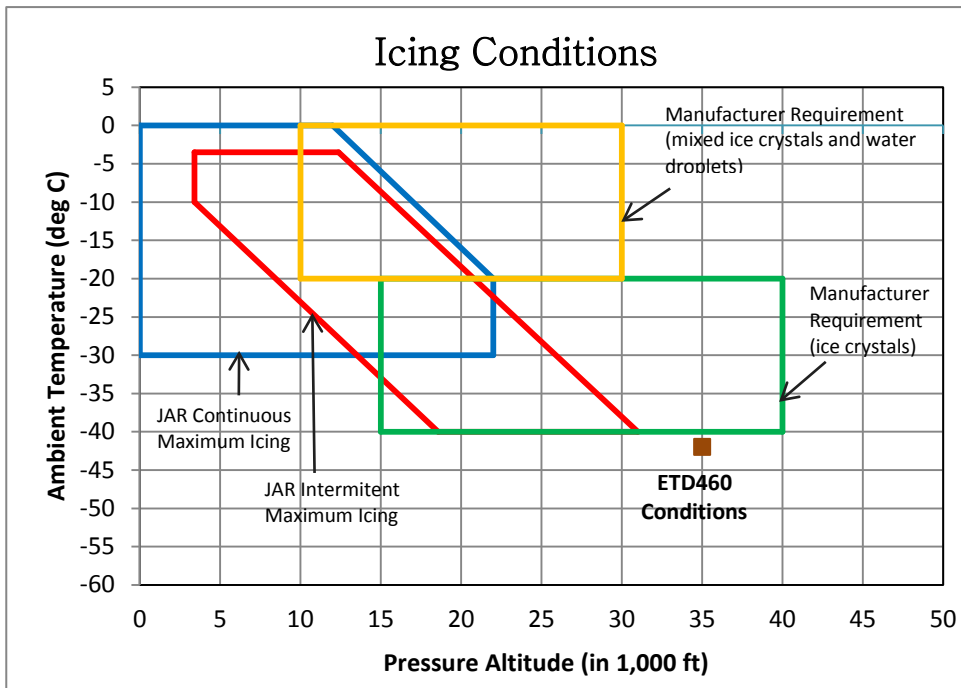
Figure 16. Ice Protection System Specification and Requirement

The JAR specification and the manufacturer requirements for the Aircraft ice protection system are shown in Figure 18, including the altitude and static ambient temperature (SAT) conditions that applied to the Incident. During the Incident, the Aircraft encountered conditions that were outside the JAR specification and the Aircraft manufacturer requirements.

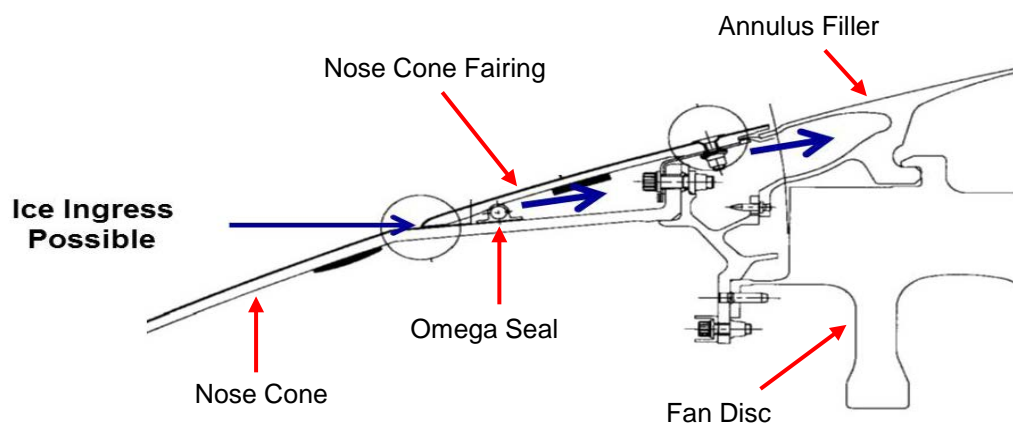
Figure 22. Ice Out-of-balance Condition Under the Annulus Fillers

The ECAM N1 vibration advisory message disappeared after the Aircraft started to descend from FL350. The reduction in N1 vibration was due to the ice melting as the Aircraft descended into warmer air. The Investigation believes that the vibration had disappeared during the descent at the moment when the combination of the air temperature, pressure, humidity and engine rotational speed were adequate for the ice to fragment, melt, and be propelled out of the engine.
