AIRCRAFT ACCIDENT REPORT AND EXECUTIVE SUMMARY

Reference:	CA18/2/3/9169	
Aircraft Registration	ZS-SAR	Date of Accident	27 April 2013		Time of Accident	±1440Z
Type of Aircraft	Cessna 152 (Aeroplane)		Type of Operation	Private Flight		
Pilot-in-command Licence Type		Private	Age	40	Licence Valid	Yes
Pilot-in-command Flying Experience		Total Flying Hours	173,0		Hours on Type	93,1
Last point of departure		Worcester aerodrome (FAWC), Western Cape province				
Next point of intended landing		Worcester aerodrome (FAWC), Western Cape province				
Location of the accident site with reference to easily defined geographical points (GPS readings if possible)						
Farm Wittekop in the Worcester district (GPS position; 33°42.507' South 019°35.794' East)						
Meteorological Information		Surface wind; 260°12kt gusting 23 kt, Temperature; 31°C, Visibility: + 10 km				
Number of people on board	1 + 0	No. of people injured	0	No. of people killed	1	
Synopsis

AIRCRAFT ACCIDENT REPORT

Name of Owner : Worcester Flying Club
Name of Operator : Worcester Flying Club
Manufacturer : Cessna Aircraft Company
Model : 152
Nationality : South African
Registration Marks : ZS-SAR
Place : Farm Wittekop, Worcester

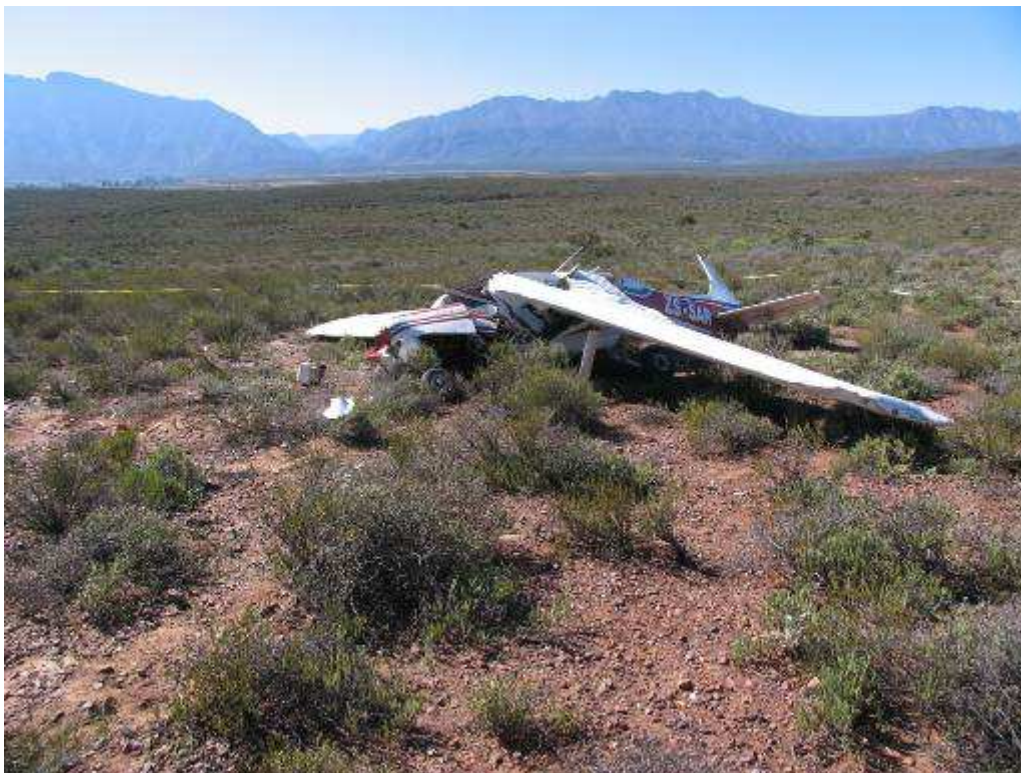
1.3.1 The aircraft was extensively damaged during the impact sequence.

Figure 3. The aircraft as it came to rest

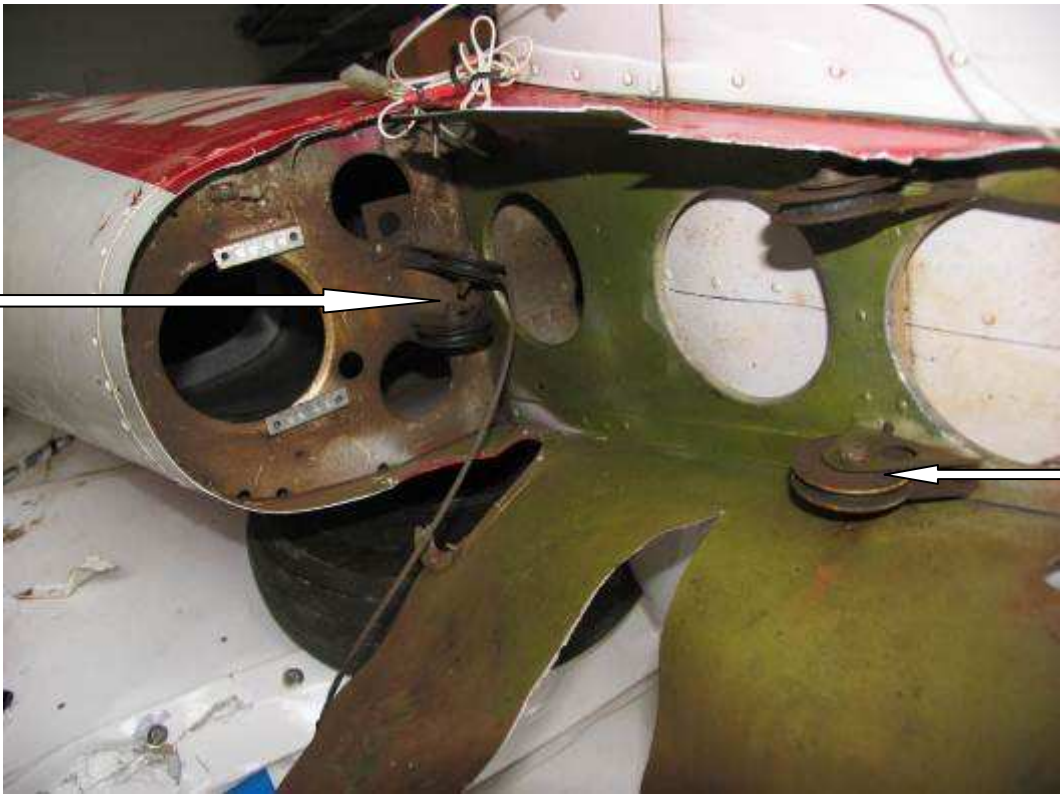
Following recovery of the wreckage the aft section of the fuselage was cut open in order to inspect the area as well as the pulleys (see figure 9). The primary objective was to ensure that the pulleys were properly aligned, free of any sharp edges and not frozen. The pulleys were found to be properly aligned, free of any sharp edges and could easily be turned by hand, nor did they display any evidence of excessive wear or lubrication. The surrounding structure was also inspected and no evidence could be found that any part of it might have caused the cable to be exposed to excessive mechanical wear during operation apart from the pulleys. The pulley shown in figure 9 as section B and also in figure 11 is the last pulley that supports the right-hand rudder cable before it protrudes from the fuselage and is visible from the outside as can be seen in figure 6.

Figure 9. The aft section of the fuselage cut open in order to inspect the rudder cable pulleys

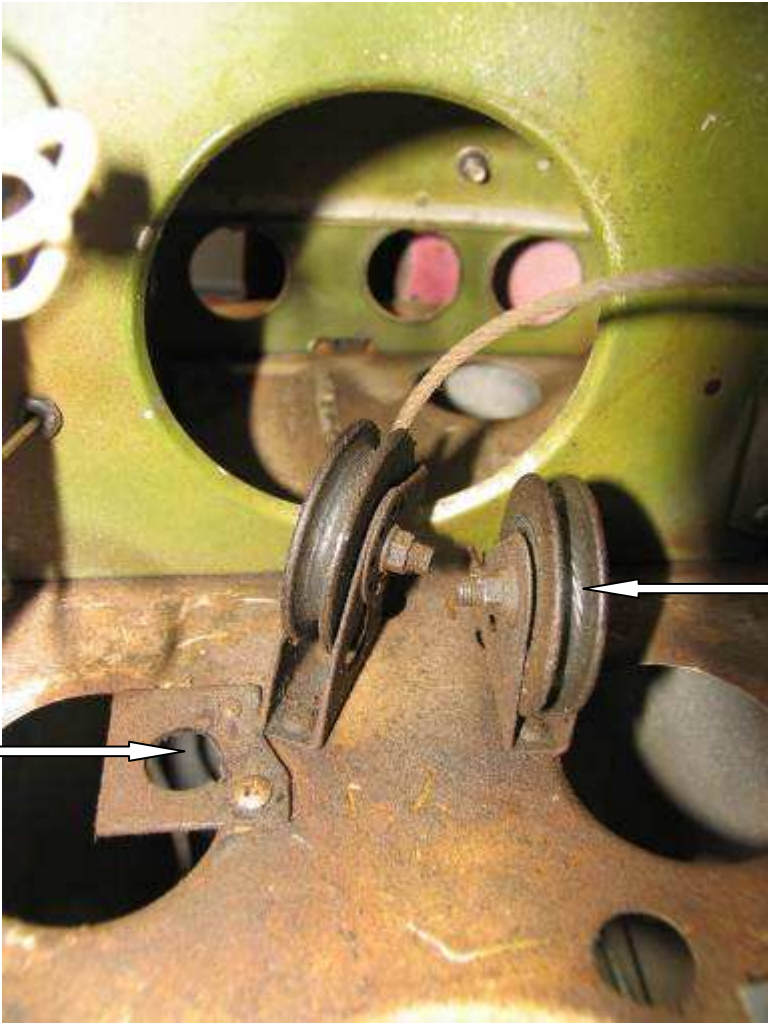
This guide supports the left-hand rudder cable.

This pulley supports the right-hand rudder cable

Figure 10. A close-up view of the pulley (Section A) that supports the right-hand rudder cable

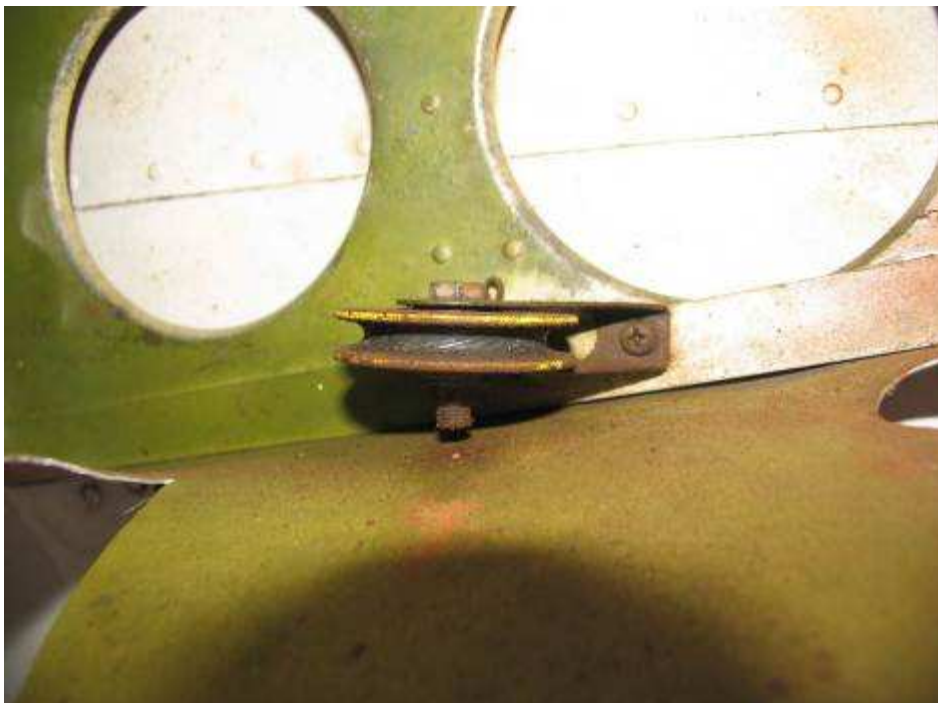
Figure 11. A close-up view of the pulley (Section B) that supports the right-hand rudder cable

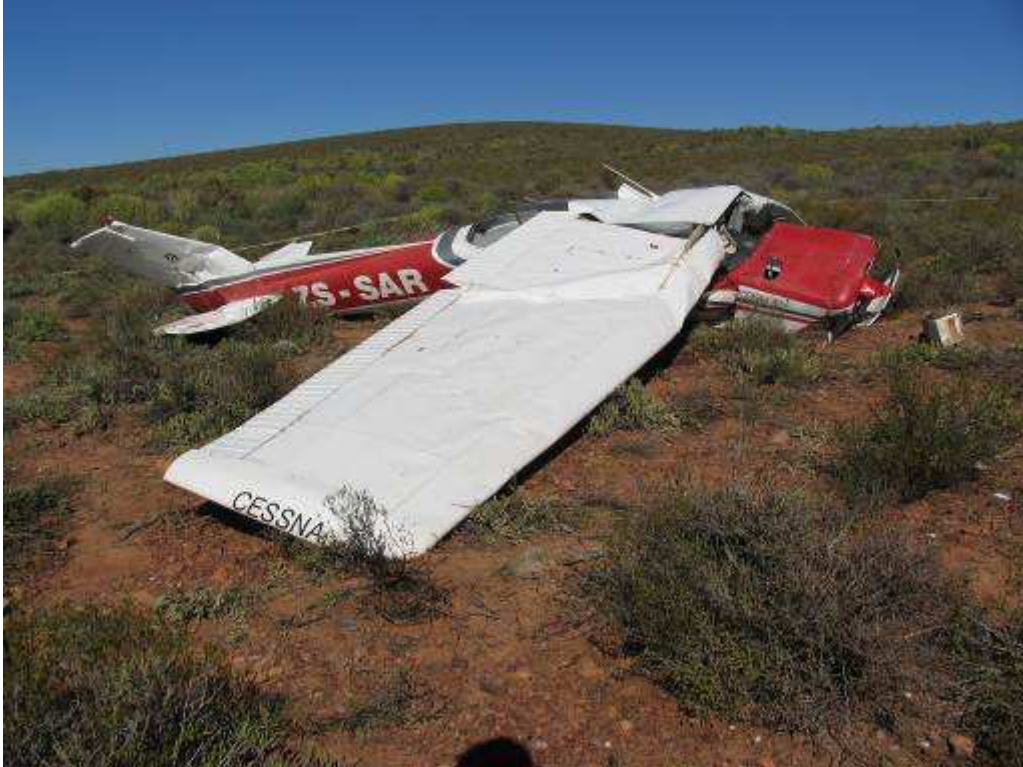
1.12.1 The accident site was located 9,2 nm east-southeast of FAWC on the farm Wittekop. The wreckage was confined to a small area and was consistent with a low velocity and a high rate of descent. The only ground markings visible were located approximately 4 m in front of the main wreckage and were caused by the nose landing gear, which broke off during the impact sequence.

The aircraft battery was found at the ground impact location as well as the nose wheel and nose landing gear strut assembly. The impact heading was 315°M. The impact sequence was associated with an aircraft that was in a left spin during ground impact, with damage to the left wing as well as the wing strut, which was found to have bent approximately mid-span along the strut. The right wing strut was undamaged. The cockpit area was substantially deformed, especially in the area of the rudder pedals as well as the roof structure. The right front door was found in the open position. The flaps were found to be in the retracted position (up). Flight control continuity was ascertained for the ailerons and elevators.

Figure 12. The aircraft as it came to rest

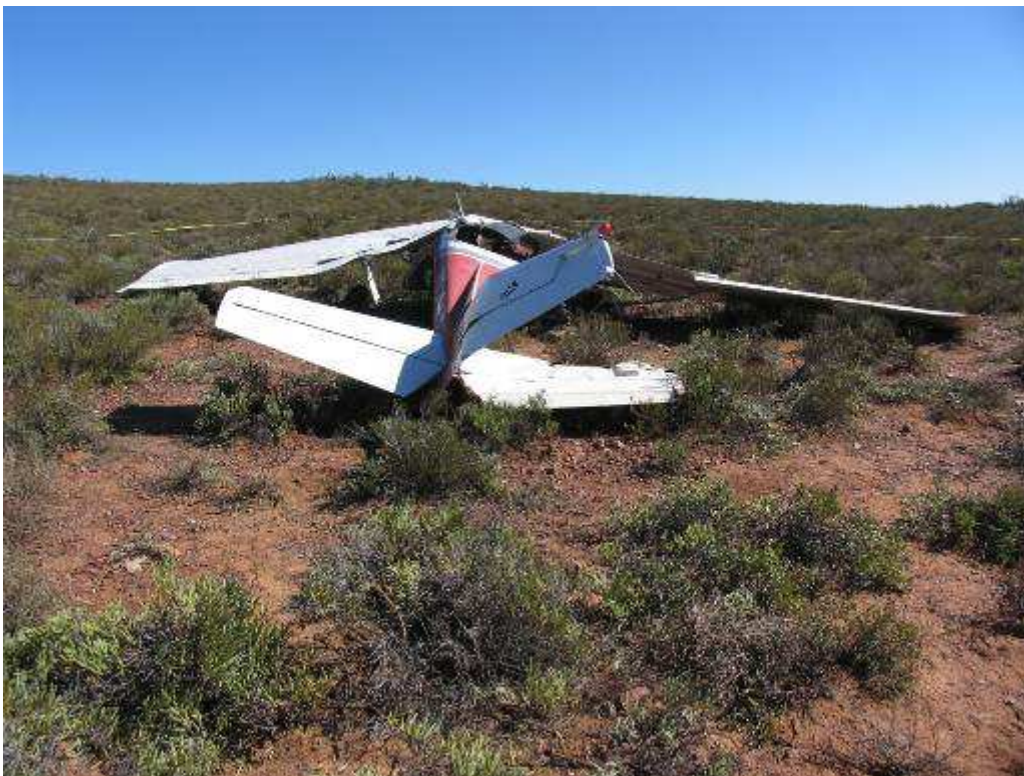
The horizontal stabiliser on the right side displayed some deflection upwards approximately mid-span along the surface; very little damage was visible to the left horizontal stabiliser. The vertical stabiliser, including the rudder, was found to be deflected towards the right, when looking at the wreckage from the aft position. The right rudder cable was found to have fractured approximately 27 centimetres from the attachment to the aft rudder bracket. The left rudder cable remained intact. Both rudder cables were removed from the wreckage for further examination.

Figure 13. Aft view of the aircraft

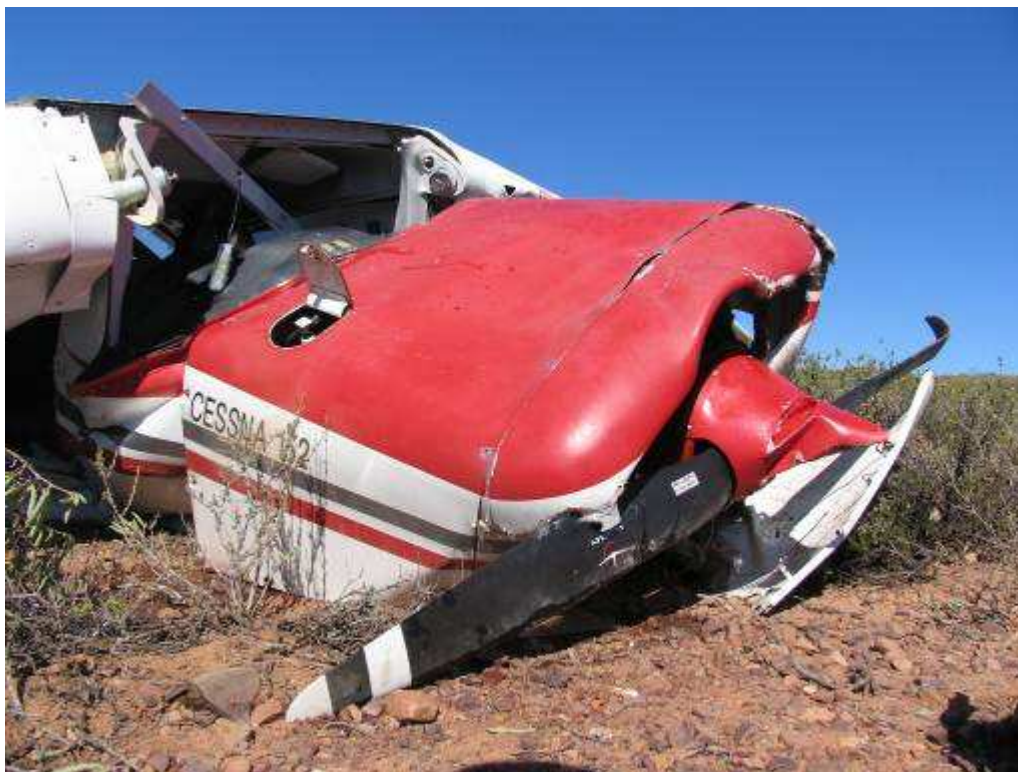
One of the propeller blades displayed signs of impact damage, with the blade tip being bent backwards; the other blade as well as the spinner revealed no signs of rotational scoring, as can be seen in figure 14 below. Cockpit examination revealed that the carburettor heat selector lever was in, the throttle was in (maximum power selected), and the mixture lever was about 1 cm out (very close to full rich).

Figure 14. A view of the propeller and front section of the aircraft.

The fact that the propeller and spinner displayed very little signs of rotation on impact could be an indication that the engine had stopped prior to the aircraft impacting the ground. The POH of the aircraft states that prolonged spinning could cause engine stoppage, but that this should not adversely affect spin recovery.

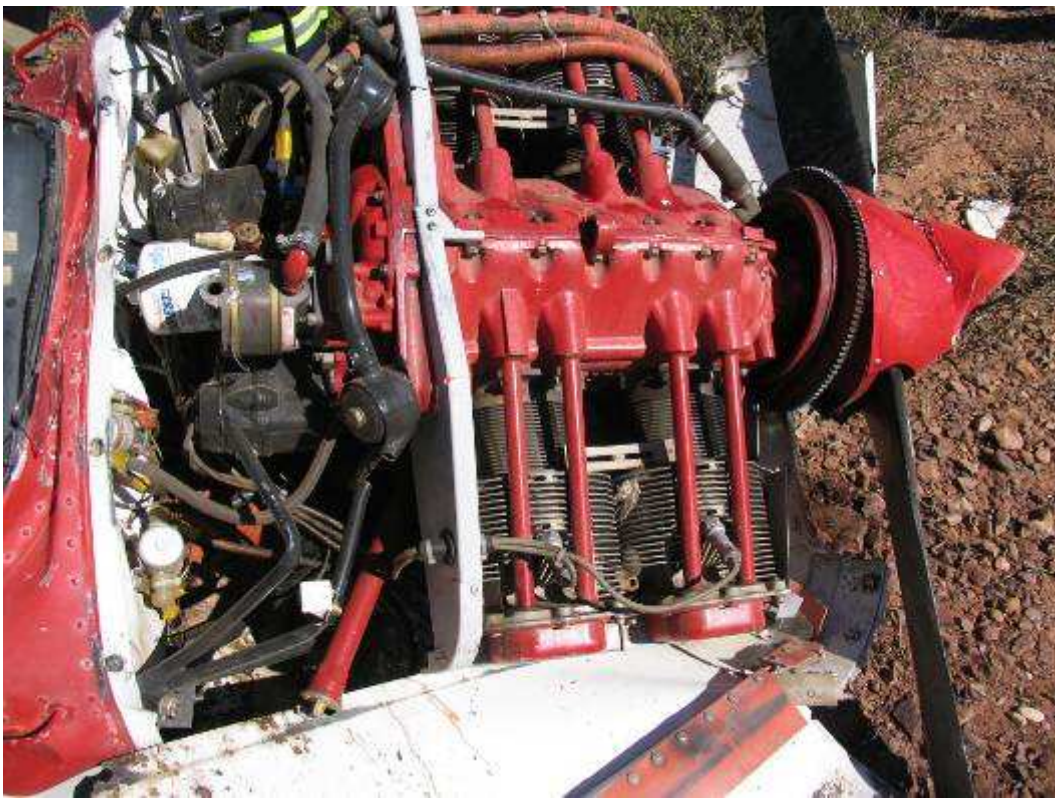
1.16.1 The engine, a Lycoming O-235-L2C, serial No. L-22456-15, was removed from the wreckage. The engine sustained impact damage and it was not possible to conduct an engine bench test run. A teardown inspection was conducted on 30 April 2013 at an aircraft maintenance organisation (AMO). The engine did not reveal any mechanical defects that could have contributed to or have caused the engine to fail. The evidence displayed was associated with normal engine operation.

Figure 15. A view of the engine taken during the on-site investigation.

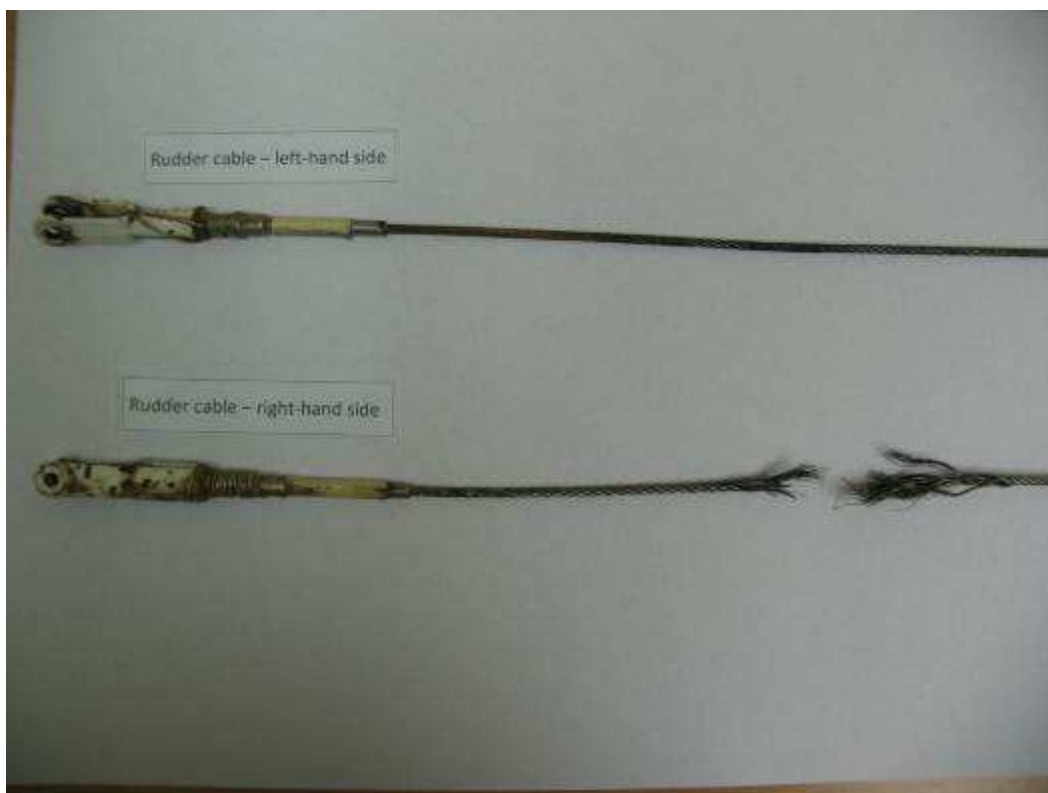
1.16.2 During the on-site investigation the right-hand rudder cable was found to have failed approximately 27 centimetres (10 inches) from the aft rudder bracket attachment (also referred to as the clevis). Both the right-hand as well as the left-hand cable assemblies 0400107-49 and -50 were removed from the wreckage and were forwarded to the Federal Aviation Administration (FAA) in the United States of America for metallurgical analysis at an approved facility. Figure 16 on the next page displays the aft section of the failed right-hand rudder cable as well as the left-hand cable that was installed on the aircraft at the time of the accident flight. A detailed metallurgical report can be found attached to this report as Annexure A. The report concludes that: *“The cable likely broke due to wear. No evidence of fatigue was noted. On all but the centre strand, the majority of the wires were worn less than 50% of the original diameter. The centre strand of the wires exhibited tensile fracture over the majority of the wires”*.

Figure 16. A view of the aft section of the two rudder cables.

The metallurgical report indicates that the right-hand rudder cable had failed due to mechanical wear, which progressed over an undetermined period of time. The left-hand cable also displayed evidence of wear, but the wear had not reached such an advanced state as the right-hand cable, which failed in operation. A breaking strength test was performed on the left-hand cable and it failed in the area where the wear was present, which was well below the 2 000 pounds engineering limit.

3.1.7 During the on-site investigation it was found that the right-hand rudder cable had failed. The failure mode was attributed to mechanical wear. The wear occurred over an undetermined period of time.

- 4.1 It is recommended to the Director of Civil Aviation that the Airworthiness division issue an Urgent Safety Advisory Notice to all Cessna 150/152 owners to ensure rudder cable integrity is not compromised in any way. A detailed inspection of the rudder cables (from the front to the back) should be conducted by an approved aircraft maintenance organisation. Such an inspection should be documented in the aircraft airframe logbook and should not be limited to a once-off inspection.

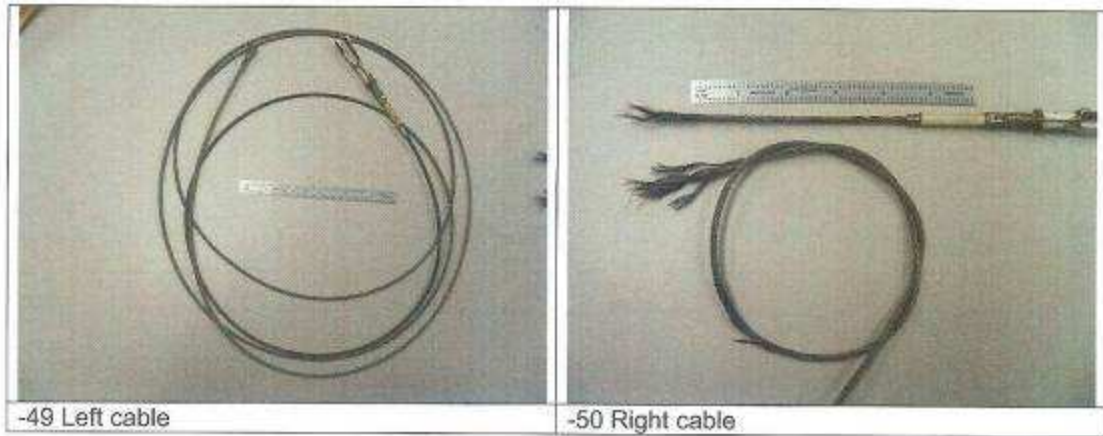
Figure 2 – Photos of cables as-received.

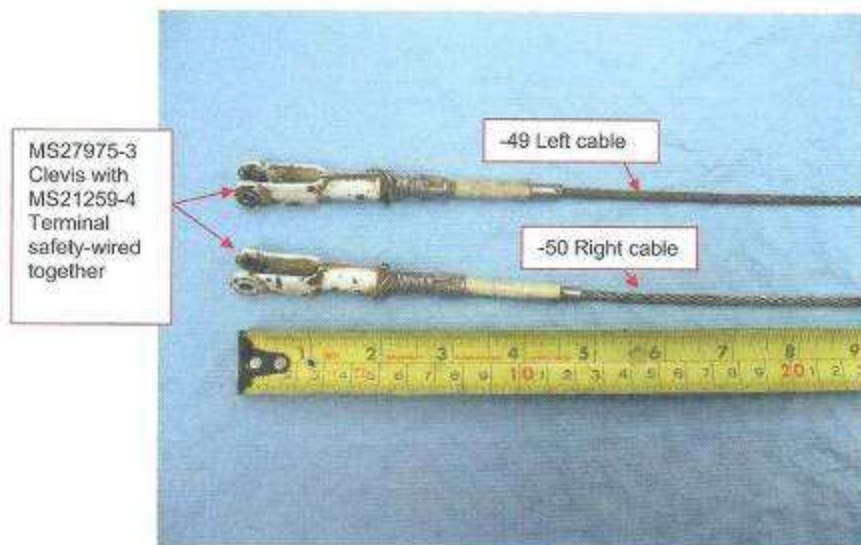
The cables were examined visually and two locations on each cable showed visible debris coating the cable, and evidence of wear at approximately 10 inches from the end of the clevis, or approximately 8 inches from the end of the MS21259-4 terminal, and at approximately 23 inches from the end of the clevis, or approximately 21 inches from the end of the MS21259-4 terminal. The Right cable was separated at approximately 10 inches from the end of the clevis, and one strand was broken at approximately 23 inches from the end of the clevis. The Left cable exhibited shiny wire surfaces in a localized area on the cable. See Figures 3 thru 5.

Figure 3 – Photo of cable terminals with clevis safety wired to it, showing condition. This is the aft end which attaches to the rudder horn.

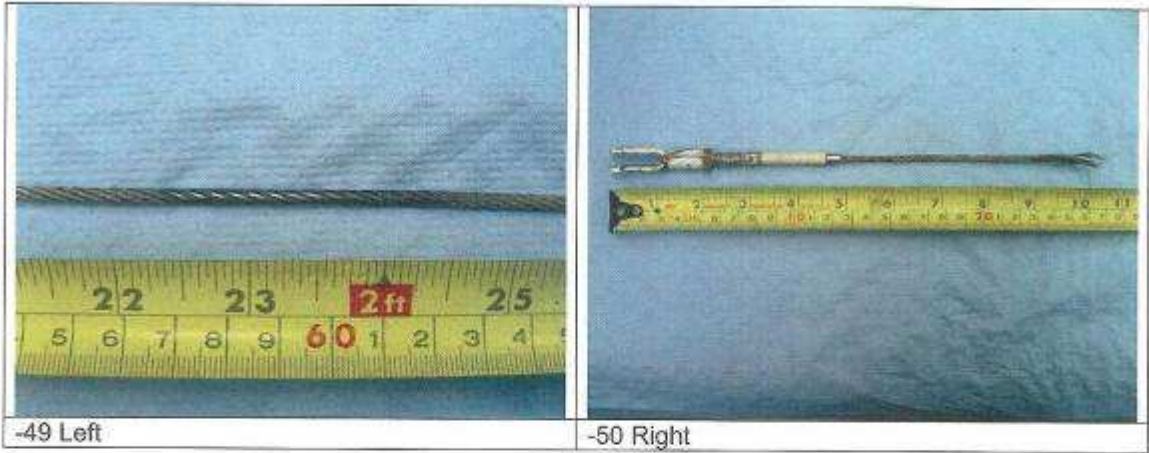
1. The cable likely broke due to wear. No evidence of fatigue was noted. On all but the center strand, the majority of the wires were worn to less than 50% of the original diameter. The center strand of wires exhibited tensile fracture over the majority of the wires.
2. Energy-dispersive spectroscopy (EDS) identified some minor amount of aluminum present in the cable debris. The debris also included white fibers, which could be seen optically. The source of these materials cannot be determined.

Figure 4 – Photo of cables at approximately 10 inches from end of clevis (ref. Figure 3 approx. 8" from end of MS21259-4 terminal) showing wear on the -49 cable and cable separation of the -50 cable.

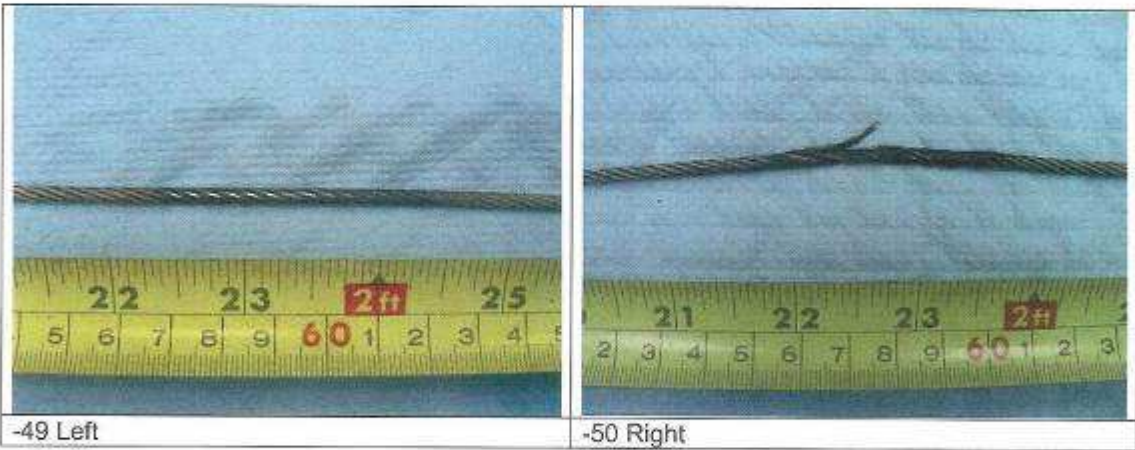
Figure 5 – Photo of cables at approximately 23 inches from the end of clevis (approx. 21" from end of MS21259-4 terminal showing wear on the -49 cable and a broken strand on the -50 cable.

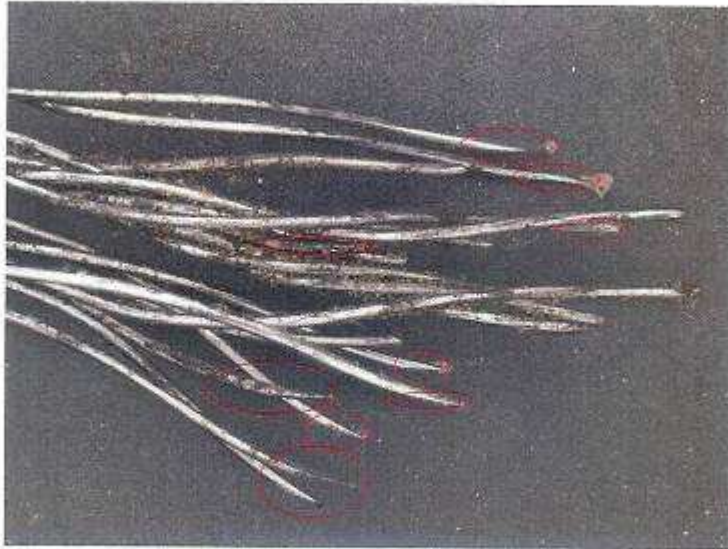
The -50 Right cable was examined at the break. The 19 broken wires of each of the 7 strands were examined in detail, see Figures 6 thru 12. On all but the center strand, the majority of the wires were worn to less than 50% of the original diameter. Only the center strand of wires exhibited tensile fracture over the majority of the wires. Figure 13 shows a closer view of the broken strand on the -50 Right cable at approximately 23 inches, where wear is evident on the broken wires. Figure 14 shows the shiny areas on the -49 Left cable at approximately 10 inches and 23 inches. Upon closer examination, the wire surfaces are worn to the point where they appear flat.

Figure 6 – Photo of Strand 1 from -50 Right cable (ref. Figure 4) showing the individual wires. Note many of the wires are flat-sided and thinned at the tip (red ovals), typical of fracture due to wear. Magnification approximately 10x.

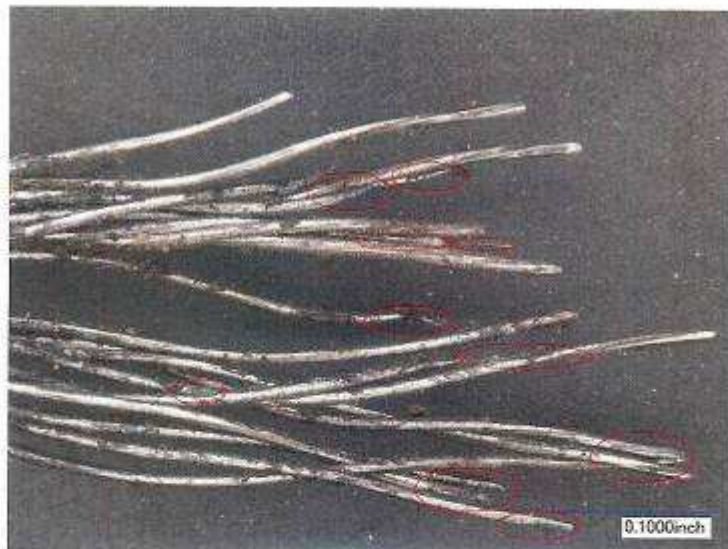
Figure 7– Photo of Strand 2 showing the individual wires. Note many of the wires are flat-sided and thinned at the tip (red ovals), typical of fracture due to wear. Magnification approximately 10x.

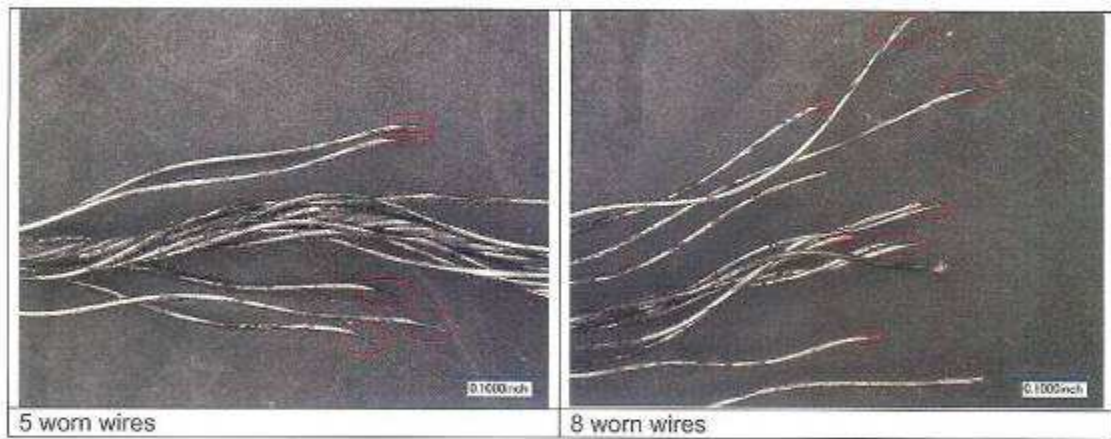
Figure 8- Photo of Strand 3 showing the individual wires. Note many of the wires are flat-sided and thinned at the tip (red ovals), typical of fracture due to wear. Magnification approximately 5x.

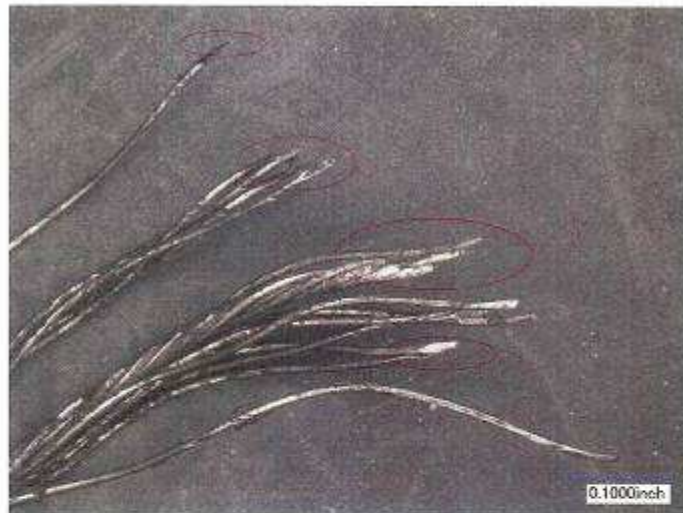
Figure 9 - Photo of Strand 4 showing the individual wires. Note many of the wires are flat-sided and thinned at the tip. Magnification approximately 7x.

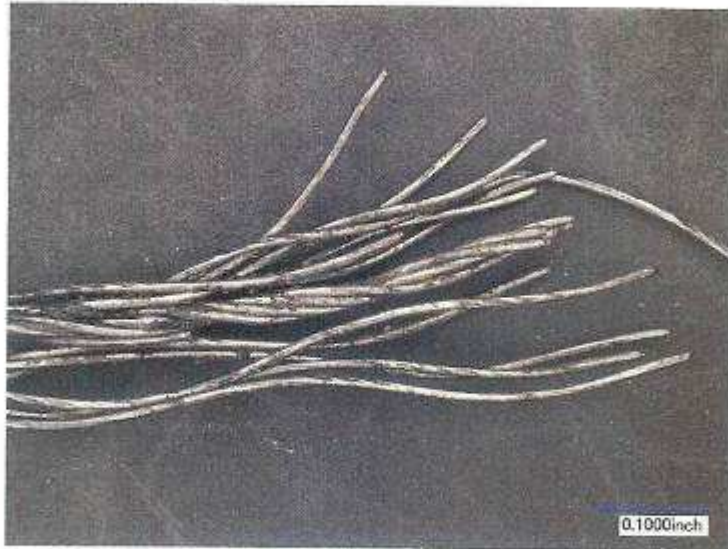
Figure 10 - Photo of Strand 5 showing the individual wires. All wires show shear-mode tensile fracture with some necking observed. This was the center strand of the cable. Magnification approximately 7x.

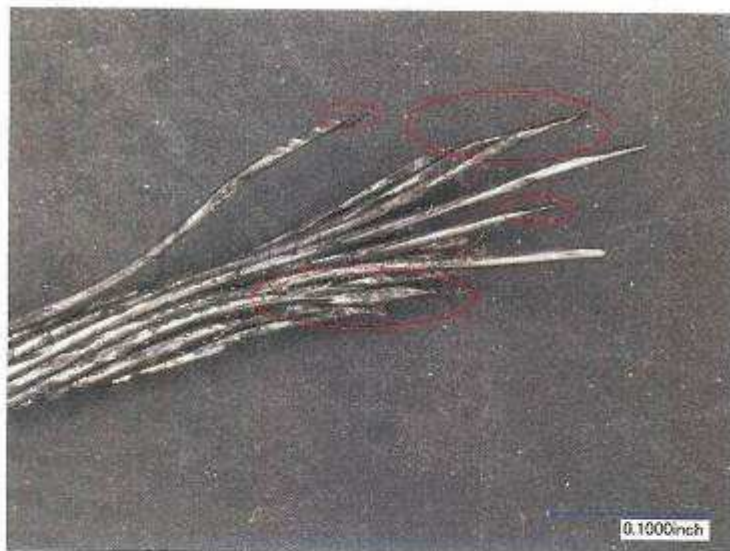
Figure 11 - Photo of Strand 6 showing the individual wires. Note wires are flat-sided and thinned at the tip (red ovals), typical of fracture due to wear. Magnification approximately 10x.

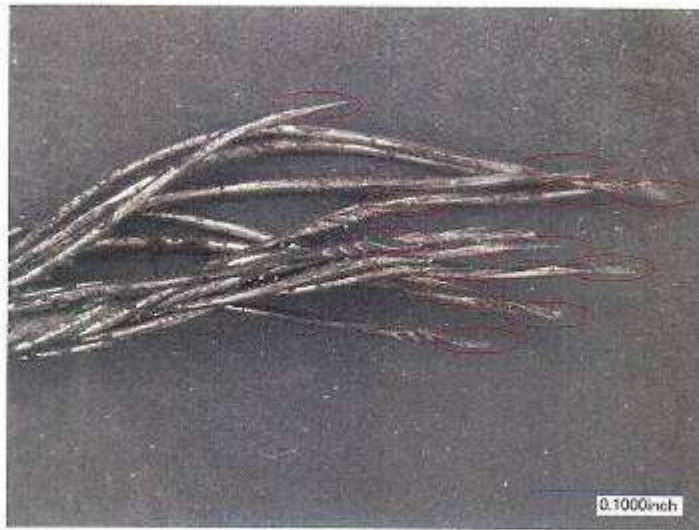
Figure 12 - Photo of Strand 7 showing the individual wires. Note nearly all wires are flat-sided and thinned at the tip (red ovals), typical of fracture due to wear. Magnification approximately 10x.

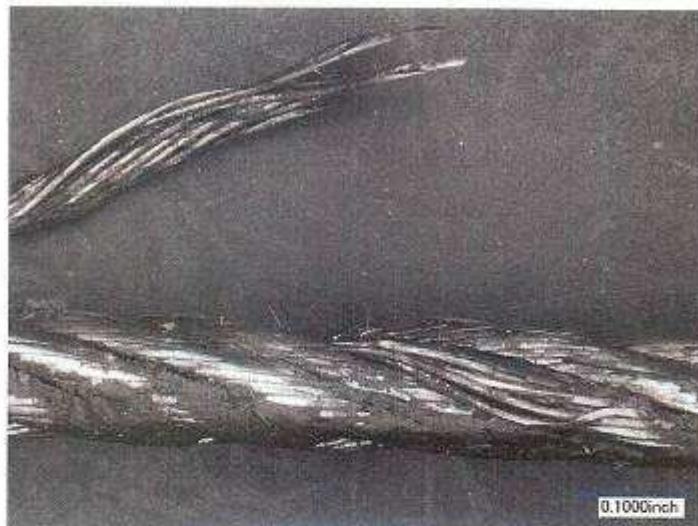
Figure 13 - Photo at slightly higher magnification of the Right cable (ref. Figure 5) showing the degree of wear at approximately 23" from the clevis and thinning of the broken wires. Magnification approximately 7x.

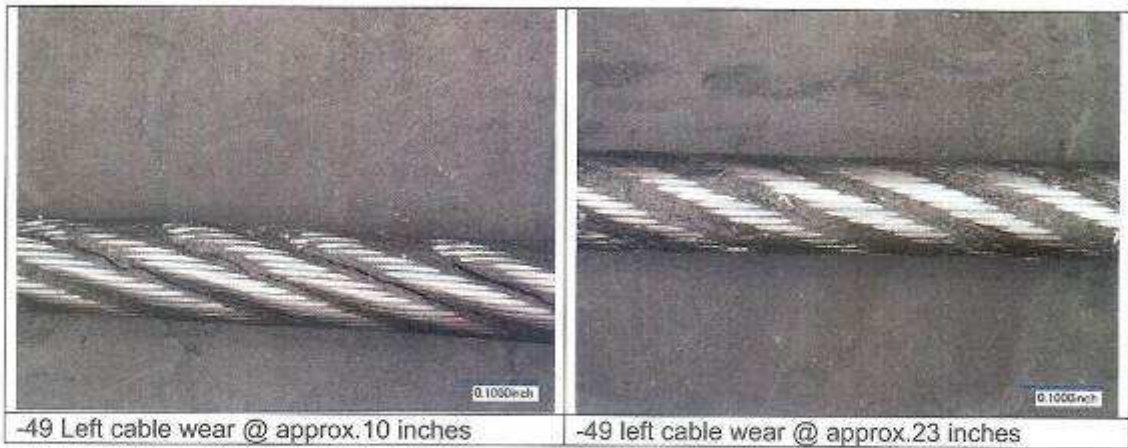
Figure 14 – Photos under magnification of the Left cable showing wear at approximately 10 inches and 23 inches. The outer surfaces of the wires are worn flat. Magnification approximately 5x.

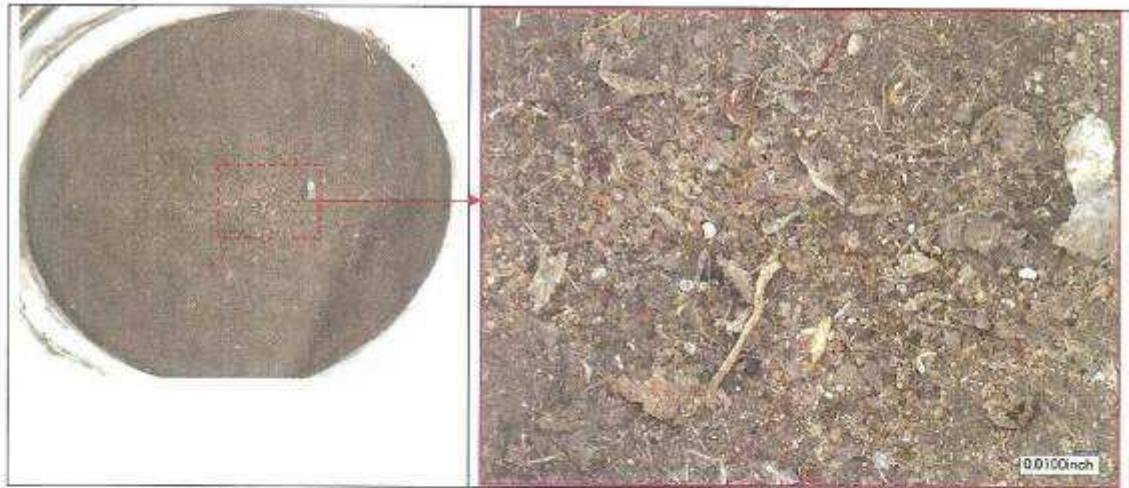
The -50 Right cable portion (ref. Figure 4) was soaked in Methyl Propyl Ketone (MPK) to remove the oil and debris from the cable. The solution was filtered, washed with MPK to remove the oil, and dried. The debris was examined optically and was found to consist of red and white fibers, large particulate, fine grey particulate, and a few shiny particles. Samples were taken to perform Energy Dispersive Spectroscopy (EDS) (Figure 15). The EDS spectrum shows elements of silicon, iron, zinc, oxygen, carbon, aluminum, magnesium, potassium, and sulfur present in the debris (Figure 16.)

Figure 15 – Photo of the filtrate from the -50 broken cable. The red fibers are a color tracer filament common to a specific cable manufacturer. The white fibers are from an unknown source, however, the cable pulleys (S378-3) are made from phenolic, which is typically fiber reinforced. Much of the large particulate resembles sand and dirt. A few shiny particles are evident. Magnification of debris approximately 15x.

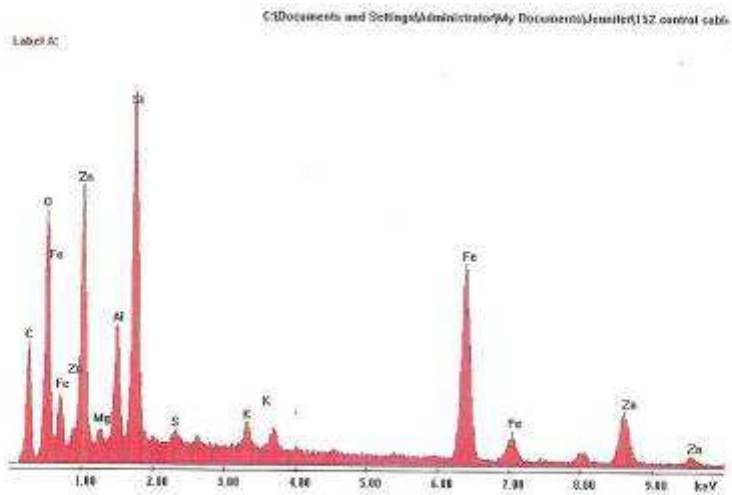
Figure 16 - The EDS spectrum shows elements of silicon (Si), iron (Fe), zinc (Zn), oxygen (O), carbon (C), aluminum (Al), magnesium (Mg), potassium (K), and sulfur (S) present in the debris.

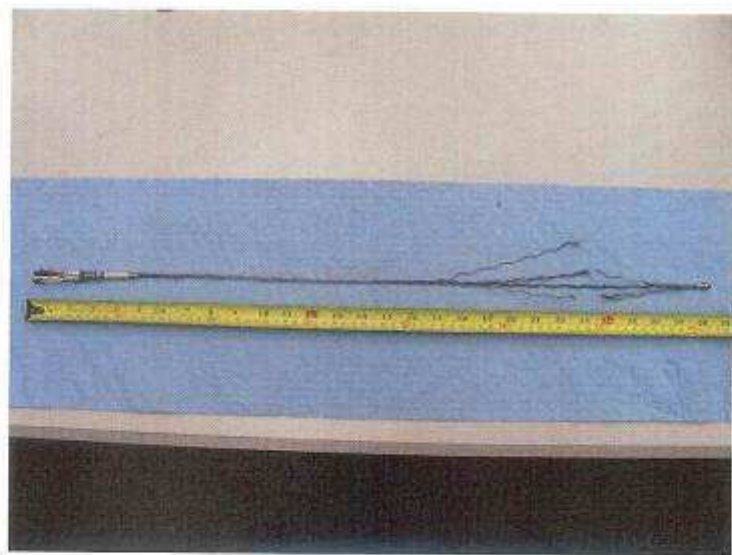
3.1.9 Although to a lesser degree, the left-hand rudder cable revealed similar damage. During a strength test that was conducted on the cable it failed in the area where wear was present.

3. The breaking strength of an undamaged portion of the cable exceeded the CSAM026 requirement of 2000 pounds, and the breaking strength of a portion of cable with localized wear on the outer strands of approximately 50%, was 1529 pounds.

Sample ID	Breaking Strength Pounds (LBS)
-49 Left cable undamaged	2133
-49 Left cable 28 inch section from end of clevis - damaged	1529
Engineering Requirement	2000 LBS. per CSAM026

Figure 17 - Photo of the section of Left cable containing worn areas tested to the point of breaking. The cable broke within the area that corresponded to the worn area at approximately 23 inches.

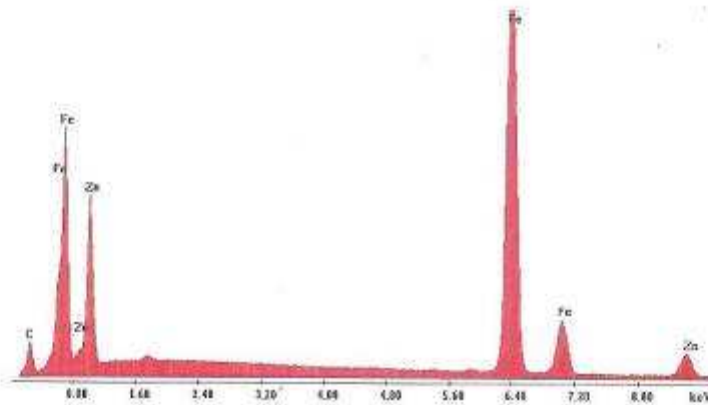
Figure 18 - EDS spectrum of wire, showing this to be a carbon steel cable. The zinc (Zn) peaks are due to the plating on the wires and are not part of the material chemistry.
