AIRCRAFT ACCIDENT REPORT AND EXECUTIVE SUMMARY

Reference:	CA18/2/3/9220	
Aircraft Registration	ZU-RGL	Date of Accident	8 September 2013		Time of Accident	1445Z
Type of Aircraft	Autogyro MTO		Type of Operation		Private	
Pilot-in-command Licence Type		National Pilot's Licence	Age	53	Licence Valid	Yes
Pilot-in-command Flying Experience		Total Flying Hours	107,6		Hours on Type	107,6
Last point of departure		Private airfield, Klipplaat farm, near Brits, North West				
Next point of intended landing		Private airfield, Klipplaat farm, near Brits, North West				
Location of the accident site with reference to easily defined geographical points (GPS readings if possible)						
Dense bush near Klipplaat farm (GPS S25°38'40.6+E027°16'44.82+ at an elevation of 3 700ft above mean sea level)						
Meteorological Information		Wind direction: 360°; Wind speed: 5kt; Visibility: 10km; Cloud base: Nil				
Number of people on board	1 + 1	No. of people injured	1	No. of people killed	0

Name of Owner/Operator : Avengo 31 (Pty) Ltd
Manufacturer : Autogyro GmbH
Model : MTO Sport
Nationality : South African
Registration Marks : ZU-RGL
Place : Klipplaat farm near Brits, North West
Date : 8 September 2013
T

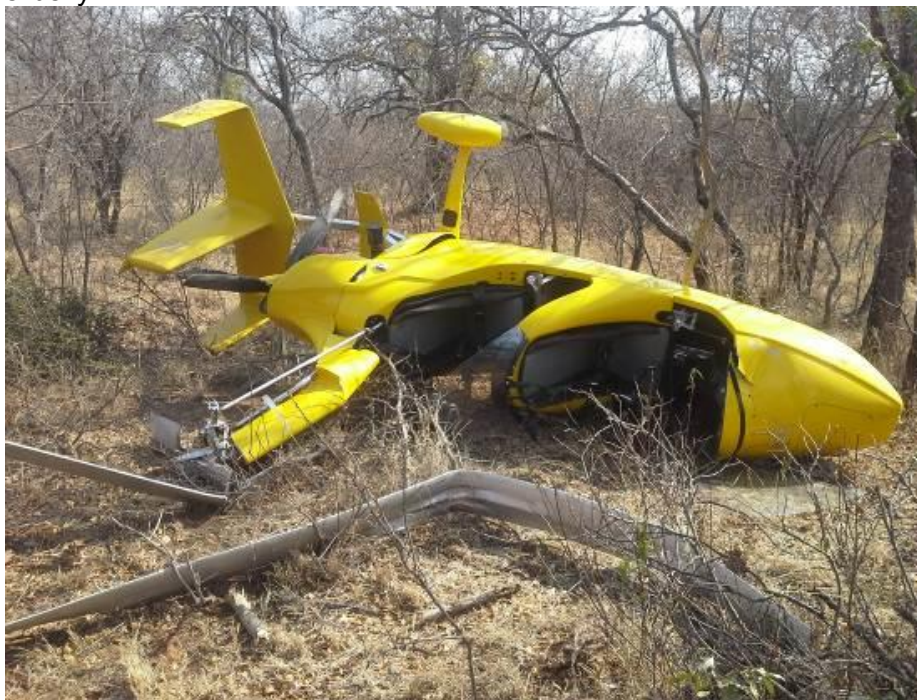
- 1.3.1 The autogyro sustained damage to the rotor blades, windshield, fuselage and underbelly.

Figure 2: The autogyro fell over onto its right side after striking the trees.

1.12.1 The accident occurred in daylight conditions during an animal surveillance flight on Klipplaat farm. The pilot reported that the aircraft experienced a downdraft and lost height. It then crashed in a bushy area and flipped onto its right-hand side. The propeller, cockpit cabin area and most of the instruments were damaged, as were the rotor blades and tail assembly. The front windscreen was destroyed and the rudder pedals were damaged.
