AIRCRAFT ACCIDENT REPORT AND EXECUTIVE SUMMARY

Reference:		CA18/2/3/1003	
Aircraft Registration	ZU-FKU	Date of Accident	21 September 2013		Time of Accident	1300Z	
Type of Aircraft	Cheetah XLS		Type of Operation		Private		
Pilot-in-command Licence Type		Microlight and Private Pilot's Licence	Age	23	Licence Valid	Yes	
Pilot-in-command Flying Experience		Total Flying Hours	155,0		Hours on Type	94,5	
Last point of departure		Hazyview Aerodrome, Mpumalanga					
Next point of intended landing		Hazyview Aerodrome, Mpumalanga					
Location of the accident site with reference to easily defined geographical points (GPS readings if possible)							
Numbi Hotel airstrip in Hazyview (co-ordinates: S25° 03' 00" E031° 08' 00")							
Meteorological Information		Surface wind: 280°13kt; Visibility: greater than 10km; Temperature: 20°C; Cloud cover: Overcast; Cloud base: 3 000ft AGL					
Number of people on board	1 + 1	No. of people injured	0	No. of people killed	0

Name of Owner : Botha T and Loots H Partnership
Name of Operator : Private
Manufacturer : Rainbow Aircraft (Pty) Ltd
Model : Cheetah XLS
Nationality : South African
Registration Marks : ZU-FKU
Place : Numbi Hotel Airstrip in Hazyview
Da

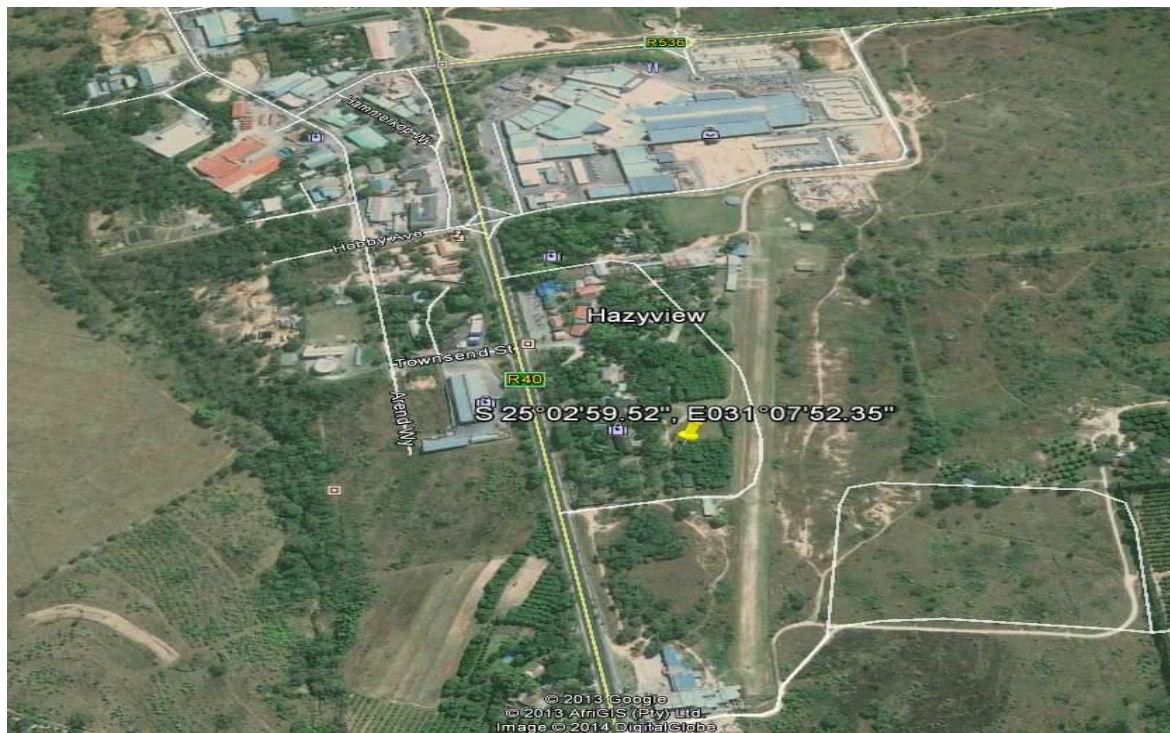
Figure 1: The Numbi Hotel airfield.

1.10.2 There are powerlines east of the runway and buildings at the end of the runway.

1.10.4 Due to the buildings in the vicinity of the airfield and the mountains surrounding the airfield, a variety of wind phenomena are likely to occur around the airfield.
