AIRCRAFT ACCIDENT REPORT AND EXECUTIVE SUMMARY

Reference:	CA18/2/3/9252	
Aircraft Registration	ZU-DZC	Date of Accident	04 December 2013		Time of Accident	1136Z
Type of Aircraft	Evektor-Aerotechnik A.S (SPORTSTAR) (Aeroplane)		Type of Operation		Training flight	
Pilot-in-command Licence Type	PPL (Aeroplane)	Age	54	Licence Valid	No	
Pilot-in-command Flying Experience	Total Flying Hours	Approximately 1261.5		Hours on Type	Unknown	
Last point of departure	Pietermaritzburg Airport (FAPM)- Kwa-Zulu Natal Province					
Next point of intended landing	Pietermaritzburg Airport (FAPM)- Kwa-Zulu Natal Province					
Location of the accident site with reference to easily defined geographical points (GPS readings if possible)						
At Richmond on a sugar cane farm with GPS reading (S 29° 56' 37", E 030° 18' 27")						
Meteorological Information	Wind direction 120°C, Wind speed 10KT, Temperature at 26°C, Dew point 12°C, QNH 1016, Visibility <10km					
Number of people on board	2+0	No. of people injured	0	No. of people killed	2

AIRCRAFT ACCIDENT REPORT

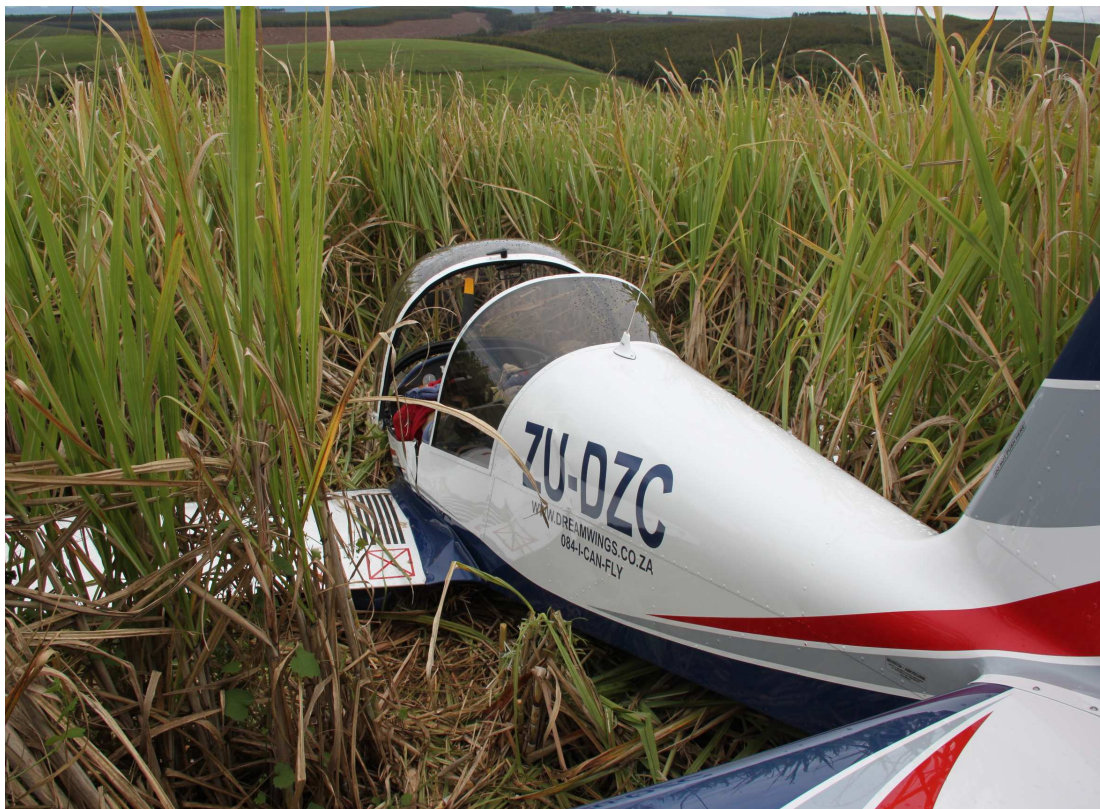
1.3.1 The aircraft was substantially damaged.

Figure 1: Shows the aircraft damage

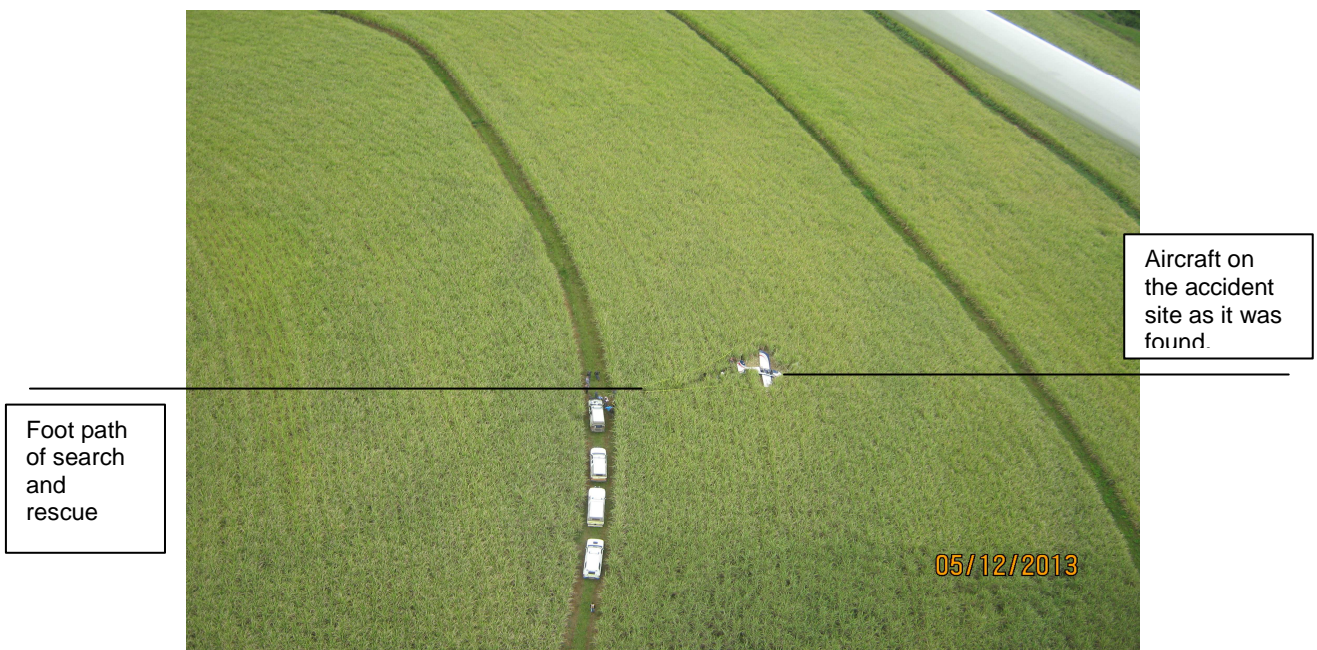
Figure 2: Shows the surrounding of the accident site

1.12.1 The onsite observations showed that the aircraft impact with the ground was on its belly. The terrain surrounding the accident site is mountainous and hilly.

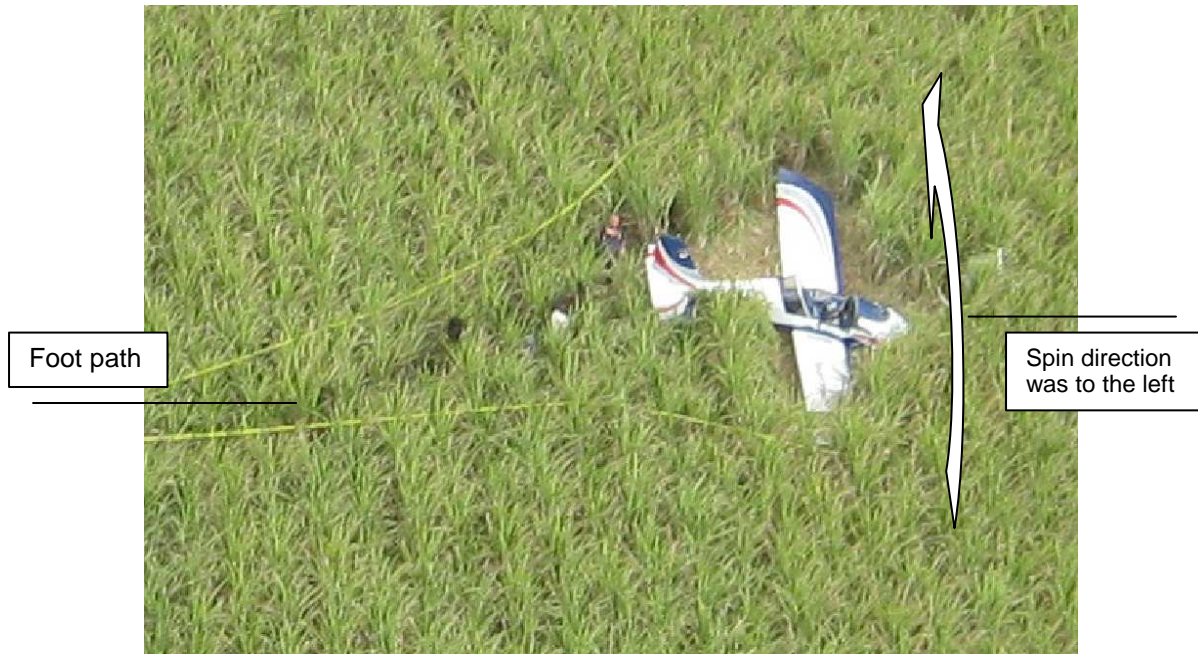
1.12.2 The aircraft wreckage pattern was consistent with an aircraft involved in a flat spin prior to impact. The aircraft remained intact facing in a north-westerly direction with only minimum distance of left rotational movement.

Figure 5: View of the spin effect on the cockpit sidewalls

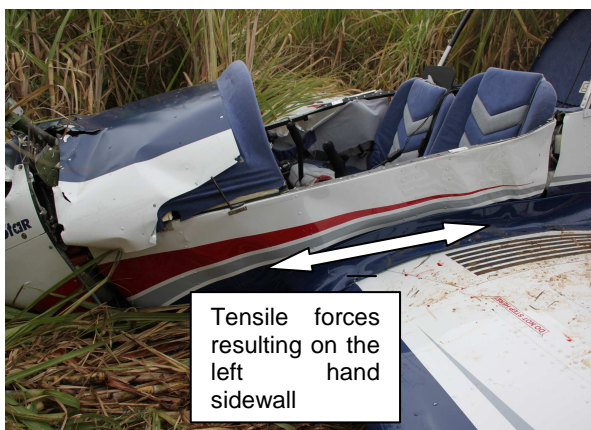
The engine ignition switch was at "ON" position with both magnetos activated. The impact damage affected the bottom surface of the fuselage, which was pushed inward to the opposite impact direction.

Figure 3: Left hand side view of the damage

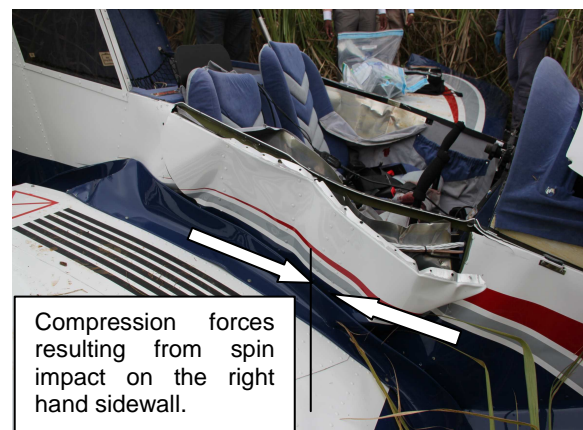
Figure 4: Right hand side view damage

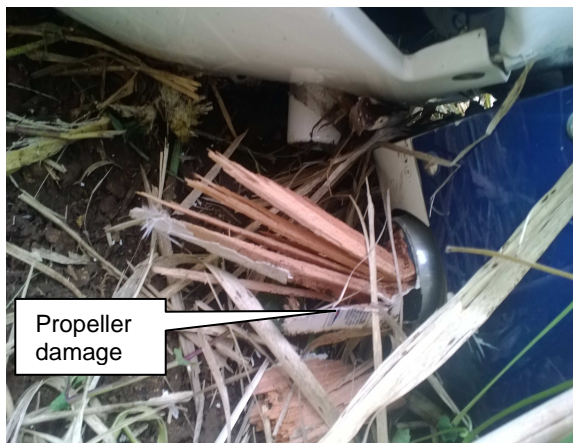
1.12.3 Further observations on the propeller damage indicated that the aircraft impact was with the engine on complete stop. Two of the three propeller blades snapped from the hub and one remained on the up-right position. During impact all three-fixed undercarriage collapsed towards the fuselage bottom and were pushed to the right

Figure 6: Shows propeller damage

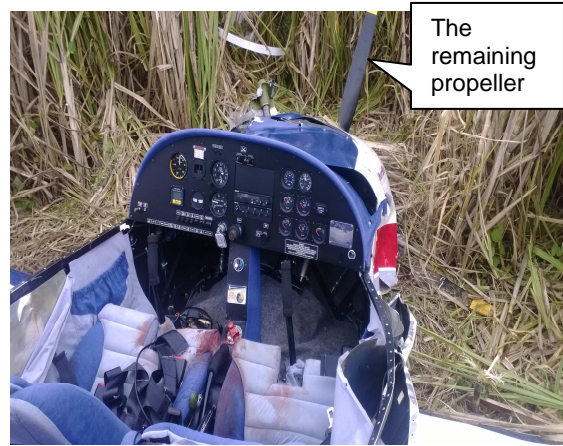
Figure 7: view of the remaining propeller

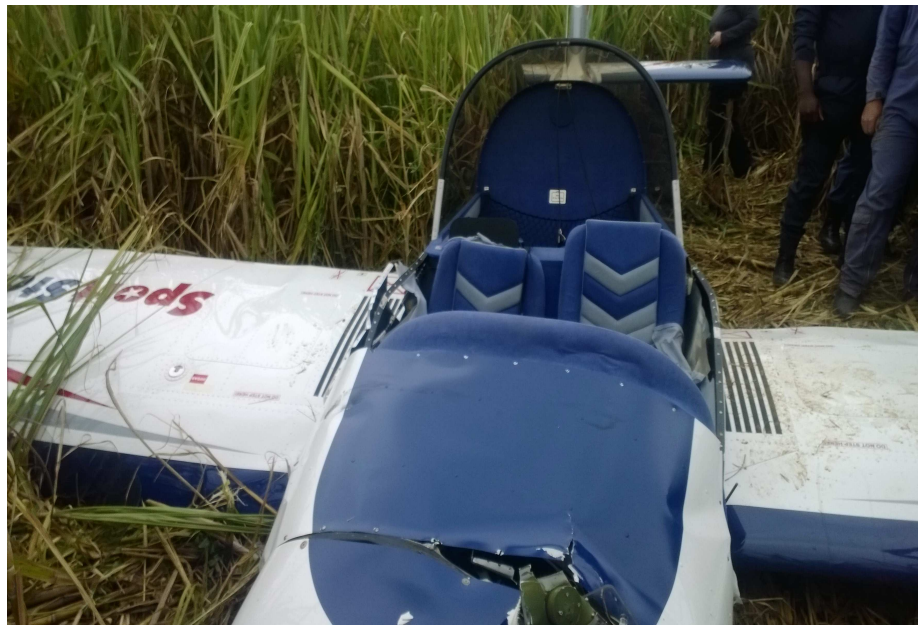
Figure 8: Shows the front view of the aircraft

The right-hand main landing gear broke off from the root attachment on the main spar of the fuselage structure and damaged the right-hand wing bottom. The damage ruptured the right wing tank causing a fuel spill on the ground. Further damage to the fuselage bottom caused by impact forces pushed the fuselage bottom upward.

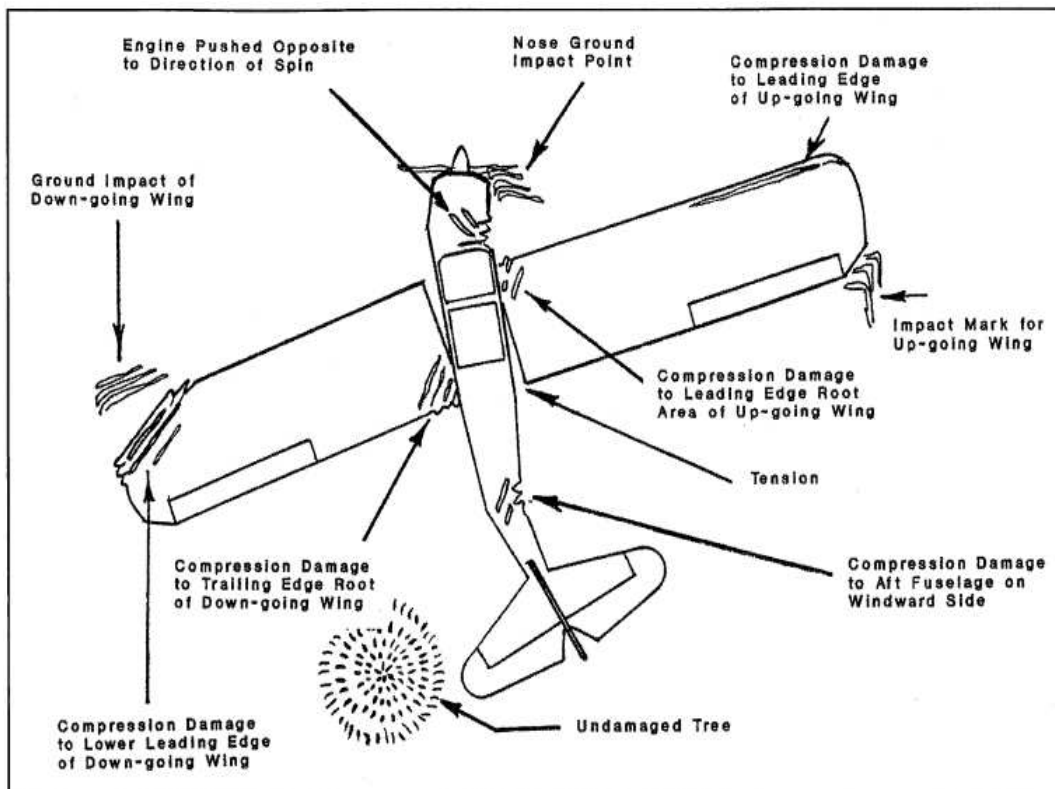
- The engine was pushed to the right (as viewed from the rear)
- Compression damage to the trailing edge root of the left wing
- Tension to the trailing edge root of the right wing
- Compression to the leading edge root of the right wing
- Compression damage to the leading edge of the right wing

Figure 9: Stall/ spin wreckage pattern

Note: Not all spin impact characters shown on this figure were experienced by the aircraft as it was involved in a flat spin.
