AIRCRAFT ACCIDENT REPORT AND EXECUTIVE SUMMARY

Reference: CA18/2/3/9253	
Aircraft registration	ZU-CLM	Date of accident	9 December 2013		Time of accident 1312Z
Type of aircraft	Bushbaby (Aeroplane)		Type of operation		Private
Pilot-in-command licence type		Commercial	Age	27	Licence valid Yes
Pilot-in-command flying experience		Total flying hours	744,4		Hours on type 67,1
Last point of departure		Nelspruit Aerodrome (FANS), Mpumalanga province			
Next point of intended landing		Nelspruit Aerodrome (FANS), Mpumalanga province			
Location of the accident site with reference to easily defined geographical points (GPS readings if possible)					
300 m short of the threshold of runway 04 at FANS (GPS position: 25°30'20.57" South 030°54'42.84" East)					
Meteorological information		Surface wind: 040%5 kt, temperature: 22 °C, visibility: +10 km			
Number of people on board	1 + 1	No. of people injured	1	No. of people killed	0
Synopsis					
<p>The pilot, accompanied by an aircraft maintenance technician, conducted a post-maintenance acceptance flight on the aircraft following an abnormally high engine water temperature indication during flight, which was a recurring event on this aircraft.</p

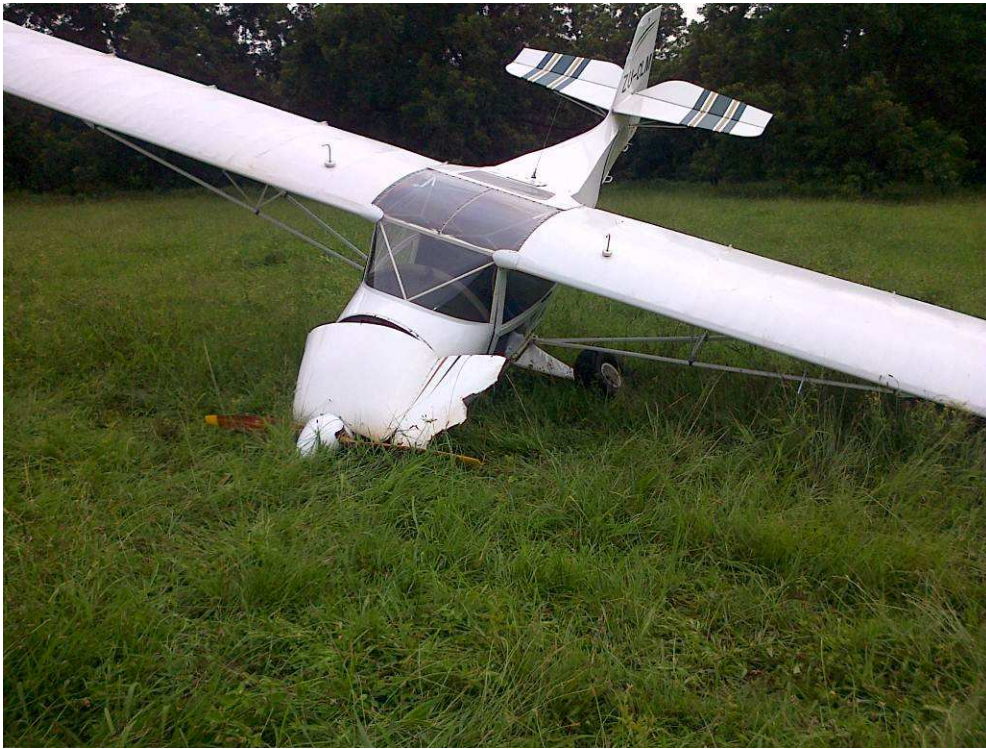
1.3.1 The aircraft sustained substantial damage during the forced landing when the nose wheel collapsed and the left wing impacted with the ground.

- 1.12.1 The pilot executed a forced landing on an open field approximately 300 m from the threshold of runway 04. During the landing the nose wheel collapsed and the left main landing gear strut collapsed partially (as can be seen in figure 2 on the next page). The aircraft came to a halt with the nose down and the left wing low, resulting in substantial damage to the lower engine, the engine cradle and the outer section of the left wing.

Figure 2 View of the aircraft as it came to rest

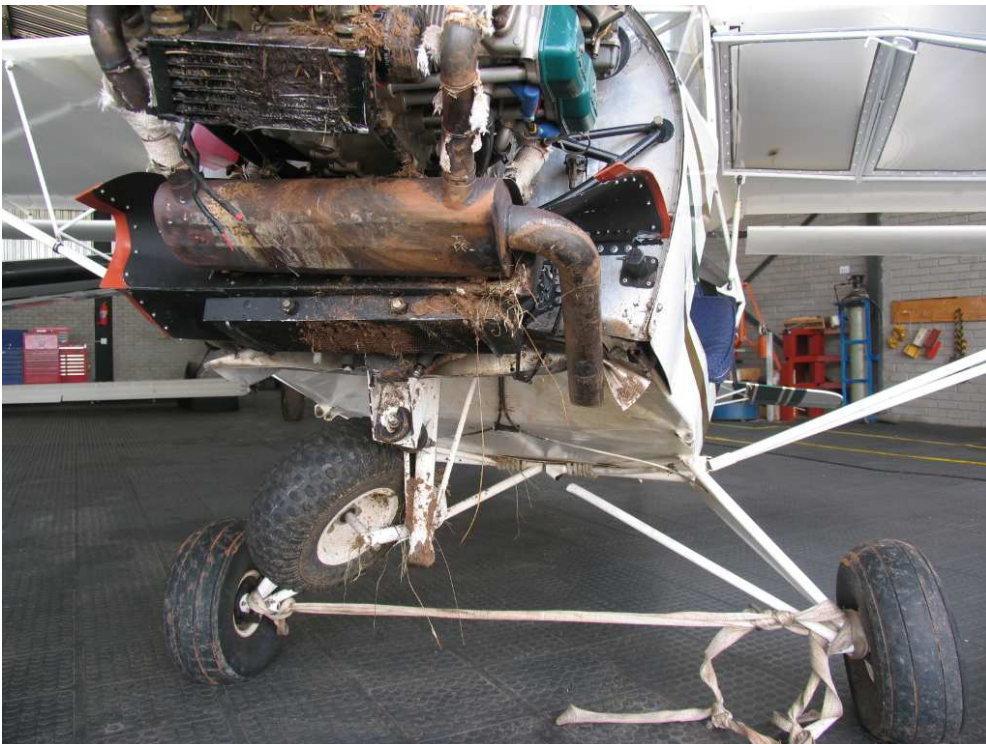
Figure 3. View of the collapsed nose gear and engine damage

1.16.3 The propeller was not damaged in the accident, as it came to a stop in a horizontal position prior to ground impact. The engine could be turned freely by hand. In a post-accident inspection on the engine, the fuel lines connecting to the fuel pump (inflow and outflow lines) were removed and were found not to contain any fuel. Both carburettor bowls were removed and showed no signs of fuel. Both fuel filters were removed and cut open; neither of them contained any fuel, but they displayed very slight traces of dirt (photo of one of the filters can be seen on the next page, figure 6). The spark plugs were removed and displayed a light greyish colour, which was indicative of normal engine operation. A compression test was performed on the engine, and no abnormalities were noted on any of the four cylinders.

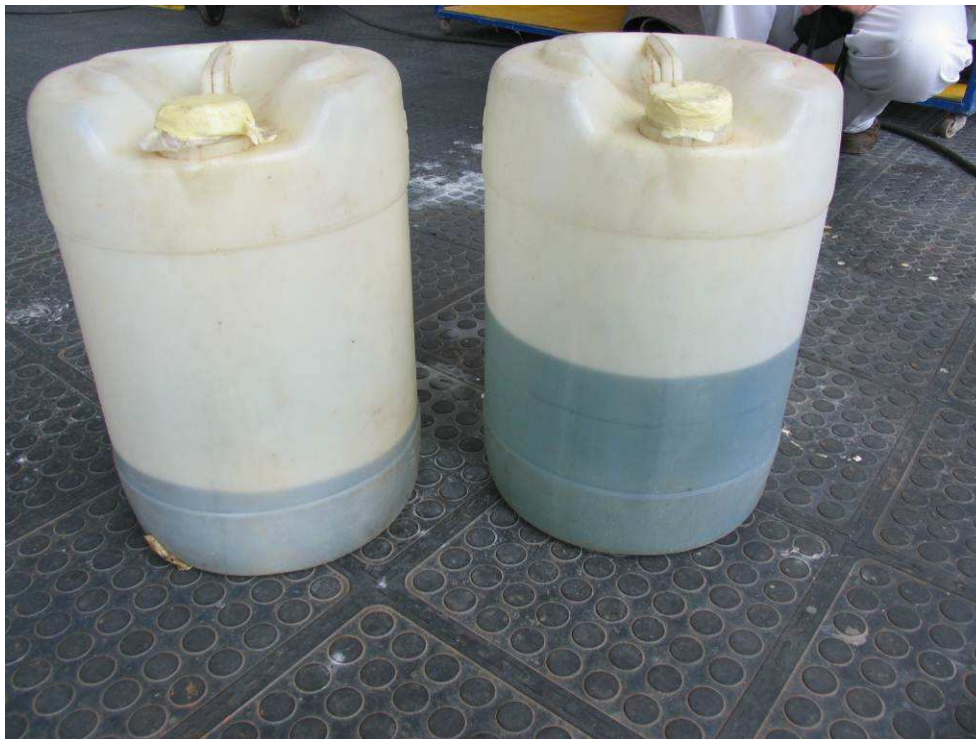
1.16.1 Following the recovery of the aircraft to an aircraft maintenance organisation (AMO) at FANS the fuel was drained from the two wing tanks. Approximately 5 litres was drained from the right tank and 10 litres from the left tank. It was further noted that the fuel grade differed between the right and left tank. The fuel in the right tank would appear to have been mogas; it was much darker in colour and smelled different from the fuel in the left tank, which was a mixture of mogas and avgas but predominantly avgas. According to the CAA approved flight manual for this aircraft the total fuel capacity was 72 litres (36 litres per tank), with the unusable fuel indicated as 5 litres (see Annexure A attached to this report).

Figure 4. The two containers with the fuel that was drained from the tanks

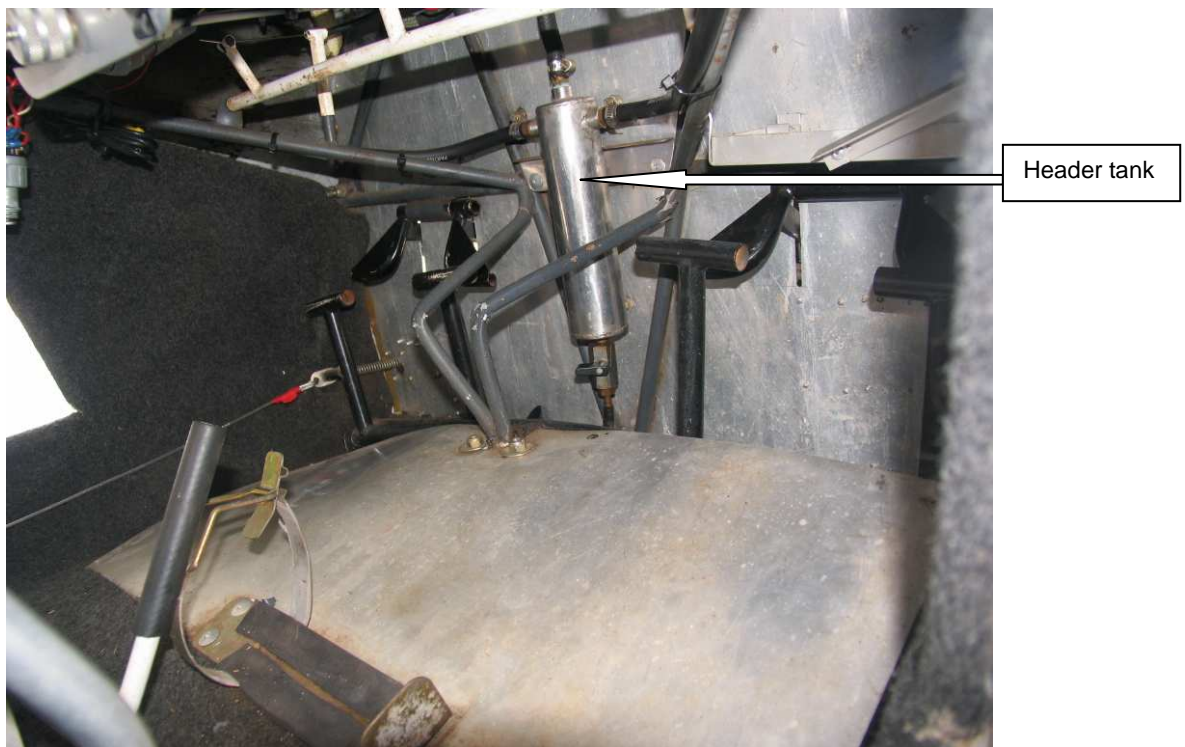
1.16.2 The header tank (see figure 5 below) was removed from its location in the cockpit/cabin area and was found not to contain any fuel. Fuel flows by gravity from the two wing tank outlets, which are located aft of the tank; it then passes through a fuel filter (one on each side) and flows to the header tank, which on this aircraft contained approximately 500 ml of fuel and was located against the forward firewall in the cockpit/cabin area. From the header tank, fuel was supplied to the engine via a mechanical fuel pump. (A newly designed header tank was installed on later models of this aircraft type and contained 5 litres of fuel).

Figure 5. The header tank against the firewall in the cockpit

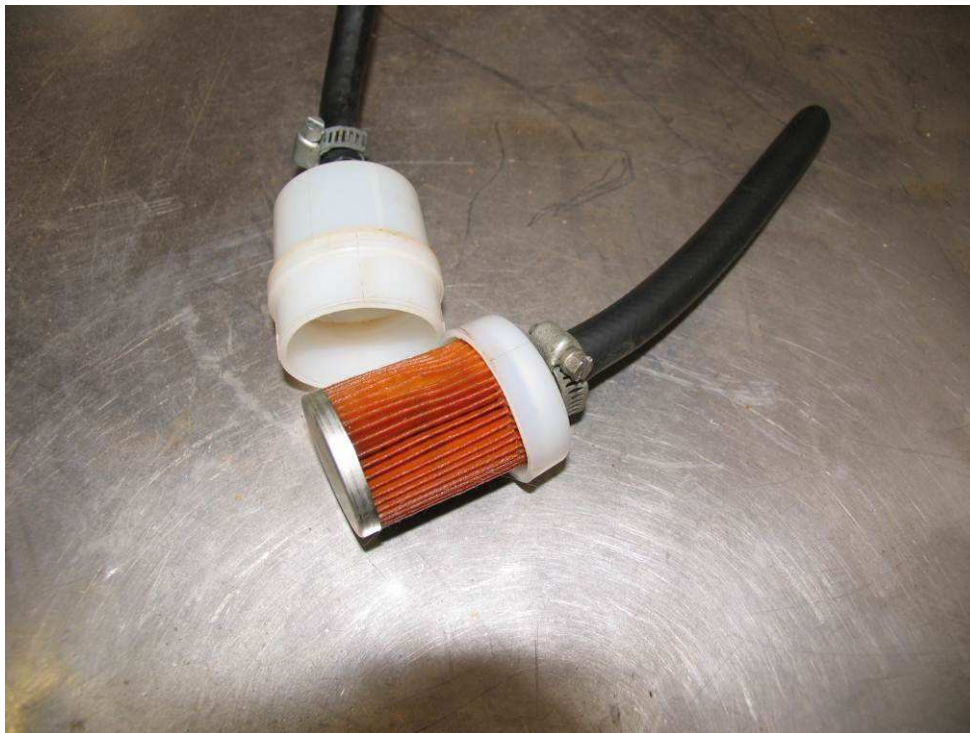
Figure 6. View of one of the fuel filters that was cut open

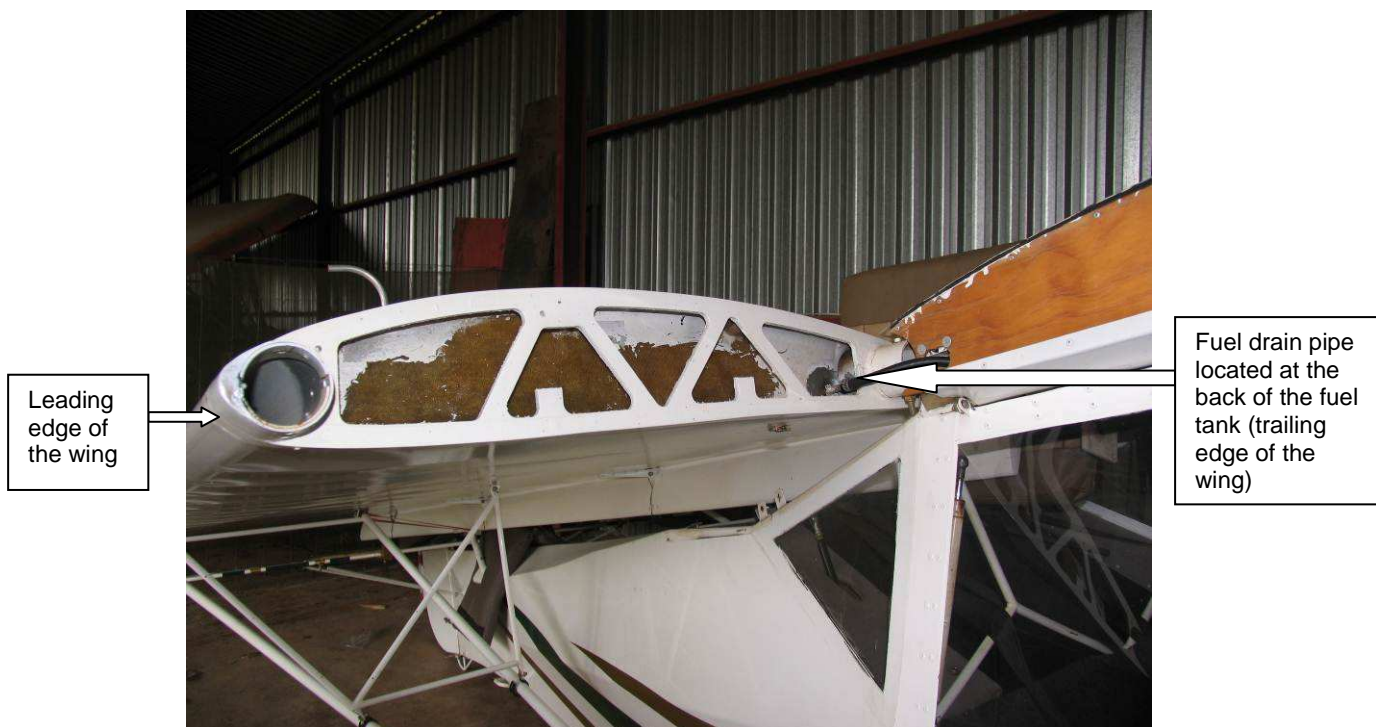
1.16.4 The fuel drains from both the wings tanks were inspected. It was found that both drains leading to the airframe/engine were positioned at the back of the tank, as can be seen in figure 7. From the wing tank the fuel flows through a filter (automotive type) as depicted in figure 6 and figure 9, and from there via the fuel shut-off lever (visible in figure 9) to the header tank and from there to the engine. According to the aircraft flight manual, if both fuel valves are in the open position simultaneously, the fuel will always feed from the left wing tank first. The fuel quantity in the wing tank can only be observed via a view hole cut in the presswood panelling from inside the cockpit during flight. The fibreglass material used in manufacturing the fuel tank has a brownish colour, which does restrict the pilot's view of the fuel quantity during flight. During the investigation it was found that certain models of this aircraft type were equipped with a fuel tank inspection light, located at the bottom of the wing tank, which the pilot can switch on during his/her pre-flight or during flight for a brief period. This gives the pilot a much clearer view of the actual fuel quantity in the tank.

Figure 7. View of the fuel drain pipe from the right wing tank

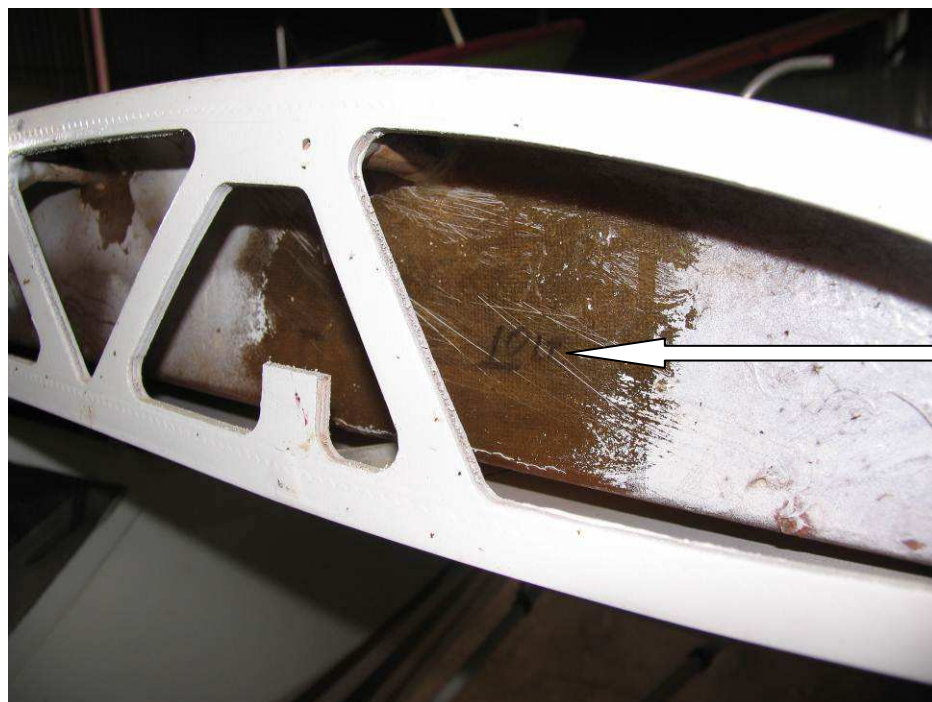
1.16.5 In the photo below (figure 8) the fuel quantity indication of 10 litres can be seen written by hand on the inside of the fuel tank with a black permanent marker. This indication should be visible to the pilot during flight via the view panel. It is evident that the white paint was sprayed over the entire wing tank side surface and a patch was cleaned afterwards in order to provide the pilot with some sort of view of the fuel level. It should be kept in mind that this is a high wing aircraft, therefore the pilot has to look upward and to the side, either to his/her left or right, to try and make an accurate assessment of the fuel level. On this aircraft the pilot's view was restricted by the brownish colour of the fibreglass.

Fuel level indication written by hand with a permanent marker on the inside of the tank.

Figure 8. Fuel quantity indication written on the inside of the wing tank

- 4.1 It is recommended to the Director of Civil Aviation that the fuel tank quantity indication system on this aircraft type be improved in order to provide the pilot with a proper visual indication of the quantity in both tanks at all times, irrespective of the fuel quantity remaining within the tanks. The investigation found the fuel tank quantity indicators on this aircraft to be of a poor design which could easily result in an inaccurate fuel indication reading by the pilot, especially when the fuel level is getting low (less than $\frac{1}{4}$ tank). This shortcoming could jeopardise the safe operation of the aircraft, as knowledge of the correct fuel level is critical to a safe flight. It was further noted that the fuel system did not contain any low fuel warning

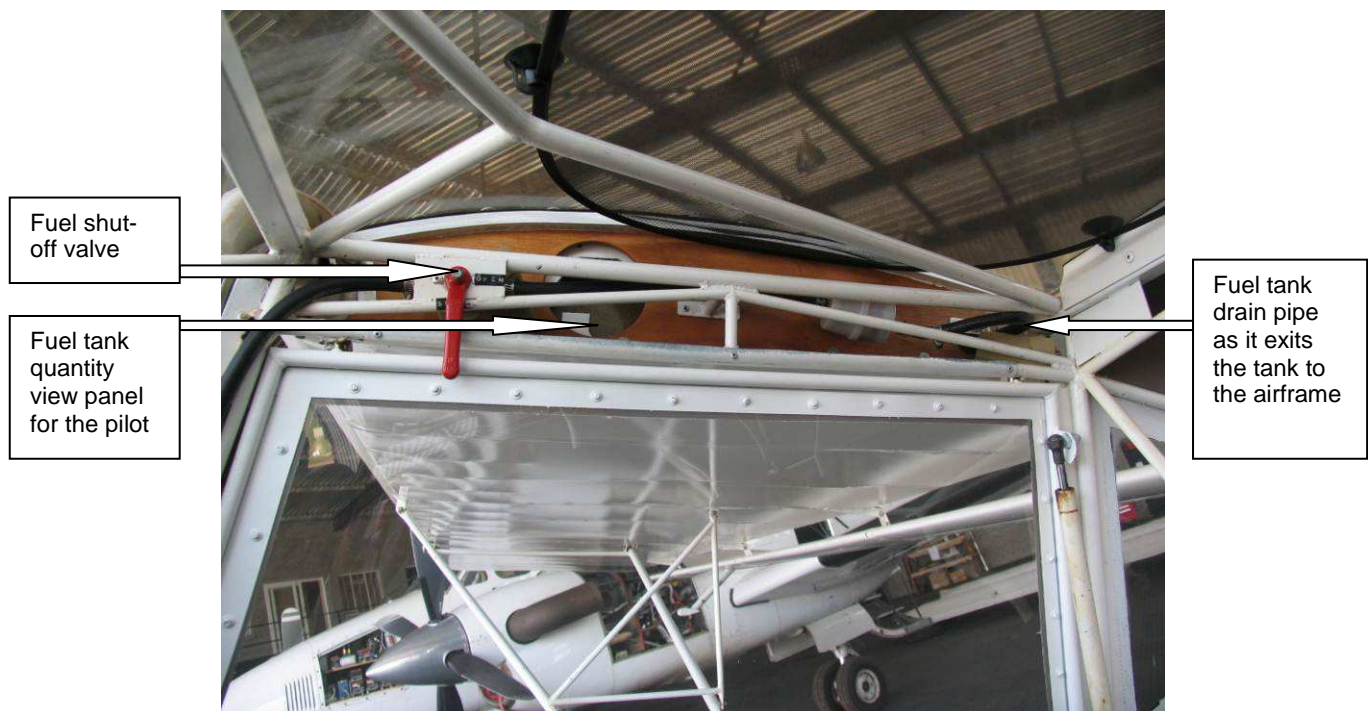
Fuel shut-off valve

Fuel tank quantity view panel for the pilot

Fuel tank drain pipe as it exits the tank to the airframe

Figure 9. Fuel tank quantity view panel taken from inside the cockpit (right wing)
