AIRCRAFT ACCIDENT REPORT AND EXECUTIVE SUMMARY

Reference:	CA18/2/3/9264	
Aircraft registration	ZS-MEA	Date of accident	30 Dec 2013		Time of accident	1630Z
Type of aircraft	Piper PA-28RT-201 (aeroplane)		Type of operation		Private	
Pilot-in-command licence type		Private Pilot	Age	50	Licence valid	Yes
Pilot-in-command flying experience		Total flying hours	104.6		Hours on type	56.6
Last point of departure		Zebula Lodge Aerodrome, Limpopo				
Next point of intended landing		Zebula Lodge Aerodrome, Limpopo				
Location of the accident site with reference to easily defined geographical points (GPS readings if possible)						
Runway 26, Zebula Lodge Aerodrome (GPS position: 24°45'24.69" South 027°58'06.05" East)						
Meteorological information		Surface wind: 270°5kt; Temperature: 20°C; Visibility: >10km				
Number of people on board	1 + 1	No. of people injured	0	No. of people killed	0	
Synopsis						
<p>The pilot, accompanied by a passenger, departed Zebula Lodge aerodrome on a local sightseeing flight of the area. They returned to the aerodrome approximately 40 minutes later. The pilot stated that he overflowed the aerodrome twice, following the unmanned aerodrome procedure whereby he

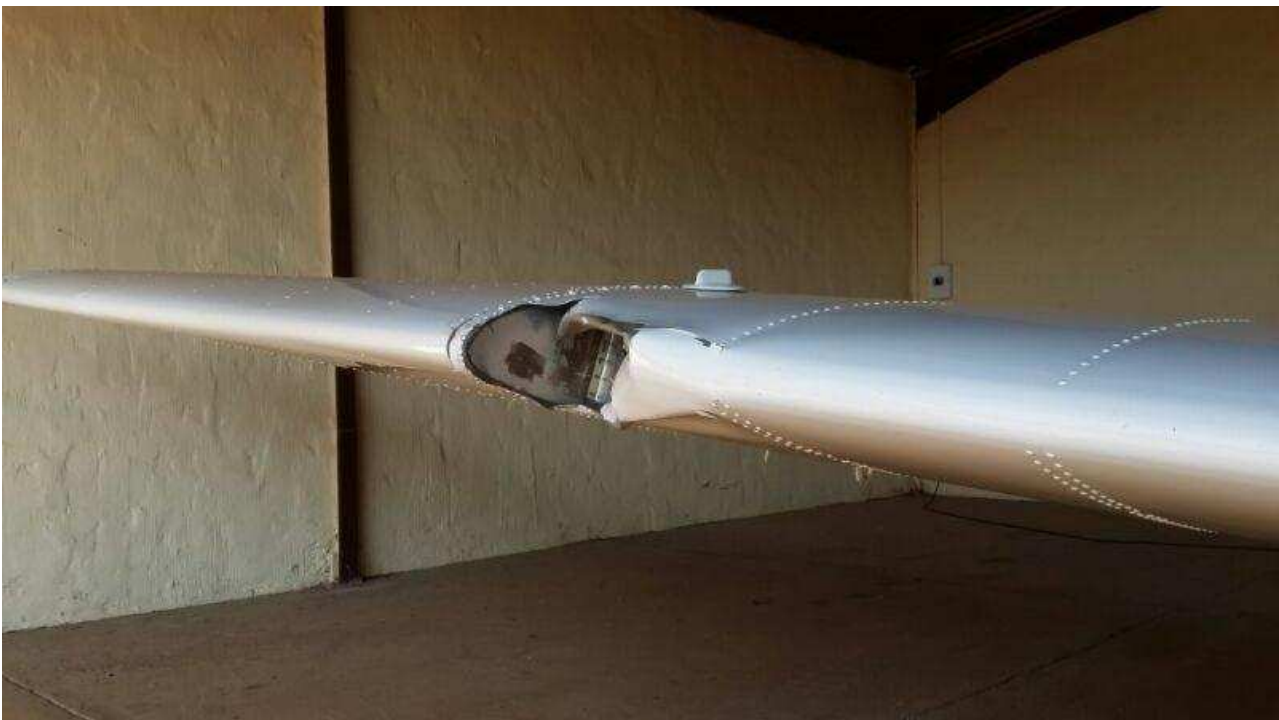
runway 26. During the landing roll, a kudu tried to cross the runway and was struck by the right wing of the aircraft. The animal was killed on impact and the wing sustained structural damage. Nobody on board the aircraft was injured.

1.3.1 The leading edge of the right wing was damaged.

Figure 1: The damage to the right wing of ZS-MEA after impact.

3.2.1 The aircraft collided with a kudu that attempted to cross the runway during the landing roll.

3.3.1 The aerodrome was unfenced and substantial numbers of wild animals roamed the property.

4.1 It is recommended that the Air Safety Infrastructure Division draft an official letter to the land owner requesting that fencing off the aerodrome area be considered in the interest of aviation safety.
