AIRCRAFT ACCIDENT REPORT AND EXECUTIVE SUMMARY

Reference:	CA18/2/3/9265	
Aircraft Registration	ZU-EFZ	Date of Accident	2 January 2014		Time of Accident	1140Z
Type of Aircraft	Bantam B22J		Type of Operation		Private	
Pilot-in-command Licence Type		Private	Age	32	Licence Valid	Yes
Pilot-in-command Flying Experience		Total Flying Hours	302.5		Hours on Type	200
Last point of departure		Nelspruit (FANS), Mpumalanga				
Next point of intended landing		Nelspruit (FANS), Mpumalanga				
Location of the accident site with reference to easily defined geographical points (GPS readings if possible)						
About 100 m from the runway threshold at The Rest airfield in the Nelspruit area, Mpumalanga (GPS co-ordinates: S25°32'34.94" E030°57'58.02" at an elevation of 3 020 ft)						
Meteorological Information		Temperature: 28°C, dew point: 15°C, wind: 070° at 7 kt				
Number of people on board	1 + 1	No. of people injured	0	No. of people killed	0	
Synopsis

Name of Owner	: Jazz Spirit 1113 CC
Name of Operator	: Micro Aviation
Manufacturer	: Micro Aviation New Zealand Ltd
Model	: Bantam B22J
Nationality	: South African
Registration Marks	: ZU-EFZ
Place	: The Rest airfield, Nelspruit, Mpumalanga
Date	:

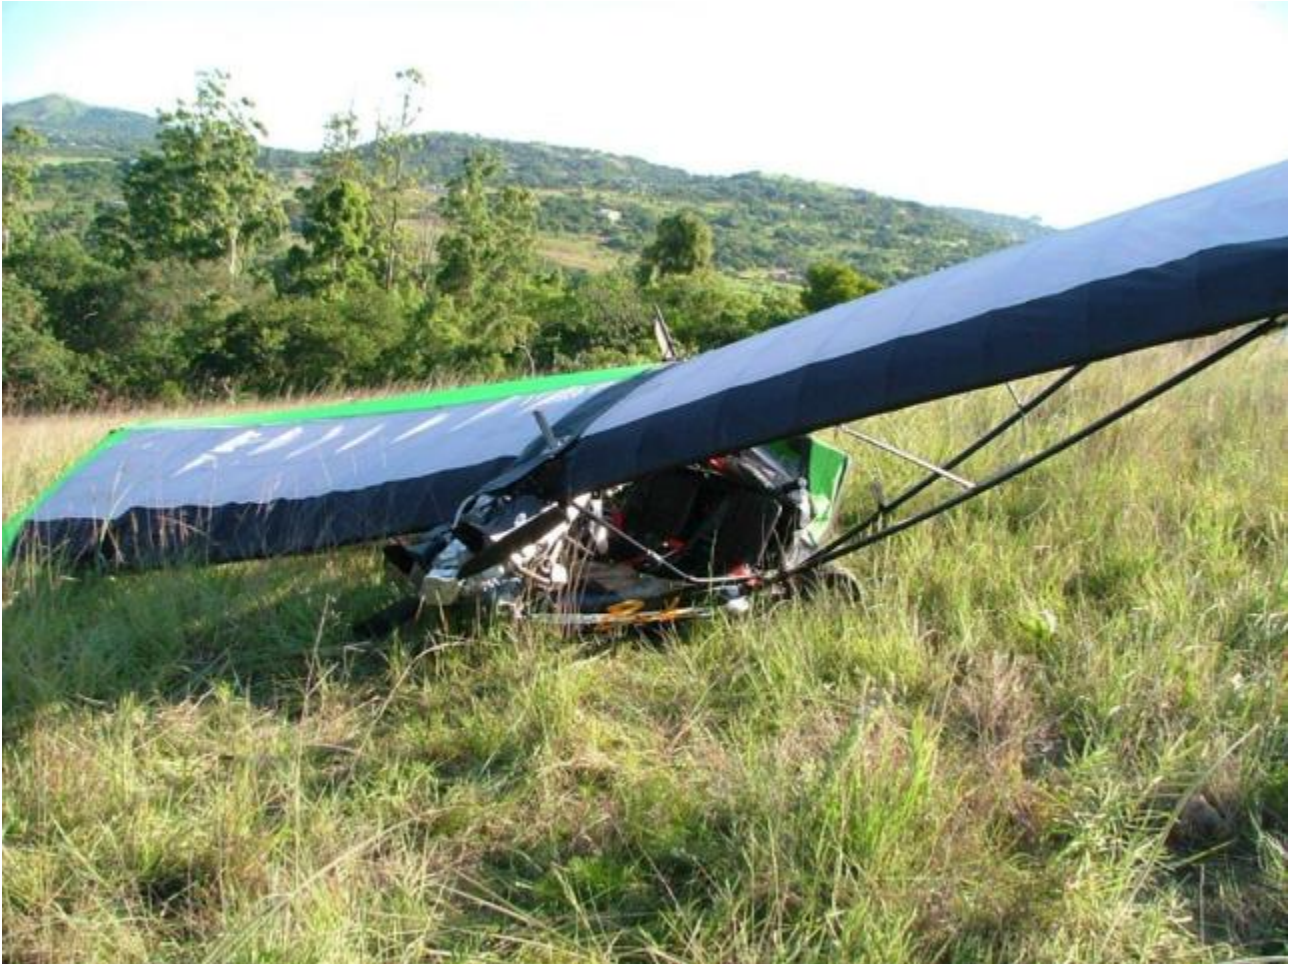
Figure 1: Accident site

- 1.12.2.1 The wreckage was located about 100 m from the threshold of Runway 22 at The Rest airfield.
- 1.12.2.2 The damage that can be seen in Figure 1 and Figure 3 is consistent with an aircraft in a left-hand turn prior to impact with the ground.
- 1.12.2.3 The left-hand wing would have been the first part of the aircraft to impact the ground, followed by the engine of the aircraft.
- 1.12.2.4 The cabin area was damaged mostly in the area of the instruments and rudder pedals. The damage was mostly due to impact forces as well as the engine.
- 1.12.2.5 The right-hand wing shows signs of compression damage of an up-going wing.
- 1.12.2.6 The aft fuselage shows signs of compression damage to the right-hand side as can be seen in Figure 3.

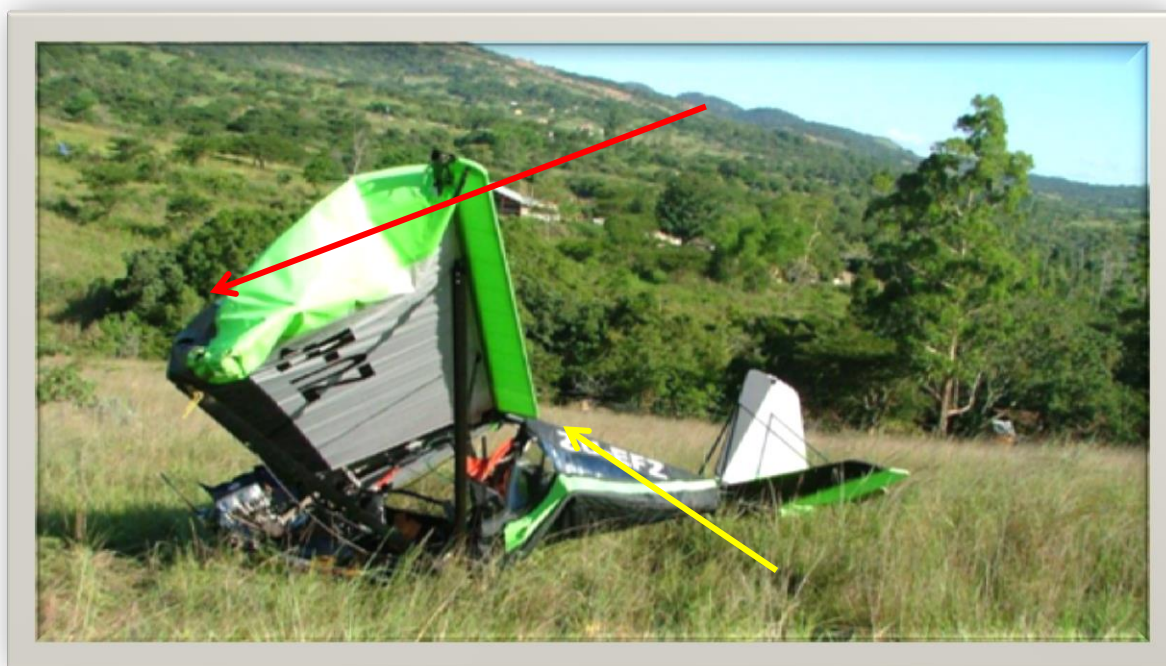
Figure 3: Damage caused to the aircraft. The red arrow indicates ground impact of the down-going wing. The yellow arrow indicates damage to the aft fuselage.

- 1.18.2 The compression damage found to the left wing of the accident aircraft (Figure 3, red arrow) is consistent with the damage caused when an aircraft enters a spin and the left wing impacts the ground, as shown in Figure 5.

- 1.18.3 The compression damage found on the aft fuselage of the accident aircraft (Figure 3, yellow arrow) is consistent with the damage caused when an aircraft that has been spinning impacts the ground, as shown in Figure 5.

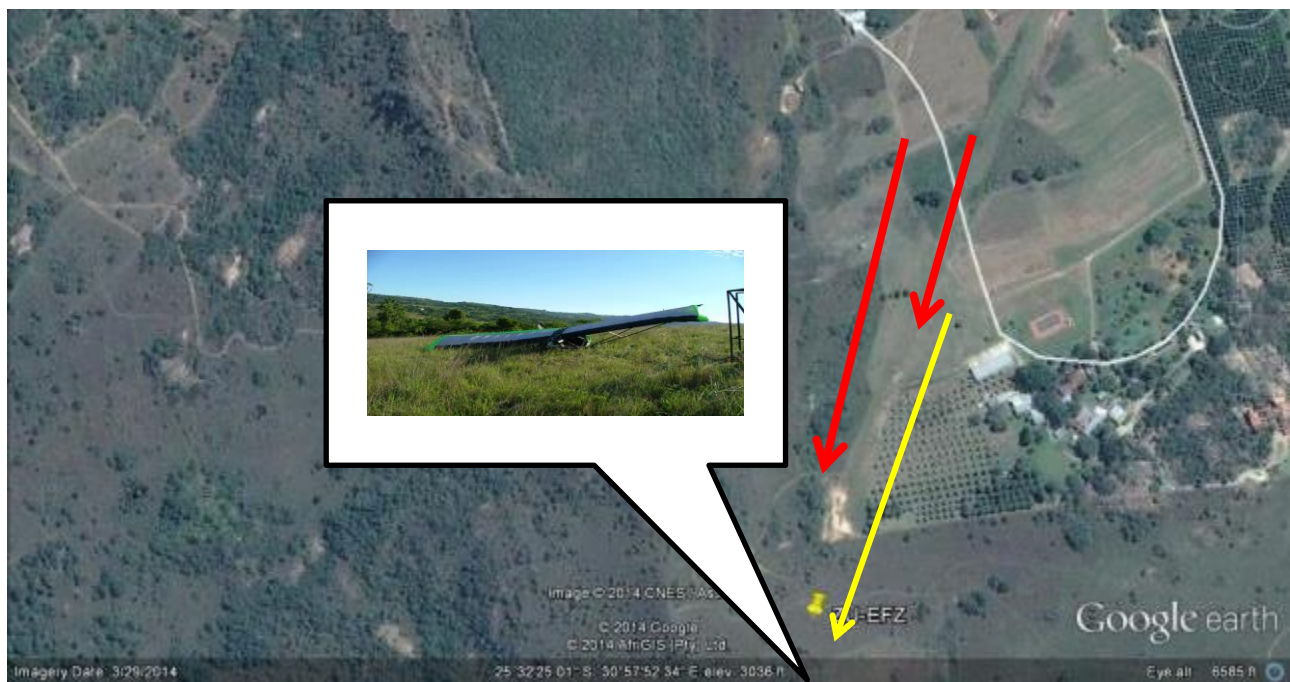
Figure 4: Red arrows indicate wind direction and yellow arrow indicates inspection run direction.

- 2.3.1 The tailwind velocity was 7 kt during the pilot's runway inspection flight. Trees and rising terrain in the area beyond the threshold of Runway 22 caused the pilot to increase the angle of attack of the aircraft in order to clear the obstacles, resulting in the aircraft stalling. The pilot stated that the aircraft experienced a downdraft prior to impact with the ground.

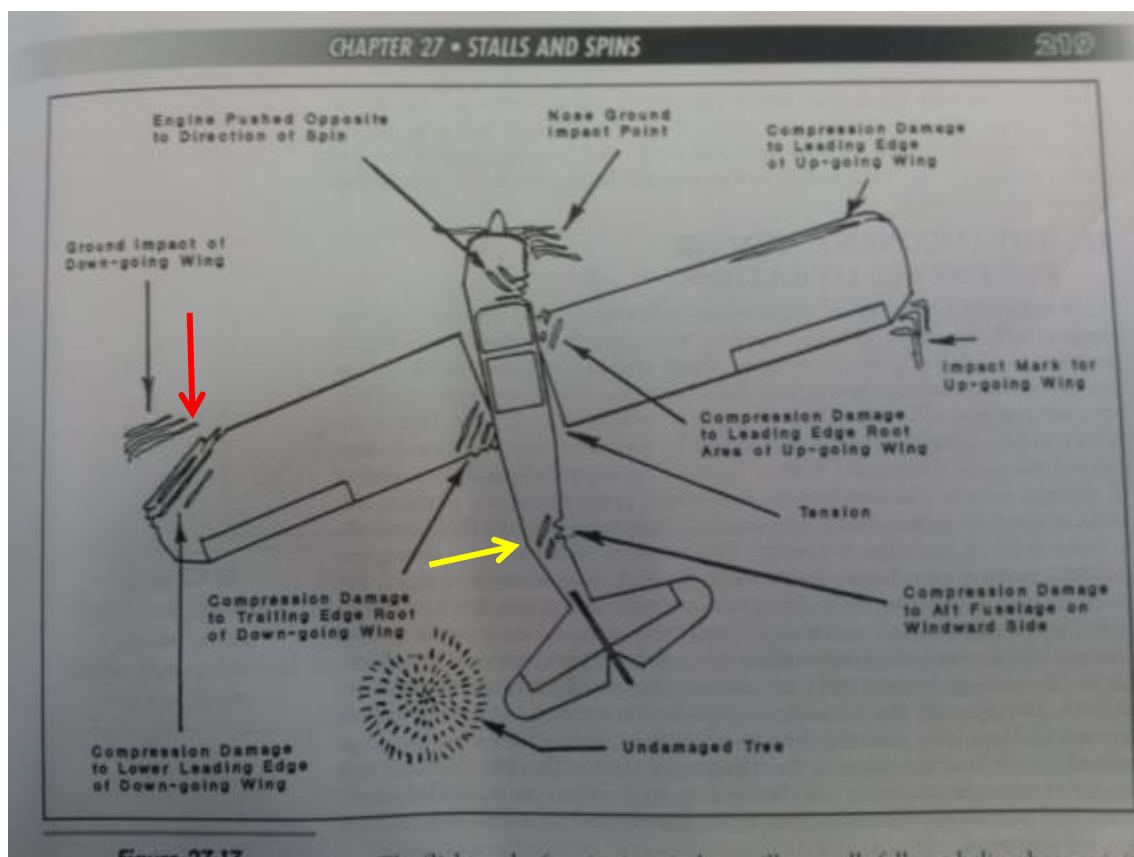
Figure 5: Damage typically found in a spinning aircraft.
