AIRCRAFT ACCIDENT REPORT AND EXECUTIVE SUMMARY

Reference:	CA18/2/3/9340	
Aircraft Registration	ZU-FSO	Date of Accident	31 July 2014		Time of Accident	1045Z
Type of Aircraft	Bantam B22J (Aeroplane)		Type of Operation	Commercial		
Pilot-in-command Licence Type	Airline Transport Pilot licence (ATPL)		Age	29	Licence Valid	Yes
Pilot-in-command Flying Experience	Total Flying Hours	2 400,0		Hours on Type	45,0	
Last point of departure	Mimosa private aerodrome: Eastern Cape					
Next point of intended landing	Mimosa private aerodrome: Eastern Cape					
Location of the accident site with reference to easily defined geographical points (GPS readings if possible)						
En route in flight to Mimosa aerodrome						
Meteorological Information	Cloud base, nil; visibility, 10 kilometers; temperature, 15 °C; wind speed, 05 knots; dew point, 12.					
Number of people on board	1 + 1	No. of people injured	0		No. of people killed	0
Synopsis	<p>The aircraft was conducting a conservation flight to co-ordinate anti-poaching runs at Addo Elephant National Park when the accident occurred. Fine weather conditions prevailed in the area and the flight was planned to last for 20 minutes. The aircraft took off u

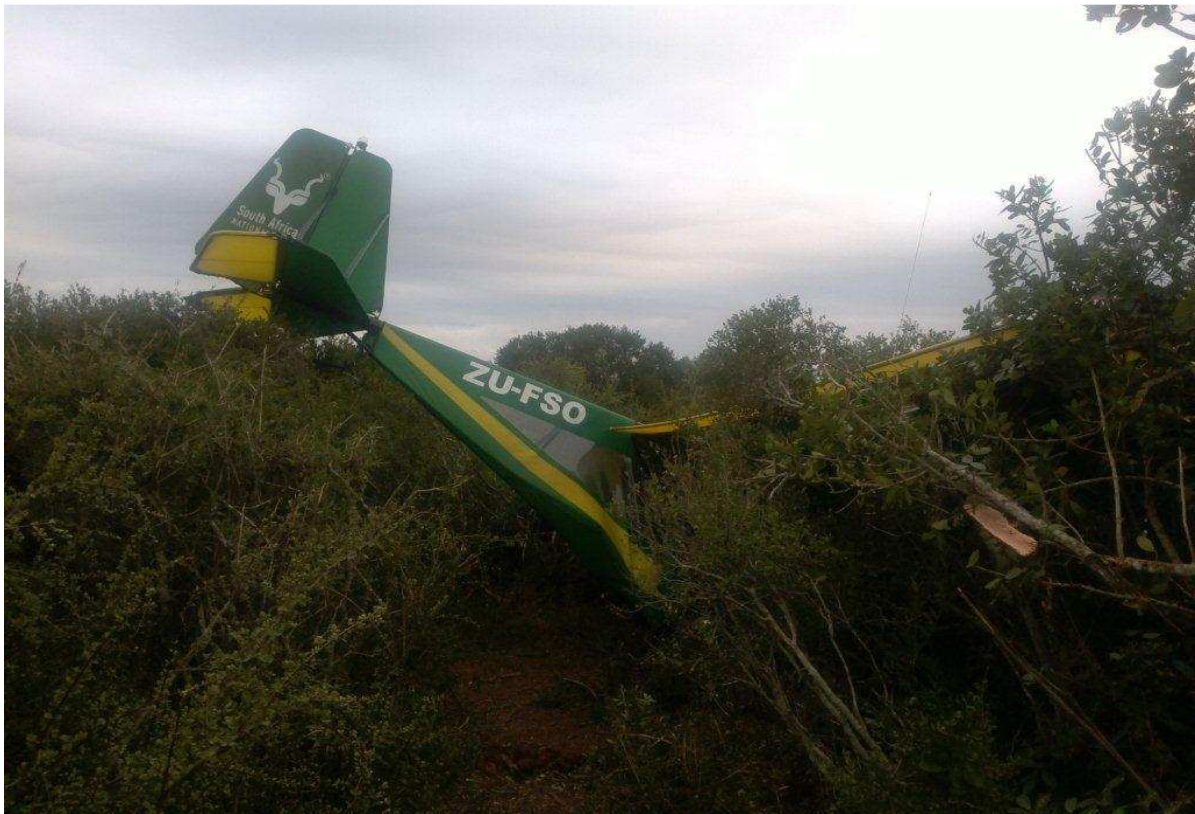
1.3.1 The aircraft was substantially damaged during the accident.

Figure 2: The aircraft as found at the accident site

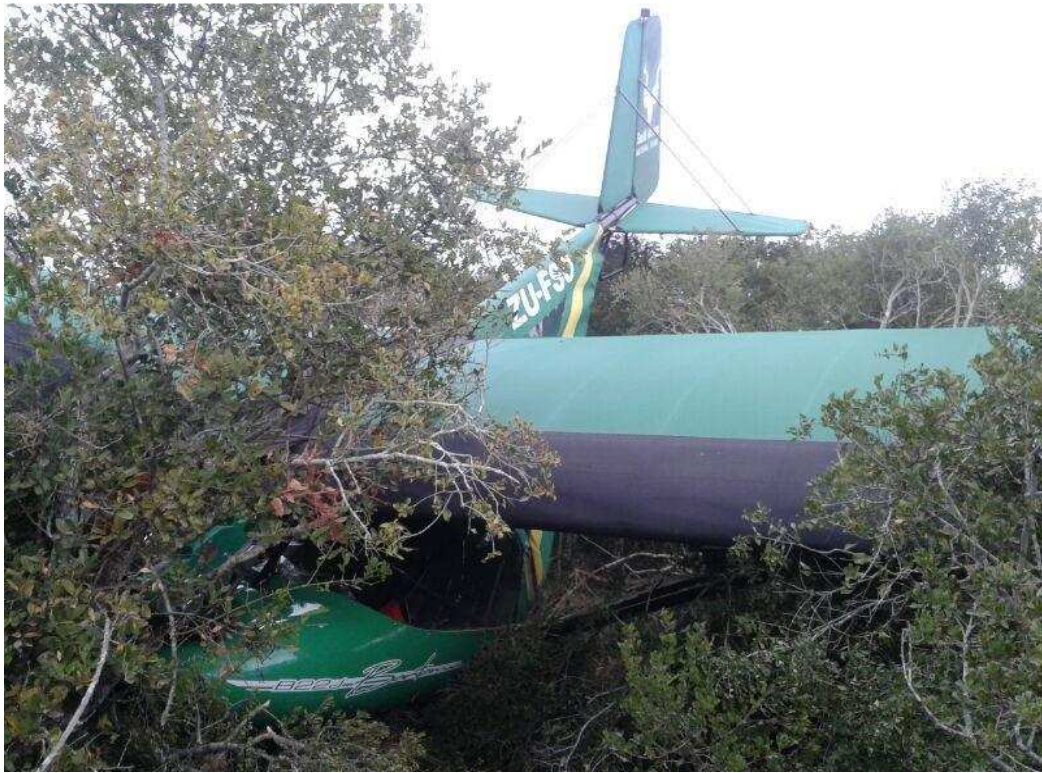
1.12.1 The aircraft came to rest in a nose-low attitude, damaging the wings. The aircraft throttle was in the closed position and the choke was off. Examination of the engine revealed damage consistent with the engine not turning before impact. The landing gear broke, the wings and wing support bars were damaged and the cabin was damaged.

Figure 5: The aircraft from the front

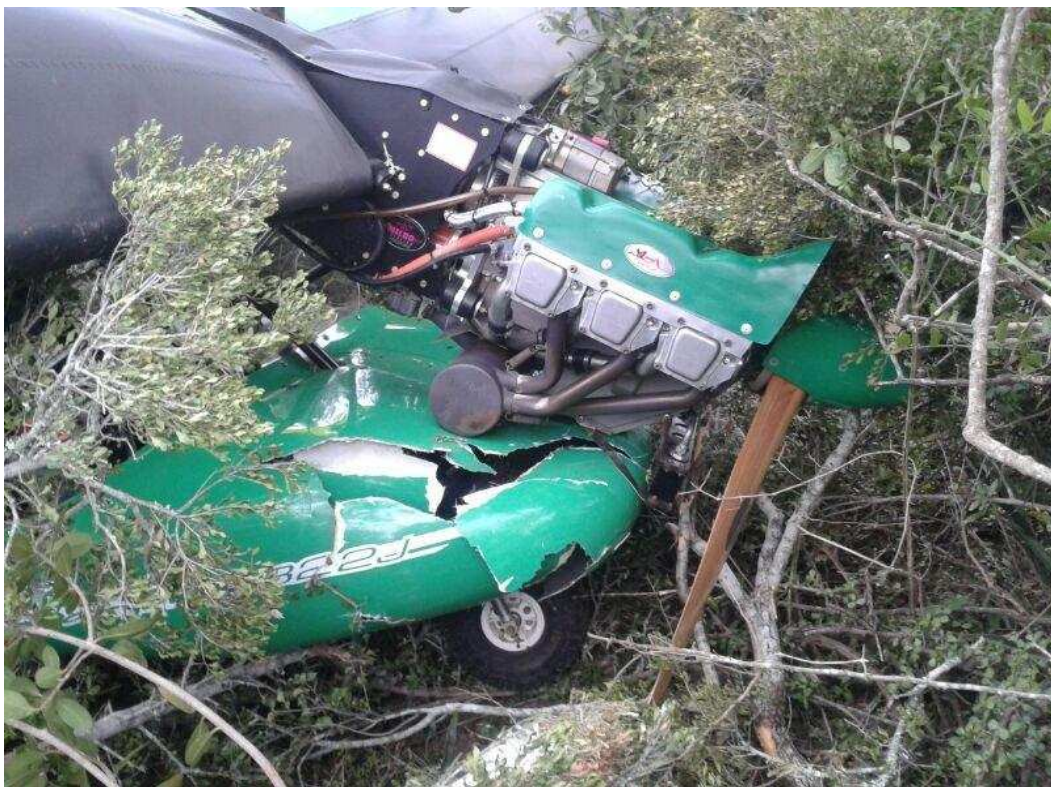
Figure 6: Top side view of the wings and the cabin

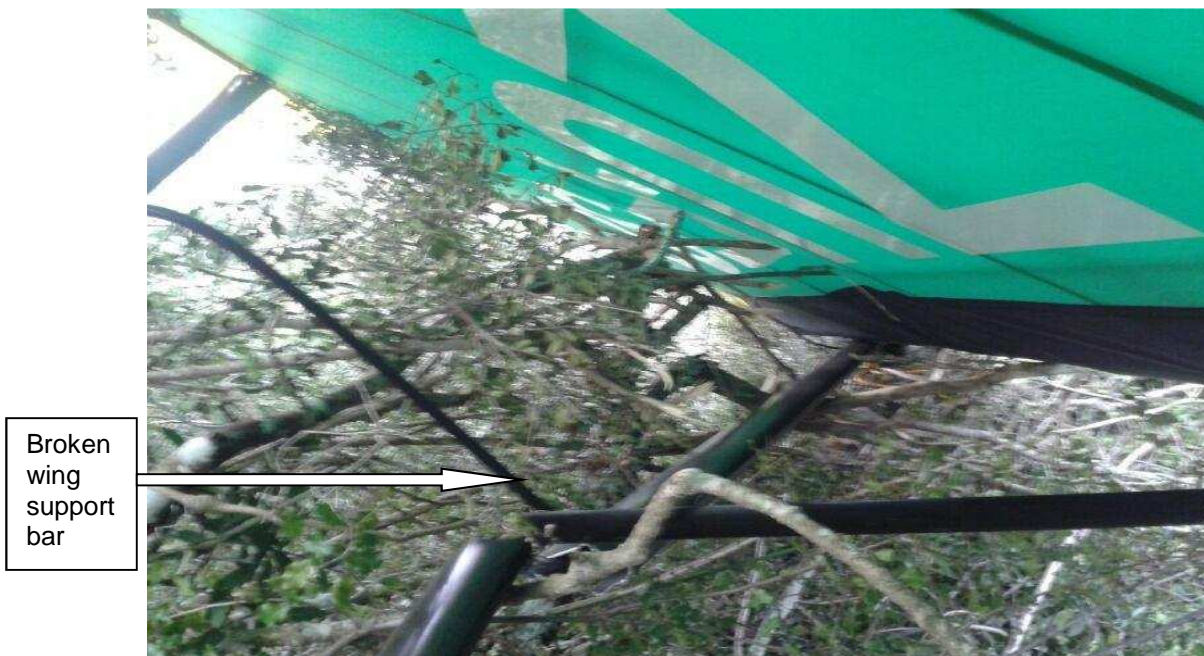
Figure 7: Broken wing support bar

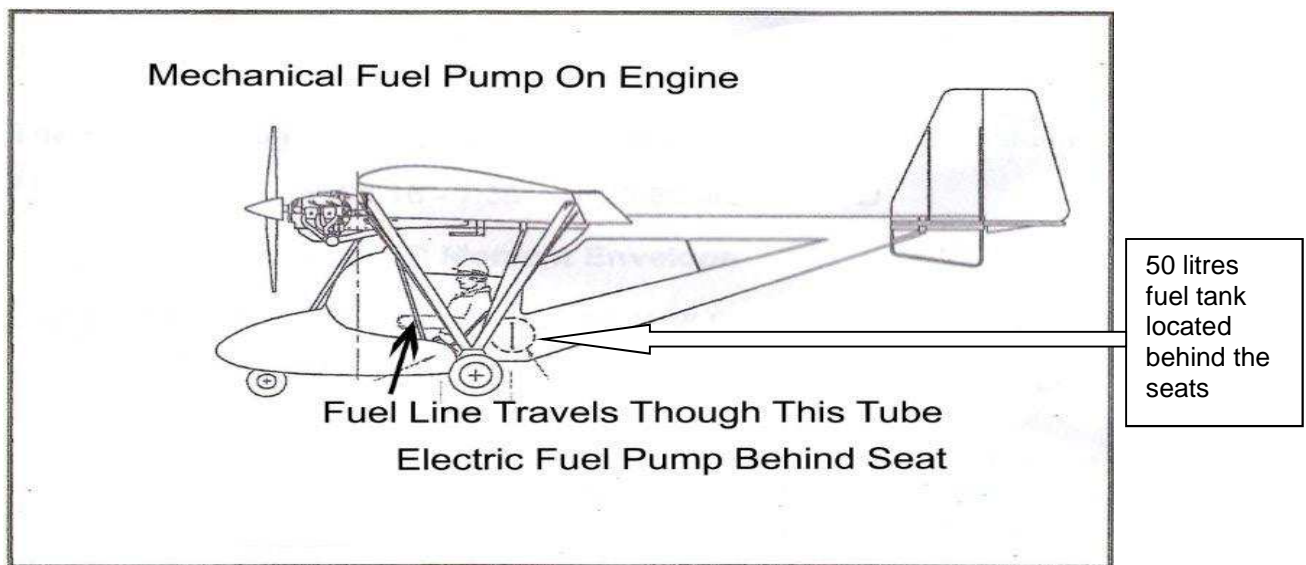
1.16.2 The aircraft was recovered to Nelspruit, after which the Jabiru engine, 3300A, serial number 33A2459, was removed from the wreck and placed on a test bench. The propeller was first tested for the correct torque and the engine was later started. The engine ran smoothly and no anomalies or run out were detected on the propeller flange. The engine temperature and the oil pressure were monitored and found to be well within limits. At no time did the engine malfunction. The fuel gauge was removed from the wreck and tested. No anomalies were noted. The investigation revealed that the engine ceased operating as a result of fuel exhaustion. The pilot statement of fuel amounting to 30 litres on departure was found to be erroneous and was eliminated. Below are pictures of the location of a fuel tank on the aircraft and a disconnected fuel pipe.

Figure 8: The location of the fuel tank

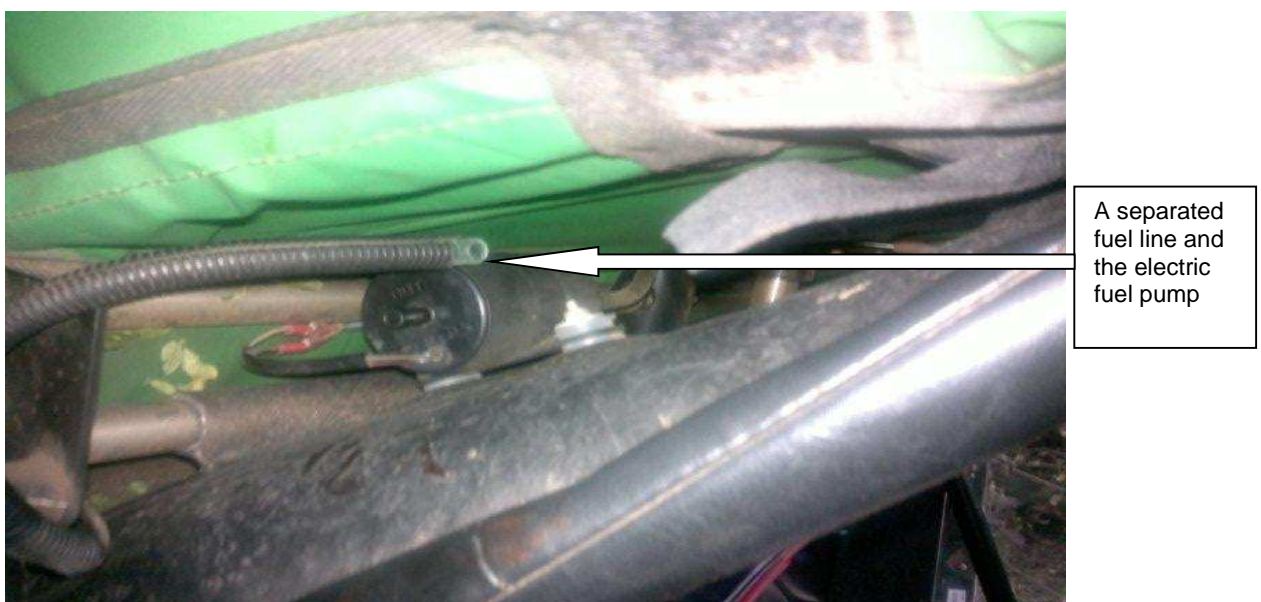
1.16.1 On-site inspection of the aircraft revealed no structural or airframe failure. All associated engine controls showed evidence of normal operation prior to the accident. Inspection of the fuel system revealed a detached fuel supply line rubber pipe connecting to the electric fuel pump, with the clamp missing. The fuel pipe was inspected and nothing abnormal was found. There was a sign of a pipe support clamp on the pipe, suggesting that it was in place and was removed. The aircraft fuel tank was empty and there was no indication of any fuel leakage at the accident site. The fuel filter was pulled and examined and no fuel was observed. Spark plugs were pulled out and they displayed a greyish colour, an indication of normal engine

Figure 9: A separated arrangement
