## AIRCRAFT ACCIDENT REPORT AND EXECUTIVE SUMMARY

Reference:	CA18/2/3/9360	
<b>Aircraft Registration</b>	ZS-TBW	<b>Date of Accident</b>	15 September 2014		<b>Time of Accident</b>	1309Z
<b>Type of Aircraft</b>	Air Tractor AT-802A		<b>Type of Operation</b>	Fire Fighting (Part 137 )		
<b>Pilot-in-command Licence Type</b>	Commercial Pilot		<b>Age</b>	65	<b>Licence Valid</b>	Yes
<b>Pilot-in-command Flying Experience</b>	Total Flying Hours		19796.1		Hours on Type	68
<b>Last point of departure</b>	Piet Retief Airfield (FAPF) -Mpumalanga Province					
<b>Next point of intended landing</b>	Piet Retief Airfield (FAPF)-Mpumalanga Province					
<b>Location of the accident site with reference to easily defined geographical points (GPS readings if possible)</b>						
Mondi Vrede Farm at GPS coordinates S 27°00'96.7" E 030°53'29.5 Elevation 4347feet AMSL in Mpumalanga Province						
<b>Meteorological Information</b>	Wind direction: 45°-54°; Wind speed: 8 knots; Temperature: 31.5°C; Dew Point: -0.9°C; Visibility: Fine. Cloud cover: CAVOK

**Name of Owner/Operator** : FFA Aviation (Pty) Ltd  
**Manufacturer** : Air Tractor Inc.  
**Model** : AT-802A  
**Nationality** : South African  
**Registrati

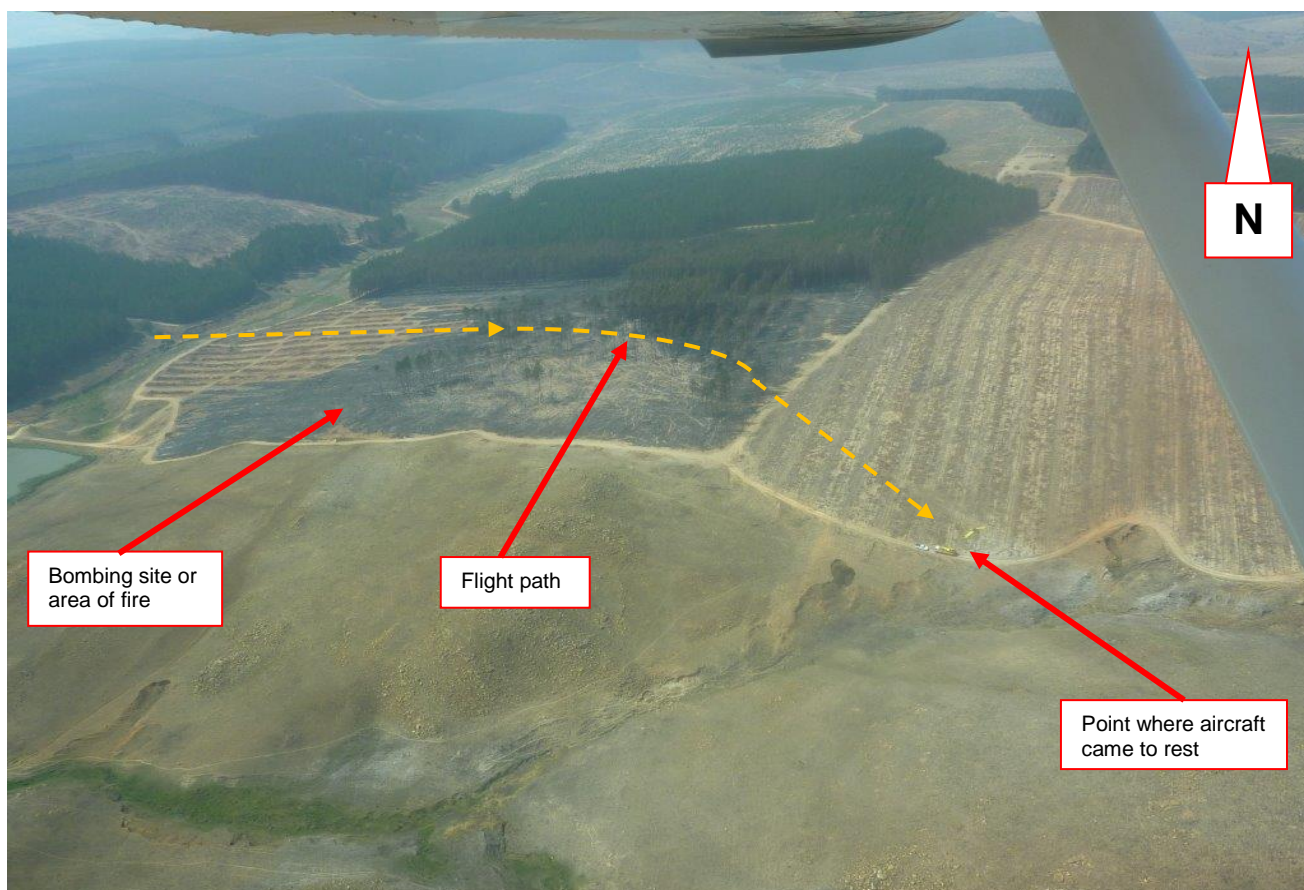
- 1.1.7 The accident occurred during daylight meteorological conditions at geographical positions determined to be 27°00'96.7" S 030°53'29.5" E, at an elevation of 4347 feet above mean sea level (AMSL).

**Figure 1:** The aerial view of the fire area, flight path and accident site

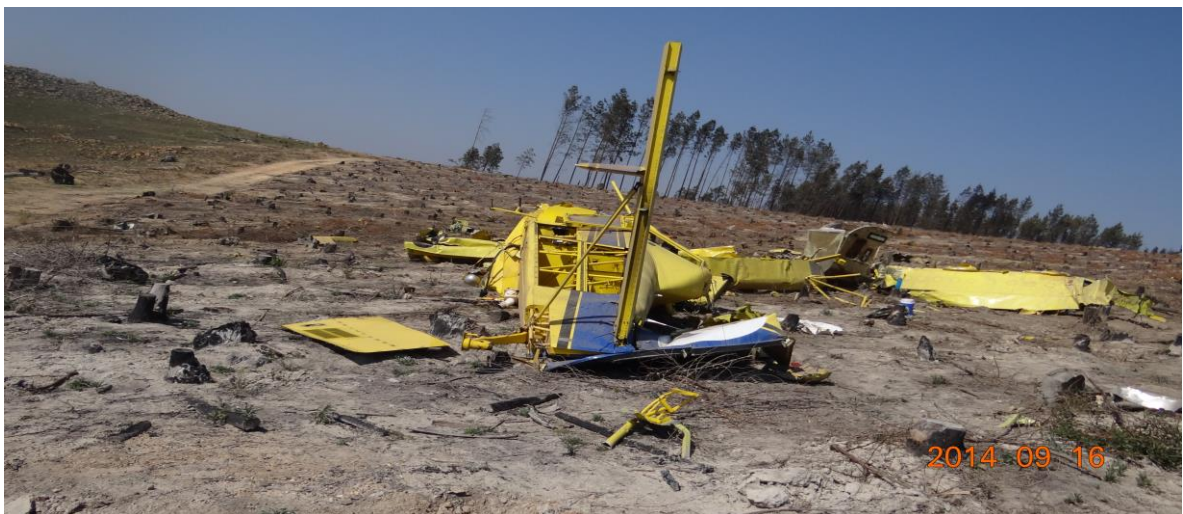
1.3.1. The aircraft was destroyed.

Figure 4: Showing the main wreckage of the aircraft at the accident site

1.12.1. The aircraft approached from the west and was flying towards the east. The aircraft impacted the tree span along its flight path during a right bank with its right wing causing it to separate approximately in the middle and whilst attempting to climb to a safe height. The impact with the trees caused the aircraft rotated 180° to the right before impacting with the ground in an inverted attitude facing South. Following the impact with the ground, the aircraft skidded approximately 200-300m before it groundlooped coming to a halt inverted and facing North.

1.12.2. The right-wing of the aircraft collided with pine trees at a distance of approximately 1000m from the main wreckage and half of the right wing separated, fell to the ground and remain at the impact point. The aircraft then impacted the ground in a nose down attitude at approximately 700m from the impact point with trees and skidded for approximately 90 metres where after the aircraft veered sharply to the right and ground looped through 90° before it came to rest 1km from the point of impact with trees. The engine had separated and was found approximately 250m from the point of impact with the ground and the remains of the right wing and left wings were 50m and 150m from the main wreckage respectively.

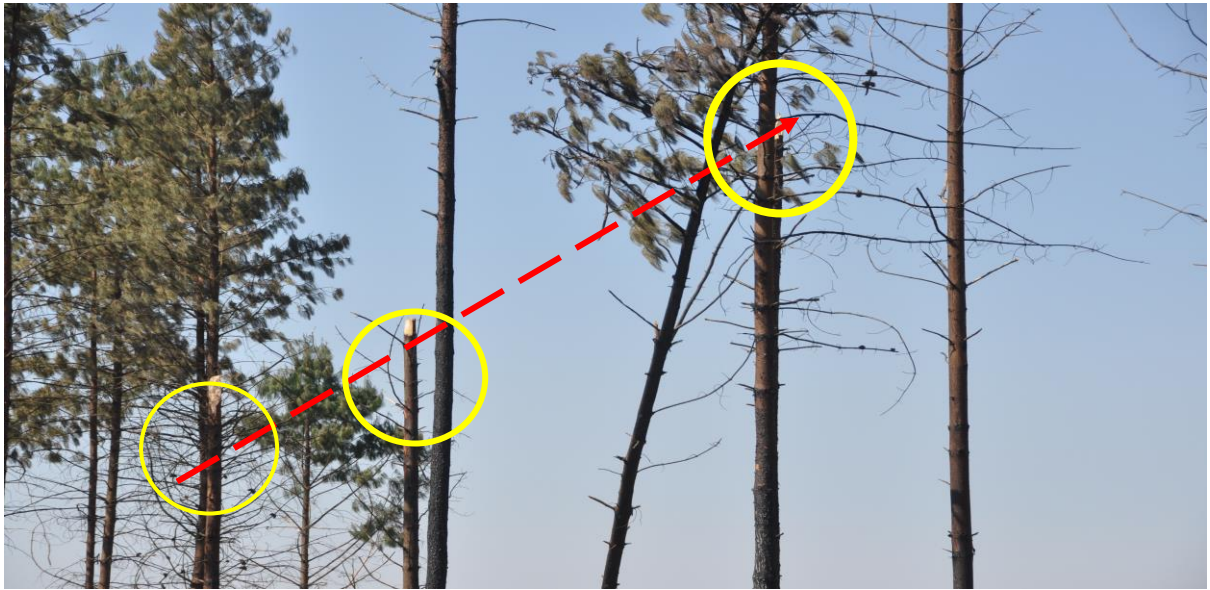
**Figure 5:** Showing impact damage caused to the trees.

1.12.3 Several tree stumps of approximately 30-50mm in length together with some aircraft debris were found scattered along the wreckage path. The main structural beams of the wings were found destroyed and the right-wing structural beam was found bent as a result of impact with the trees and the ground during the impact sequence.

- 1.12.4 The cabin area was destroyed during the impact sequence with the ground.
- 1.12.5 The aircraft impacted trees approximately 15 meters tall situated at an uphill at the located fire area.

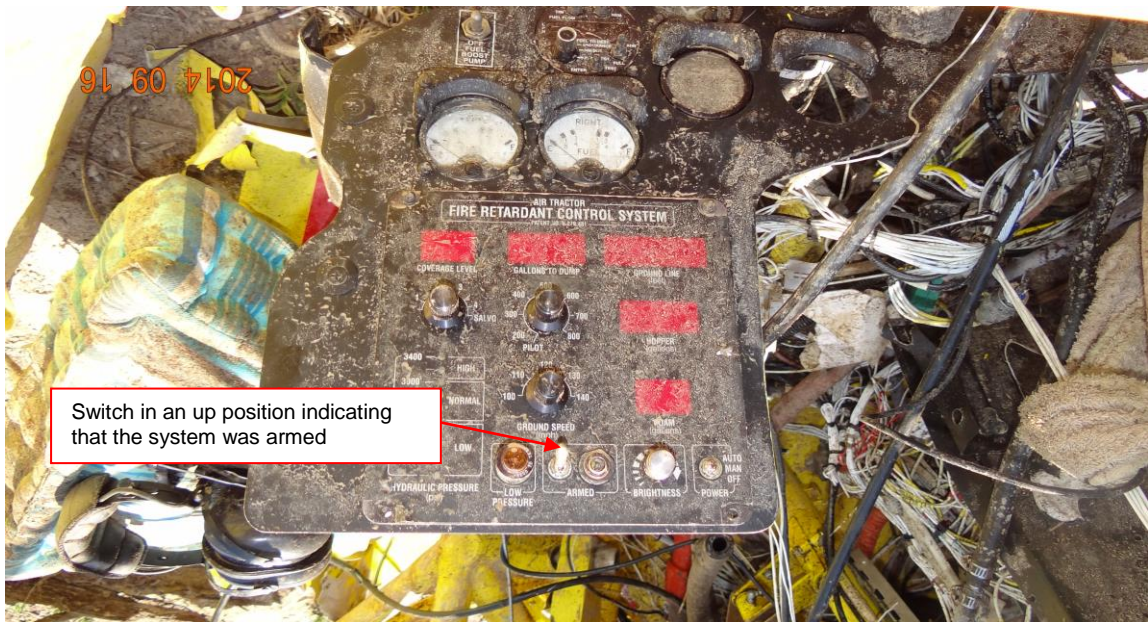
- 1.6.9.2 According to the aircraft manufacturer, the manual mode of operation is provided as a backup to the automatic mode of operation as the first method for performing an emergency dump. The investigation indicated that the pilot did not attempt to select the manual operation when the automatic mode of operation became unserviceable. See below figure indicating that the auto mode operation was selected and armed.

**Figure 8:** Showing FRDS Gen I automatic control panel taken at the accident site

- The FRDS auto control panel was inspected to verify the positions of switches and indicators. Also to verify whether or not the different light bulbs were illuminated ON or OFF. (Refer to the aircraft information above)

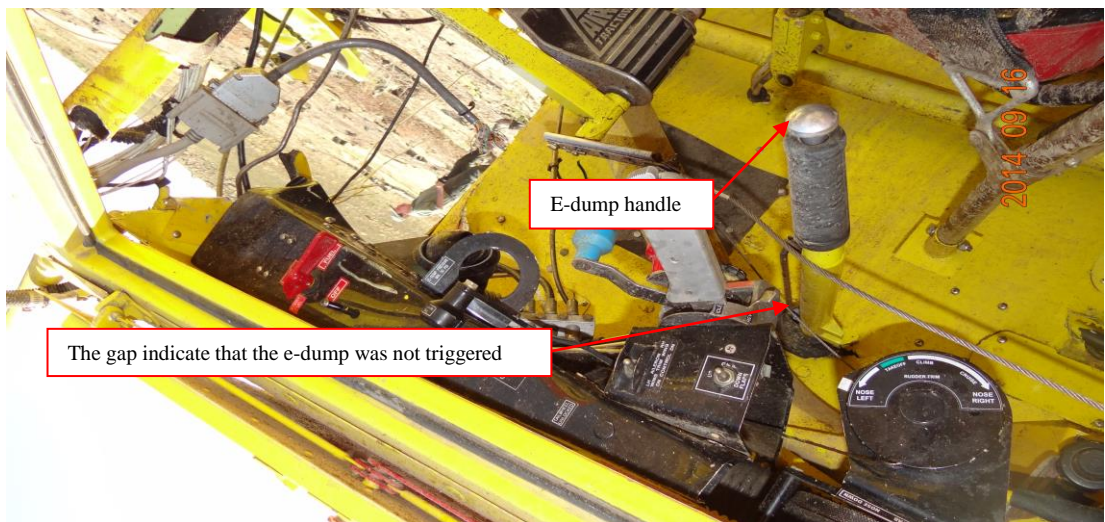
1.6.9.3 According to the aircraft manufacturer, the E-Dump mode of operation is the third method for performing an emergency dump for FRDS actuate the airframe emergency dump handle. The investigation indicated that E-Dump handle was not actuated to open the gatebox doors by the pilot during the flight. The figure below shows the E-Dump handle in the aft position not triggering the pneumatic emergency dump system.

**Figure 9:** showing E-Dump Handle taken at the accident site

2.2.4 During the investigation, there was no evidence found which would indicate that the pilot made an attempt to use the Manual or Emergency modes of the Gen 1 FRDS system prior to impact. It is thus most likely that he did not operate either of the two systems or did not have sufficient time to engage the two systems prior to the crash due to his attempt to get to a safe altitude.

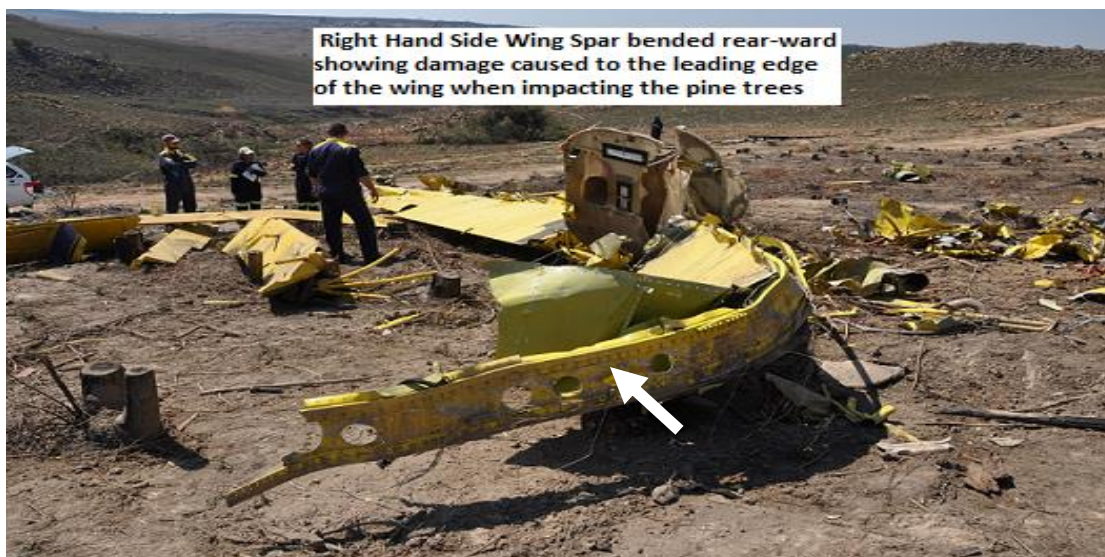
**Figure 10:** showing right-hand side wing

- 1.12.6 The aircraft was destroyed during the impact sequence with the trees and the ground.
- 1.12.7 The right-wing impact with the trees at an estimated angle of approximately 45°-60° below the crown of the trees. The impact angle imprint on the pine trees was consistent with the aircraft attitude, nose pitched-up during the impact sequence. Debris of the right-wing was observed in the area of the impacted trees. The main wreckage came to rest at GPS reading S 27°00'96.7" E 030°53'29.5

- 2.2.7 The right wing separated at approximately midpoint before the aircraft impacting the ground in an inverted and nose down attitude. The part of the wing that separated remained in the vicinity of the trees it impacted with.
- 2.2.8 The aircraft then impacted the ground in an inverted attitude and skidded for approximately 150m before the engine separating and continued for another 150m before the cockpit separated in to two and coming to halt.
- 2.2.9 The pieces of the right wing were found some 50m and pieces of the left wing were found 150m behind from the main wreckage.
- 2.2.10 The aircraft was destroyed during impact with the pine trees and subsequently with the ground and tree stumps.
