AIRCRAFT ACCIDENT REPORT AND EXECUTIVE SUMMARY

Reference:	CA18/2/3/9361	
Aircraft Registration	ZS-IFK	Date of Accident	15 September 2014		Time of Accident	1808Z
Type of Aircraft	Cessna C172 (Aeroplane)		Type of Operation		Private	
Pilot-in-command Licence Type	Private pilot (PPL)		Age	24	Licence Valid	Yes
Pilot-in-command Flying Experience	Total Flying Hours	58		Hours on Type	Unknown	
Last point of departure		Newcastle Aerodrome (FANC): Kwa-Zulu Natal province.				
Next point of intended landing		Rand Aerodrome (FAGM): Gauteng province.				
Location of the accident site with reference to easily defined geographical points (GPS readings if possible)						
On a privately owned farm outside Newcastle at GPS co-ordinates determined to be South 27° 43.095 ' East 029° 49.777 ' at an elevation of approximately 4 445 feet above mean sea level (AMSL).						
Meteorological Information		Mid-level clouds were observed in the vicinity of the Newcastle area with surface data readings as follows: Temperature 32°C, Dew point temperature -3°C, Wind speed 07 knots.

AIRCRAFT ACCIDENT REPORT

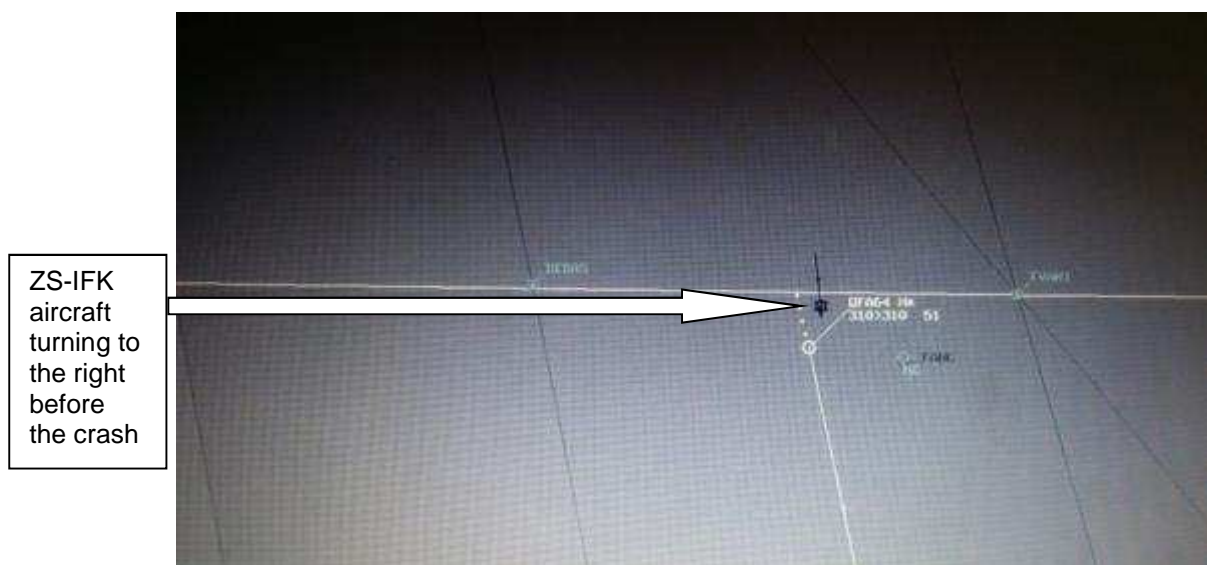
Figure 2: The radar footage depicting ZS-IFK aircraft making a turn just before the crash

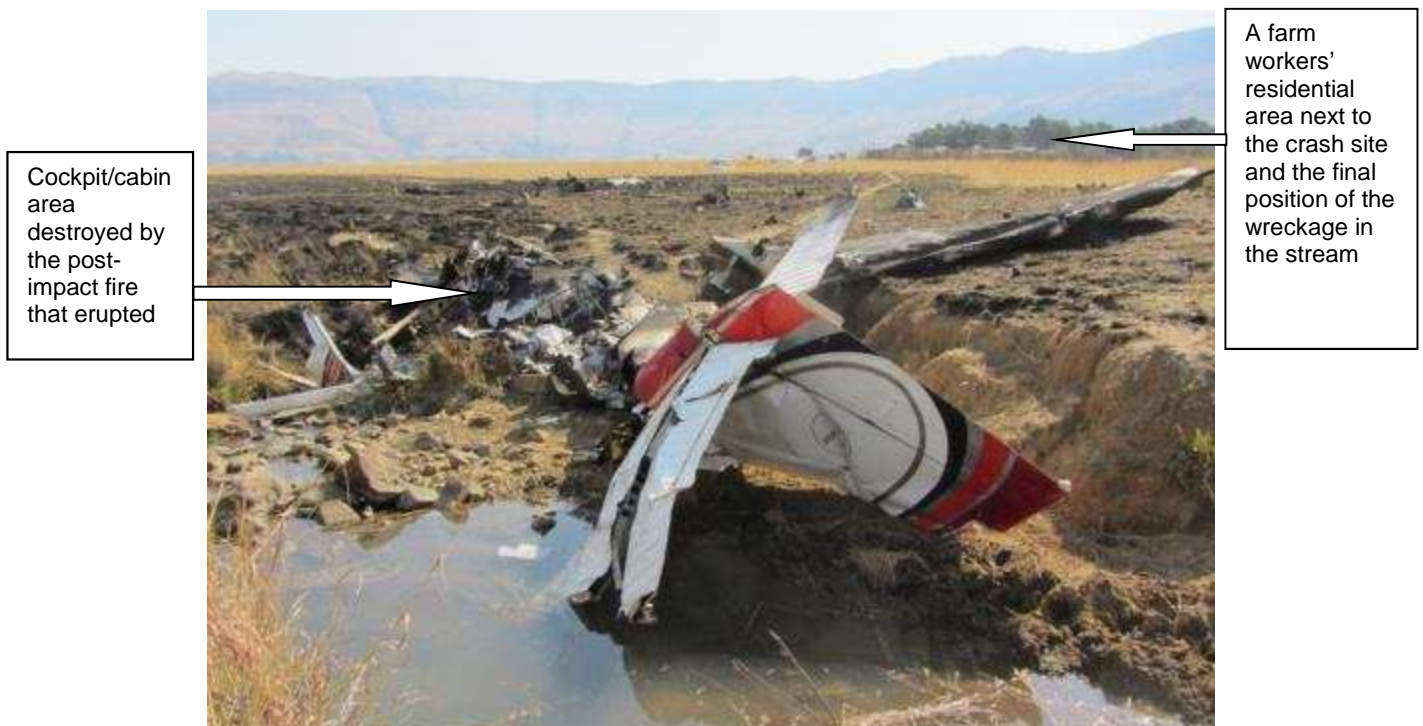
1.3.1 The aircraft was destroyed by the post-impact fire that erupted. See Figure 4 below.

Figure 4: Accident site showing the wreckage and burnt vegetation

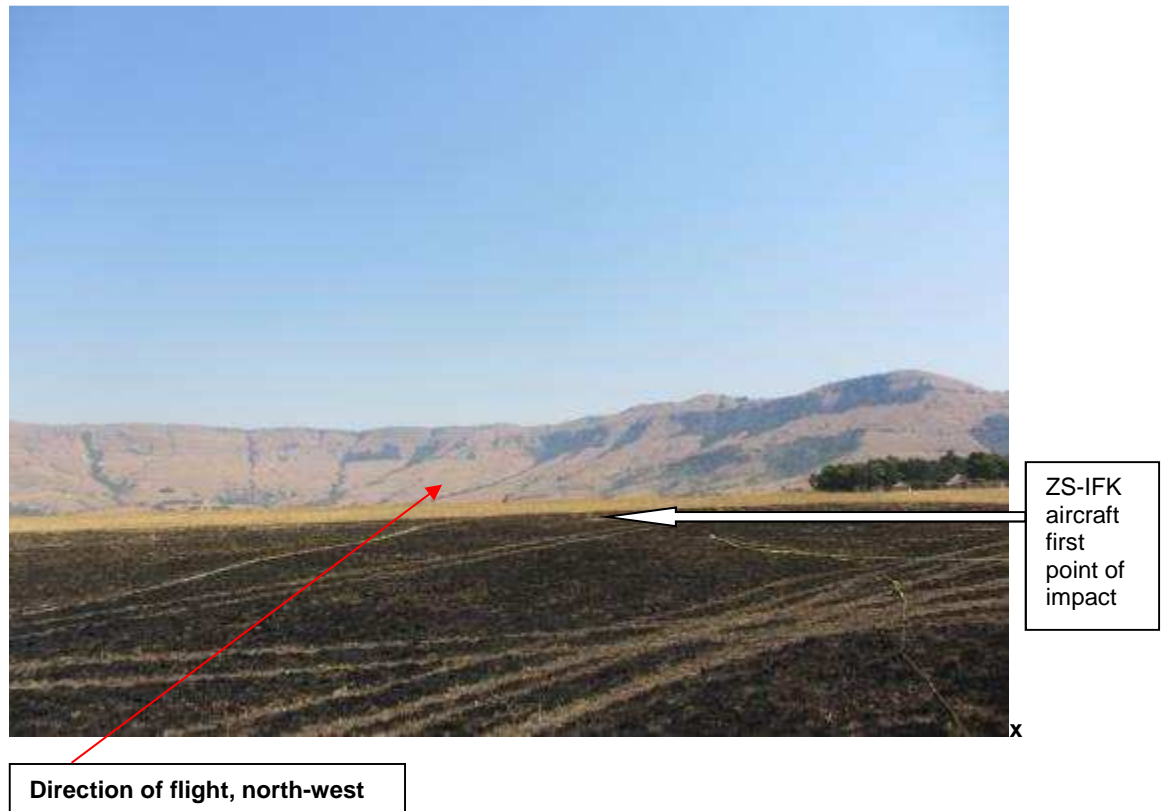
1.12.1 The aircraft crashed to the ground while en-route to FAGM aerodrome during the night. The impact sequence indicates that the aircraft was in a nose-down attitude when it hit the ground.

Figure 8: The direction of flight and the accident site. In this photograph, the aircraft flight path was towards the mountain: the accident happened on the flat ground after the turn was initiated.

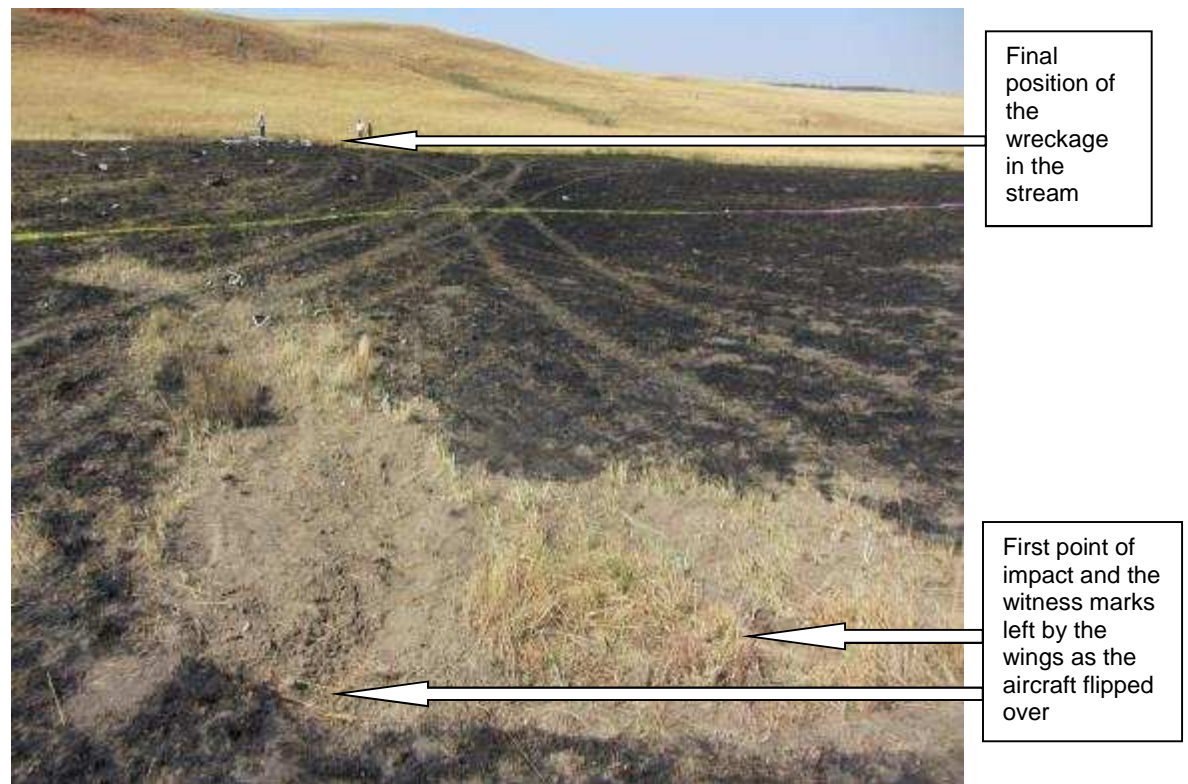
1.12.2 Examination of the accident site revealed that the aircraft was under power when it collided with the ground. The aircraft struck the ground nose-down, shattering the nose gear strut, shock absorber, wheel assembly and the gear fork. The aircraft flipped over and the safety harnesses securing the occupants failed from overload. Both occupants were then flung out of the aircraft. The occupants were found approximately 73 m from the first point of impact on the other side of the stream. During the accident sequence, the right wing detached from the fuselage and this was probably caused by overload. It was extensively damaged by fire.

Figure 9: First point of impact and position of wreckage

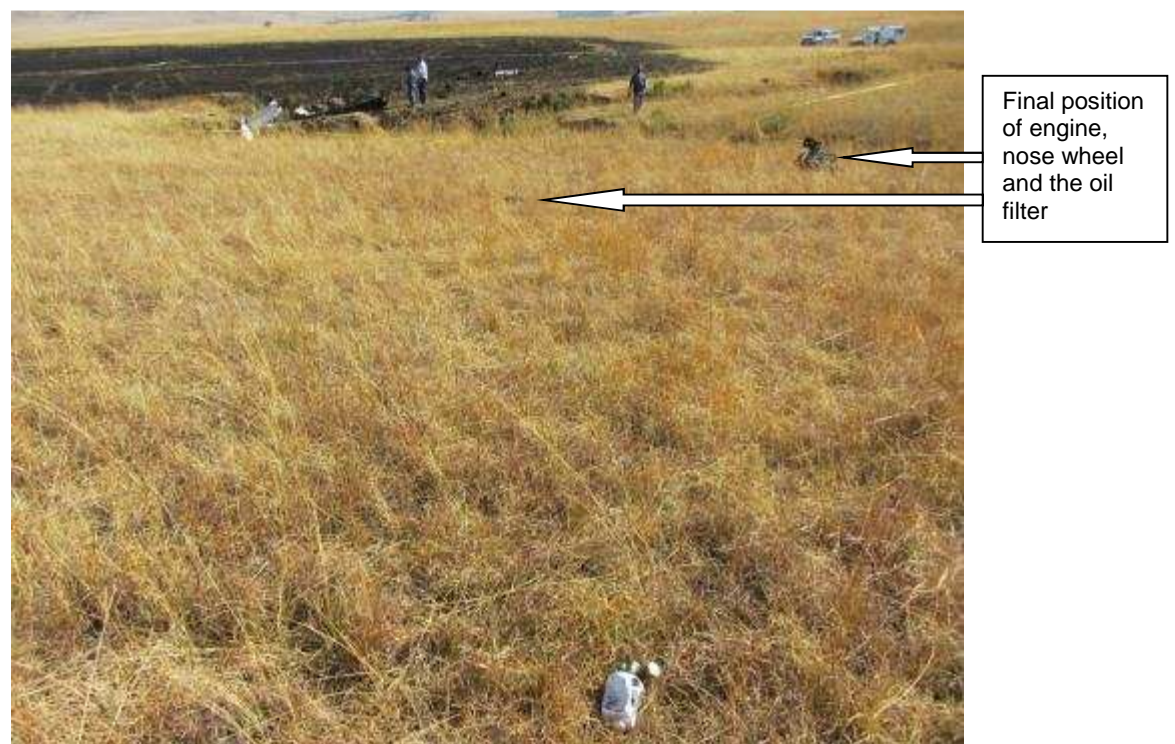
immediately prior to collision with the ground. The engine oil sump ruptured after impact and some of the engine components such as the oil filter, the oil cooler, the carburettor, and the magnetos were destroyed as shown in Figures 9, 10 and 11.

Figure 10: The engine and the nose wheel on the other side of the stream

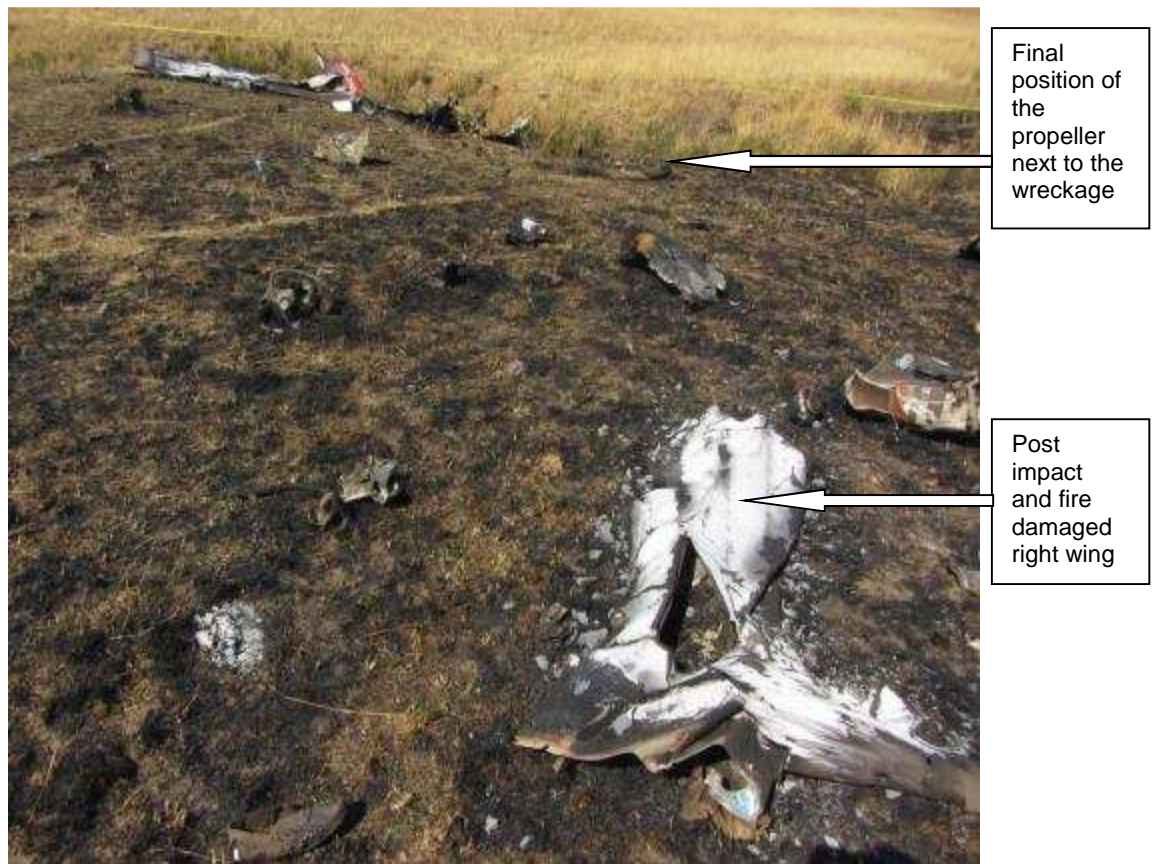
1.12.3 The landing light was damaged during the accident sequence. Both the wing fuel bladder cells ruptured and the accident site was set alight, probably by the hot engine. The wreckage excluding the vertical and the horizontal stabilisers was consumed by the fuel-fed fire. The engine detached from the airframe and was found on the other side of the stream next to the bodies and the nose gear fork. The damage on the propeller indicated that the engine was producing power

Figure 11: The right wing and the propeller

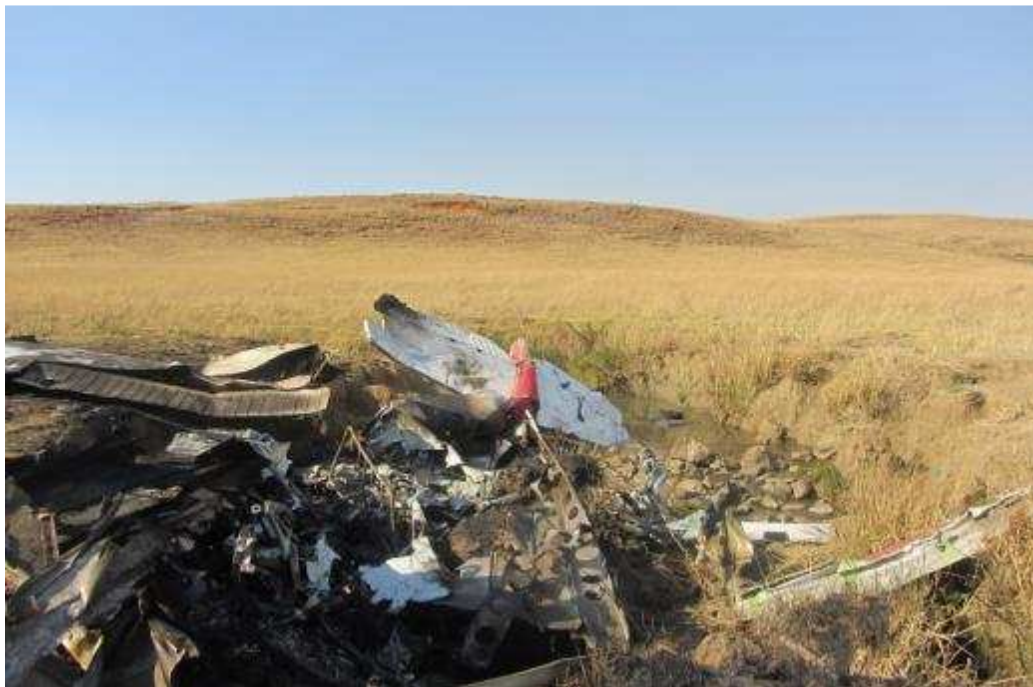
1.12.4 The tail section displayed wrinkling attributable to impact forces. The aircraft battery was dislodged from its mounting point and was found in the stream. The aircraft's electrical system and associated wiring were destroyed. Both control columns were destroyed. The wing flaps were in a neutral position and the position of the ailerons could not be confirmed. The spring-loaded main landing gear and the wing struts were destroyed by impact forces. Flight controls continuity could not be established and most of the engine and flight instruments were destroyed during the accident sequence. All the antennas, including that of the transponder, were destroyed by impact. Those instruments that survived the accident sequence, such as the turn co-ordinator and the heading indicator, provided no usable information regarding their pre-accident configuration or condition. The pilot and the passenger seats were detached from their respective mounting points and thrown out of the aircraft. The entire cockpit/cabin was consumed by fire leaving no evidence. Overall examination of the wreckage determined that the aircraft was intact prior to impact. Figures 12 and 13 show the crash damage.

Figure 12: Closer view of the wreckage

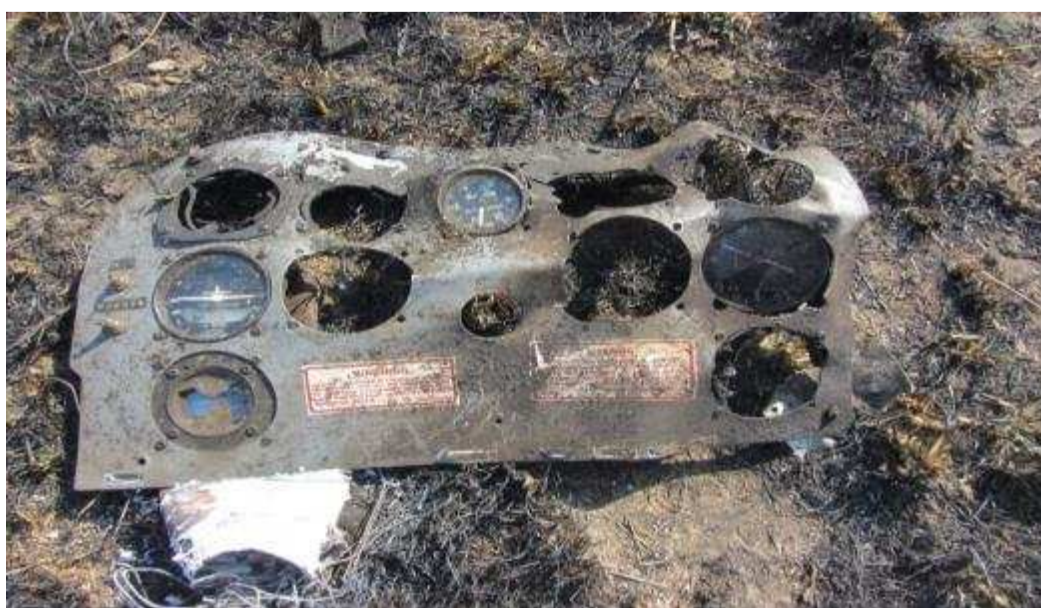
Figure 13: A damaged instrument panel
