AIRCRAFT ACCIDENT REPORT AND EXECUTIVE SUMMARY

Reference:	CA18/2/3/9359	
Aircraft Registration	ZS-EJB	Date of Accident	15 September 2014		Time of Accident	1710Z
Type of Aircraft	Cessna 210 (Aeroplane)		Type of Operation		Commercial	
Pilot-in-command Licence Type		Commercial	Age	68	Licence Valid	Yes
Pilot-in-command Flying Experience		Total Flying Hours	1625		Hours on Type	180
Last point of departure		Nelspruit Aerodrome (FANS), Mpumalanga Province				
Next point of intended landing		Nelspruit Aerodrome (FANS), Mpumalanga Province				
Location of the accident site with reference to easily defined geographical points (GPS readings if possible)						
Approximately 20km North East of Nelspruit Aerodrome at the GPS: S25 17q56.8+E031 04q10.7+Elevation 870m.						
Meteorological Information		Surface wind North Easterly at 10knots. Visibility: Fair. Temperature: 30C.				
Number of people on board	1 + 0	No. of people injured	1	No. of people killed	0

Name of Owner : FFA Assets (PTY) LTD
Name of Operator : FFA Assets (PTY) LTD
Manufacturer : Cessna Aircraft Company
Model : T210F
Nationality : South African
Registration Marks : ZS-EJB
Place : 20km North East of Nelspruit Aerodrome
Date : 15

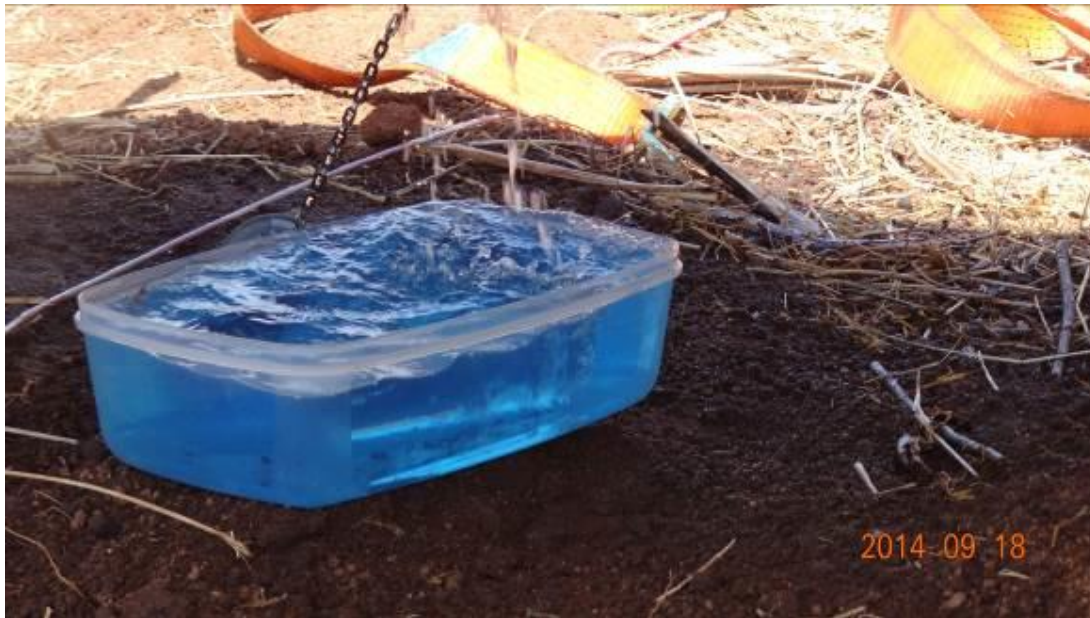
- 1.6.2 The right hand tank was empty and the left-hand tank had approximately more than 5 litres usable avgas fuel, which was drained into a container. During transfer of fuel to the container some spilled onto the ground.

Figure 1: Fuel which was drained from the left wing.

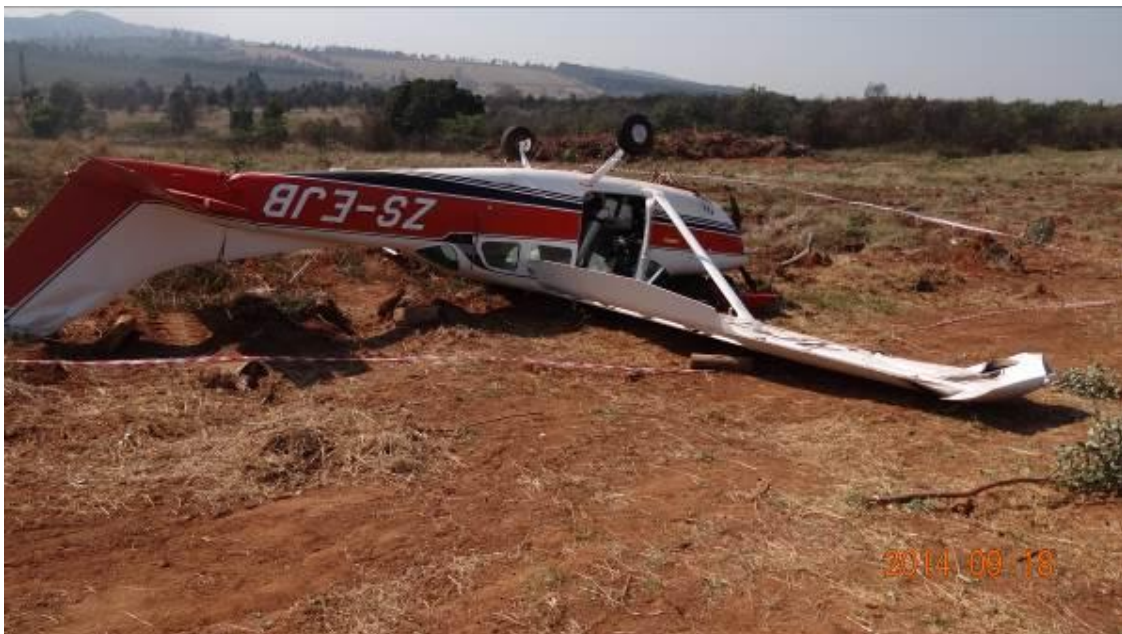
1.3.1 The aircraft sustained extensive damage to the wings, propeller, vertical stabilizer, horizontal stabilizer, and the nose wheel broke off.

1.12.1 The aircraft touched down in a Southerly direction with the nose wheel first. It then collided with the hidden tree stump and nosed over and came to rest in an inverted position on open. The nose wheel broke off but the aircraft remained intact.

Figure 2: Wreckage of the aircraft

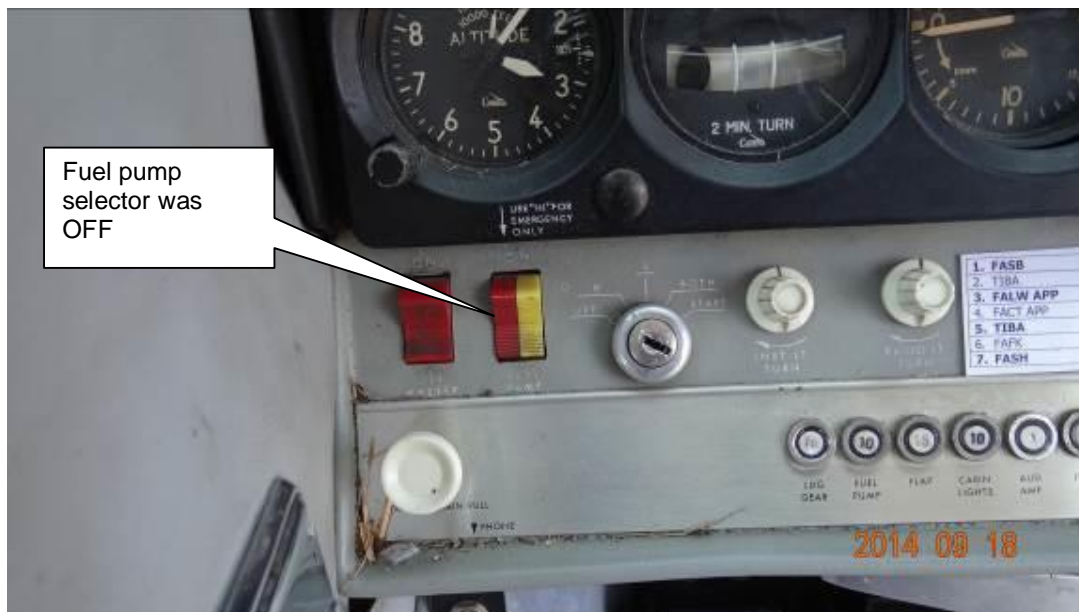
1.16.1 During the onsite investigation it was discovered that the fuel pump selector was set to OFF. The left-hand wing contained fuel but due to the fact that the selector was not ON the fuel was not pumped to the engine. The manufacturer requires the pump to be switched ON when changing from a dry tank to a tank containing fuel, as per placard inside the aircraft.

Figure 3: Fuel pump selector in the OFF position

3.3.1 The pilot omitting to switch ~~ON~~ the fuel pump prior to changing tanks to ensure positive fuel flow resulted in a fuel starvation.

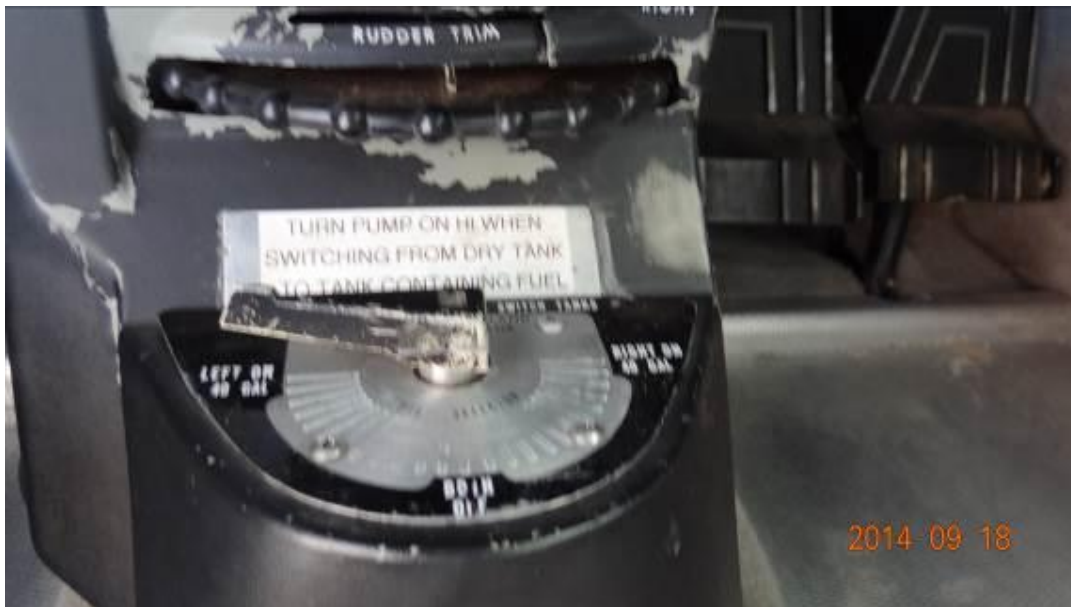
Figure 4: Indicate fuel selector on the left wing
