AIRCRAFT ACCIDENT REPORT AND EXECUTIVE SUMMARY

Reference:	CA18/2/3/9362	
Aircraft Registration	ZS-RUU	Date of Accident	22 September 2014		Time of Accident	1000Z
Type of Aircraft	Robinson R44 Raven II		Type of Operation		Commercial	
Pilot-in-command Licence Type		Commercial	Age	23	Licence Valid	Yes
Pilot-in-command Flying Experience		Total Flying Hours	1146.0		Hours on Type	928.7
Last point of departure		Pennygum Country Cottages, Underberg, KwaZulu-Natal province				
Next point of intended landing		Pennygum Country Cottages, Underberg, KwaZulu-Natal province				
Location of the accident site with reference to easily defined geographical points (GPS readings if possible)						
In an open field in the Himeville area (GPS position S 29°51'54.8" E 029°38'40.9").						
Meteorological Information		Wind: 040°/04Kts., Visibility: 10000m. Temperature: 24°C. Dew point: 09°C. Cloud cover: Nil. Cloud base: Nil.				
Number of people on board	1+1	No. of people injured	0	No. of people killed	1+1

AIRCRAFT ACCIDENT REPORT

Name of Owner : E'Scape Airtours Charters and Transfers CC
Name of Operator : E'Scape Airtours Charters and Transfers CC
Manufacturer : Robinson Helicopter Company
Model : R44

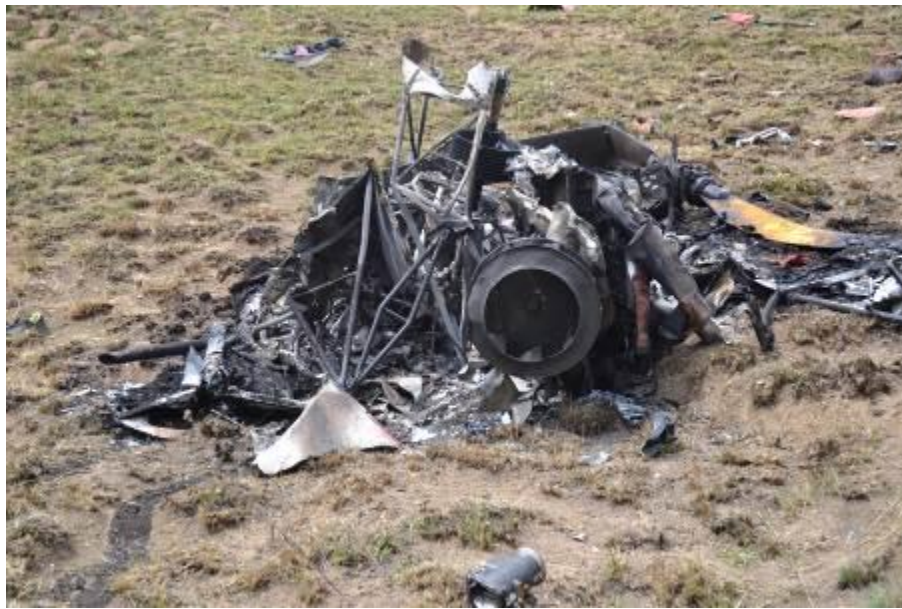
- 1.3.1 The helicopter was destroyed by the post-impact fire.

Figure 1: View of the helicopter, destroyed by the post-impact fire.

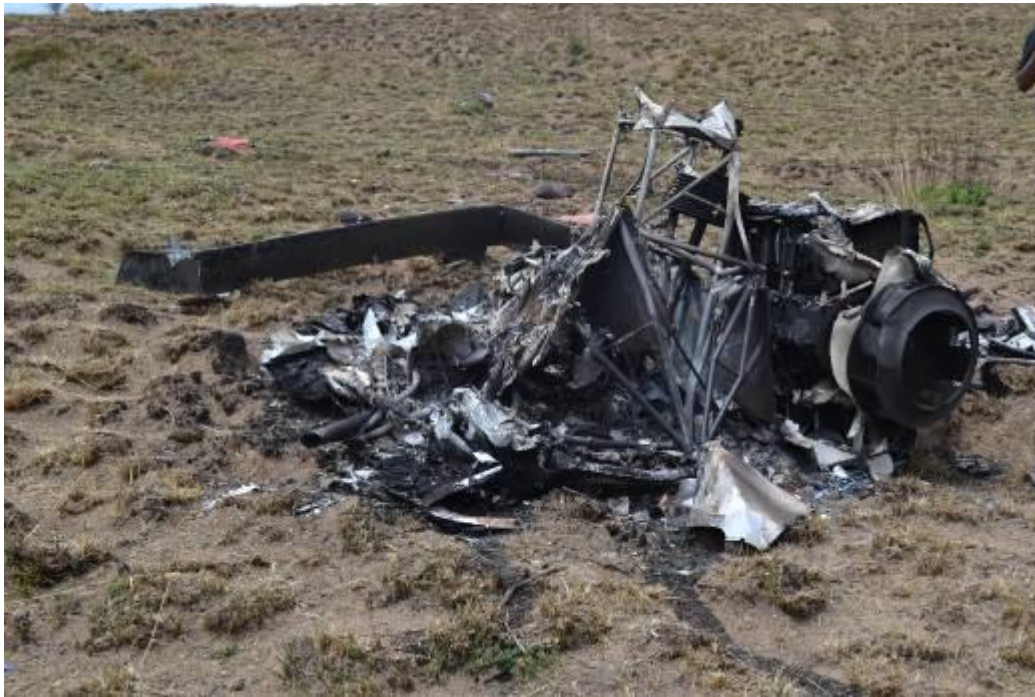
The cabin and fuselage of the helicopter were destroyed by the post-impact fire.

Although the engine was extensively damaged, it remained retained inside the engine mounting support. However, it was destroyed by the post-impact fire.

Figure 2: Damage caused to the fuselage and engine of the helicopter.

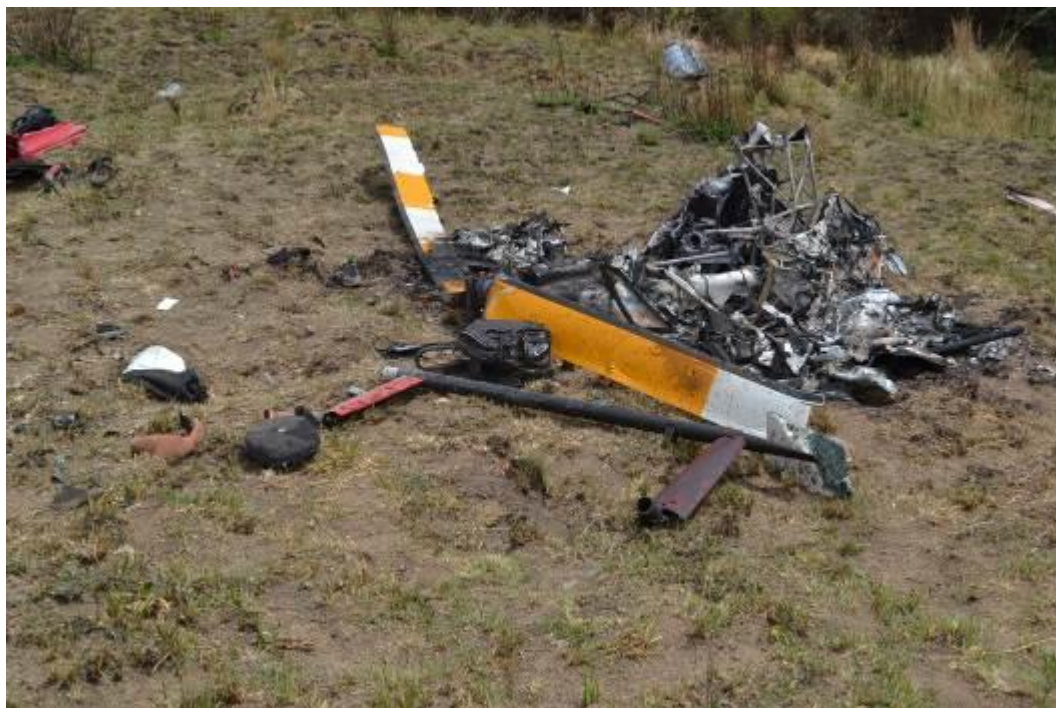
After the accident it was found that both main rotor blades had remained attached to the main rotor head. One of the main rotor blades was intact although impact damage was visible, while the other main rotor blade was severed halfway along the length of the blade.

Figure 3: Both main rotor blades remained attached to the main rotor head following the accident sequence.

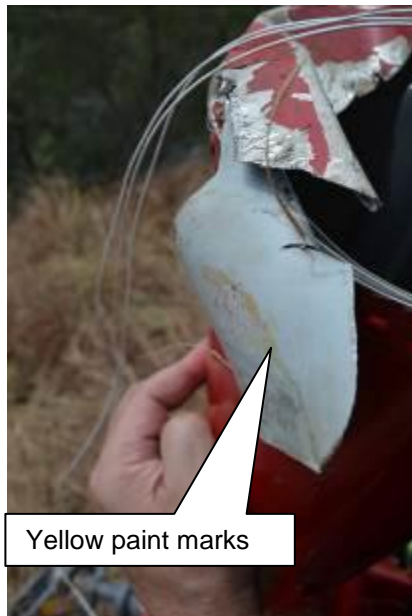
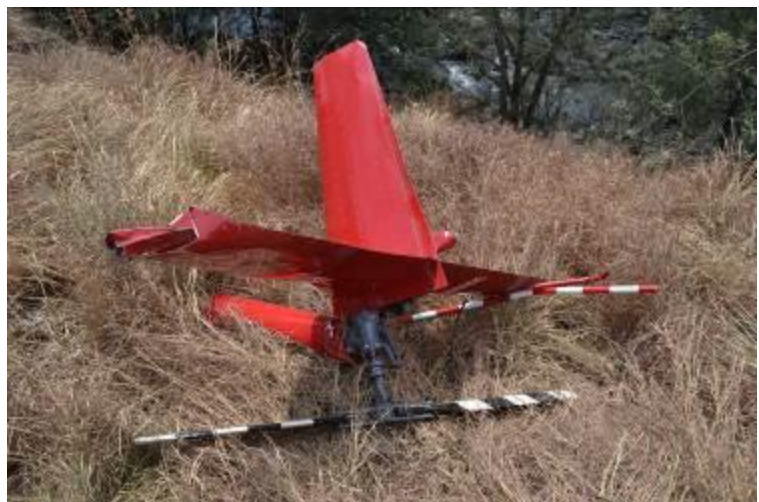
The rear end of the tail boom section, containing the tail rotor system and horizontal stabilizer, was found approximately 100m from the main wreckage in the direction from where the helicopter was flying. Yellow paint marks were visible on the tail boom surface at the place where the tail boom was severed by the main rotor blades.

Figure 4: Severed tail boom section.

- 3.2.1 The helicopter's tail boom was severed/cut off by the main rotor blades during an evasive action to prevent a collision with electrical power lines. As a result, the helicopter collided with the ground.

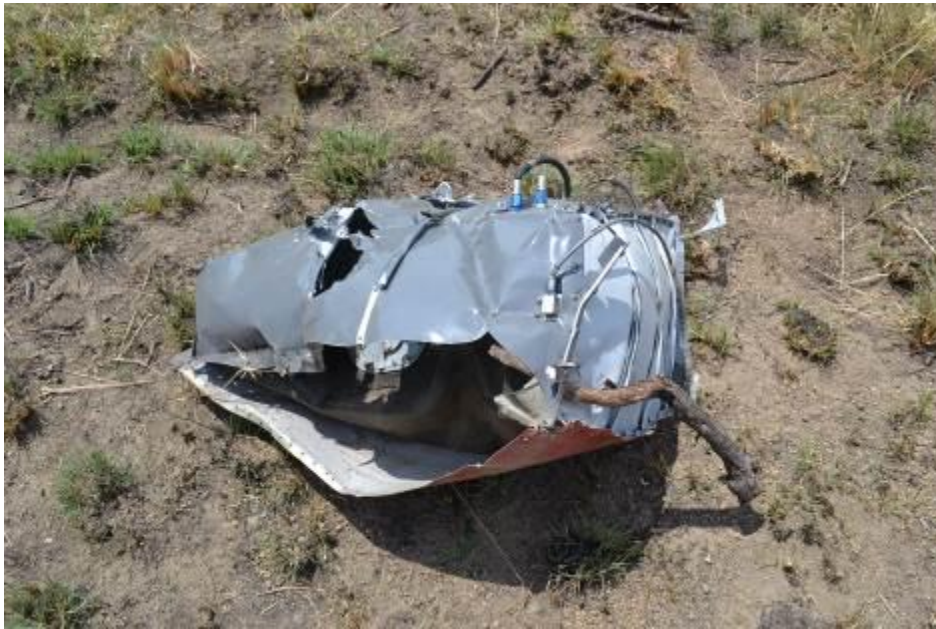
The fuel tank of the helicopter became separated from the fuselage during the accident sequence and it was found approximately 10m away from the fuselage. The fuel tank was torn open and no fuel remained in it.

Figure 5: The damaged fuel tank.

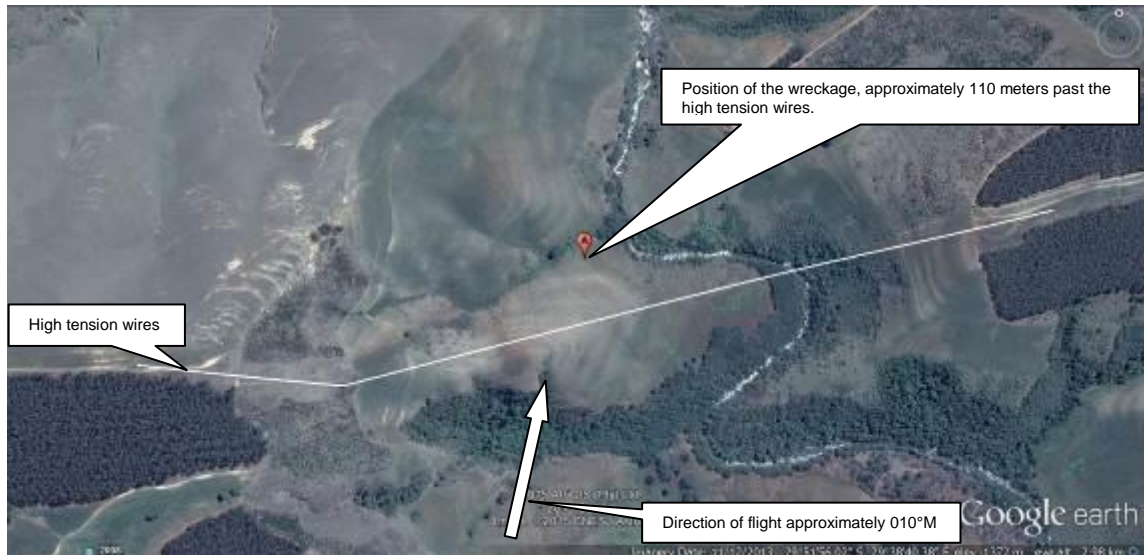
1.18.1 The route being followed by the pilot before the accident was down a valley. There was some relatively high ground within that valley in the area of the accident site. Electrical high tension wires were spanning the valley. It was not possible to

establish the precise height of those wires where they spanned the valley in the vicinity of the high ground; however, they were known to be less than 500ft above ground level (AGL). The precise height at which the flight was conducted was also not known. However, it seems that at the height at which the pilot was flying moments before the accident, the electrical wires spanning the valley blended in with the surrounding mountains, and were therefore difficult for the pilot to see.

Figure 6: Position of the wreckage relative to the high tension wires that spanned across the valley.

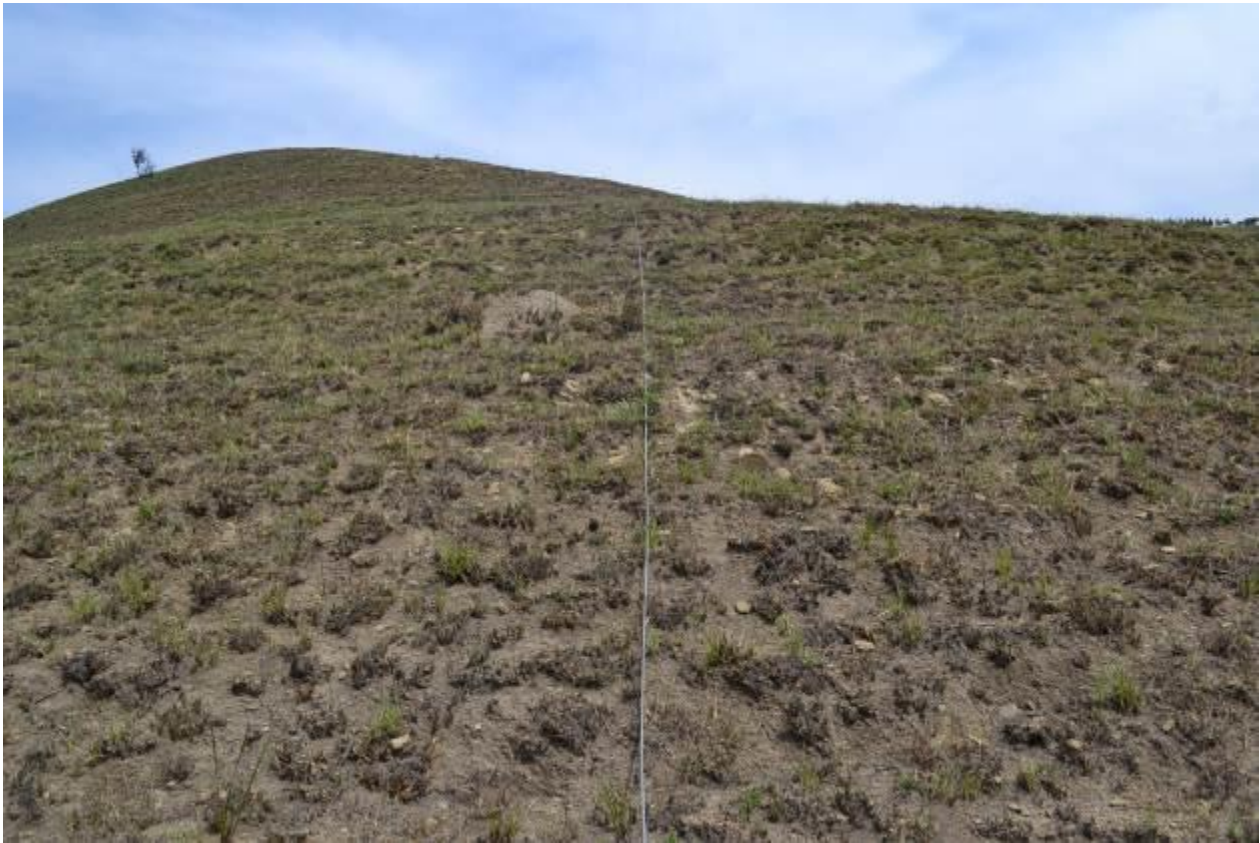
Figure 7: The high tension cable as it was found on the ground.

- 1.18.3 The cable was found to be lying on the ground in a straight line. An inspection of the cable could not reveal any marks or evidence of any collision by the helicopter with the cable. It became clear that the cable had been lying in that position for some time as vegetation has started to cover it.

- 1.18.4 ESCOM confirmed that the cable broke during a snowfall in the area during the previous winter and the cable was lying on the ground since then.
