Havarikommisjonen
Accident Investigation Board Denmark

FINAL REPORT

Serious incident

BOMBARDIER INC. DHC-8-202

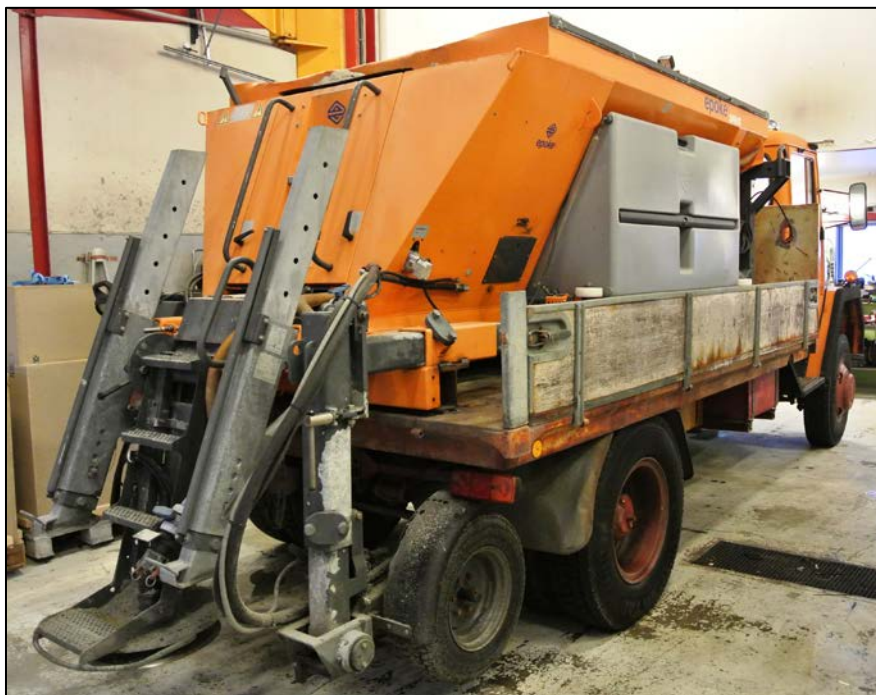
1.10.3.3 Melting agent and/or sand spreader

The melting agent and/or sand spreader was out of service precluding the airport from an effective runway ice deposits clearing throughout the day of the serious incident, which probably changed the runway conditions of melted snow (wet runway) in the morning (local time) into a partly ice covered runway at noon (local time).

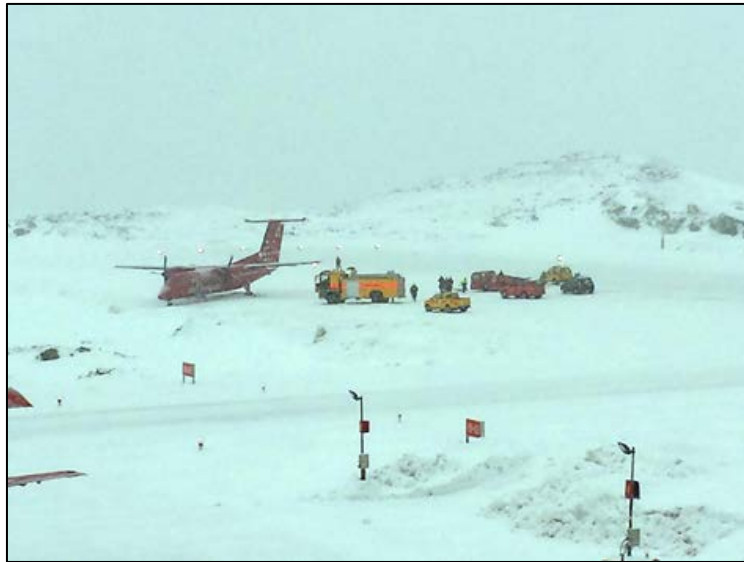
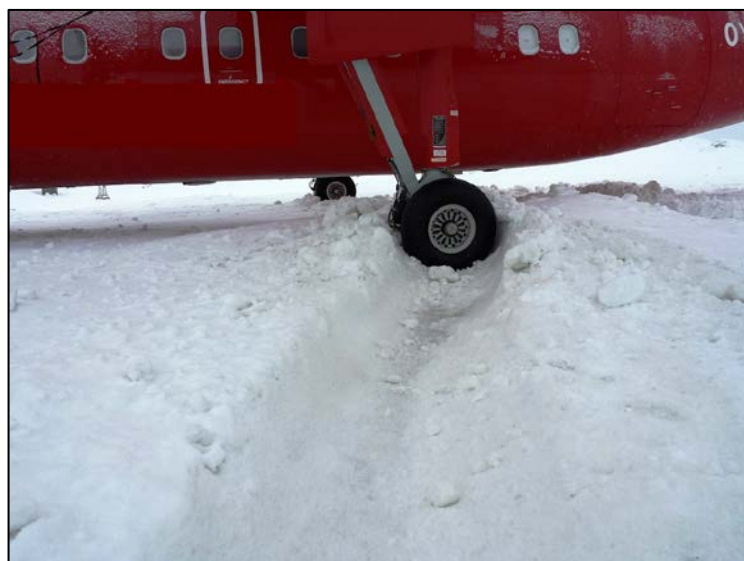
1.12.1 Place of serious incident

The aircraft came to a stop in the safety zone 45 meters east of the runway centre line to runway 23 and 110 meters south of the apron taxiway side stripe (latest position recorded by the aircraft FMS).

The aircraft departed the runway at approximately 35 knots and ended up in loose snow in the safety zone.

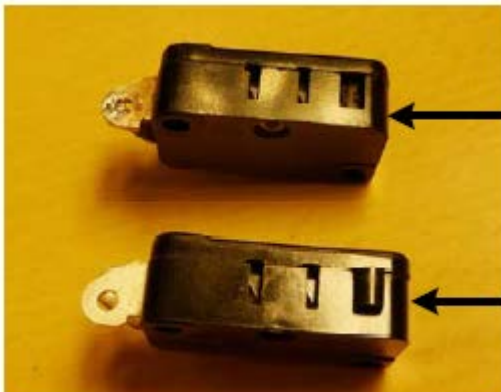
Affected micro switch removed from OY-GRK
The plunger is not spring loaded. No micro switch function and the plunger moved freely and disappeared inside the micro switch housing.

Factory new micro switch
The plunger is spring loaded and when pressed, the micro switch function was audible.

Upon landing on runway 23, the right hand power lever operated micro switch failed momentarily resulting in the propeller control system to momentarily react as the aircraft still was in flight and thereby causing the right hand propeller to begin momentarily feathering (beta backup protection).

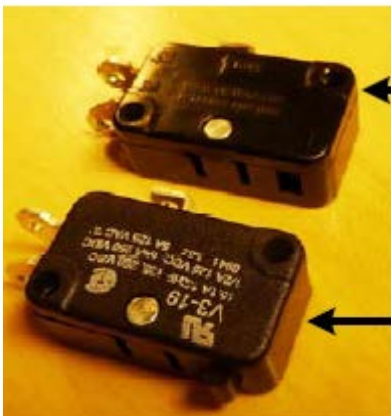
Affected micro switch removed from OY-GRK
The plunger is not spring loaded. No micro switch function and the plunger moved freely.

Factory new micro switch
