## AIRCRAFT ACCIDENT REPORT AND EXECUTIVE SUMMARY

Reference: CA18/2/3/9397	
<b>Aircraft Registration</b>	<b>ZU-WCC</b>	<b>Date of Accident</b>	08 January 2015		<b>Time of Accident</b> 0738Z
<b>Type of Aircraft</b>	Bantam B22J		<b>Type of Operation</b>		Private-Part 91
<b>Pilot-in-command Licence Type</b>		National Pilot Licence	<b>Age</b>	22	<b>Licence Valid</b> Yes
<b>Pilot-in-command Flying Experience</b>		Total Flying Hours	131.1		Hours on Type 107.2
<b>Last point of departure</b>		Hoedspruit Civil (FAHT) : Limpopo Province			
<b>Next point of intended landing</b>		Hoedspruit Civil (FAHT) : Limpopo Province			
<b>Location of the accident site with reference to easily defined geographical points (GPS readings if possible)</b>					
2 nm North East of Hoedspruit Civil (GPS position S24°20'14.02" E030°57'17.75").					
<b>Meteorological Information</b>		Wind direction: 240°, Speed: 02 kts, Temperature: 25°, Visibility: Clear, Dew point: 18°C.

**Name of Owner/Operator** : Sargant M R  
**Manufacturer** : Micro Aviation New Zealand LTD  
**Model** : Bantam B22J  
**Nationality** : South African  
**Registration Marks** : ZU-WCC  
**Place** : Hoedspruit Civil (FAHT)  
**Date** : 08 Ja

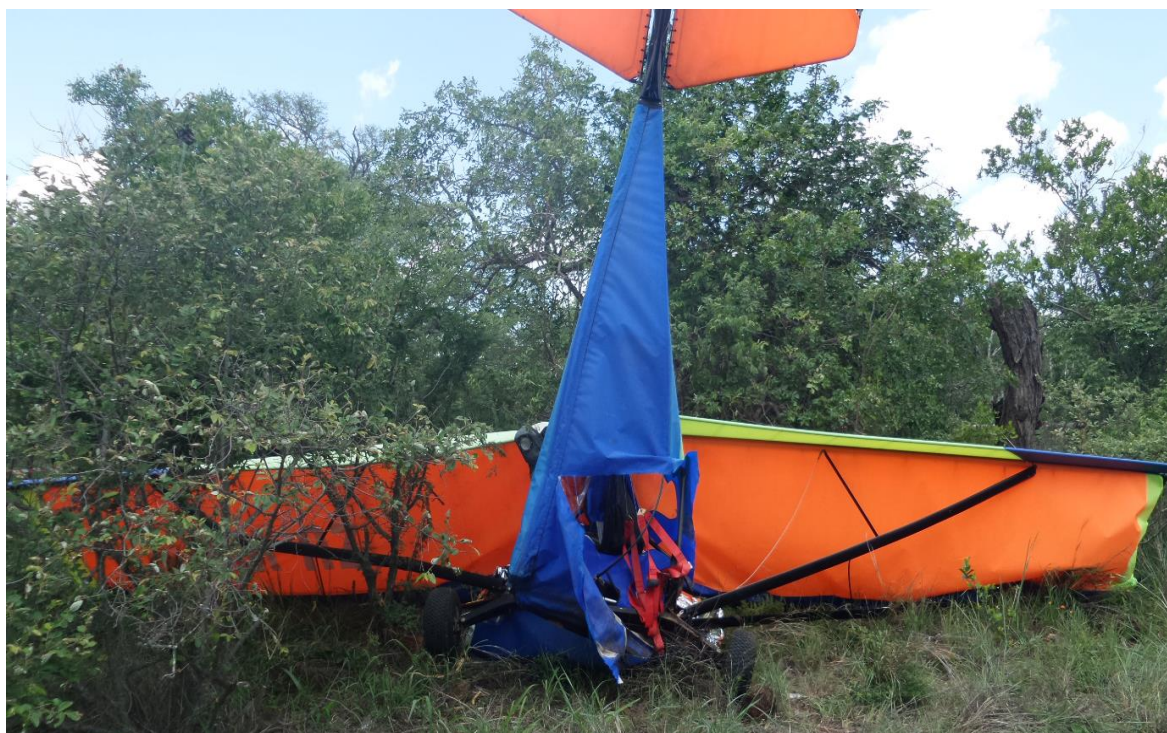
1.3.1 The aircraft was substantially damaged during the accident sequence.

FIGURE 2: Shows the damaged aircraft.

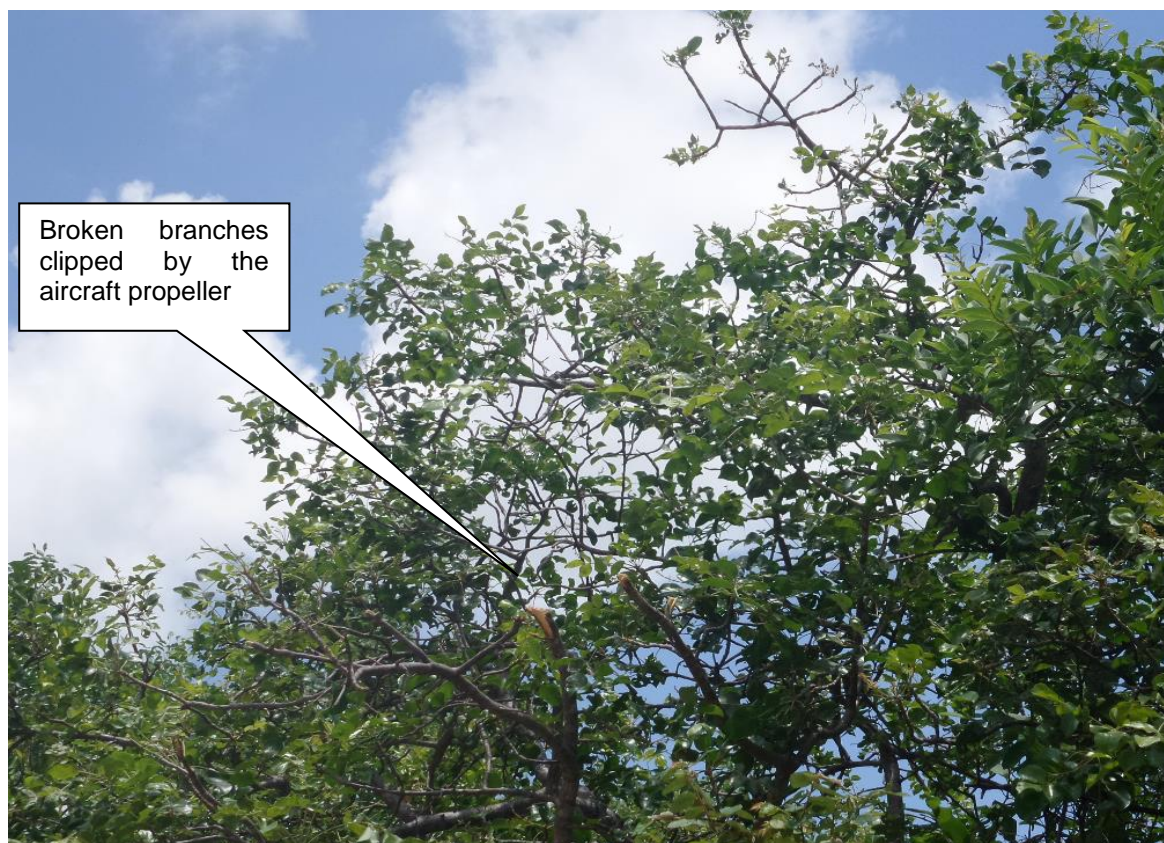
1.4.1 Tree branches were broken by the propeller during the aircraft dive.

FIGURE 3: Damage caused to the trees.

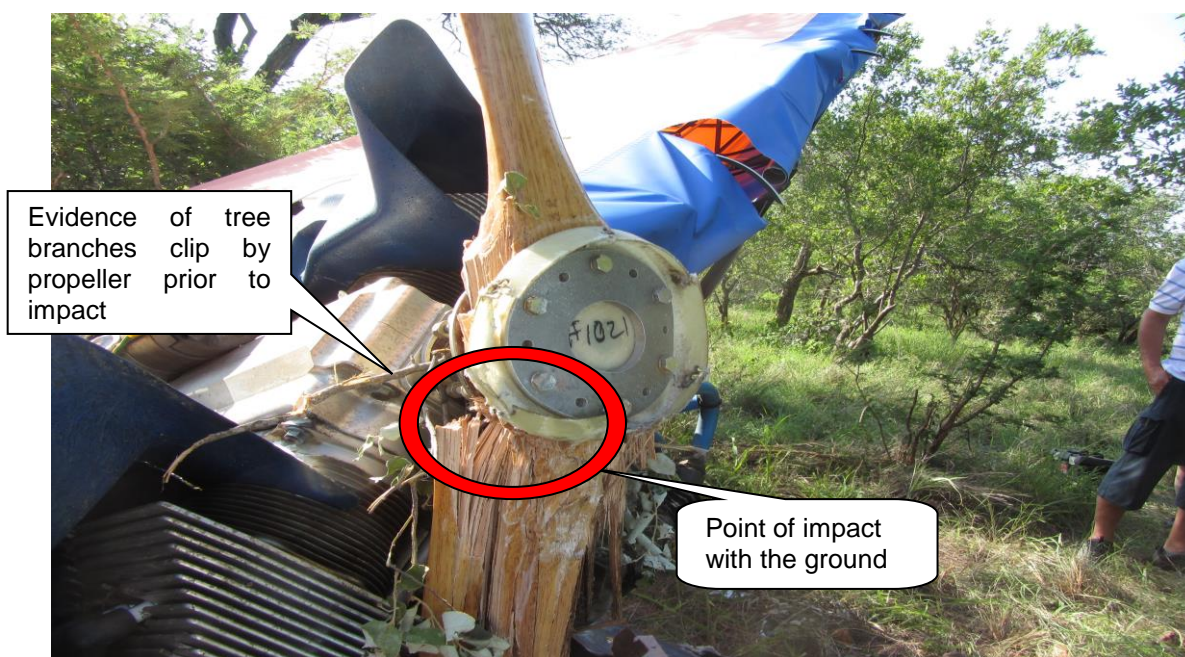
FIGURE 4: Shows point of initial impact.

1.12.1 The aircraft accident occurred in bushy terrain approximately 1 nm north-east of FAHT. According to the eyewitness, the aircraft looked like it was flying upside down. Prior to impact the propeller blades hit the treetop and collected some evidence of broken branches. This was followed by the aircraft making contact with the ground with the right wing first and then impacted hard with the propeller on a rocky surface.

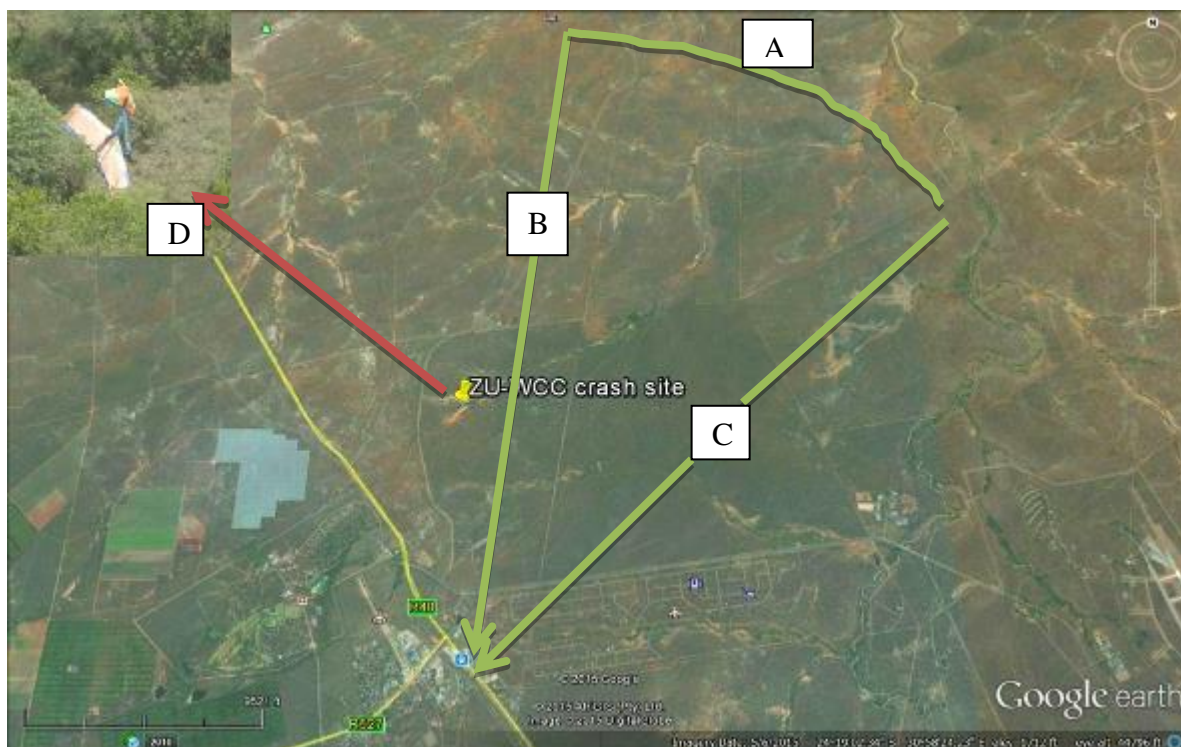
- Arc A: is the approximate position where the Mayday call was made, according to the pilot's information as recorded. The pilot indicated that he was 2 nm from Hoedspruit civil.
- B & C tracks cover an area bounded by headings 210° and 240°. The aircraft could have been anywhere between those tracks.
- D shows enlarged resting position of the aircraft facing 250°.

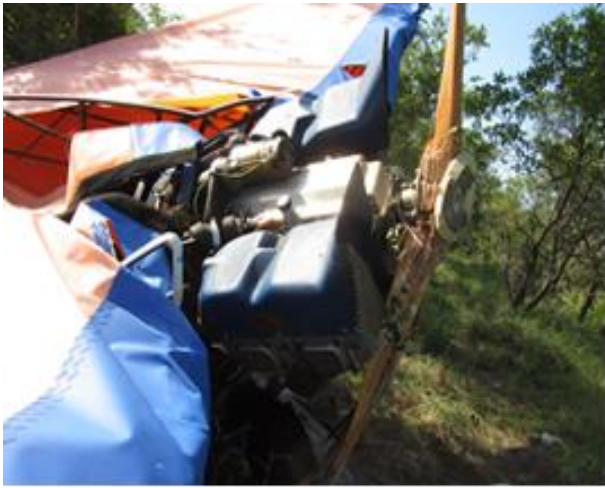
1.12.2 Damage was caused to the propeller, supporting tubes, wings and nose section of the aircraft. (See figures 6, 7 and 8 below.)

FIGURE 6: Damage to the propeller

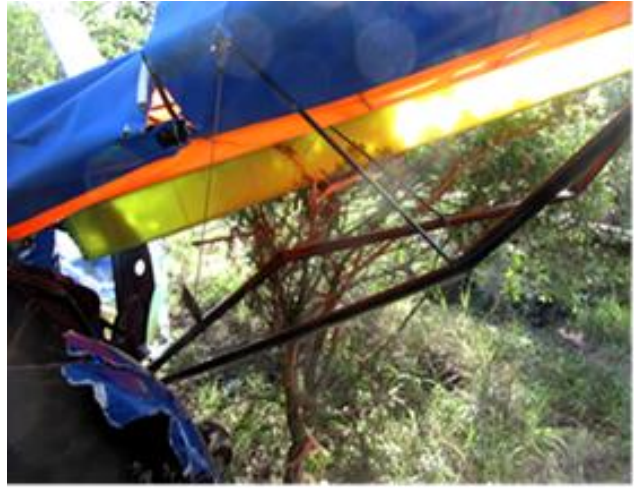
FIGURE 7: Damage to right wing structure

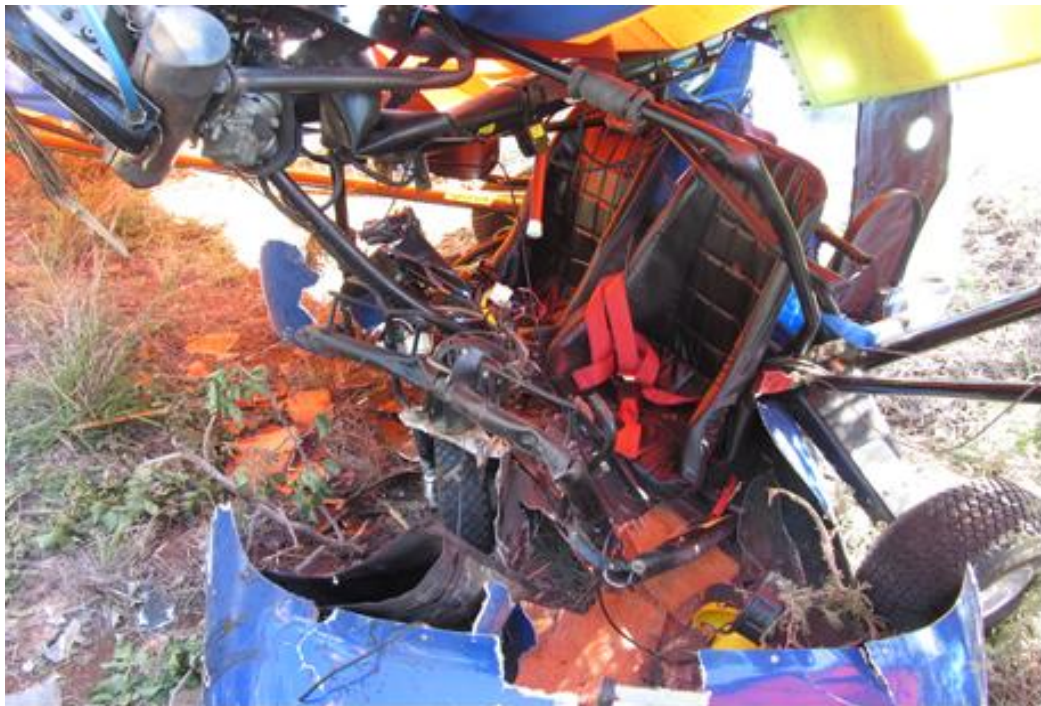
FIGURE 8: Destroyed cockpit

1.15.1 The accident was not survivable due to the magnitude of the impact forces and the attitude of the aircraft during the accident sequence. The cockpit area was destroyed during the impact.

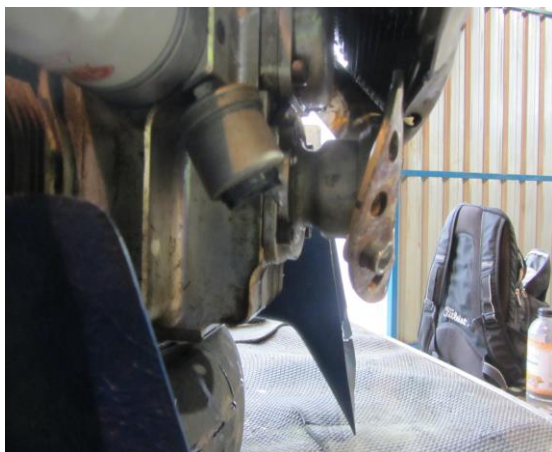
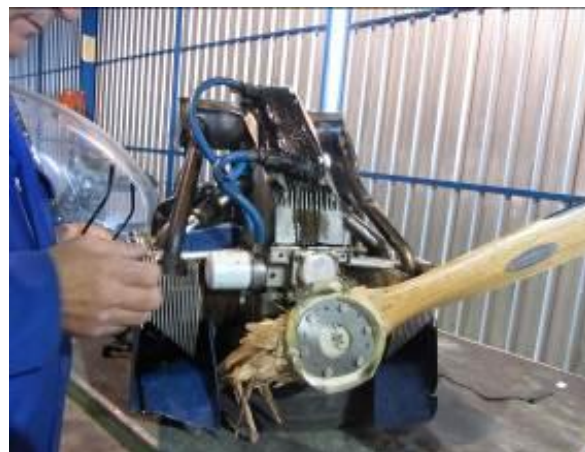
FIG 9: Damage during the accident

FIG 10: Engine taken to AMO for inspection

All damage was accounted for as the result of the accident sequence. Post-accident inspection revealed that the crankshaft propeller flange was bent to the right due to the angle of impact with the ground. (See figure 9 and 10 above.)

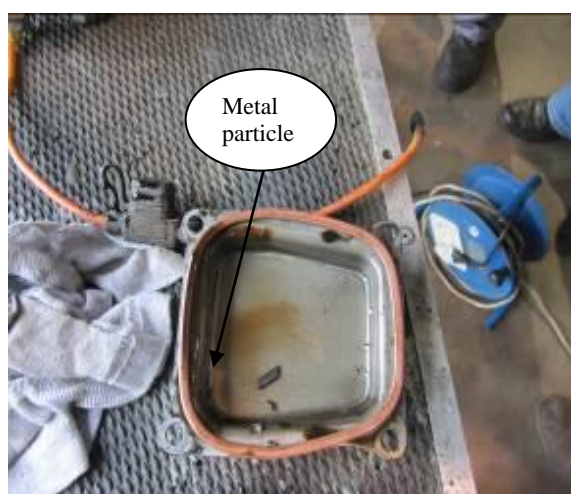
FIGURE 11: Metal fracture

Further investigation was carried out and engine cylinders were removed. Metal particles were found on number 2 rocker covers as shown in figure 11 above. Various metal and aluminium particles were found in the rocker box area of cylinder number 2 as shown in figure 12 above.

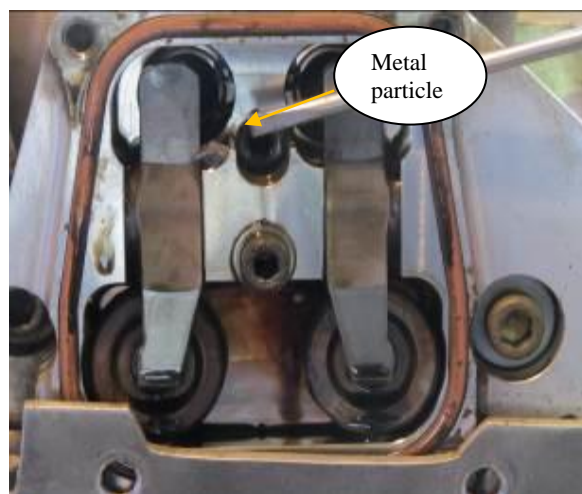
FIGURE 12: Valve rocker arm damaged

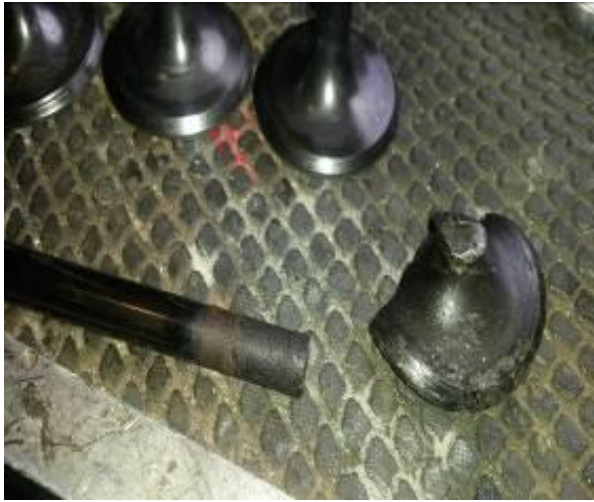
FIGURE13: Broken exhaust valve head

Number 2 exhaust valve head was found broken off from the valve neck as shown in figure 13 above. The piston on number 2 cylinder was damaged and got stuck in the cylinder barrel as shown in figure 14 above.

Possible cause of engine failure, exhaust valve on number 2 cylinder's valve head broke off and turned side-ways in combustion chamber with catastrophic results.

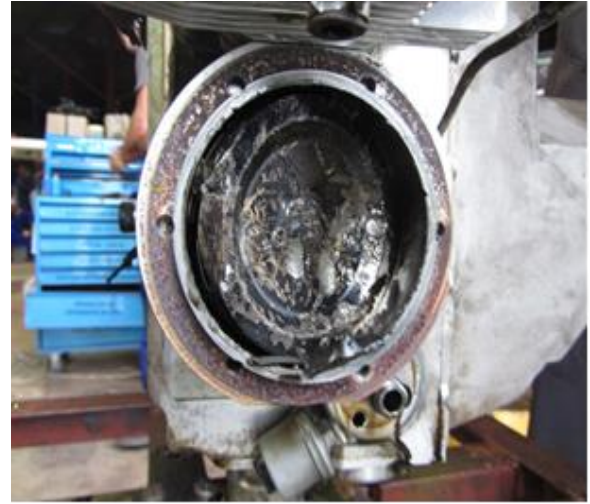
FIGURE 14: Damaged piston head

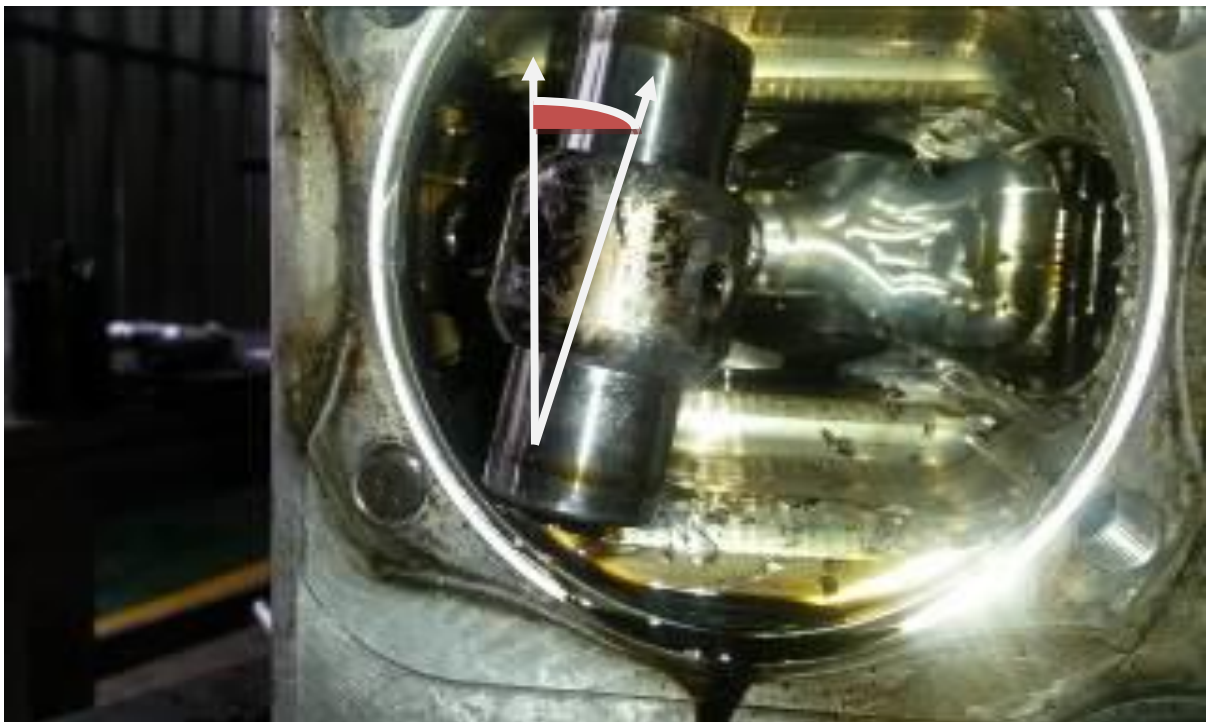
FIGURE15: Bent connecting rod

Number 2 connecting rod was found bent as shown in figure 15 above. No other defects could be found on the engine or components.
