AIRCRAFT ACCIDENT REPORT AND EXECUTIVE SUMMARY

Reference:	CA18/2/3/9407	
Aircraft Registration	ZU-YUM	Date of Accident	14 February 2015		Time of Accident	1345Z
Type of Aircraft	Lancair 360		Type of Operation		Private(Part 91)	
Pilot-in-command Licence Type		Private Pilot	Age	38	Licence Valid	Yes
Pilot-in-command Flying Experience		Total Flying Hours	809.9		Hours on Type	366.8
Last point of departure		Parys Aerodrome (FAPY), Parys, Free State Province				
Next point of intended landing		Kitty Hawk Aerodrome (FAKT), Pretoria, Gauteng Province				
Location of the accident site with reference to easily defined geographical points (GPS readings if possible)						
On the farm Boomplaas next to Parys Aerodrome, Free State Province (GPS S26°52.820 E027°31.337 at 4728ft elevation)						
Meteorological Information		Temperature: 31 °C; Wind 270°/08 kt gusting 20-25 knots; Visibility: 10 000 m; Cloud Cover: None				
Number of people on board	1+1	No. of people injured	0	No. of people killed	2

AIRCRAFT ACCIDENT REPORT

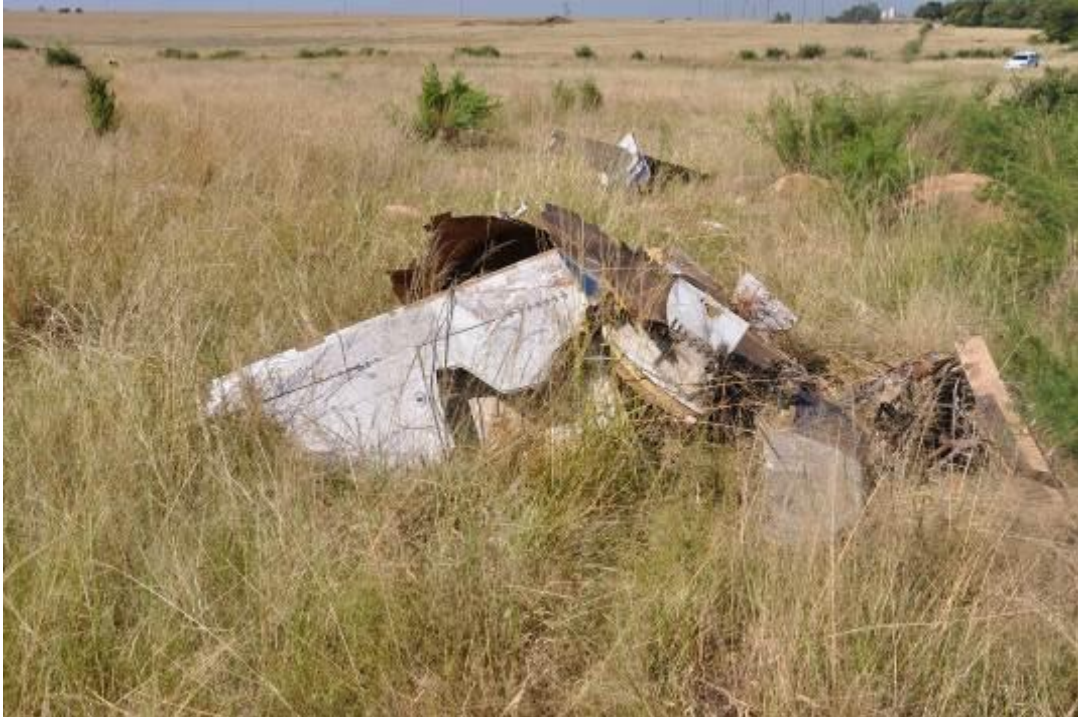
1.3.1 The aircraft was destroyed.

Figure 2: View of aircraft wreckage

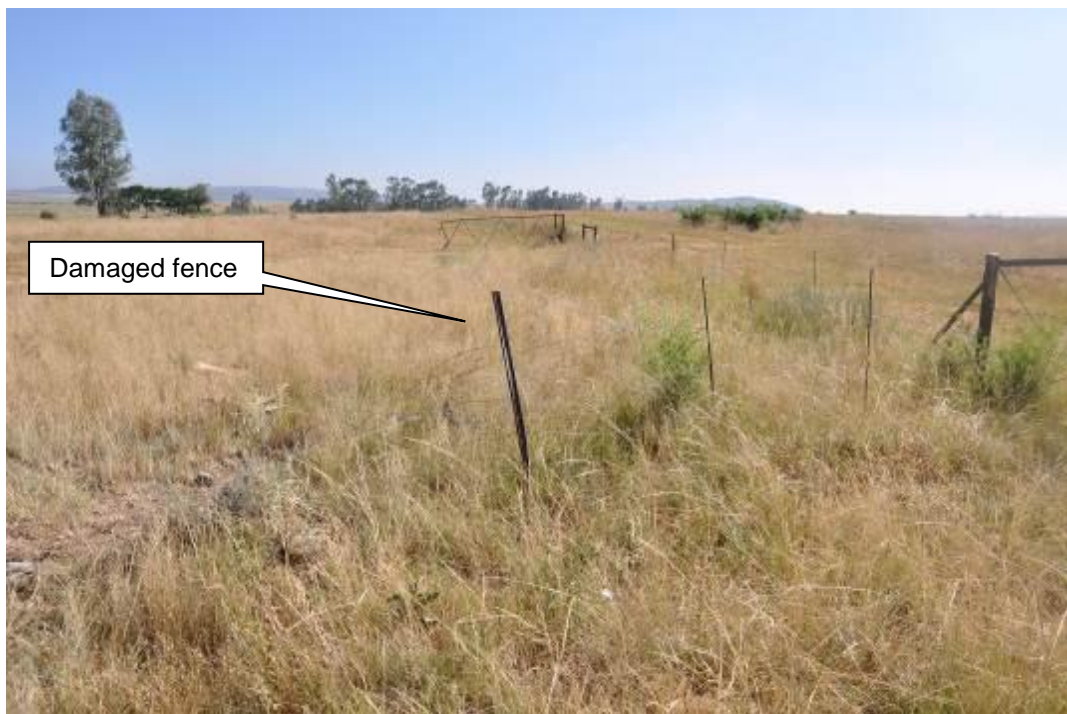
1.4.1 During the accident sequence, the aircraft damaged two wire fences on the farm Boomplaas.

Figure 3: View of first impact with the damaged wire fence

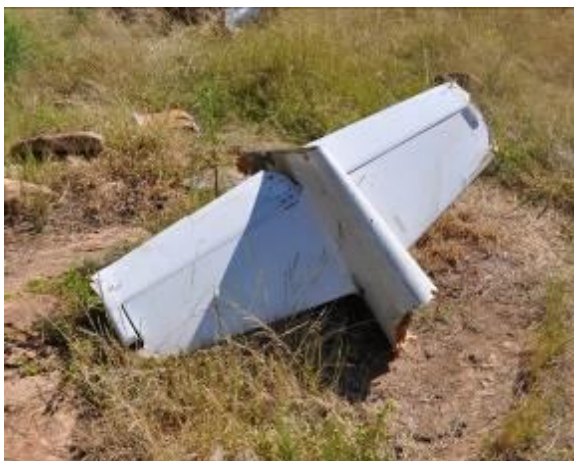
- The damage sustained to the propeller indicated that the engine was at a high power setting at the time of the impact sequence.
- Both wings of the aircraft disintegrated and were destroyed during the impact sequence. Pieces of the wing were found scattered around.
- Both wing tanks disintegrated during the crash.
- The cockpit area and forward part of the cabin were completely destroyed.
- The nose landing gear and both main landing gear broke from the fuselage and was found at separate locations.
- The tail broke from the fuselage.

Figure 6: The tail of the aircraft

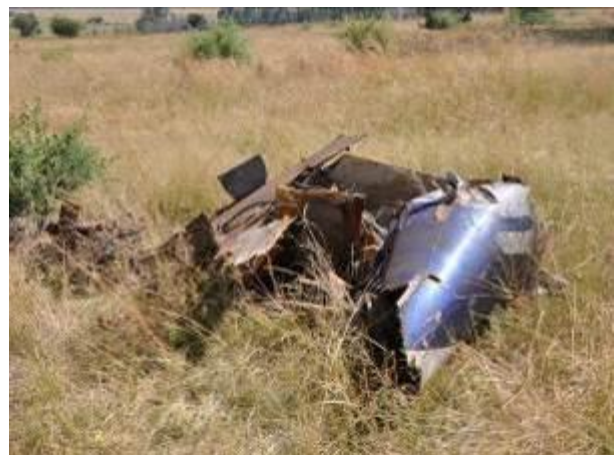
Figure 7: The fuselage

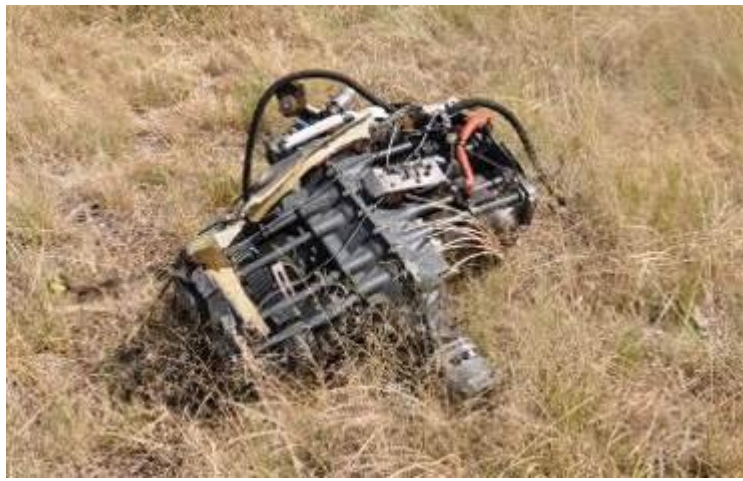
Figure 8: The engine was found 219m from the initial point of impact

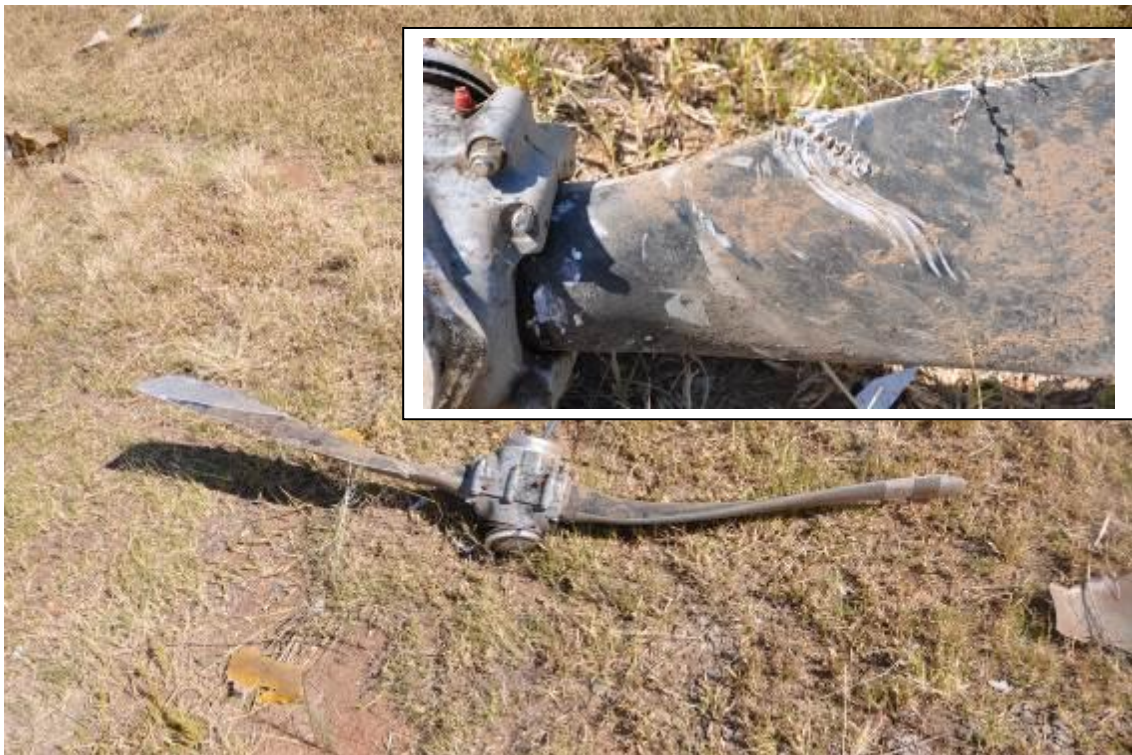
1.12.2 The wreckage path indicated that the aircraft impacted the ground, where after it impacted a wire fence. Witness marks on the propeller indicated the impact of the propeller with a metal rod from the fence. The propeller carved into the hard ground 11 m from the first point of impact, which indicated that the engine was operating at a high power setting. Witness marks then indicate the wing impacting the ground. The propeller was found 37 m from the first point of impact. The tail of the aircraft was found 111 m from the first point of impact, followed by the fuselage and the main landing gear 165 m from the first point of impact. The fibreglass wings disintegrated on impact with the ground and the engine was found 219 meters from the initial point of impact with no evidence that it had rolled along the ground. It appears to have bounced and travelled through the air for most of that distance, which indicates the high speed of the aircraft during the accident sequence.

Figure 9: The propeller
Inset: The evidence marks from impacting the fence's metal rod

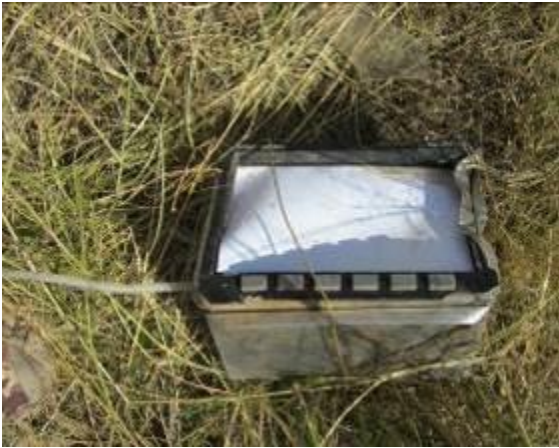
The contents of the on-board flash storage on the Flightdek D180 avionic unit could be accessed; however, there were no data logged. The manufacturer stated that this sometimes happens with the first generation equipment as data logging was an optional feature that customers had to enable.

Figure 10: The Flightdek D180 avionic unit from ZU-YUM

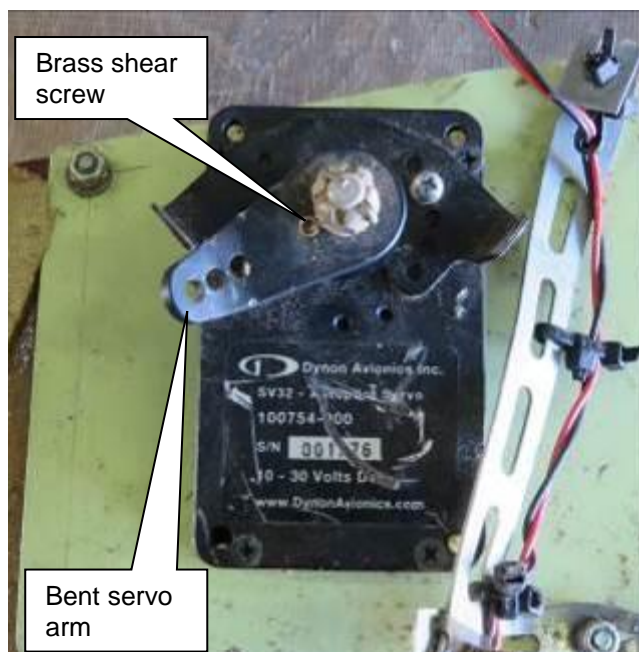
The elevator servo was recovered with the brass shear screw still intact. The servo arm, which attaches via a push-pull rod to the elevator was, however, found bent caused by impact damage. The elevator servo was found jammed and when it was opened, it moved freely. The investigation determined that the elevator servo jammed due to impact damage during the accident sequence. The intact brass shear screw indicates that no manual override was necessary to disengage the elevator servo. The ZU-YUM accident occurred during the take-off/climb phase of flight and during this flight phase, the autopilot will also not be engaged.

Figure 12: The elevator servo of ZU-YUM
