AIRCRAFT ACCIDENT REPORT AND EXECUTIVE SUMMARY

Reference:	CA18/2/3/9426	
Aircraft Registration	ZU-DVB	Date of Accident	25 March 2015		Time of Accident	1137Z
Type of Aircraft	Gyrocopter RAF 2000 GTX SE FI		Type of Operation		Private Part 94	
Pilot-in-command Licence Type		NPL	Age	49	Licence Valid	Yes
Pilot-in-command Flying Experience		Total Flying Hours	358.5		Hours on Type	354.3
Last point of departure		Uitenhage (FAUH) aerodrome: Eastern Cape province				
Next point of intended landing		Uitenhage (FAUH) aerodrome: Eastern Cape province				
Location of the accident site with reference to easily defined geographical points (GPS readings if possible)						
In a bushy terrain outside the aerodrome						
Meteorological Information		Wind direction: 230°; Wind speed: 13kt; Air Temperature: 26°C; Dew point: 18°C; Clouds coverage: SCT; Cloud base: 020ft				
Number of people on board	1+1	No. of people injured	0	No. of people killed	2	
Synopsis

AIRCRAFT ACCIDENT REPORT

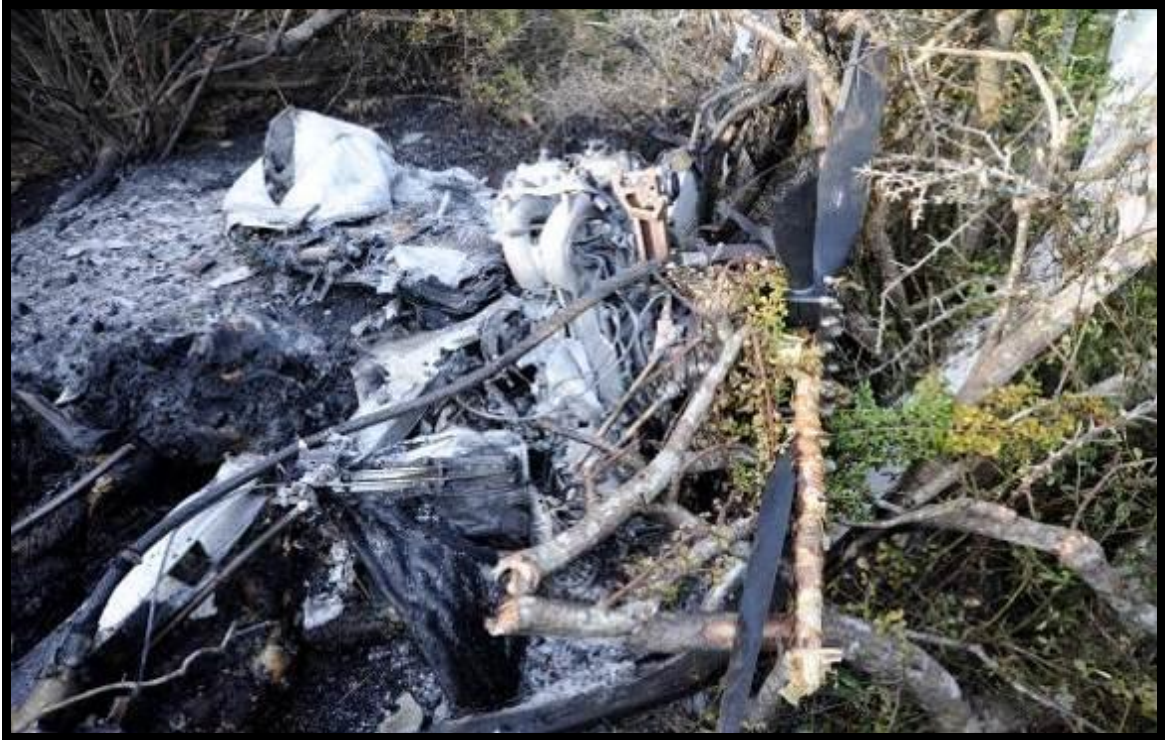
1.3.1 The aircraft was destroyed during the accident sequence.

Figure 2: Shows the remains of the aircraft (Gyrocopter)

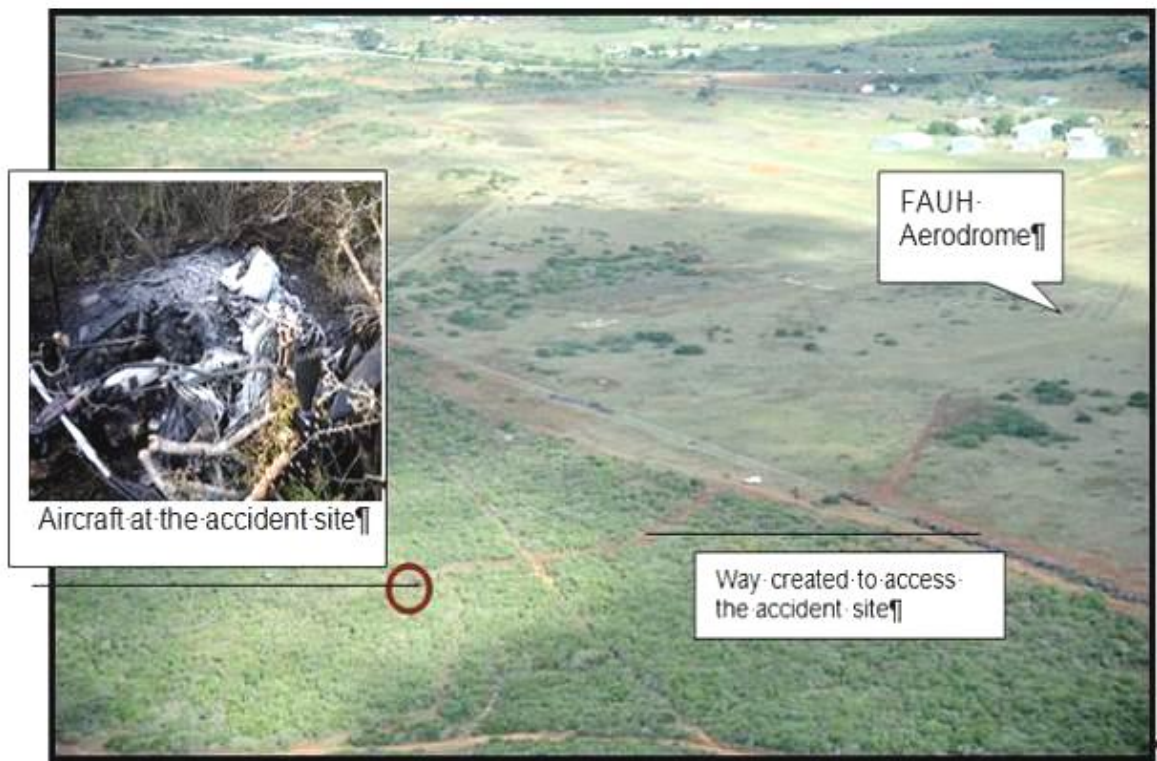
1.12.1 The aircraft accident occurred in a bushy terrain during a circuit flight around the aerodrome. The terrain was not easily accessible; however, a way leading to the aircraft wreckage was created with the help of road workers who were doing road construction in the area near the accident. The aircraft wreckage was located on the south-eastern side of the aerodrome, at a distance of approximately 100 m from the perimeter fence. The accident site indicates two points of impact with some bush damages in the direction of where the main wreckage was found. The initial point of impact in relation to the flight path heading direction was behind the final point of impact where the aircraft was engulfed by post impact fire.

Figure 4: Shows the accident

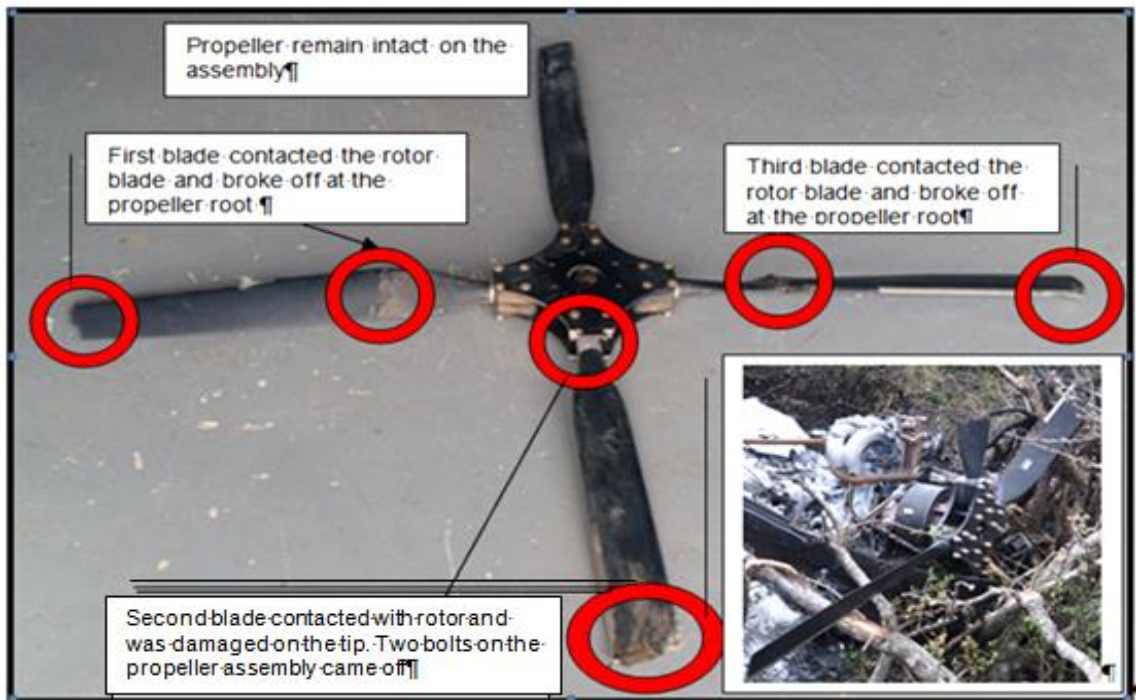
- All four propeller blades were recovered during aircraft recovery, three of which were damaged due to contact with the rotor blade during flight. One propeller blade was recovered at a distance of approximately 150 m in the direction at which the aircraft was approaching from. Two more propeller blades were still attached to the propeller assembly. One propeller blade was found with damages to the tip of the leading edge with two of the four attachment bolts missing. The third blade was found at the point of initial impact. The damages on all three propeller blades are consistent with the damage that occurred when the engine was turning at high power.

Figure 5: Shows the recovered aircraft propeller assembly

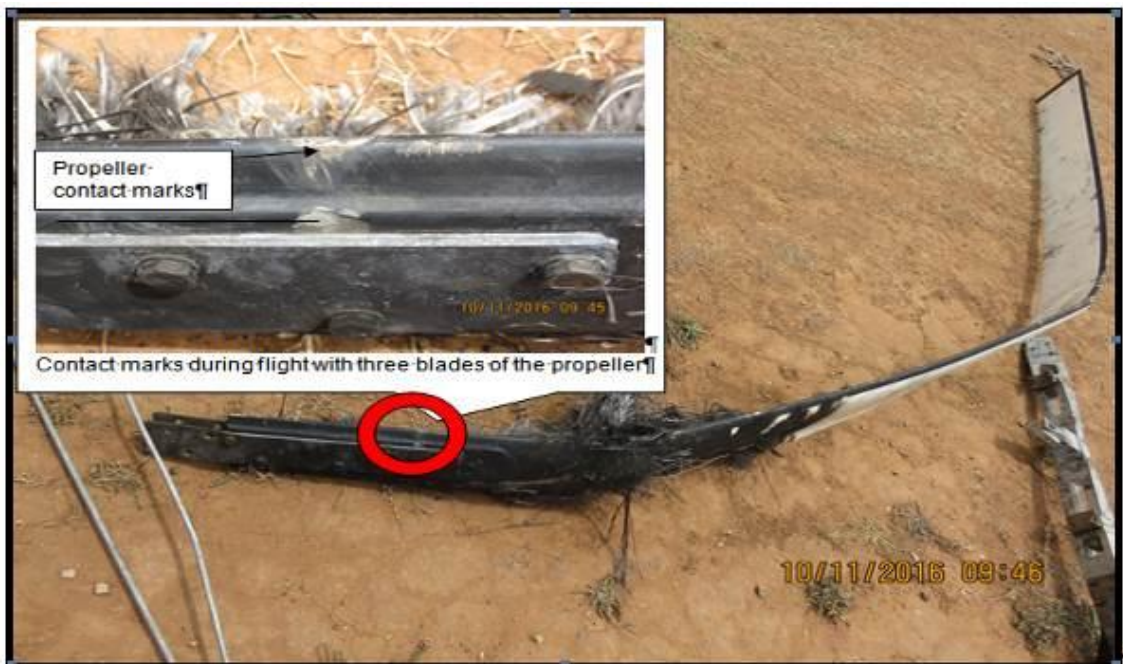
- The rotor blades did not separate from the mast assembly and had evidence of fire damage. One of the rotor blades showed evidence of contact marks with a moving object at a distance, equivalent to the propeller tip position.

Figure 6: Shows damage to the rotor blade and the contact mark with the propeller blades

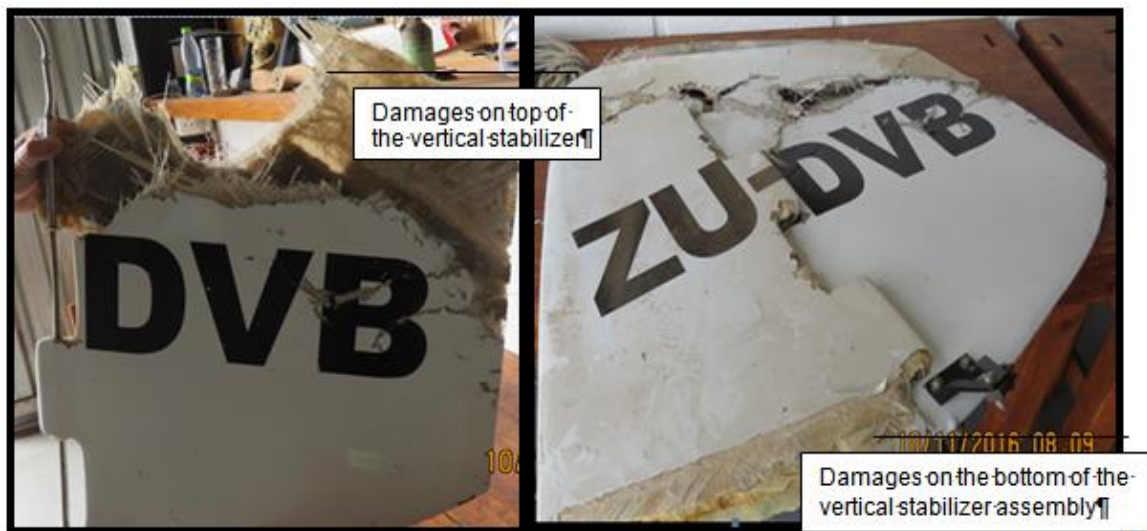
According to the evidence on the vertical stabiliser, which was recovered within a radius of approximately 10m from the main wreckage, the damages are consistent with impact caused by contact with a rotor blade however more damages might have resulted during the impact sequence on the bushy terrain. (Refer to figure 7 below)

Figure 7: Shows the damages on the vertical stabiliser

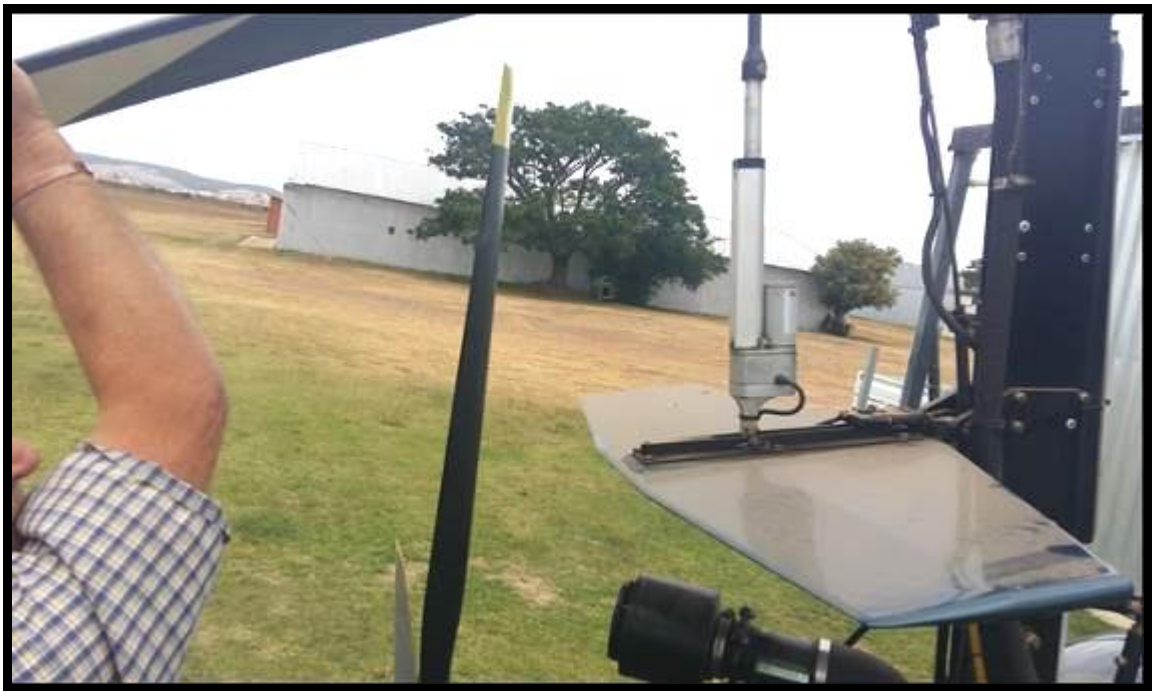
Figure 8: Shows how clearance demonstration was achieved

1.16.2 To conduct an experiment, the same type of aircraft was used to illustrate the clearance between the propeller and the main rotor as provided by further restrictions of the gimble head/stop. This was after the findings of the wreckage examination, whereby the mast assembly gimble head bolts were adjusted. With settings as found on the aircraft in Figure 9 below, the rotor has sufficient clearance during operation condition that prevents contact with the propeller. With settings as observed on the gimble heads of the accident aircraft as shown in Figure 11, during simulation the rotor has a high chance of making contact with the propeller blades

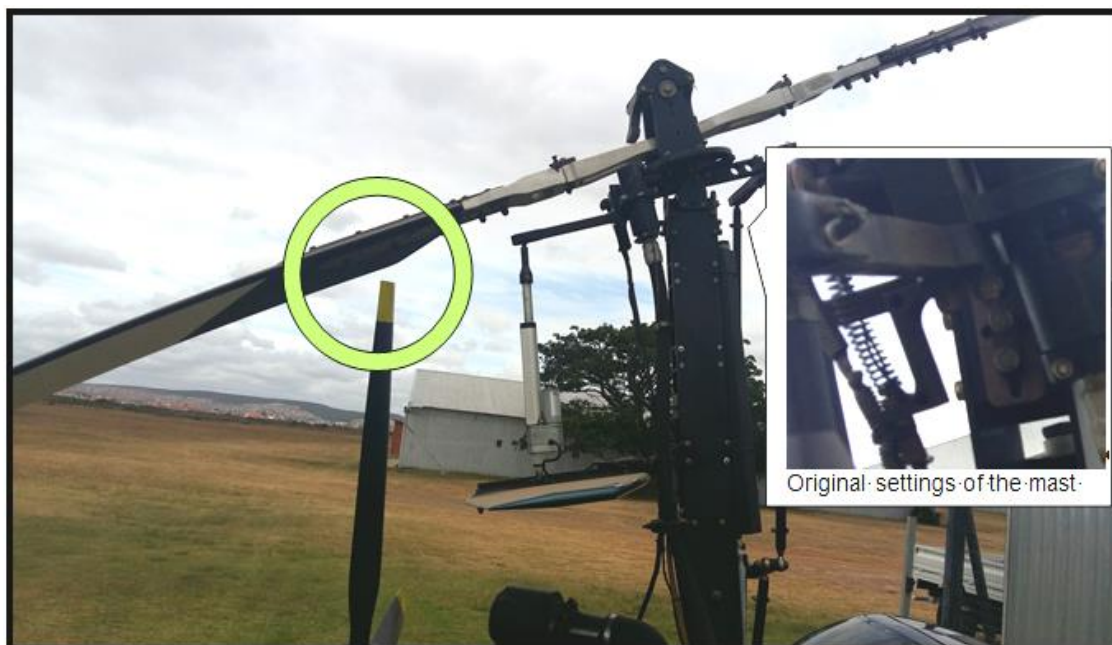
Figure 9: Shows the clearance with the original adjustment as it was found on the aircraft type

Sufficient clearance was observed with the original settings on the serviceable aircraft during demonstration.

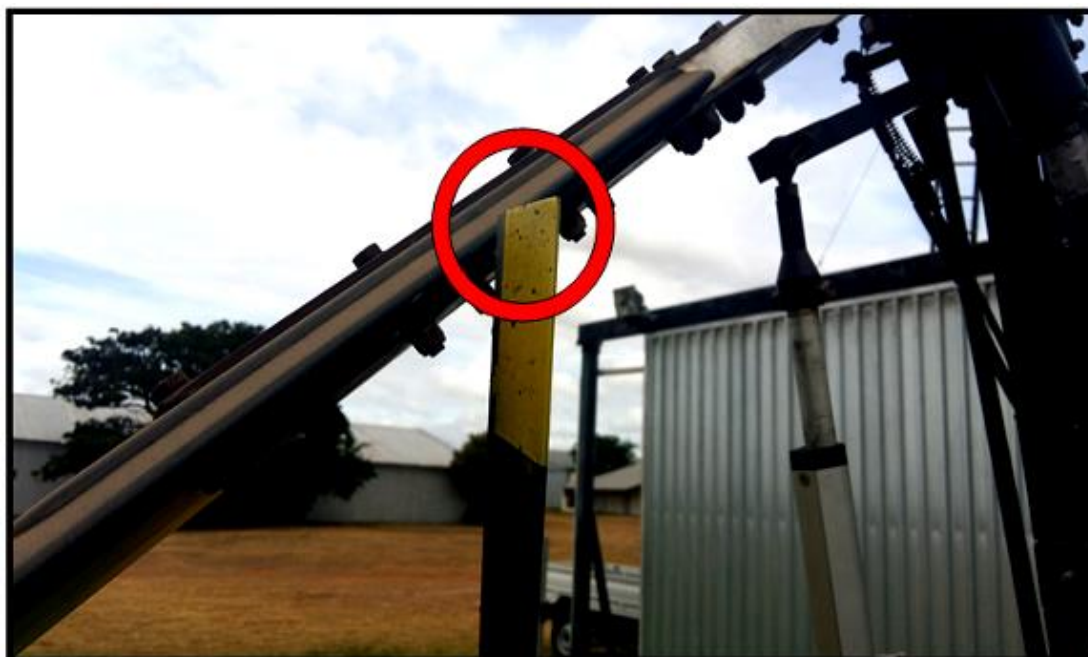
Figure 10: Contact possible when bolts are set to the position as they were found on the accident aircraft

When bolts were set to the position as found on the accident aircraft mast

assembly, the rotor clearance to the propeller showed possible contact during operation activities. Refer to Figure 11 below.

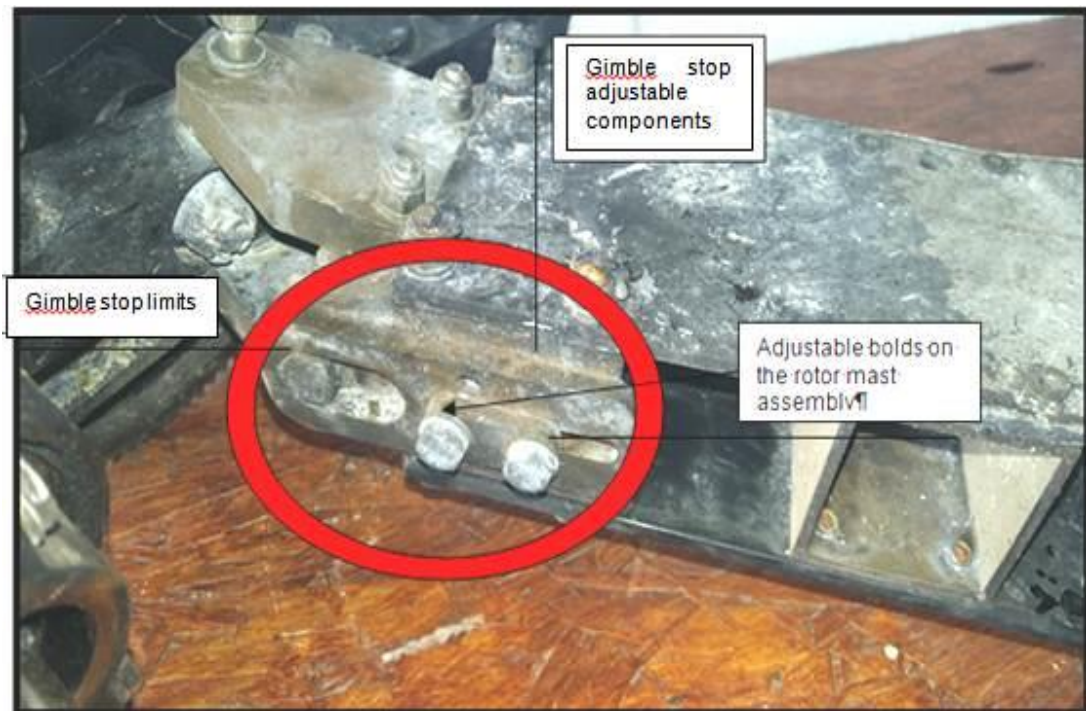
Figure 11: Shows the mast assembly gimble head/stop adjustment as found on the accident aircraft

The mast assembly has two sliding plates (gimble head/stop) in both front and rear. The gimble head/stop was adjusted equally, as observed during the investigation. According to the manufacturer, this can only be done as recommended by the manufacturer and should be performed by an aircraft maintenance-approved person. The slide adjustable (gimble head/stop) plate provides extra stop for the rotor mast assembly. A 1 cm adjustment is equivalent to a 1-degree angle deflection longitudinally on the rotor blade. The slide plate on the accident aircraft was found flashed to the maximum adjustment.

By default setting -1 degree forward, 18 degree backward, if you go 22 degrees or more, this will have catastrophic consequences in flight.

1.4 All critical components like rotor-blades, hub-bars, gimble heads must be returned to the OEM or the RAF TAP for any adjustments or activities on these components.

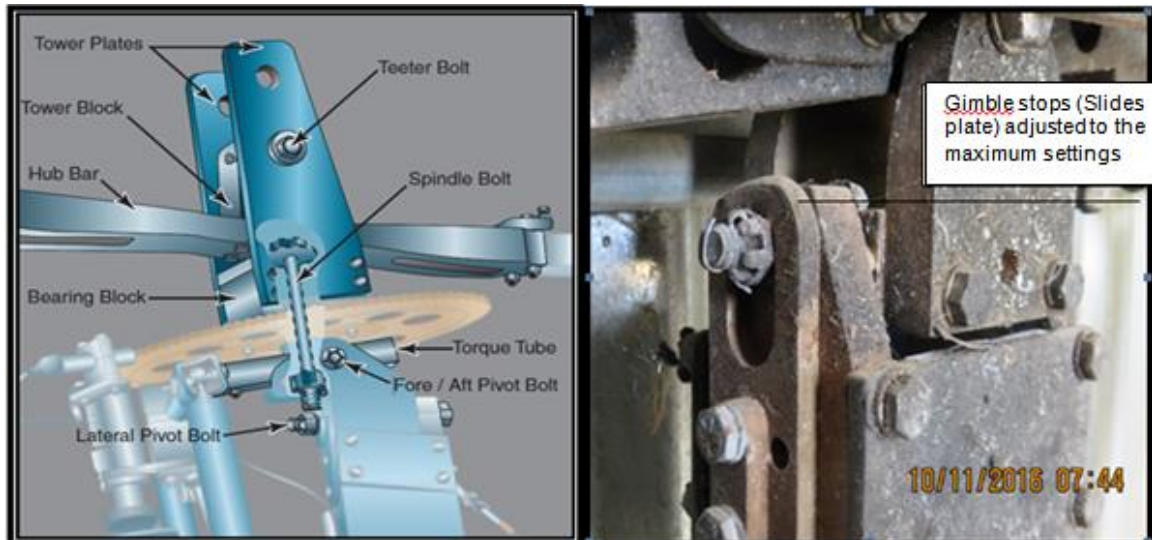
Figure 14: Shows gimble (slide plates) stop adjusted

- 2.4 The gyrocopter type is equipped with two teetering rotor blades. At the time of the flight, the gimble stops were adjusted to the maximum position with the mast assembly (refer to Figure 14). This allowed the retreating blade at the time, which flexed down and flapped, to make contact with the tail stabiliser, followed by contact with three propeller blades during flight. Contact marks were observed on one of the rotor blades during the investigation follow-up at a distance equivalent to the propeller position. Following contact, the aircraft engine and the rotor blades came to a complete stop. This resulted in a loss of lift that could have been generated by the main rotor through autorotation, which is a design fail-safe feature on the rotorcrafts. The aircraft impacted nose first, prior to it flipping over and was engulfed in fire.

3.1.5 The aircraft's gimble stops were adjusted to the maximum position prior to the accident flight. This allowed the rotor blades to make contact with both the tail stabiliser and the propeller blades during flight.
