AIRCRAFT ACCIDENT REPORT AND EXECUTIVE SUMMARY

Reference:	CA18/2/3/9428	
Aircraft registration	ZS-HFO	Date of accident	3 April 2015		Time of accident	0903Z
Type of aircraft	Robinson R44 Raven II		Type of operation	Private		
Pilot-in-command licence type	Private		Age	40	Licence valid	Yes
Pilot-in-command flying experience	Total flying hours		337.8		Hours on type	287.7
Last point of departure	Helipad, Reaction Unit South Africa, Durban, Kwa-Zulu Natal Province					
Next point of intended landing	Verulam Recreational Grounds, Durban, Kwa-Zulu Natal Province					
Location of the accident site with reference to easily defined geographical points (GPS readings if possible)						
Polo field in Verulam, Durban (GPS position: 29°38.764qSouth 031°03.455qEast, elevation 100 feet AMSL)						
Meteorological information	Surface wind: 180°/5kt, Temperature: 31°C, Visibility: + 10km.					
Number of people on board	1 + 1	No. of people injured	1 + 1	No. of people killed	0

Name of Owner : Reaction Unit South Africa
Name of Operator : Private
Manufacturer : Robinson Helicopter Company
Model : R44 Raven II
Nationality : South African
Registration Marks : ZS-HFO
Place : Polo field in Verulam, Durban
D

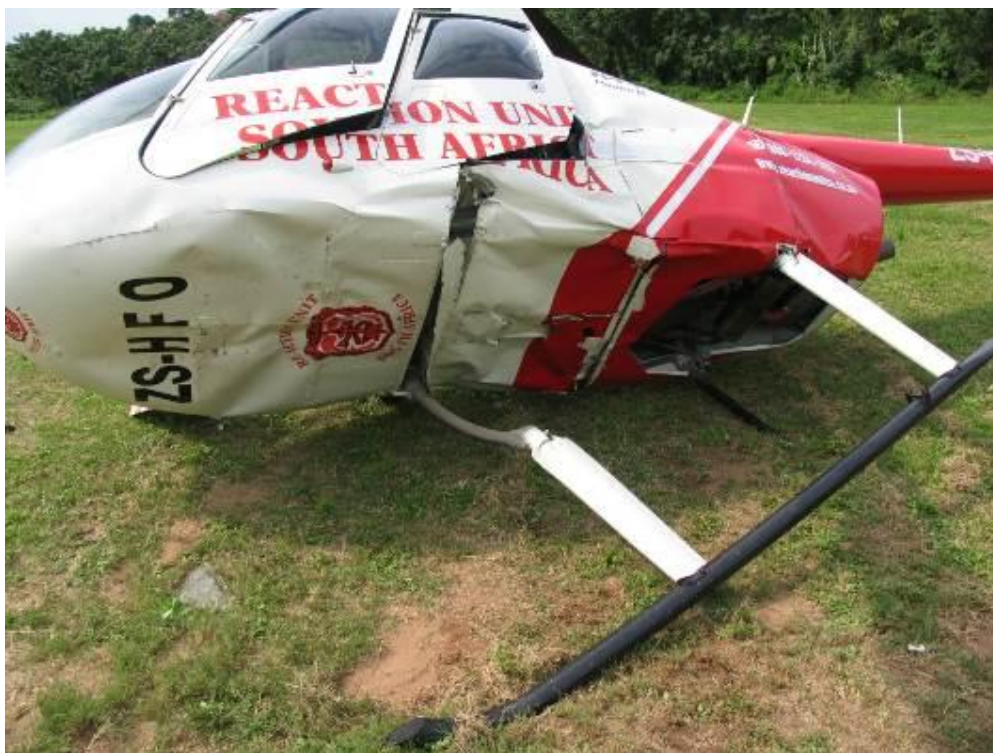
- 1.3.1 The helicopter sustained a substantial amount of damage during the impact sequence.

Figure 1. A photograph of the helicopter showing how it came to rest

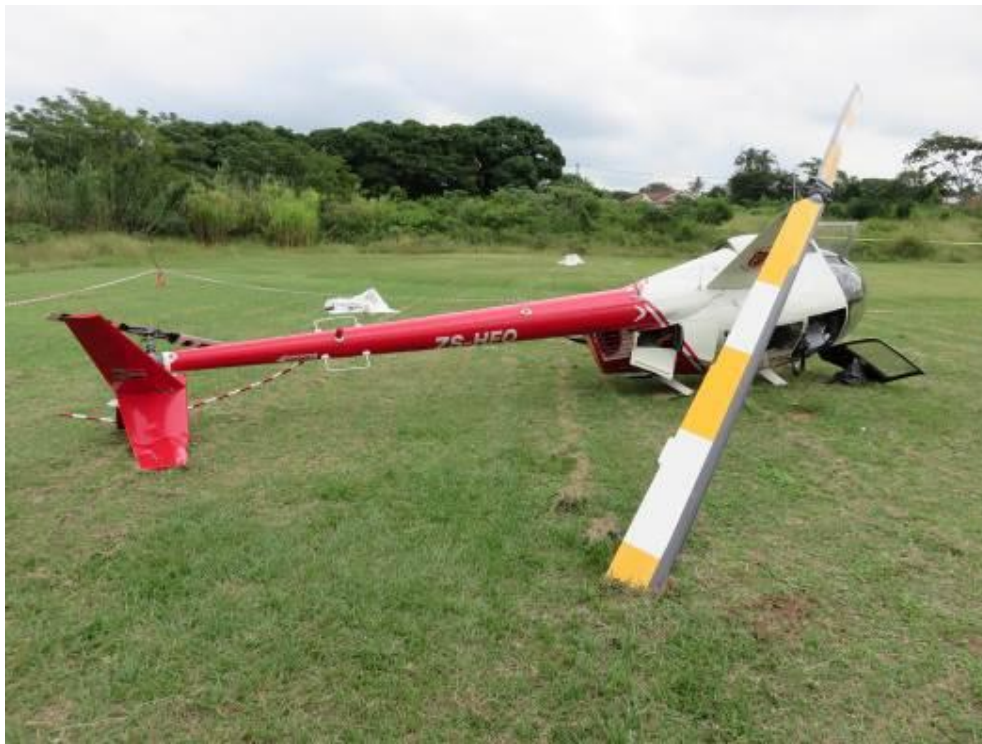
- 1.12.1 The helicopter impacted the ground in an open grass field (Polo field); at the moment of impact it was travelling in a north-easterly direction. Observation of the ground impact markings indicated that no lateral movement took place during the impact sequence. The front cross tube assembly separated from the fuselage during impact and the helicopter started to roll over to the right, but came to rest in a semi rolled-over attitude when one of the main rotor blades impacted the grass surface on the right-hand side of the helicopter. This blade supported the fuselage and, with the assistance of the horizontal stabilizer, allowed the helicopter to remain in a semi rolled-over attitude as shown in Figure 2 below.

Figure 2. A photograph of the helicopter after it came to rest

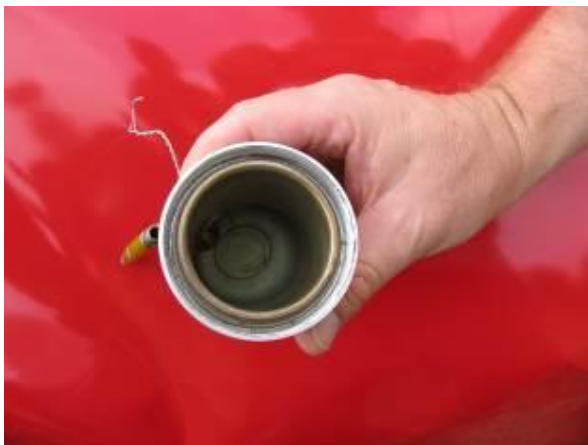
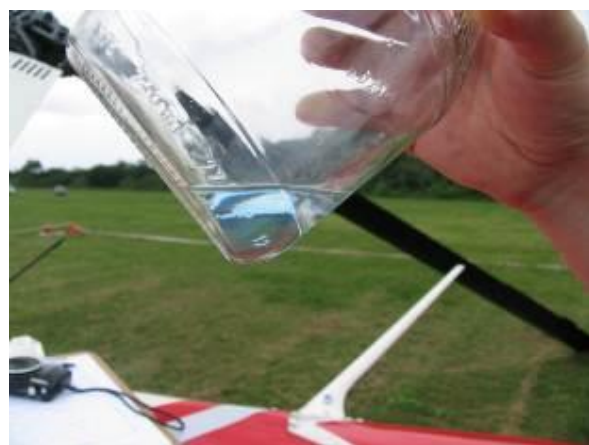
1.12.2 Both fuel tanks remained intact during the accident sequence and they both still contained some fuel. The gascolator was removed during the on-site investigation and the fuel that was in the unit was drained into a clean glass container; the results of a subsequent test showed that the fuel was of the correct grade and free of contamination.

Figure 3. A photograph of the gascolator that still contained some fuel (a), and the fuel sample that was found to be clean (b)

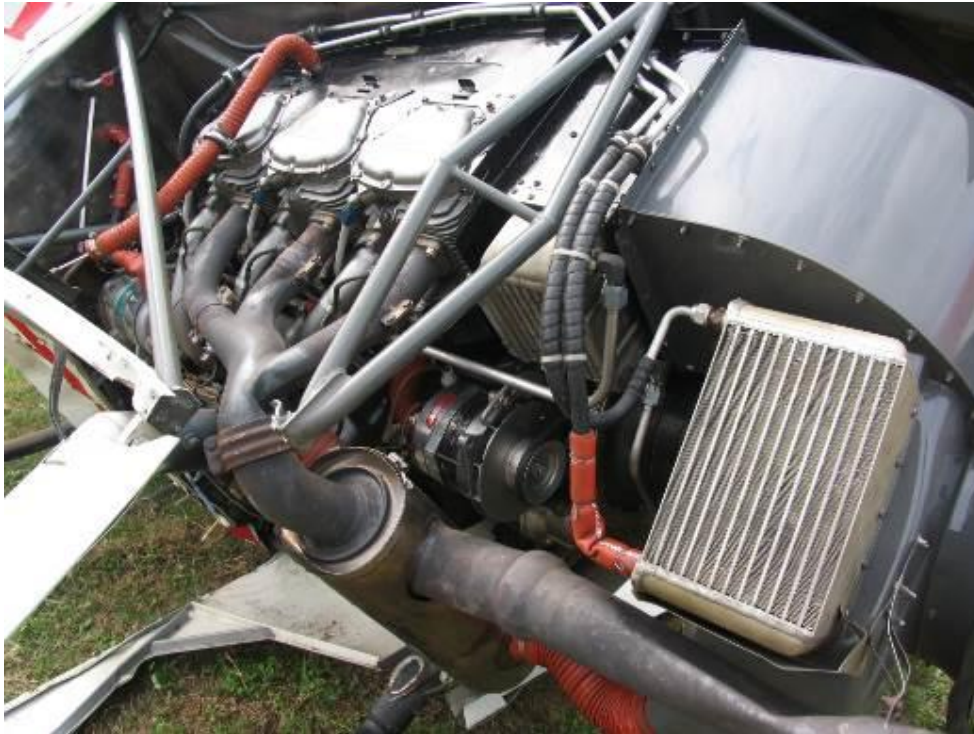
1.12.4 The engine did not sustain any impact damage. Because the helicopter came to rest in a semi rolled-over attitude, it was only possible to remove the spark plugs on the left-hand side of the engine when looking at the wreckage from the aft position. All the spark plugs displayed a light greyish colour consistent with normal engine operation. It was possible to rotate the engine using the cooling fan.

Figure 4. A photograph of the engine taken during the on-site investigation

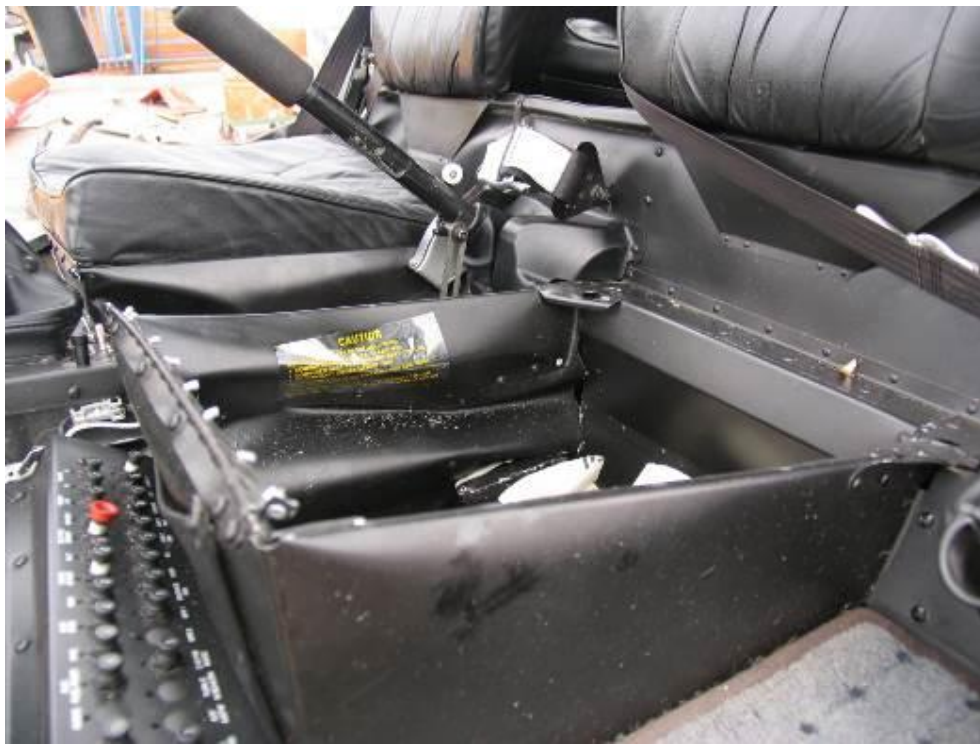
1.12.5 The cockpit/cabin area remained intact. The two front seat structures displayed some compression deformation, which was associated with the vertical impact trajectory of the helicopter. See Figure 5 on the next page.

Figure 5. The left front seat support structure, with the pilot seat visible next to it

1.15.2 The pilot and the passenger were properly restrained by making use of the three-point safety harnesses provided in the helicopter. Both the front seat structures display evidence of deformation associated with the vertical impact sequence. The cockpit/cabin area remained intact.

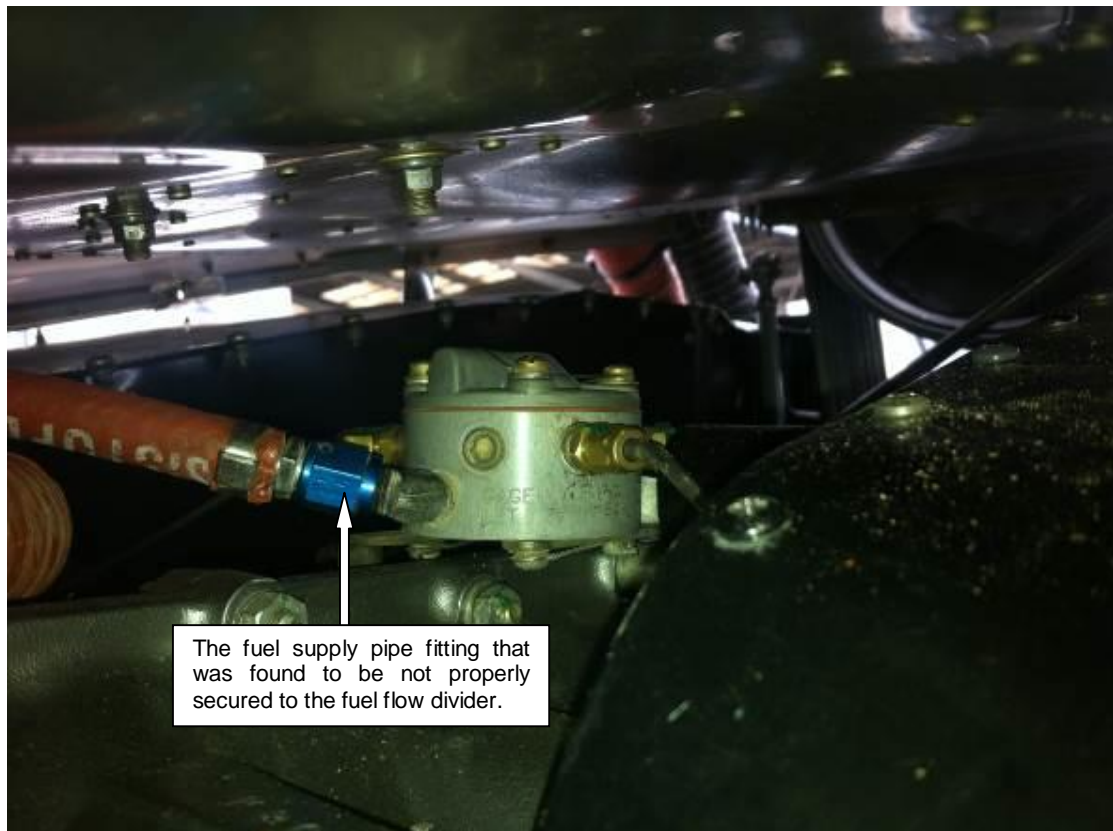
Figure 5. A view of the fuel supply line from the FCU to the fuel flow divider

The post field investigation revealed that the fuel pipe supplying fuel from the FCU to the fuel flow divider had leaked fuel from the fitting where it attached to the fuel flow divider. There was evidence indicating that the fitting was not properly fastened during maintenance and during the operation of the engine and the break-in procedure. Thus, the fitting started to unscrew itself during engine operation, and this process was aggravated by the vibrations associated with engine operation. As the fuel flow divider is located on top of the engine, any fuel leak from that fitting would have been very difficult to detect. Indeed, it would be difficult to inspect the area in which the unit is located after the engine is installed in the airframe because the unit will then be positioned directly below the main transmission deck. The

- 3.1.7 The engine operated for a period of 2.8 hours following installation in the airframe; it then stopped while in operation in flight.
- 3.1.8 It was found that the fuel pipe supplying fuel from the FCU to the fuel flow divider was not properly secured at the fuel flow divider end.

- 3.1.9 Because the fitting was not secured, the fuel pressure delivered to the fuel flow divider was not high enough to activate the diaphragm within the divider and to allow fuel to pass through to the fuel nozzles/cylinders.

- 4.1 It is recommended to the Director of Civil Aviation that the engine manufacturer be consulted to ensure that the fuel line connecting to the fuel flow divider from the FCU cannot become unsecured once attached and tightened to the unit. It is specifically recommended that the fuel pipe be secured by means of a wire locking once tightened. In the current configuration the application of torque seal to the unit gives maintenance personnel an indication that the pipe fitting is most probably secured: however this practice does not ensure 100% compliance and to remedy this, it is recommended that a wire locking should be incorporated.

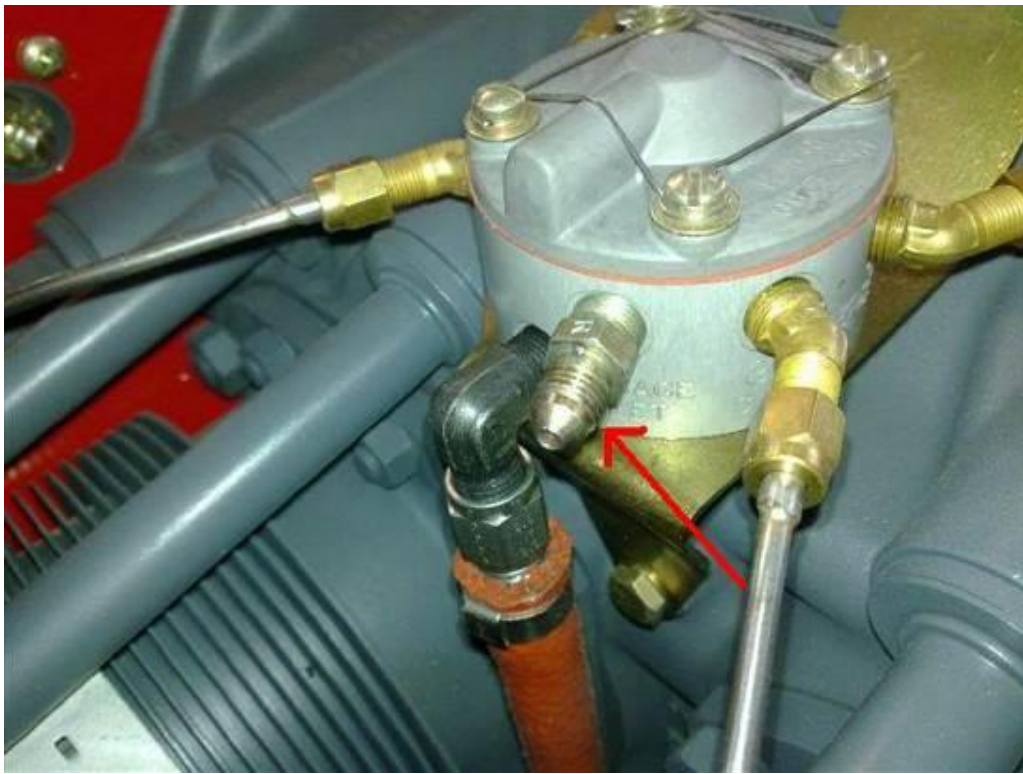
Figure 6. A fuel flow divider with the fuel pipe from the FCU disconnected (for illustration)

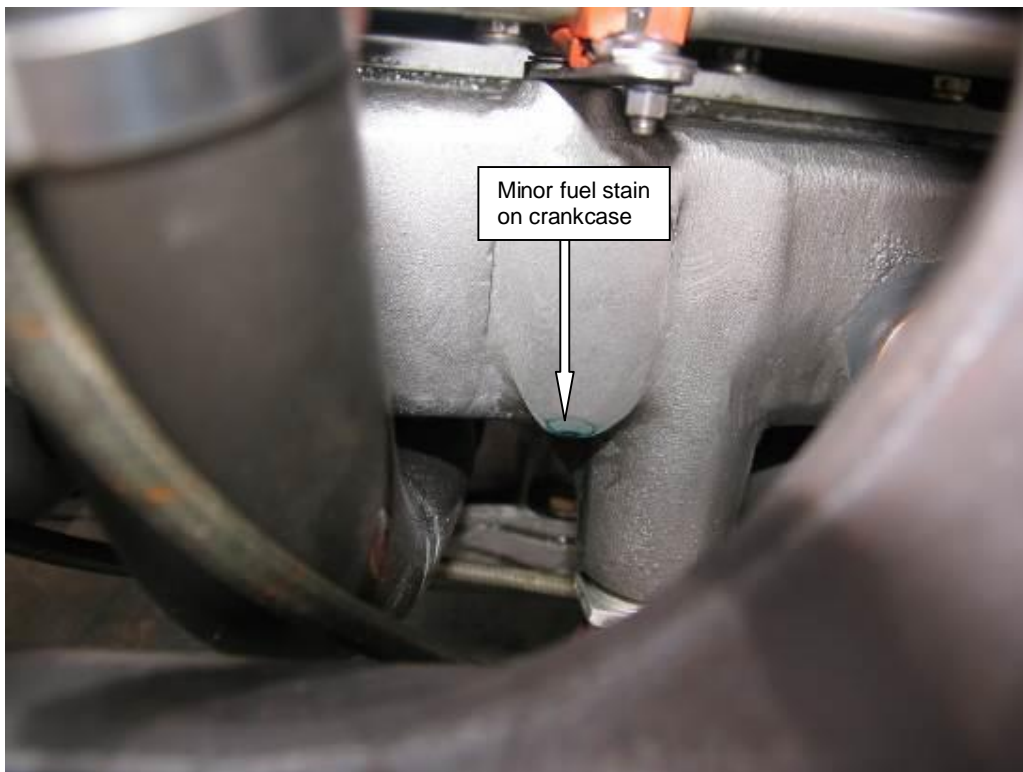
Figure 7. The fuel stain on the side of the crankcase

As the fuel started leaking from the fitting it came into contact with the hot engine crank case and probably vaporised immediately; therefore, it did not leave any evidence, such as a fuel stain, in a place that could readily be seen by maintenance personnel. However, a minor fuel stain was noted on the right-hand side of the engine after it was recovered in the post field investigation. This stain would only have been visible if the maintenance personnel or the pilot had conducted a detailed inspection of the engine in that specific area. Apart from that one fuel stain, no other evidence associated with a fuel leak could be found. Although the fitting did not unscrew completely from the unit it is believed that the fuel pressure at the entrance to the fuel flow divider was not high enough to activate the diaphragm within the unit that allows fuel to pass to each of the fuel nozzles, and from there, to enter each of the cylinders. The engine stoppage was therefore attributed to fuel starvation and this finding is supported by the fact that the engine test run presented normal engine operation after the fuel pipe fitting connecting to the fuel flow divider was secured.

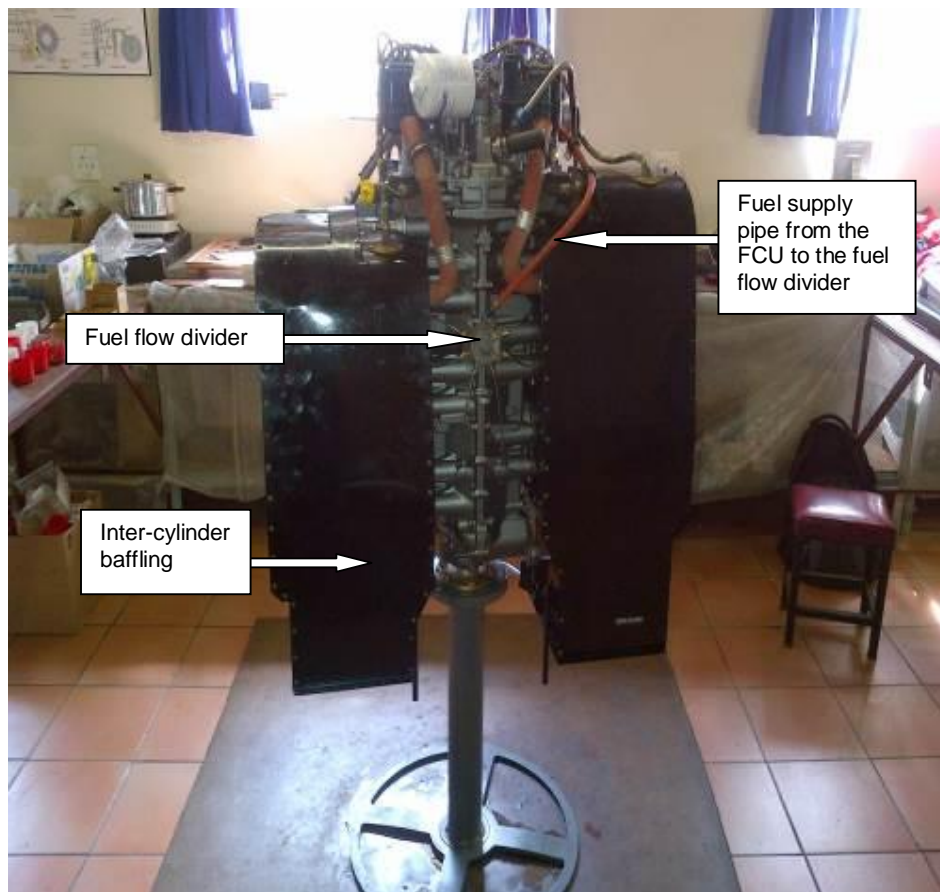
1.17.3 The AMO that performed the engine overhaul was in possession of a valid AMO Approval certificate. Following the engine overhaul, the AMO issued a Certificate of Release to Service. Figures 8 and 9, below, show the engine while it was still in the engine overhaul facility before it was couriered to the AMO in Durban.

Figure 8. The engine after it was overhauled

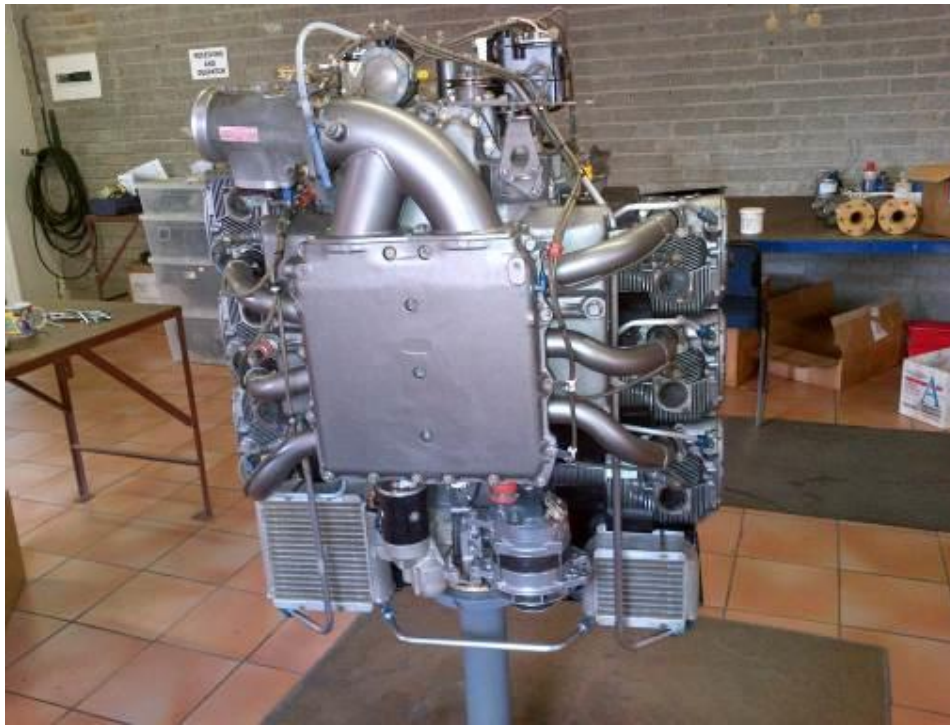
Figure 9. The bottom side of the engine without the exhaust stack installed
