Accident and Incident Investigations Division

AIRCRAFT ACCIDENT REPORT AND EXECUTIVE SUMMARY

Reference:	CA18/2/3/9459	
Aircraft Registration	ZS-SBM	Date of Accident	01 August 2015		Time of Accident	0915Z
Type of Aircraft	Robinson R44		Type of Operation		Training (Part 141)	
Pilot-in-command Licence Type		CPL	Age	29	Licence Valid	Yes
Pilot-in-command Flying Experience		Total Flying Hours	2022.1		Hours on Type	747.0
Last point of departure		Wonderboom Aerodrome (FAWB): Gauteng Province				
Next point of intended landing		Wonderboom Aerodrome (FAWB): Gauteng Province				
Location of the accident site with reference to easily defined geographical points (GPS readings if possible)						
Aeropark Zynkraal runway 27 (GPS: 25°54'11.44"S, 028°32'44.63"E)						
Meteorological Information		Wind: Light and variable; Visibility: 10km; Temperature: 15°; Cloud cover: None				
Number of people on board	2+0	No. of people injured	0	No. of people killed	0	
Synopsis						
<p>An instructor and a student were engaged in a training flight from Wonderboom aerodrome (FAWB) with the intention to practise circuits and autorotation at Aeropark Zynkraal airfield and then return to FAWB. The student pilot sta

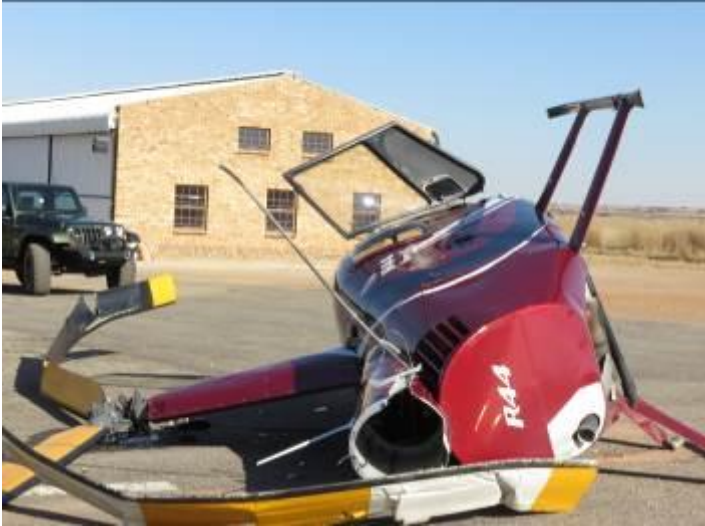
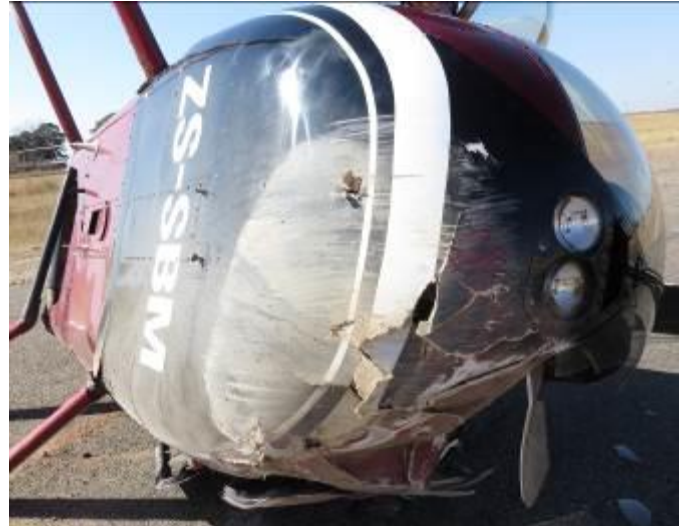
- 1.3.1 The helicopter sustained substantial damage to the main rotor blades, tail boom, left hand skid, the fuselage and windshield.

FIGURE 2 & 3: Damage to the helicopter.

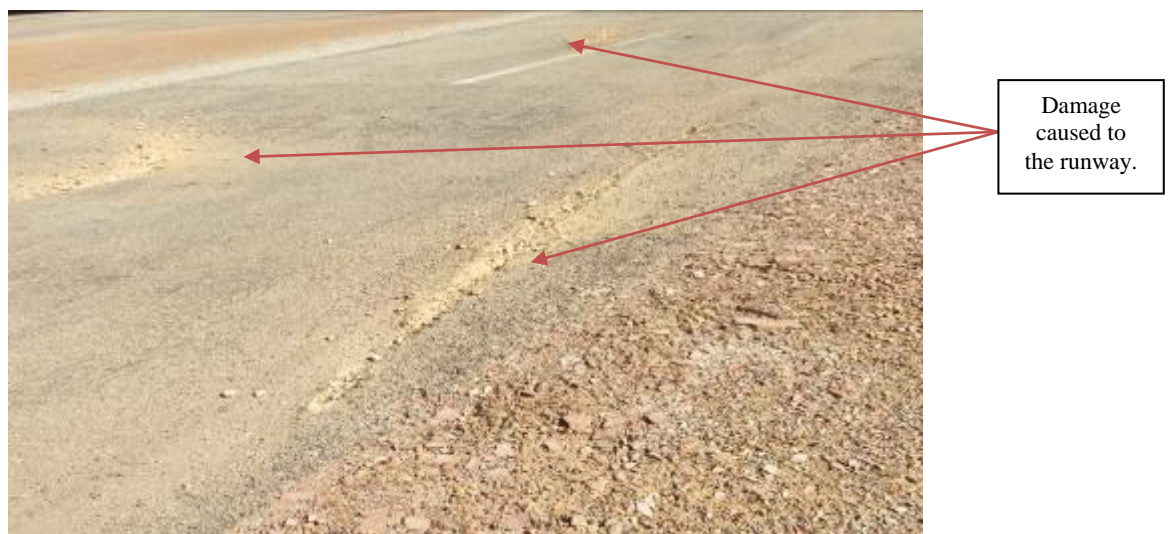
- 1.4.1 The main rotor blades struck the ground 3 times and left marks on the runway.

FIGURE 4: Main rotor blades marks on the runway.

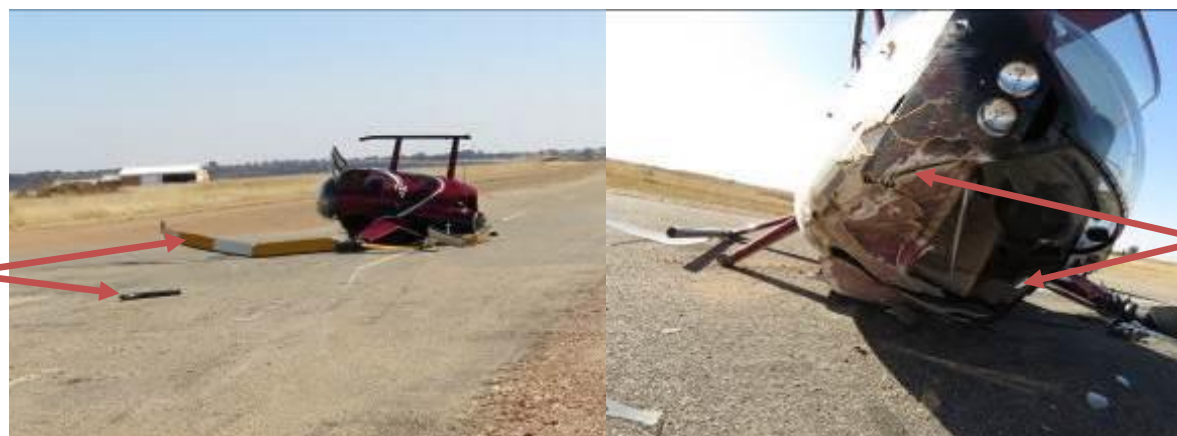
1.12.2 The helicopter sustained substantial damage to the main rotor blades, tail boom, left hand skid, the fuselage and windshield.

FIGURE 6 & 7: Position of the helicopter as found on site.

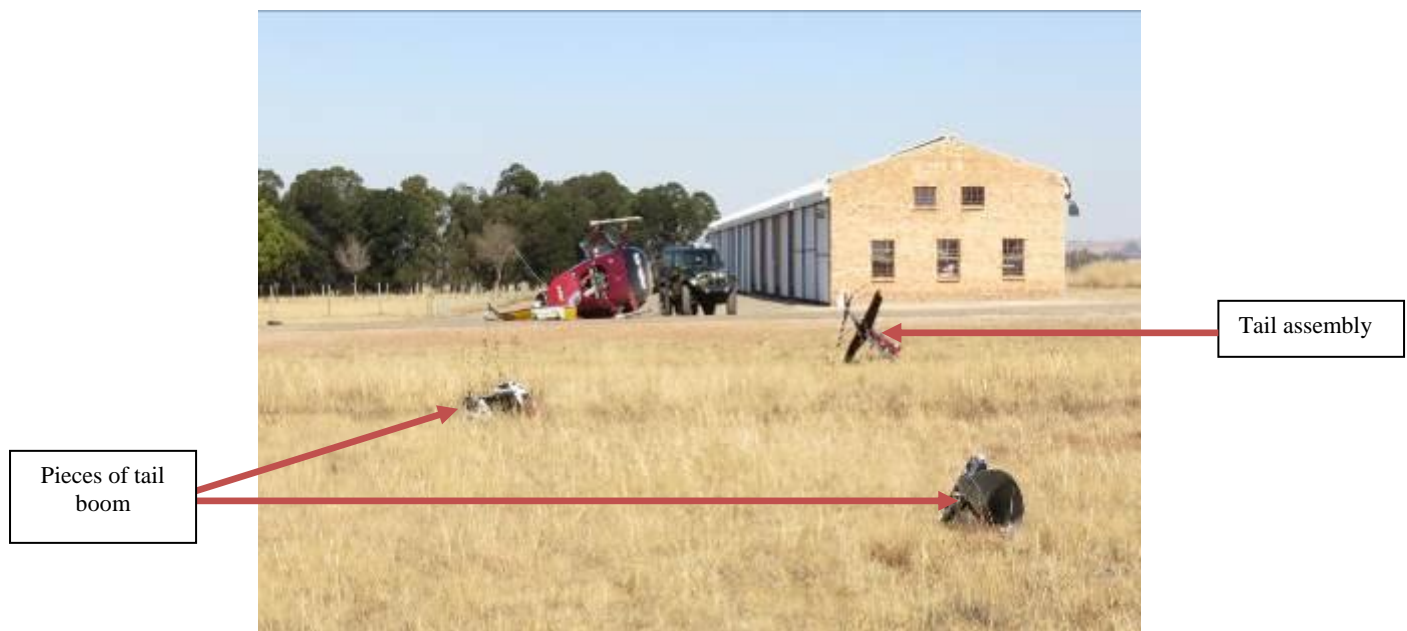
1.12.1 The student pilot stated that they started with one circuit at Aeropark Zynkraal. On final approach for runway 27 at Aeropark, the student pilot initiated an autorotation. The student pilot stated that during autorotation the rotor RPM started to decay. The instructor tried to recover the helicopter but was unsuccessful. The helicopter left hand skid struck the ground and broke off. The helicopter rolled over and came to rest at the centre of the runway. The damage to the main rotor blades is consistent with a rotor system striking the tail boom while turning at moderate RPM.

FIGURE 8: Wreckage distribution as found on site.

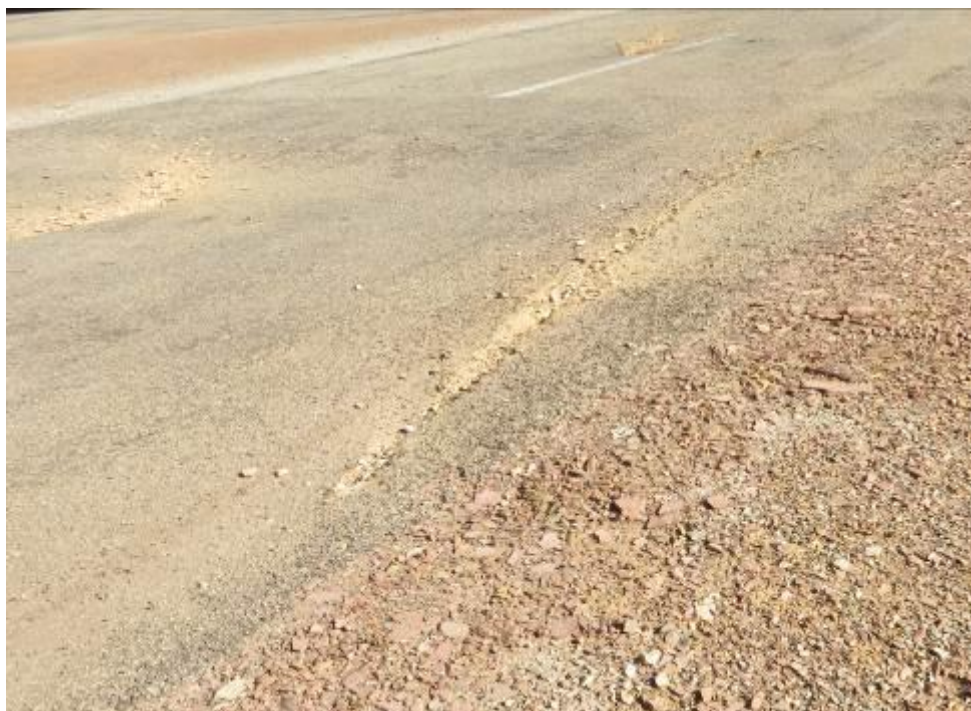
1.12.3 The main rotor blades struck the runway three times and cut off the tail boom into pieces.

FIGURE 9: Main rotor blades marks on the runway.
