## AIRCRAFT ACCIDENT REPORT AND EXECUTIVE SUMMARY

Reference:	CA18/2/3/9465	
<b>Aircraft Registration</b>	ZS-UZZ	<b>Date of Accident</b>	22 August 2015		<b>Time of Accident</b>	0758Z
<b>Type of Aircraft</b>	Pitts Special S-1S (Aeroplane)		<b>Type of Operation</b>		Private ( Part 91)	
<b>Pilot-in-command Licence Type</b>	Private Pilot	<b>Age</b>	46	<b>Licence Valid</b>	Yes	
<b>Pilot-in-command Flying Experience</b>	Total Flying Hours	309.1		Hours on Type	11.4	
<b>Last point of departure</b>	Brits Aerodrome (FABS): North West province					
<b>Next point of intended landing</b>	Rustenburg Aerodrome (FARG): North West province					
<b>Location of the accident site with reference to easily defined geographical points (GPS readings if possible)</b>						
Residential holding Plot 70, Rashoop at GPS position South 25°31'20" East 027°46'33" elevation of 3700ft						
<b>Meteorological Information</b>	Wind: 150°/05KT, Visibility: 10 000m, Temperature: 23°C, Dew point: 09°C, Cloud cover: Clear skies. Cloud base: CAVOK.

## AIRCRAFT ACCIDENT REPORT

**Name of Owner** : A Denoon  
**Name of Operator** : A Denoon (Private)  
**Manufacturer** : Pitts  
**Model** : Special S-1S  
**Nationality** :

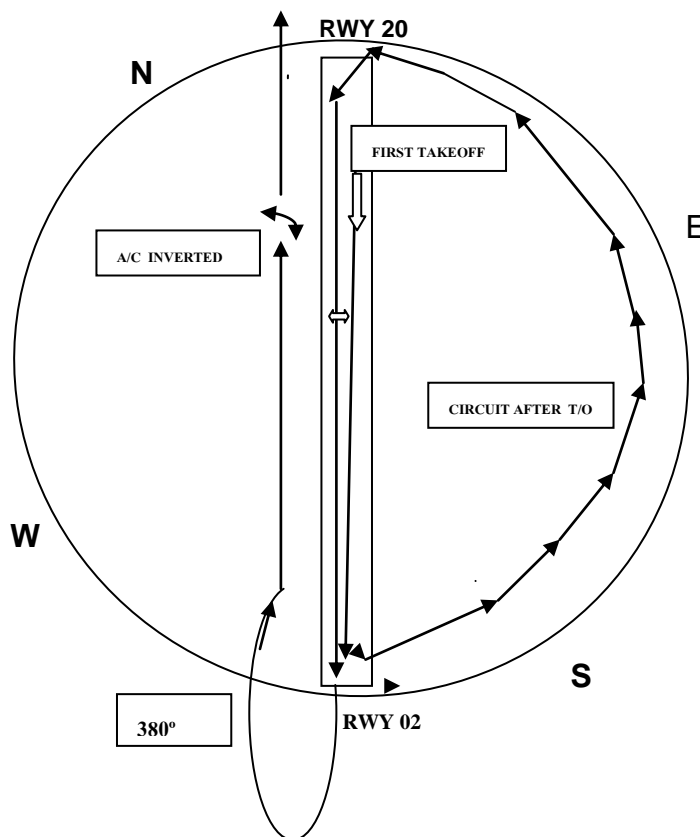
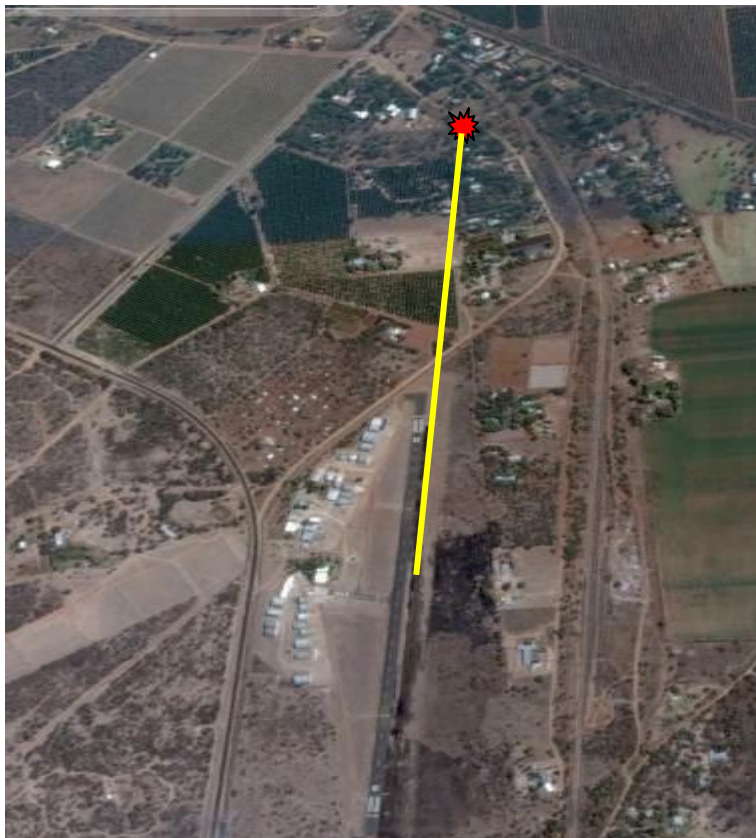
- 1.1.6 The pilot was fatally injured during the accident sequence.
- 1.1.7 The sketch of the circuit flown by the pilot during take-off before the accident occurred are illustrated below:

**Figure 1:** The accident site in relation to the runway.

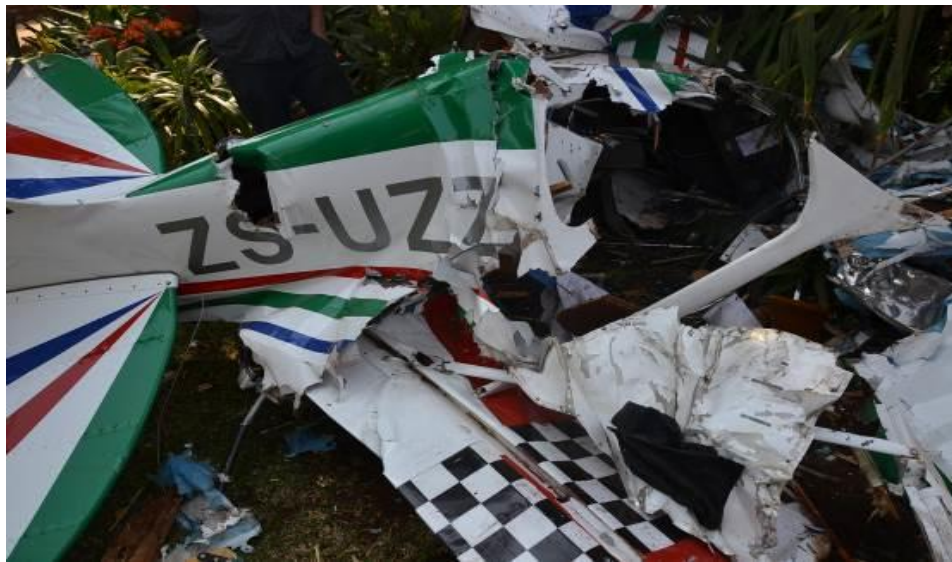
**Figure 2:** View of the main wreckage.

1.12.1 The forward section of the fuselage, including the engine, was significantly compressed. Both the upper and lower wings separated from the fuselage during impact and was destroyed.

1.12.2 The engine remained attached to the engine mounting support and displayed severe impact damage.

1.12.3 The propeller fractured at the propeller hub assembly.

1.12.4 The wreckage was found inverted, 5 metres away from the first impact point with a tree and a bird aviary. The height of the impact with the tree was 5 metres. The aircraft main wreckage heading was determined to be 360° in a northerly direction.

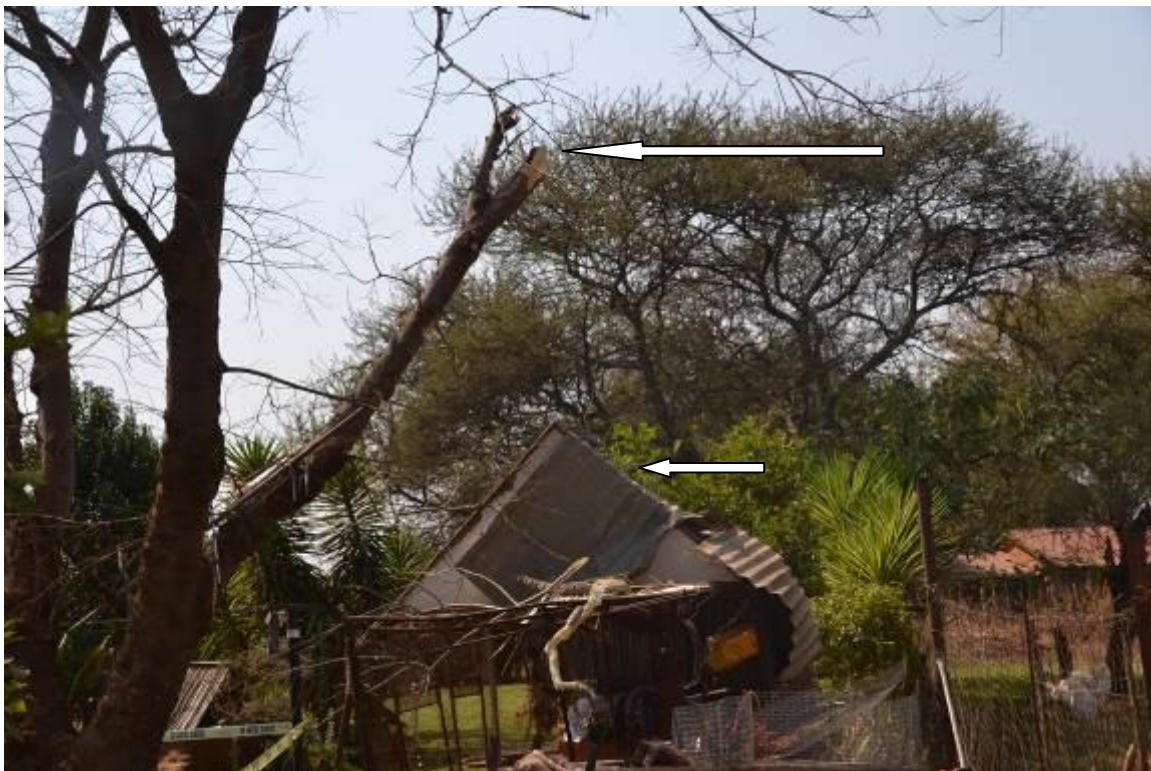
- 1.4.1 Damage was caused to a tree and a bird aviary before the aircraft impacted the ground.

**Figure 3:** Shows Aircraft Impacted Tree & Bird Aviary Before Impacting Ground

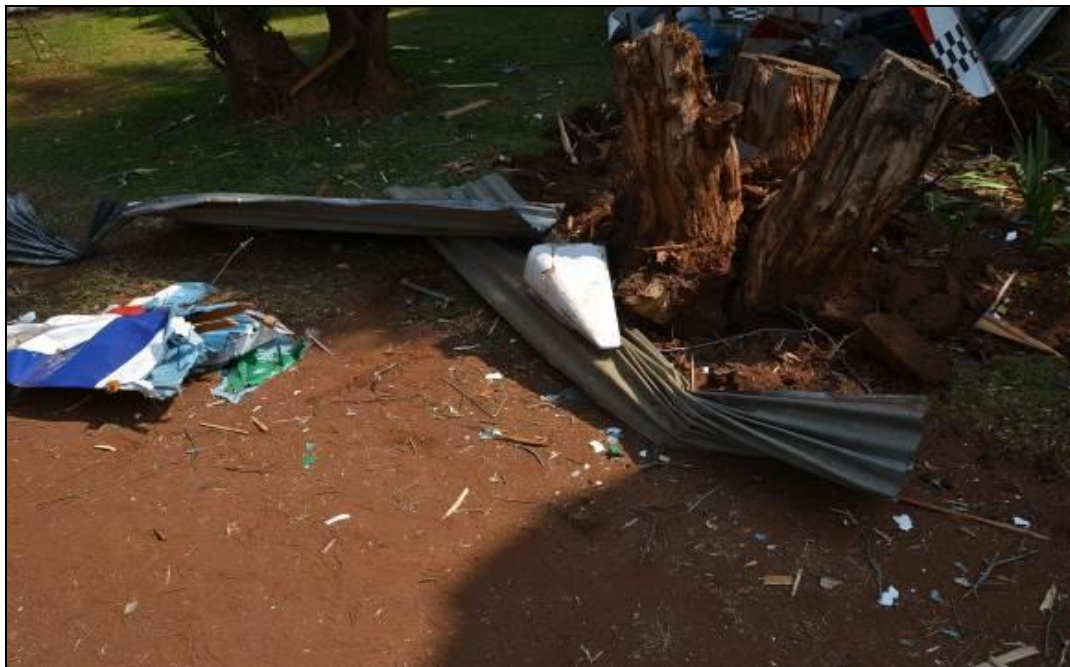
**Figure 4: Shows Damaged Top Section of Bird Aviary**
