## AIRCRAFT REPORT AND EXECUTIVE SUMMARY

Reference:	CA18/2/3/9483	
<b>Aircraft Registration</b>	ZU-FZF	<b>Date of Accident</b>	25 September 2015		<b>Time of Accident</b>	0945Z
<b>Type of Aircraft</b>	Sling 2		<b>Type of Operation</b>		Private Part 61	
<b>Pilot-in-command Licence Type</b>	PPL	<b>Age</b>	43	<b>Licence Valid</b>	Yes	
<b>Pilot-in-command Flying Experience</b>	Total Flying Hours	171.9		Hours on Type	4	
<b>Last point of departure</b>	Grand Central Airport (FAGC), Gauteng Province					
<b>Next point of intended landing</b>	Grand Central Airport (FAGC), Gauteng Province					
<b>Location of the accident site with reference to easily defined geographical points (GPS readings if possible)</b>						
Near Eagles Creek Airfield at an open field near the N14 highway (GPS coordinates: S25°54'23.59" E028°02'19.88")						
<b>Meteorological Information</b>	Wind direction: 120°; wind speed: 6 kt; air temperature: 32°C; visibility: CAVOK; cloud base: 4 500 ft; cloud cover: SCT045

## AIRCRAFT ACCIDENT REPORT

**Name of Owner** : Slingstar Aviation (Pty) Ltd  
**Name of Operator** : Aviation Towards Success (ATS)  
**Manufacturer** : The Airplane Factory (Pty) Ltd  
**Model** : Sling 2

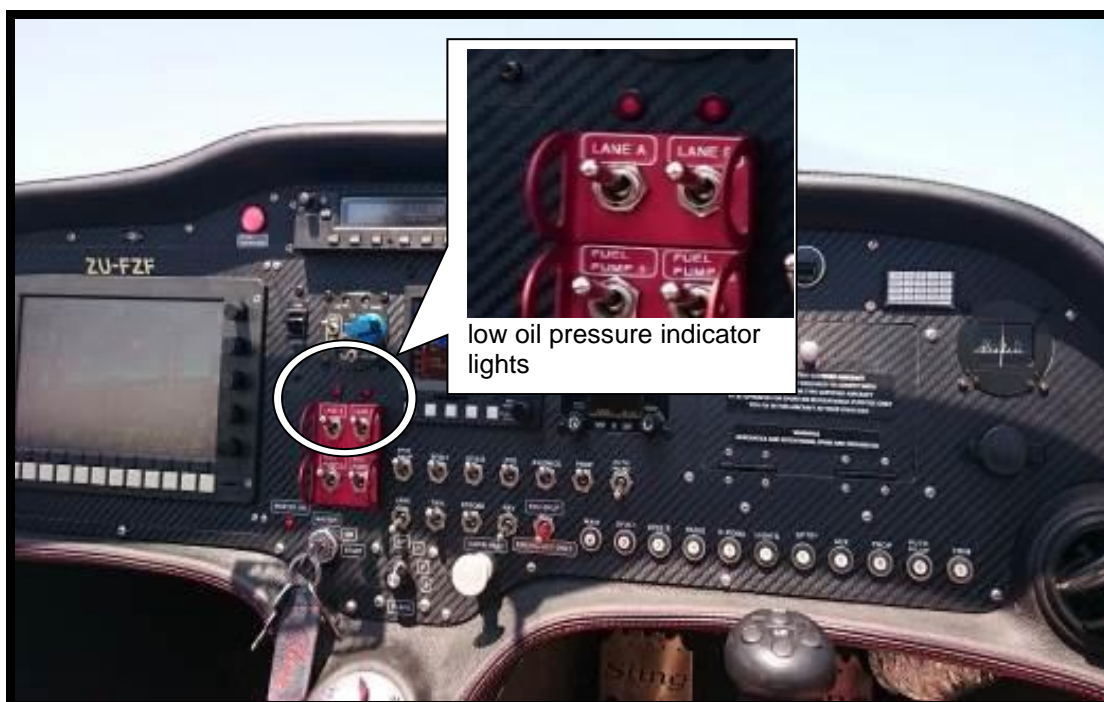
**Figure 1:** The low oil pressure indicator lights

*Note: According to the pilot, the picture was taken during flight by the passenger at the time of engine failure.*

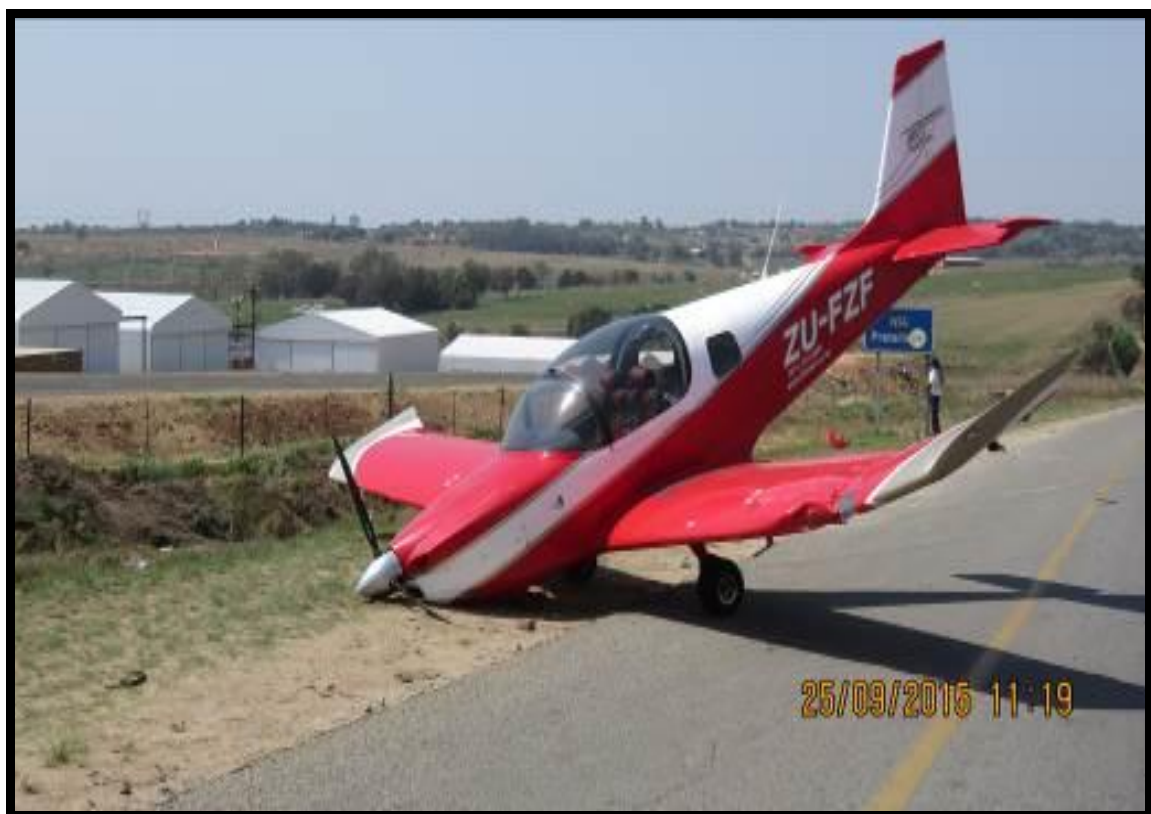
1.3.1 The aircraft sustained substantial damage to the nose landing gear, right landing gear, engine, propeller and the left wing outer leading edge and structure.

**Figure 2:** The aircraft as it came to a full stop

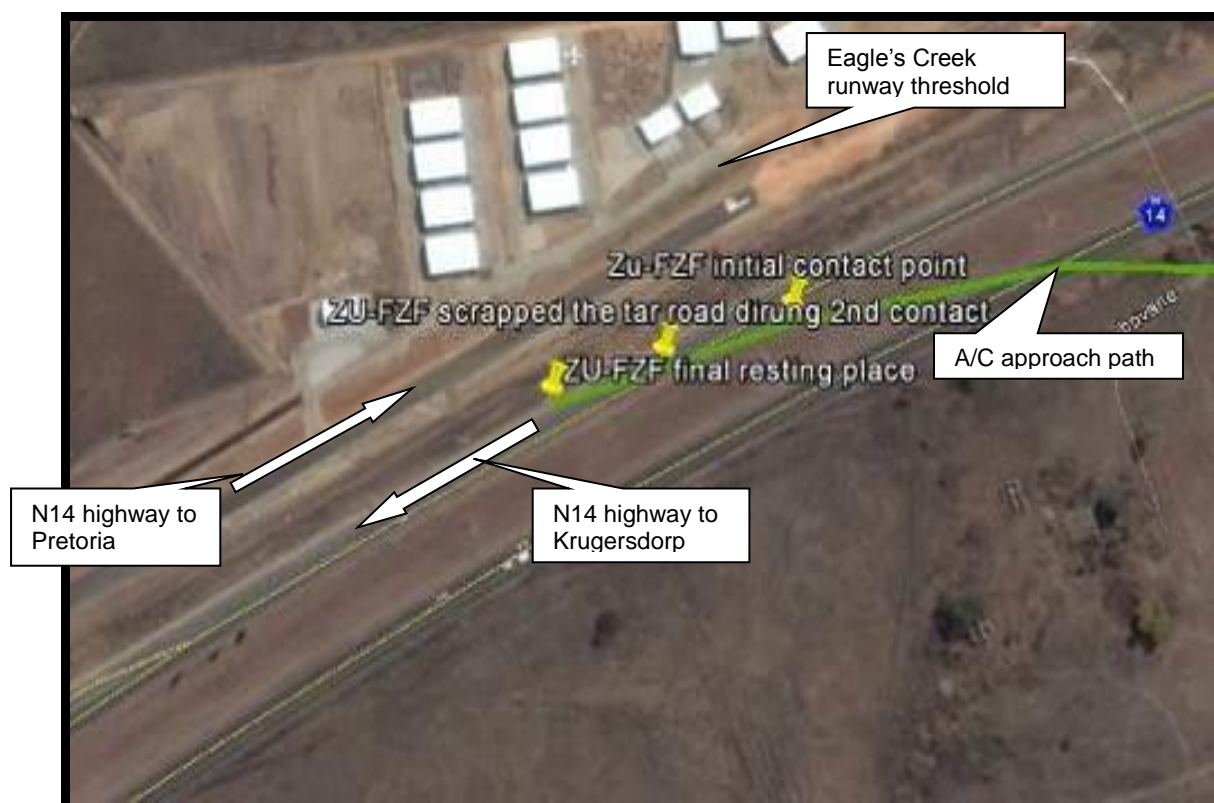
**Figure 3:** The aircraft path and the contact points

1.12.1 The aircraft forced landing occurred on the N14 highway near the intended diversion airfield. During a turn towards the intended identified landing airfield, the aircraft began to lose height at a high rate of descent. During approach, the aircraft was heading at an angle of approximately 45° toward the intended runway. The pilot attempted to control the aircraft during glide, however the aircraft contacted the ground hard between the two opposite road traffic space and bounced onto highway to Pretoria. The aircraft came to a full stop at approximately 55 m from the runway centreline, which was at approximately 33 m from the threshold of Runway 26.

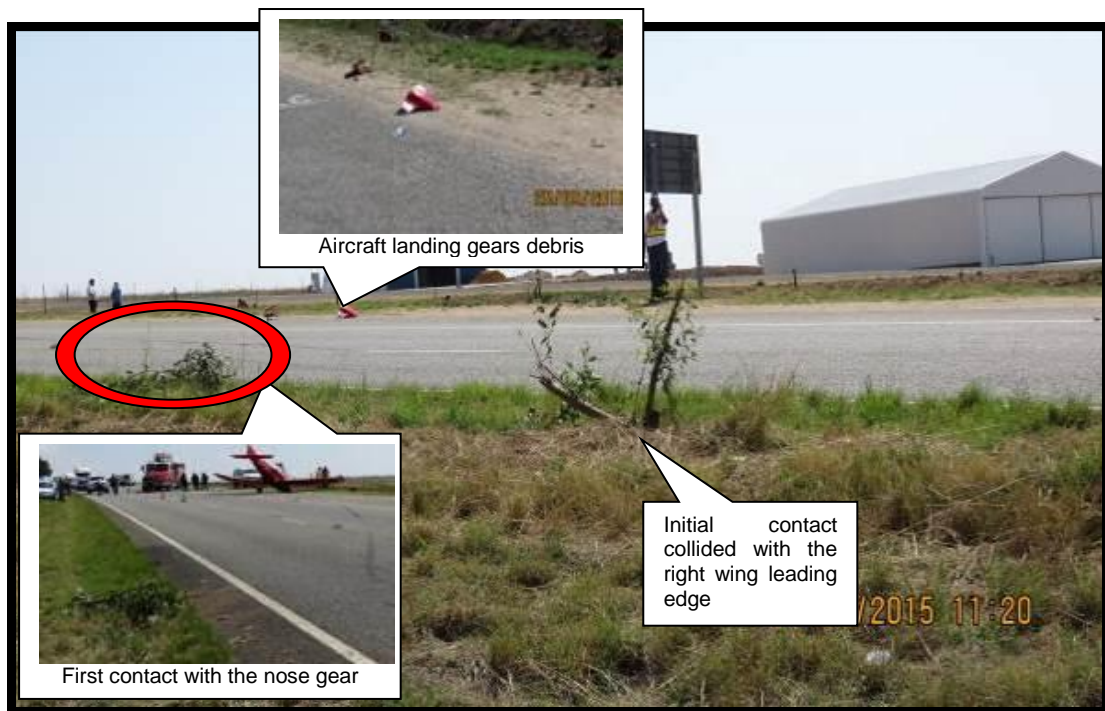
**Figure 4:** Shows the aircraft path and the contacts points

1.12.2 The aircraft impacted at a low angle and in a slight left roll attitude. During impact, the aircraft contacted the ground hard with the main landing gears and the left wing outer part first, approximately 70 m away from the wreckage resting point, and bounced. Upon contact the left wing sustained structural damage, with visible bending on the leading edge caused by collision with a small tree. The left main landing gear was pushed into the wing bottom, causing damage under the left wing.

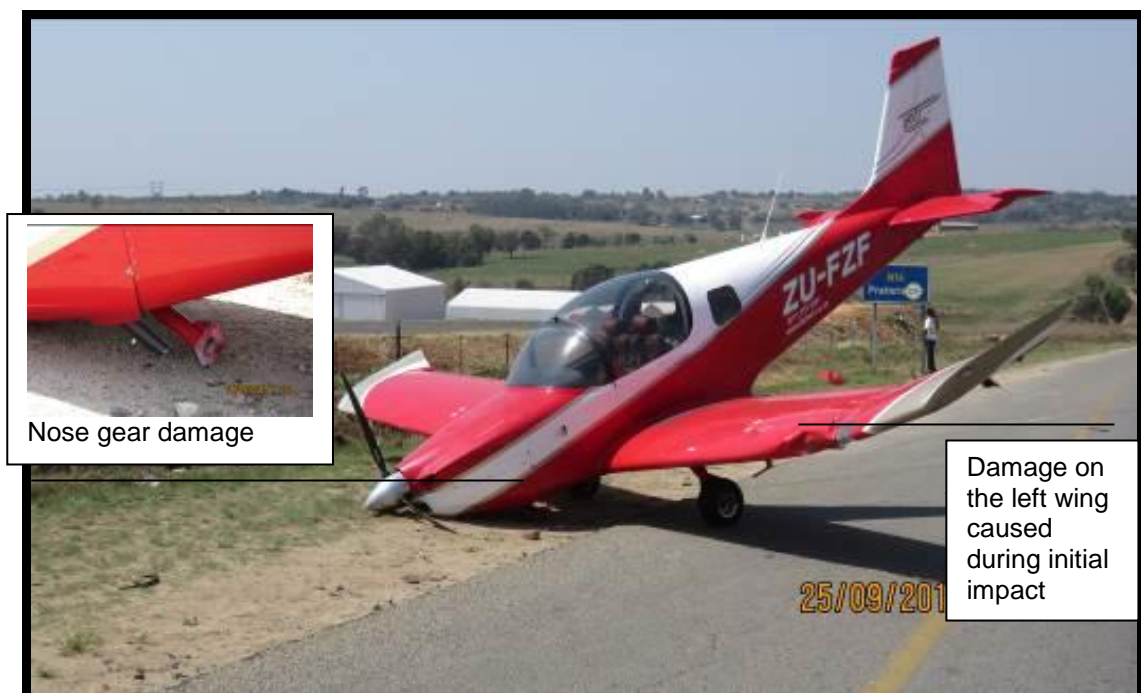
**Figure 5:** The aircraft as it came to stop

During the second contact, at approximately 15 m from the initial contact point, the nose wheel impacted and collapsed and then detached from the wheel assembly. The nose wheel caused more damage to the aircraft bottom surface as it detached. Two blades of the three-bladed propeller contacted the ground and sustained damage. This was followed by the nose section scraping along the tar road surface as the aircraft crossed the road until the aircraft came to a full stop. The nose wheel was found on the right side of the plane, across the road, approximately 4 m away from the main aircraft wreckage.

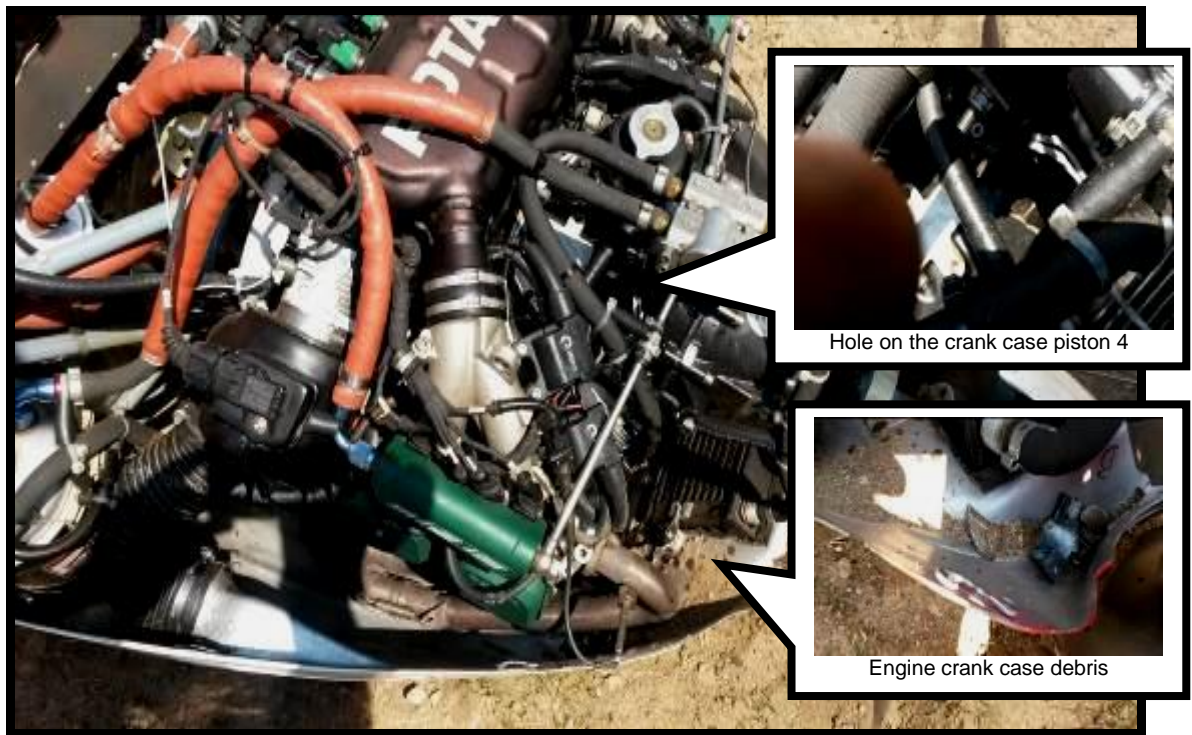
**Figure 6:** Damage on the engine

1.12.3 Beside airframe damage, there was more visible damage observed on the engine crank case next to piston number 4's cylinder. The aircraft wreckage was fairly localised within a radius of 10 m. The aircraft came to a full stop across the road, with the aft part of its tail protruding onto the road, causing traffic obstruction on one road traffic lane.

- 2.3 At the time of the initial low oil pressure lights going on, the oil was escaping the engine after the seal failed. After sufficient oil had run out, lubrication was insufficient, which led to number 4 connecting rod failure due to metal-to-metal friction, and damaging the engine top casing prior to total failure.

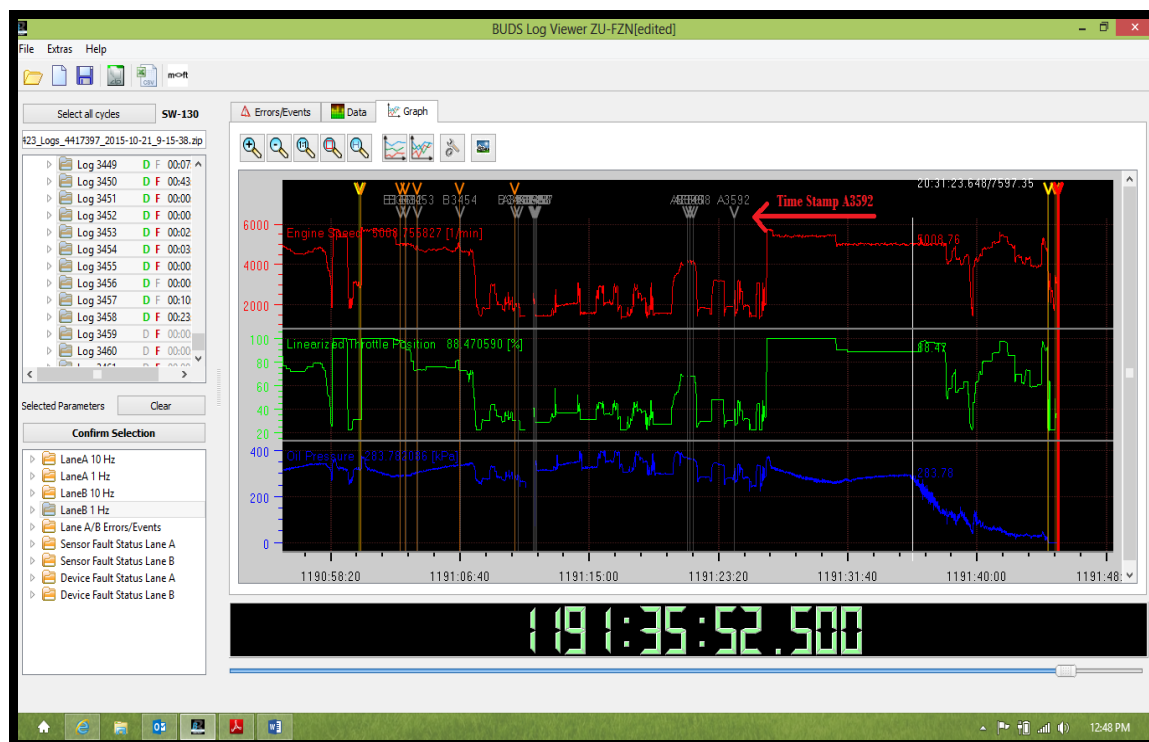
Figure 7: ECU data log of last few flights

Figure 7 above represents the ECU log for the last few flights of the aircraft prior to

the engine failure. The arrow drawn in the image above represents a time stamp. A time stamp demonstrates to the technician the point in time at which the lanes were cycled, showing also the time when the aircraft was turned on.

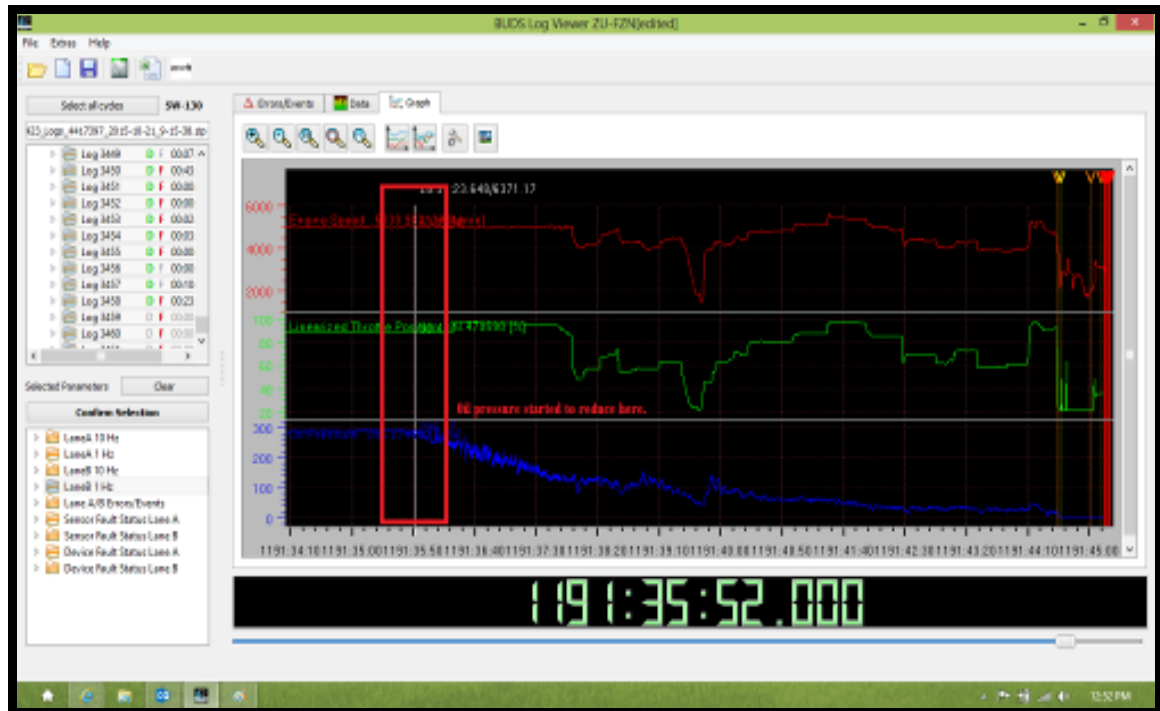
**Figure 8:** The ECU log for the accident flight

Figure 8 above shows that at 1191:35:52.000 the oil pressure started reducing, highlighted in the red block. The oil pressure, prior to the failure of the water pump impeller oil seal, was between 2.8 bar and 3.0 bar. As represented in figure 8, the throttle position was set between 88% and 100% with a revolutions per minute (RPM) of 5 000 before oil pressure started reducing in the engine.

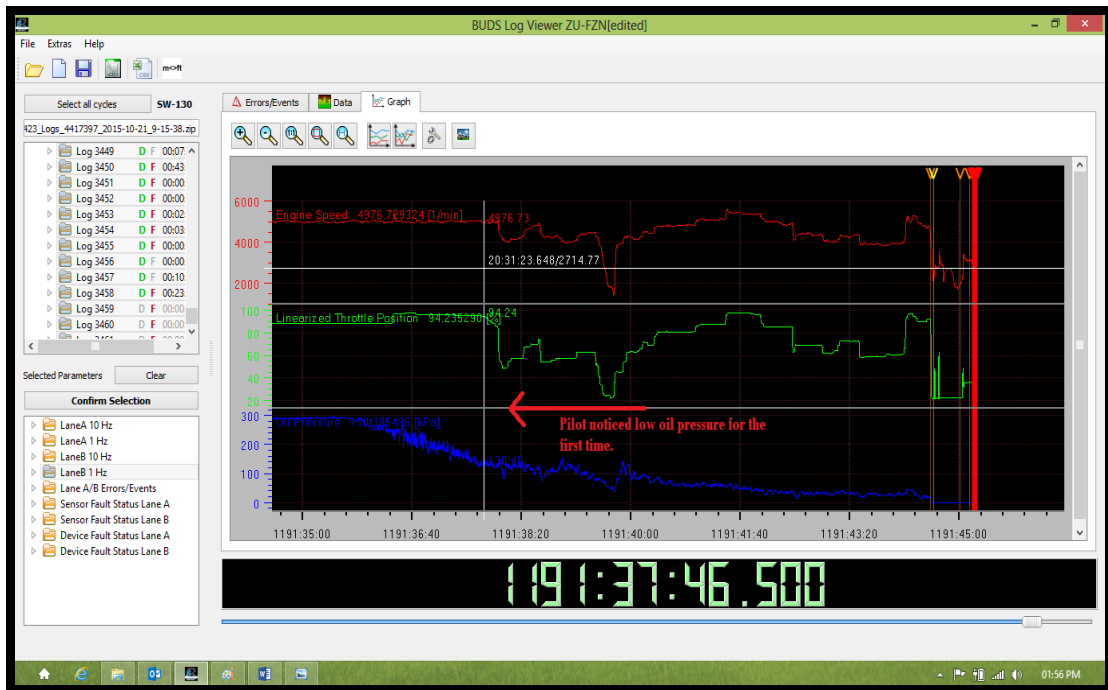
Figure 9 below would appear to illustrate the time that the pilot noticed that the oil pressure was low, resulting in his reduction of the throttle setting. The time stamp is 1191:37:46.500. From the time the oil pressure dropped from the normal 2.8 bar to low (CAUTION) 1.2 bar, it took the pilot from 1191:35:52.000 to 1191:37:46.500, which is 2 minutes and 32 seconds, to react. In the image above you can see that once the pilot noticed the oil pressure at 1.2 bar, he reduced the throttle setting from 95% to 48% bringing the RPM to 4 000. After 40 seconds the pilot further reduced power to 22%, reducing RPM to 1 700; the oil pressure then reduced further to 0.47 bar.

**Figure 9:** The pressure warning initiating stage

The Rotax operator's manual stipulates that 0.8 bar is minimal oil pressure below 3 500 RPM. The RPM was well above 3 500 for 4 minutes.

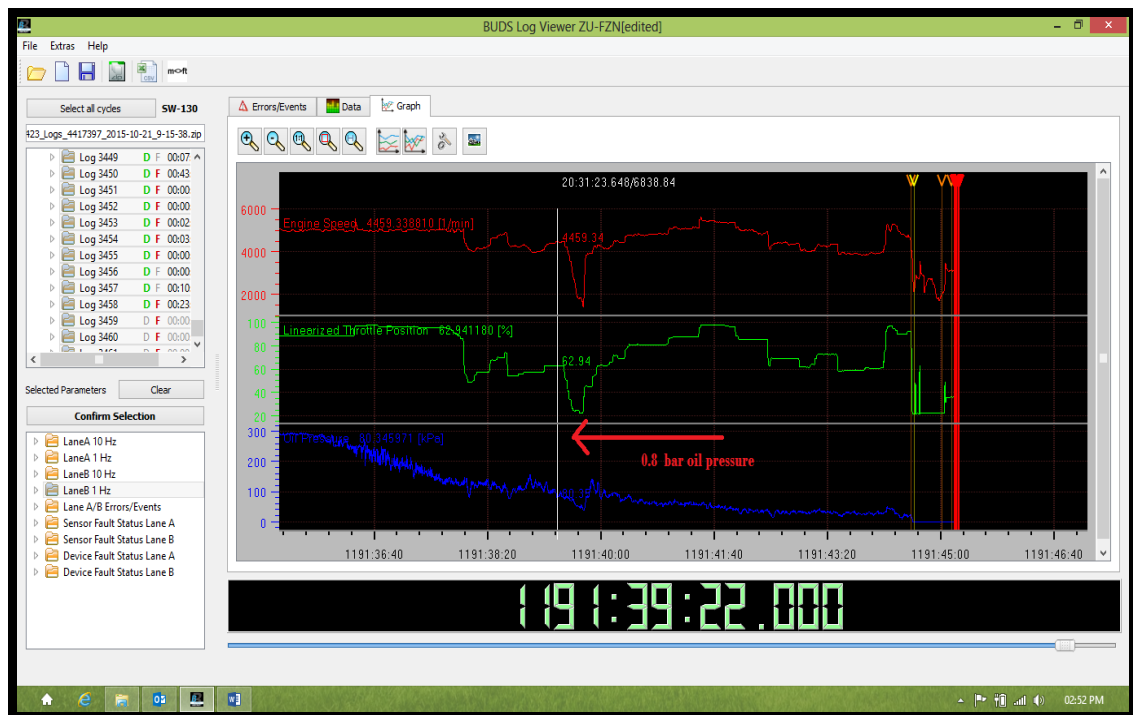
**Figure 10:** When oil pressure reached 0.8 bar

Figure 10 illustrates when the oil pressure reached a minimum 0.8 bar at time stamp 1191:39:22.000. The oil pressure reached 0.8 bar and continued reducing over a period of 5 minutes, until it reached 0.2 bar. Once the oil pressure reached 0.0 bar the engine ran for a further 1 minute and 17 seconds before the engine

completely shut down as a consequence of the connecting rod failure on cylinder number 1.

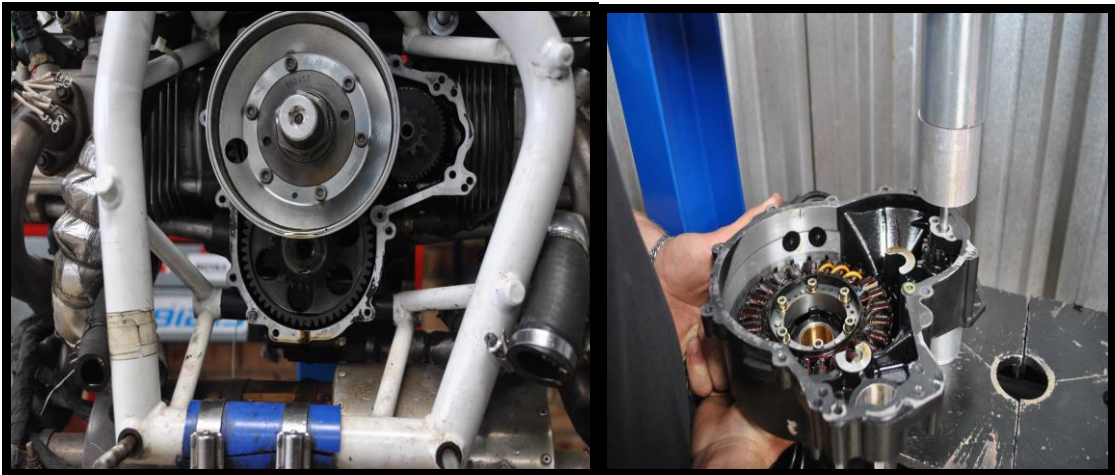
**Figure 11:** Removal of the ignition housing

The ignition housing and associated components and the impeller shaft were removed to inspect the rotary seal and associated oil seal. On inspection, the oil seal was clearly damaged, the shaft sealing lip appearing to have separated from the seal.

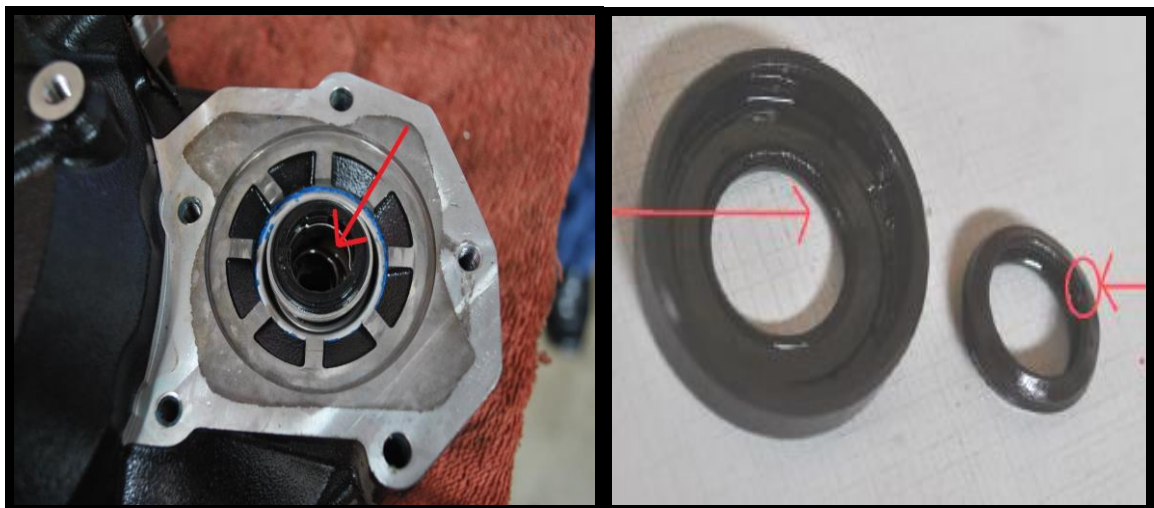
**Figure 12:** The oil seal damage during installation

Since the ignition housing, impeller, rotary and oil seal had been removed (to access the engine stator) some 10 hours prior to the failure, it was speculated that in re-assembly the oil seal may have been damaged, leading to its failure. The precise events leading to the engine failure itself could be substantially gleaned by reference to the record contained in the flight log on the ECU for the engine. The logs were downloaded onto an AMO computer using the Rotax-developed BUDS

- 2.4 Post engine investigation revealed that the engine oil/water seal was damaged. The damage on the oil/water seal was consistent with damage caused during maintenance.

- 4.1 This incident serves to underline the importance of ensuring that all maintenance is completed entirely and correct. The incorrect installation of oil seal caused damaged and let to oil starvation, this starved the engine of oil and led to the engine power loss in flight. It therefore recommended that the Director of Civil Aviation during the safety oversight activities bring to the attention of aviation maintenance organisation the human factor errors made in the maintenance environment.

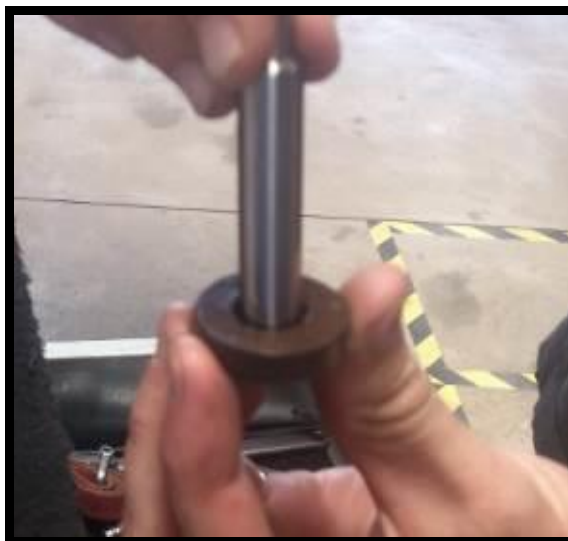
**Figure 13:** Wrong installation pattern

During seal installation mistakes can be made, as demonstrated by Rotax during the maintenance induction course on how to install the seal. When inserting the shaft with a wrong pattern, the oil seal gets damaged easily as it stretches. The shaft is installed inside out to allow compression on the seal during fitting, as opposed to stretching the seal.

The investigator, considering advice from the accredited maintenance personnel, is of the opinion that during maintenance a wrong technique was used to insert the shaft through the seal (Figure 13). When using this technique to insert the shaft, damage is caused to the seal. When the shaft is forced through the seal's tapered hole, it stretches the seal neck and causes it to weaken. When more excessive force is applied, seal material damage results, without the technician noticing. During operation, the seal will fail over time as pressure builds up.

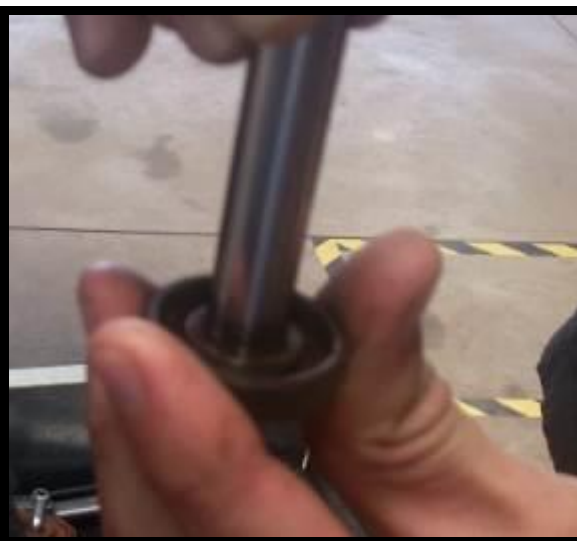
**Figure 14:** Correct installation pattern
