Accident Investigation Final Report

State File Number: 940711EPTRB
Type of Occurrence: Accident
Date of Occurrence: October 02th 2015
Place of Occurrence: Bahregan Helipad
Aircraft Type: Agusta A109E
Registration: EP-TRB
Operator: Tara Helicopter Service

Main rotor pitch links examination Final report

Accident on **03/10/2015**
at **Bahregan Airport (Iran, Islamic Republic of)**
to the **helicopter AGUSTA - A109 - E**
registered **EP-TRB**

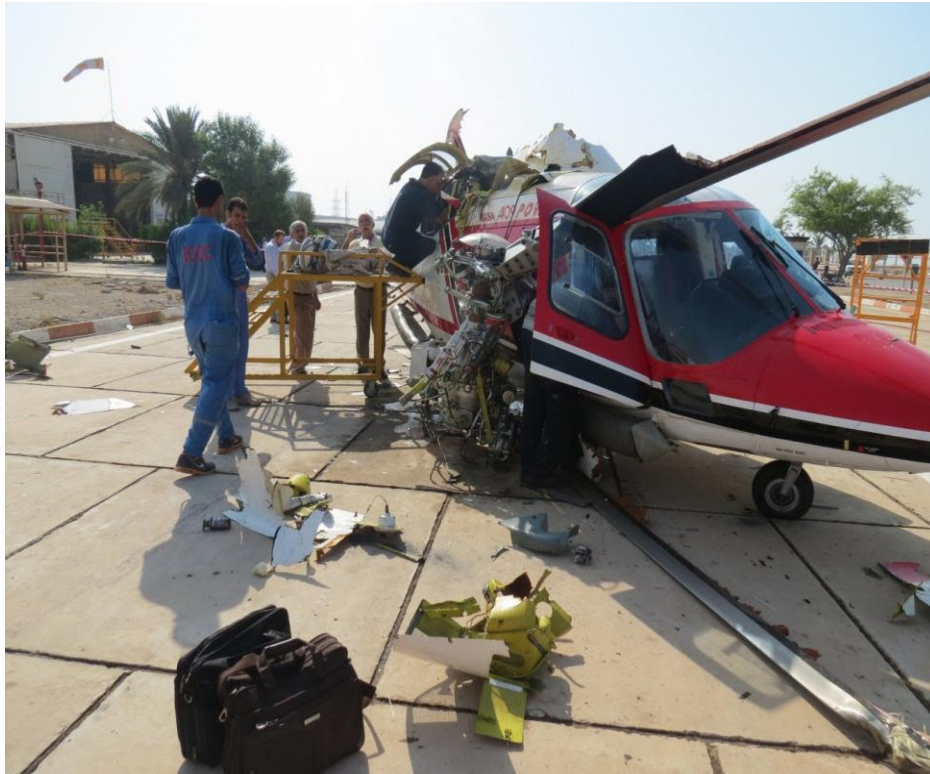
- Two main blades were broken, separated from transmission due to impact with tail boom and two others were damaged totally.
- The tail boom was tear down and tail rotor shaft cut

1- Main Transmission

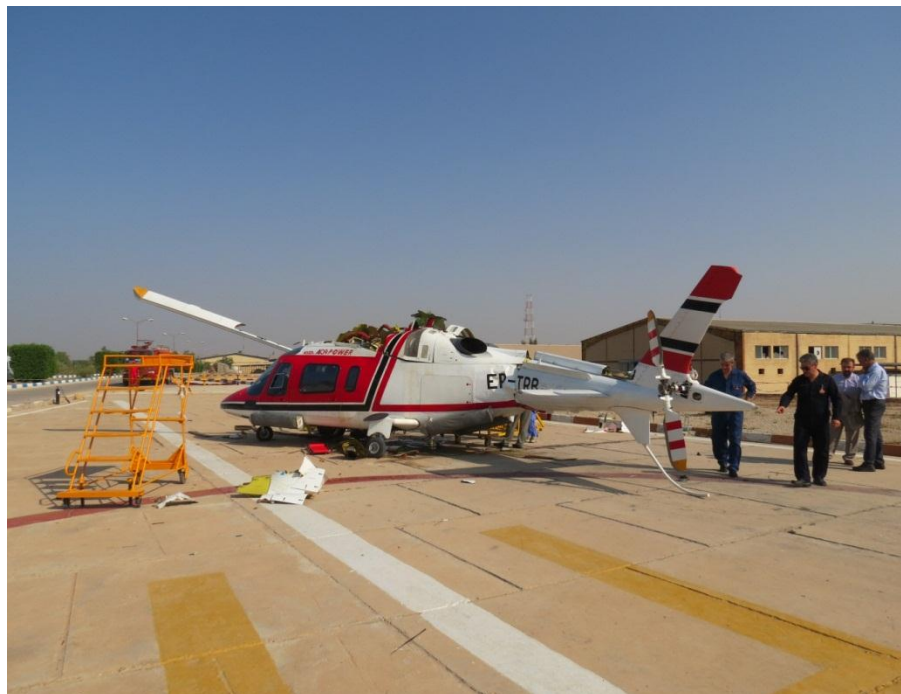
2- Broken Tail Boom

- The Red Main Rotor blade impacted the tail boom and was found 32 meters from the site of accident in front of the helicopter at 11 o'clock relative to the nose of helicopter.
- The right main landing gear had collapsed outward.
- Tail Rotor blades got shredded & delaminated.
- Tail Boom skin got damaged at a few places.
- Pilot side door damaged and seized.
- Tail fin damaged.
- RH horizontal stabilizer was broken at mid-section.
- MAIN Fairing was broken.
- Pitch link horn of Red MRB was broken.
- The drag dampers of Red, Blue & Yellow MR blades sheared off.
- Tail drive shaft fairing cut at three places.
- Tail Rotor blades badly were damaged.
- A wide hole was created on the tail boom.

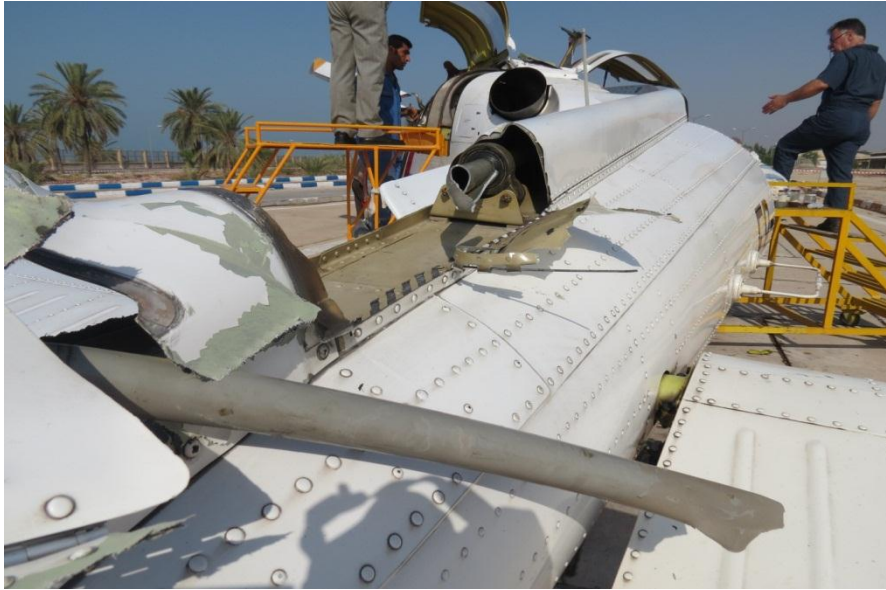
3- The Broken & Cut Tail Rotor Shaft

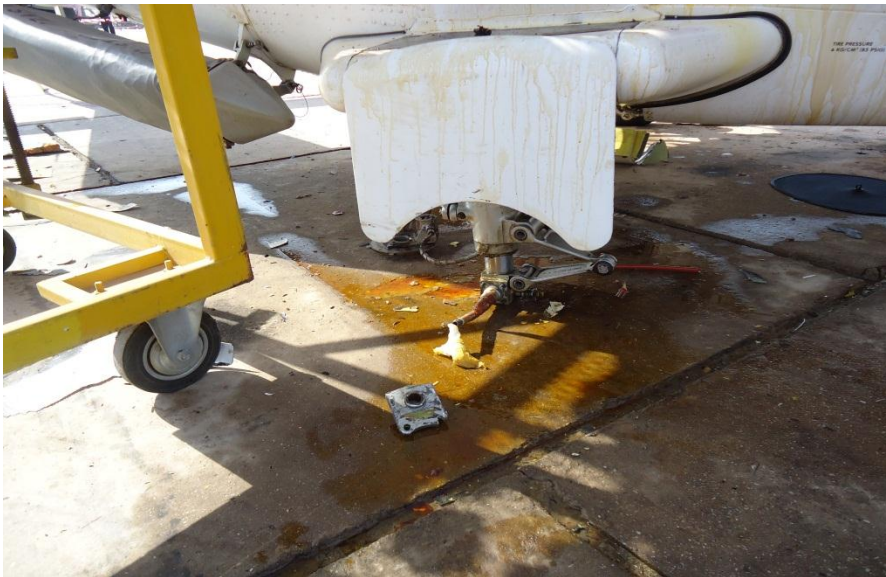
4- R/H Main Landing Gear

- When the ground resonance occurred, the pilot did not take any corrective action according to the procedures in flight manual.
- The cause of broken of the right wheel shaft of the helicopter was high vibration or high shaking

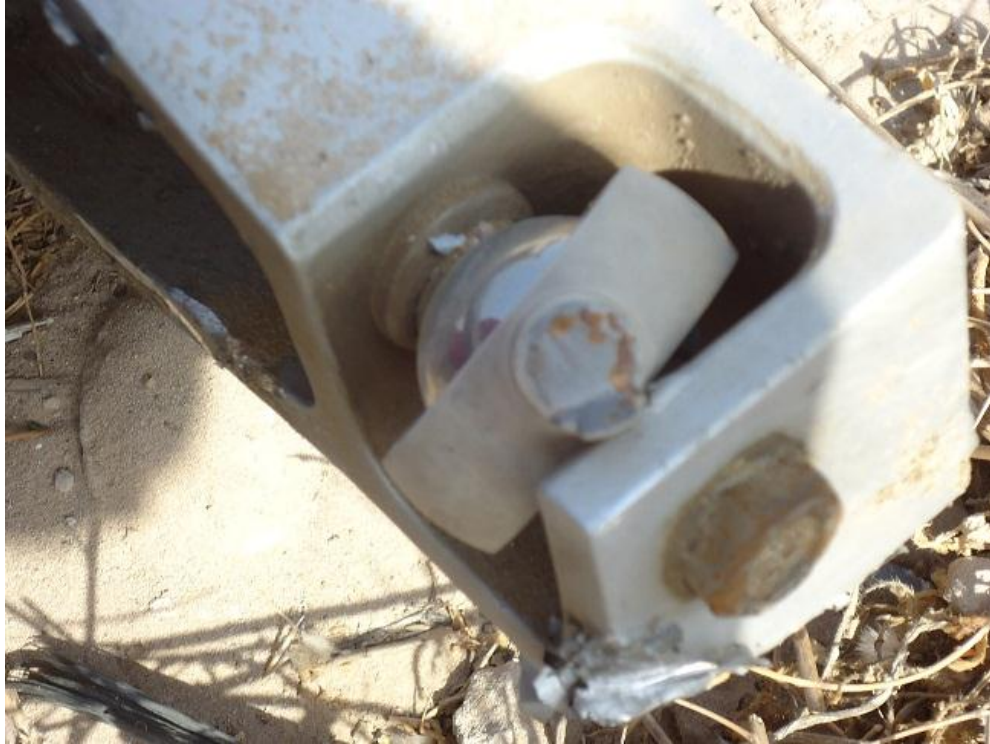
1.16.1 The investigation team has seen some corrosion on the broken pitch links. So the pitch links were delivered to the BEA laboratories for analysis. The design data was sent to the BEA by the manufacturer. Examination of the suspected red pitch links was done and there was no evidence of fatigue stress failure revealed. (Analysis report was attached)

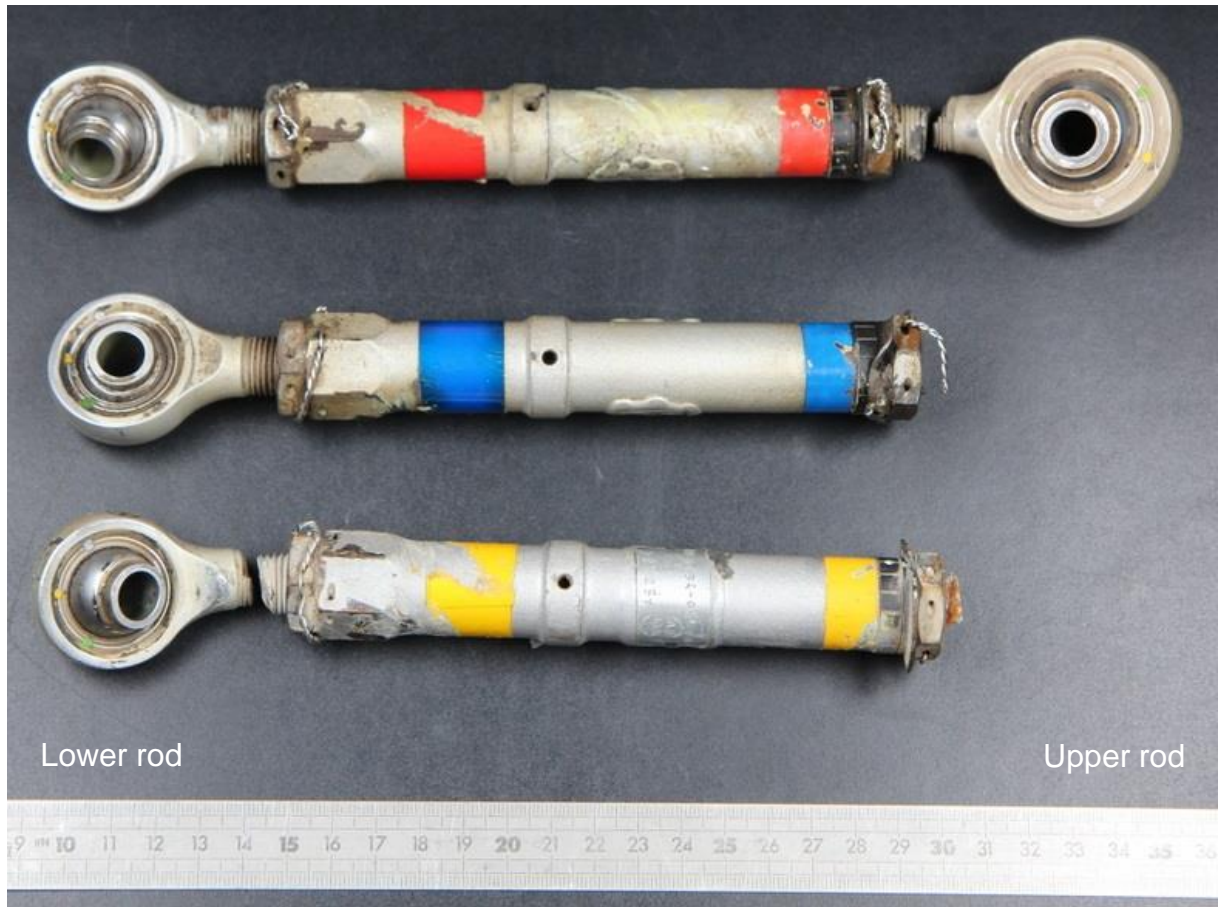
General view of the three pitch links – two upper rods (blue and yellow) are missing

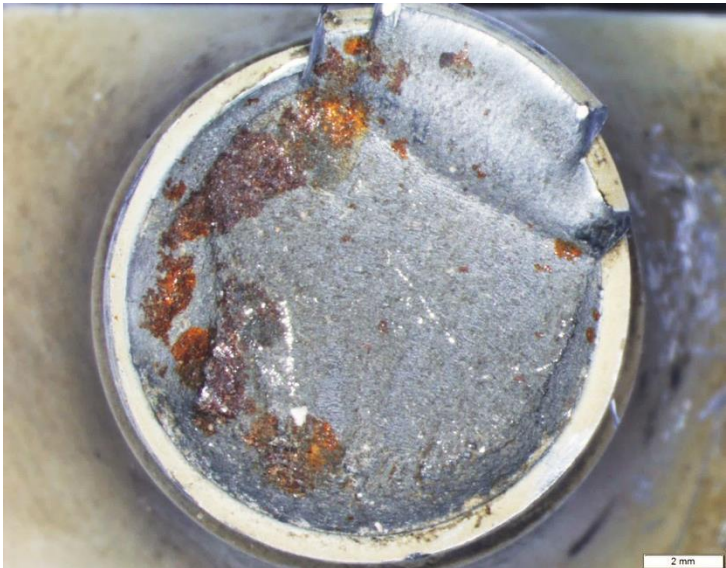
Fracture surface of the upper rod end, upper side

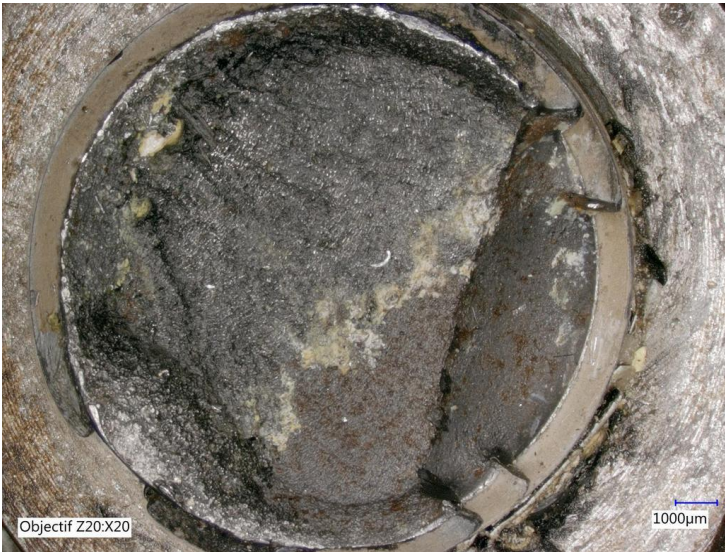
Fracture surface of the upper rod end, lower side

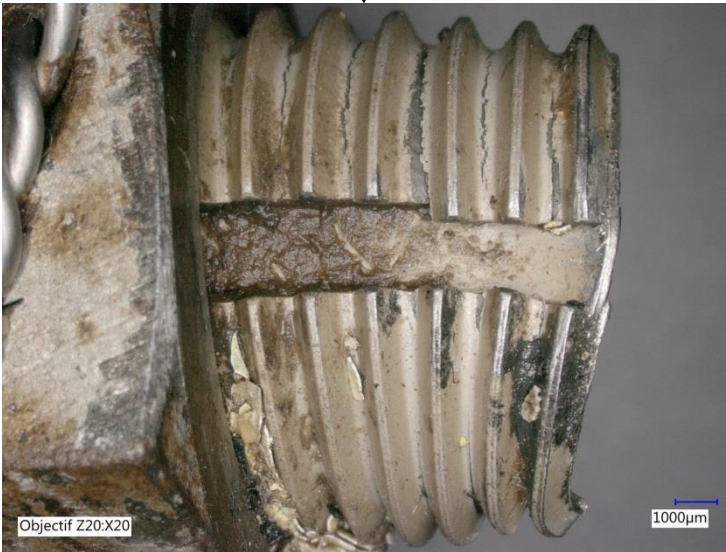
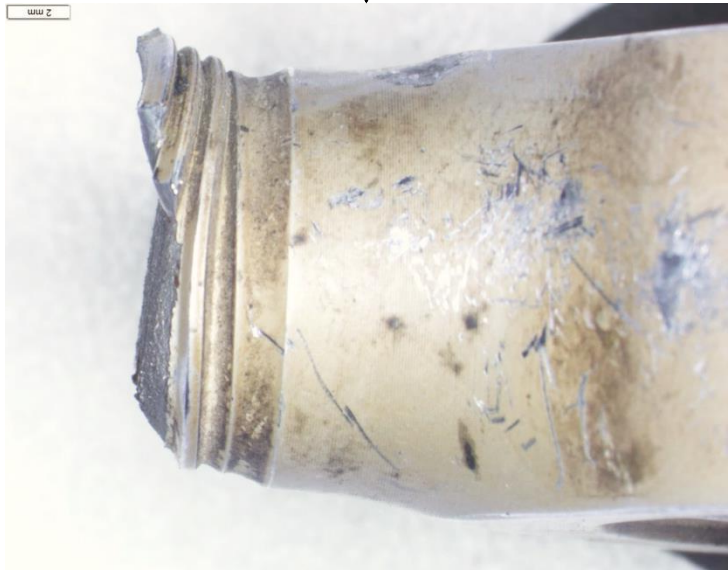
Side views of the fracture surfaces areas, showing significant plastic deformation

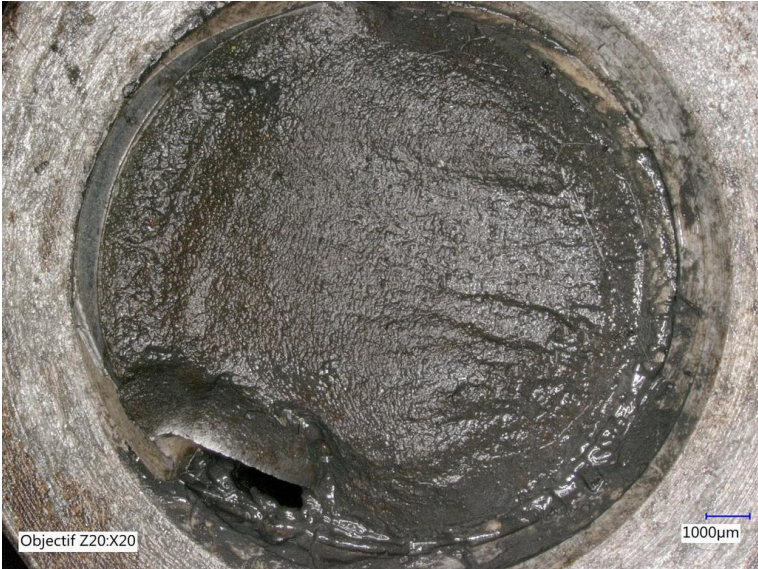
Fracture surface of the upper rod end

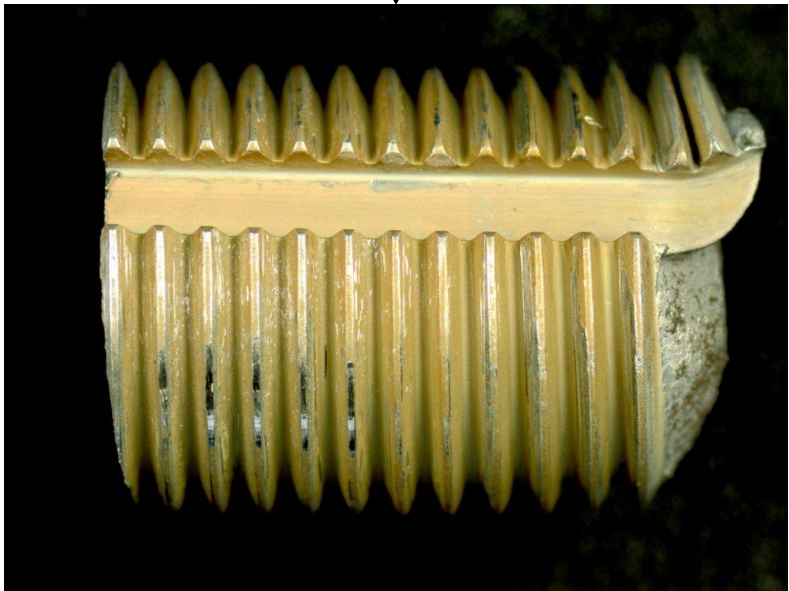
Side view of the fracture surface area after cutting of the housing, showing significant plastic deformation

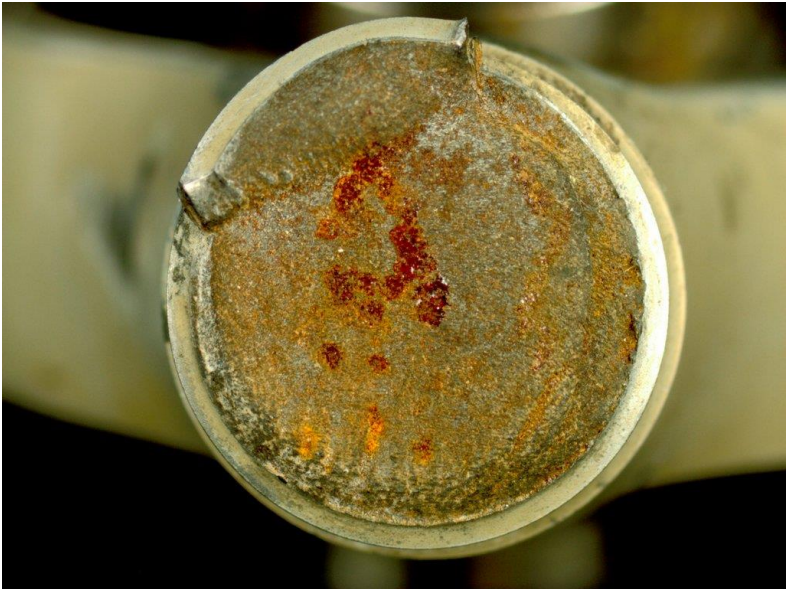
Fracture surface of the lower rod end

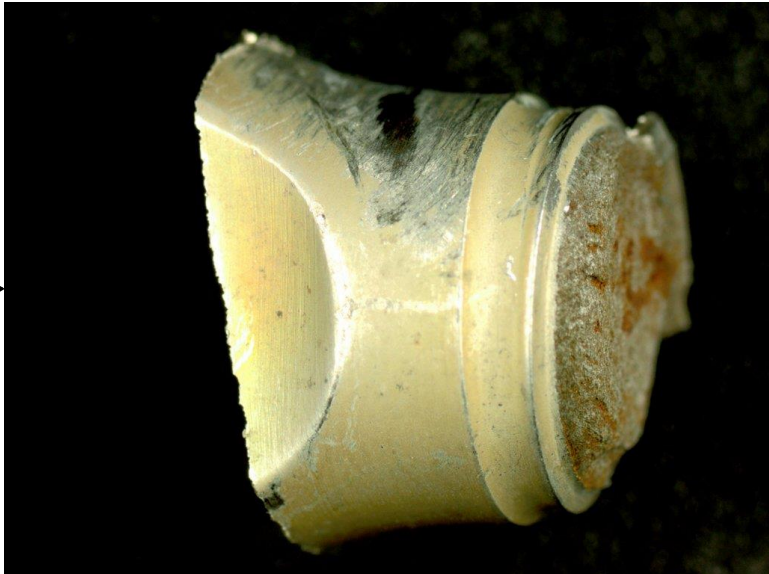
Side view of the fracture surface area after cutting for SEM examination

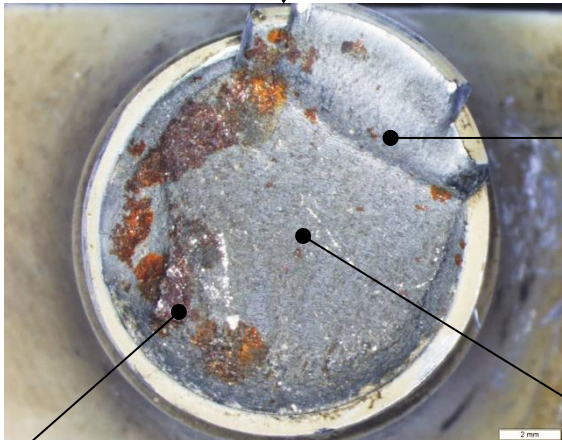
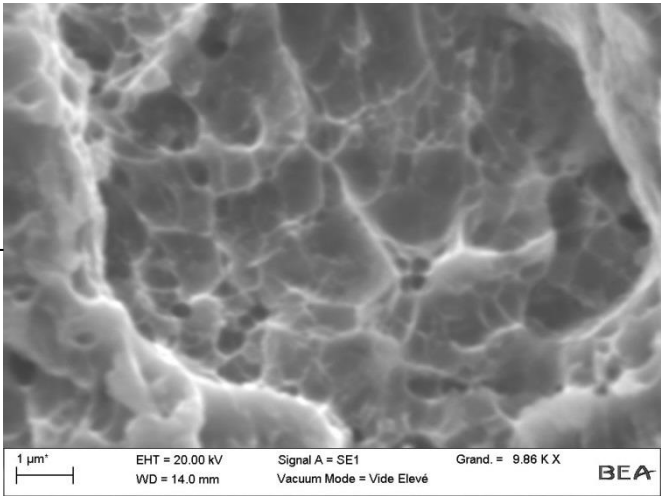
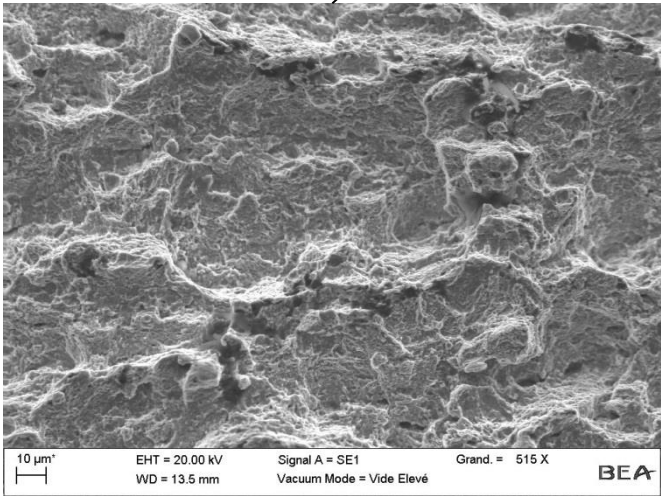
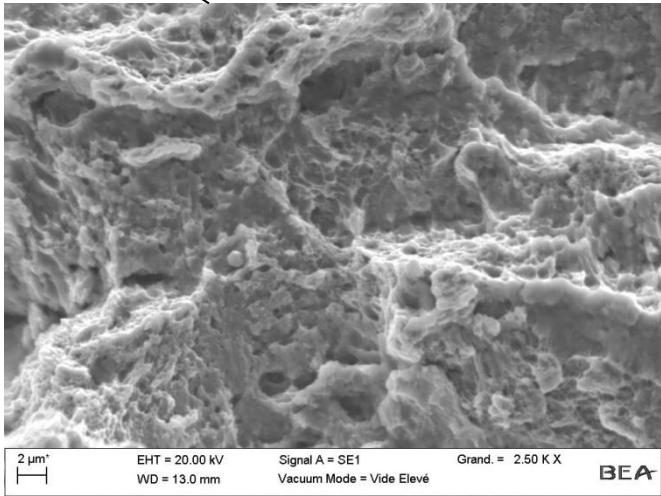
SEM examination of the upper fracture surface of red pitch link showing dimples, typical of sudden failure by overload.

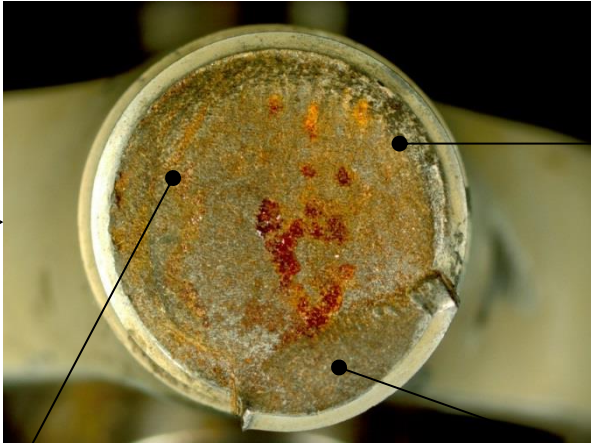
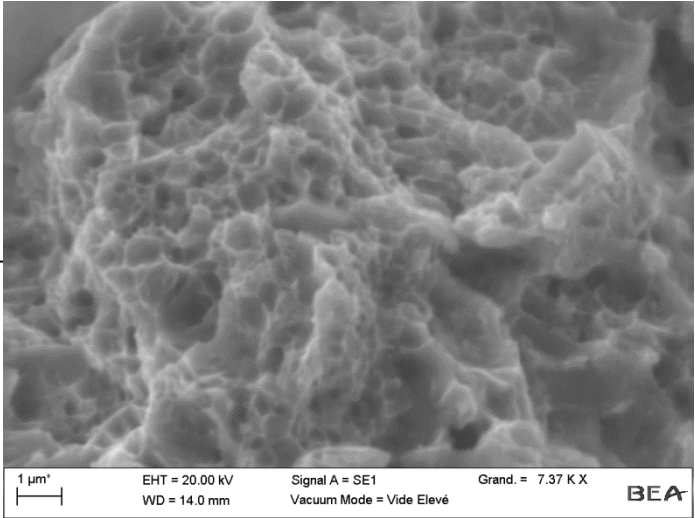
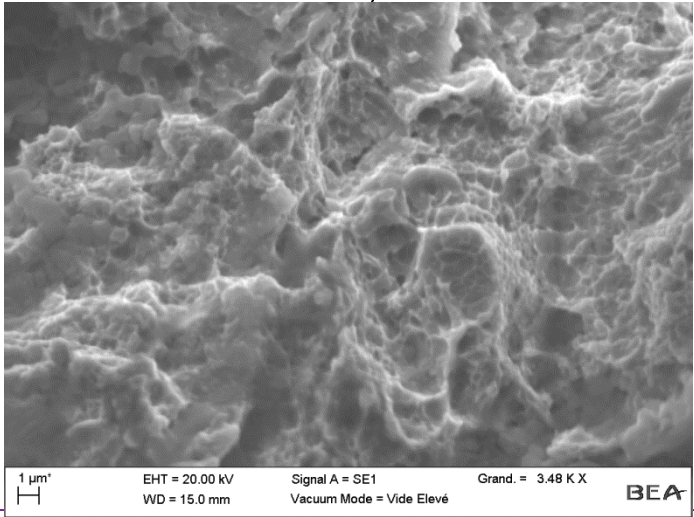
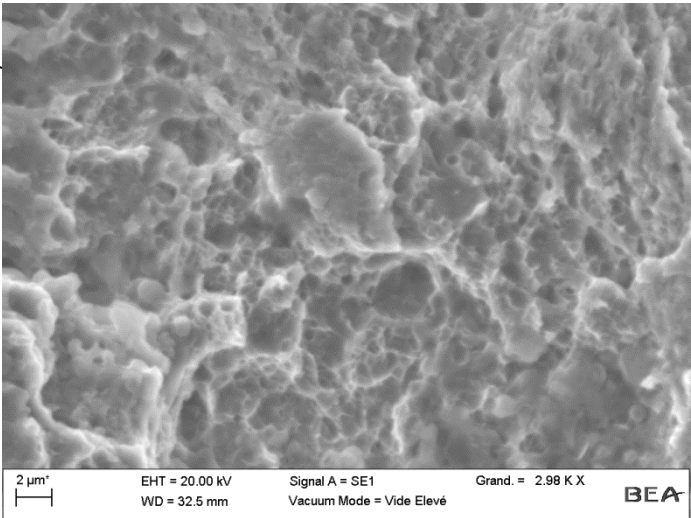
SEM examination of the lower fracture surface of red pitch link showing dimples, typical of sudden failure by overload.

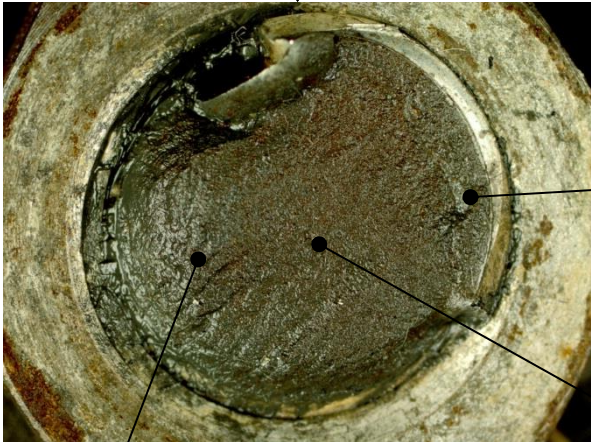
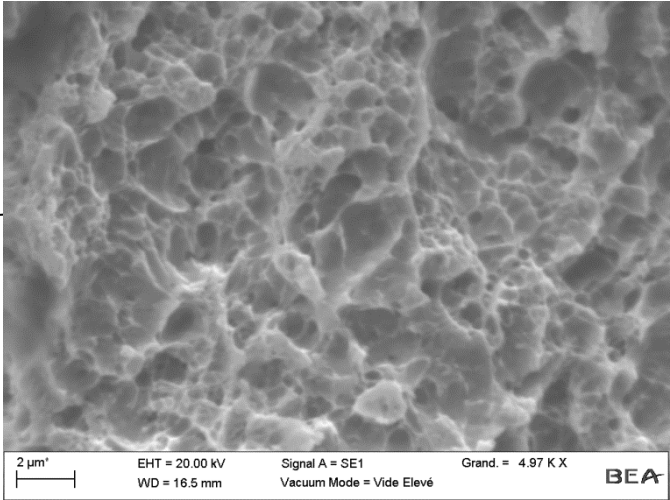
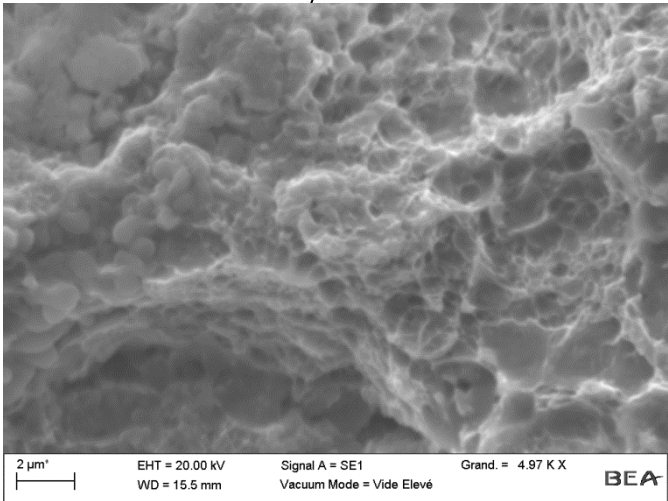
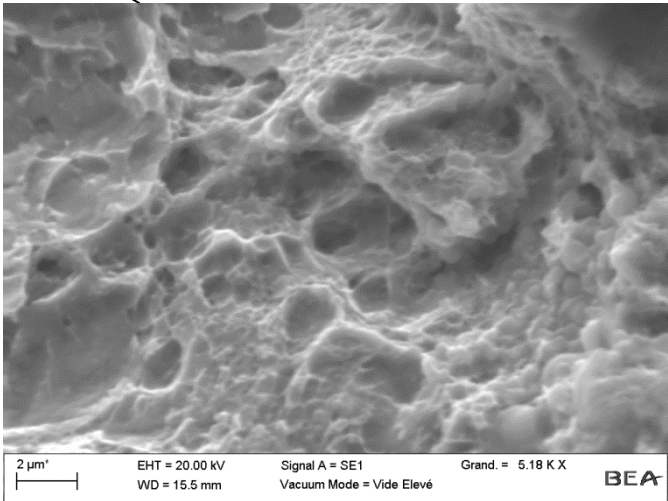
SEM examination of the upper fracture surface of red pitch link showing dimples, typical of a sudden failure by overload.

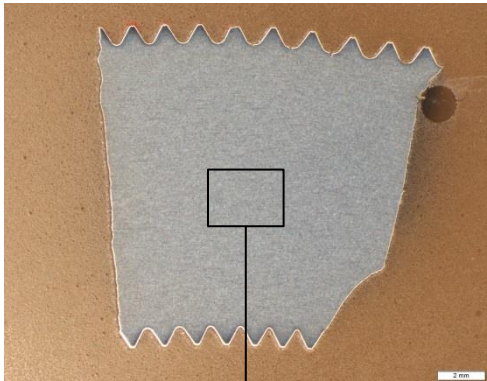
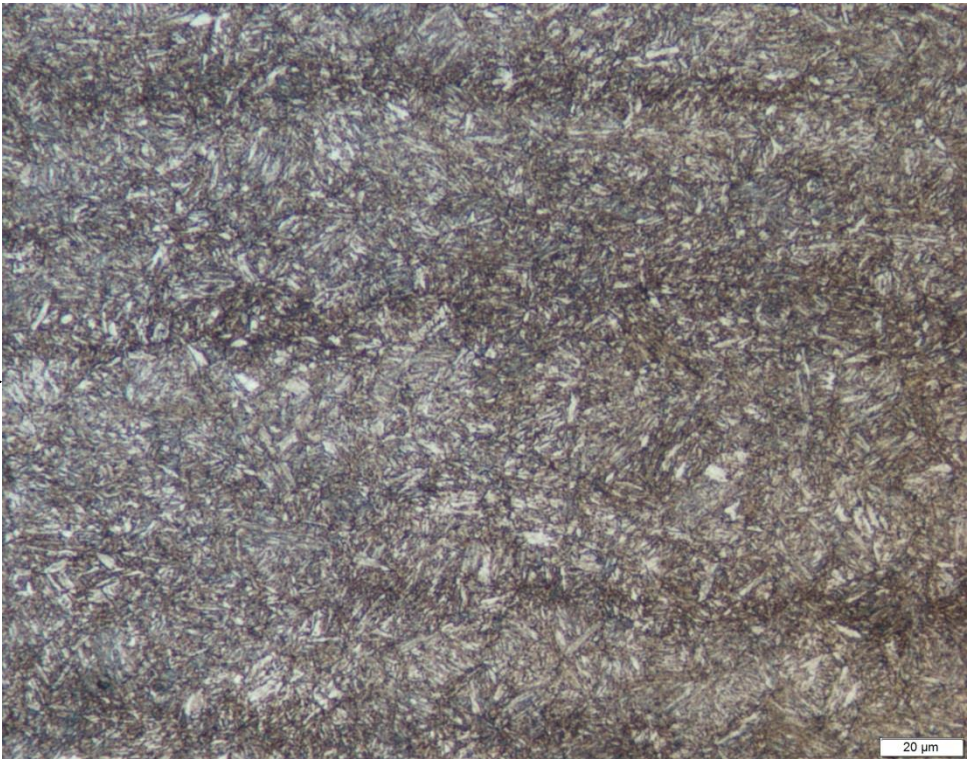
Micrograph examination showed a martensitic microstructure

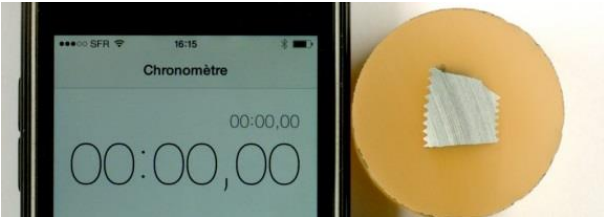
T = 0s, temp=21.8degC

A corrosion test was performed in the BEA laboratory, on the core material to be representative of the fracture surface. The sample used was the micrograph sample, coming from red pitch link. A water drop was deposited on the sample and several pictures were taken at several time intervals. Pictures are presented below. The same test performed on the threads (which are coated) did not generate any corrosion.
