AIRCRAFT ACCIDENT REPORT AND EXECUTIVE SUMMARY

Reference:	CA18/2/3/9497	
Aircraft Registration	ZS-FHG	Date of Accident	07 November 2015		Time of Accident	1048Z
Type of Aircraft	Piper PA-28-180 (Aeroplane)		Type of Operation		Part 141	
Pilot-in-command Licence Type	Private pilot licence	Age	22	Licence Valid	Yes	
Pilot-in-command Flying Experience	Total Flying Hours	126.5		Hours on Type	102.7	
Last point of departure	Port Elizabeth international airport (FAPE): Eastern Cape province					
Next point of intended landing	George aerodrome (FAGG): Western Cape province					
Location of the accident site with reference to easily defined geographical points (GPS readings if possible)						
Westerly side of the airport on the perimeter fence at GPS co-ordinates, S33° 59' 28.64' E025° 36' 07.06'.						
Meteorological Information	Temperature: 22° C, Dew-point: 15°C, Wind speed: 14 knots, QNH 1013hPa					
Number of people on board	1 + 0	No. of people injured	0	No. of people killed	1

AIRCRAFT ACCIDENT REPORT

Name of Owner : 43 Air School
Operator : (AIFA) Avic international flight training academy
Manufacturer : Piper Aircraft Cooperation
Model : PA-28-180
Nationality : South African
Registra

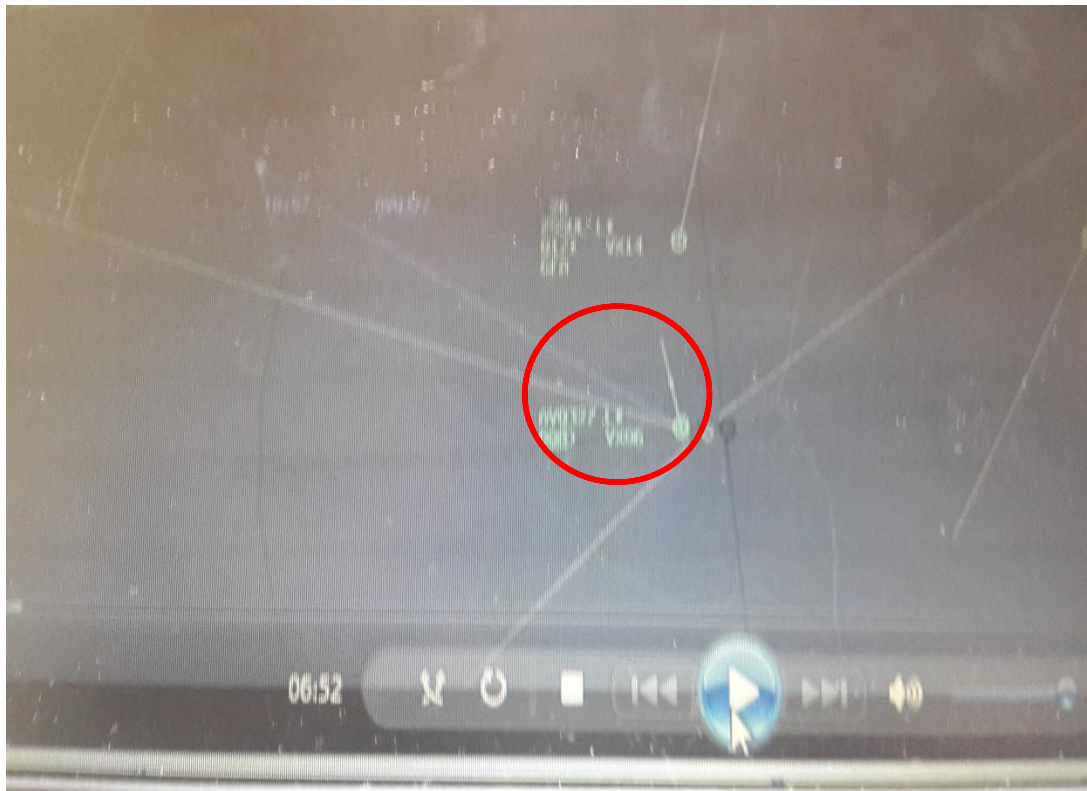
Figure 1: Radar identified target depicting AVQ327 aircraft initiating a turn to the right and reporting an emergency passing 600 feet AGL. This indicates that the transponder was still operational.

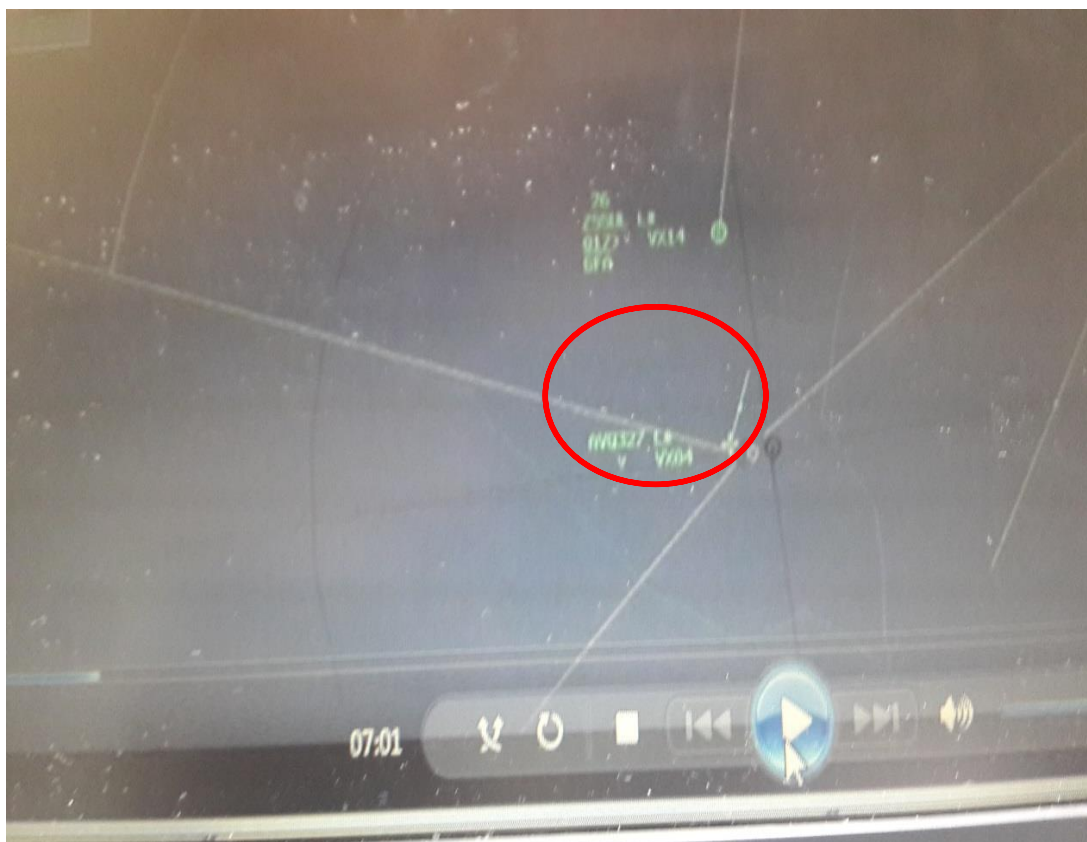
Figure 2: Another radar target depicting AVQ327 at a different angle continuing in a turn to the right and having lost 200 feet in 9 seconds

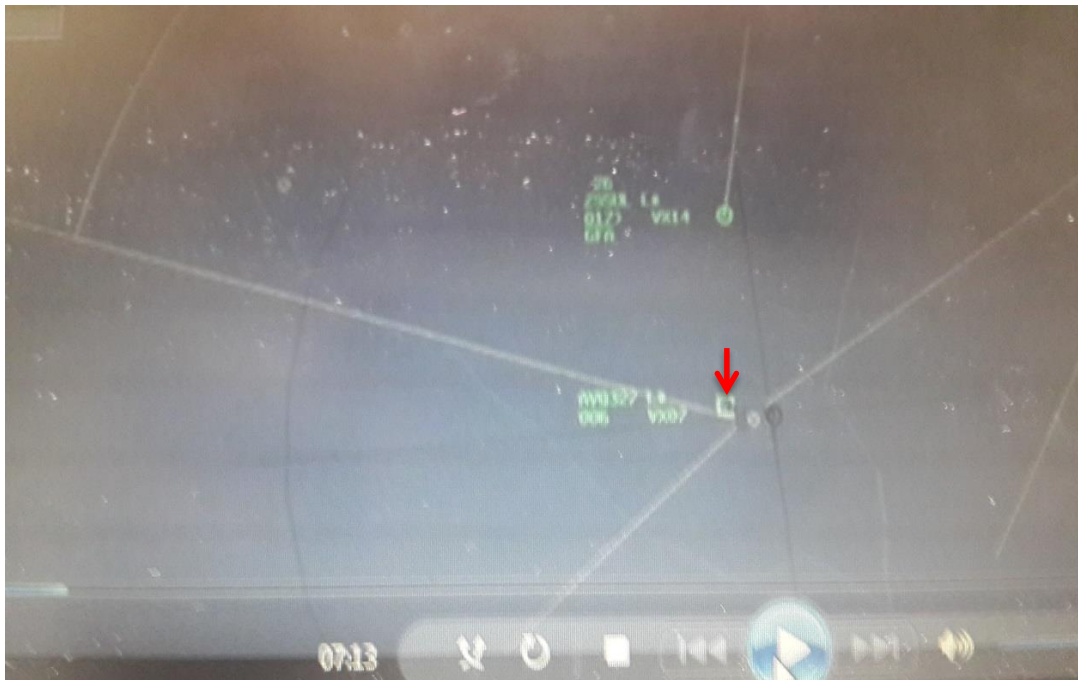
Figure 3: AVQ327 was no longer radar identifiable hence the target is now a square

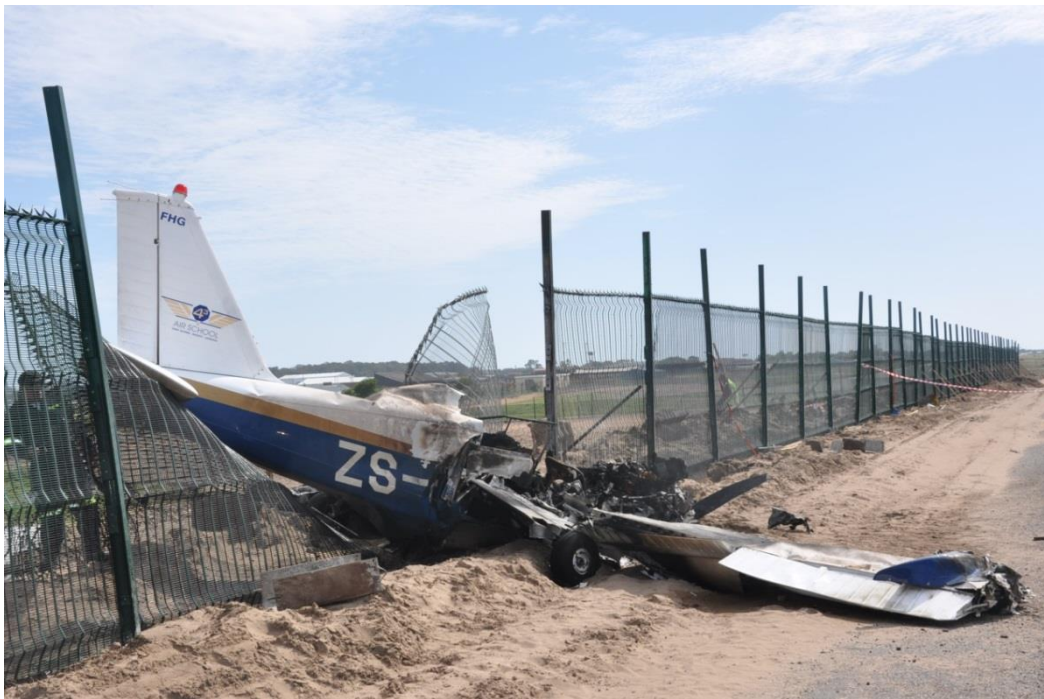
- 1.3.1 The aircraft was destroyed by the post fuel-fed fire that erupted during the accident sequence.

Figure 5: The wreckage as found at the crash site

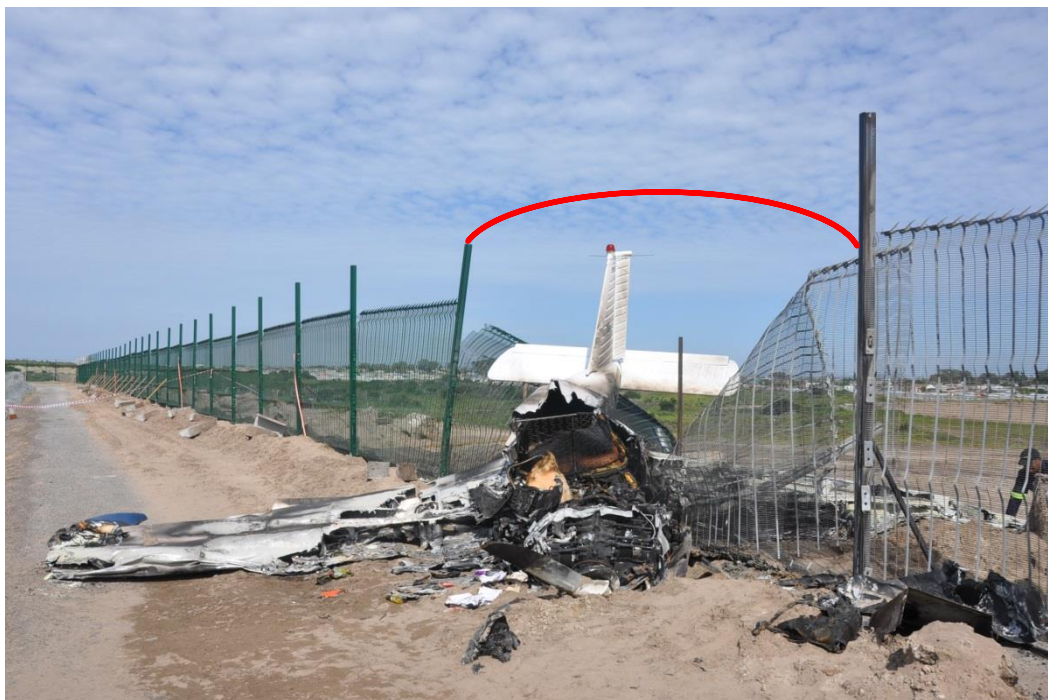
- 1.4.1 The airport perimeter fence (four complete panels and three posts) which had just been erected was damaged during the accident sequence. Attached below is the photograph showing the damage to the airport perimeter fence.

Figure 6: View of a damaged wildlife exclusion FAPE airport perimeter fence

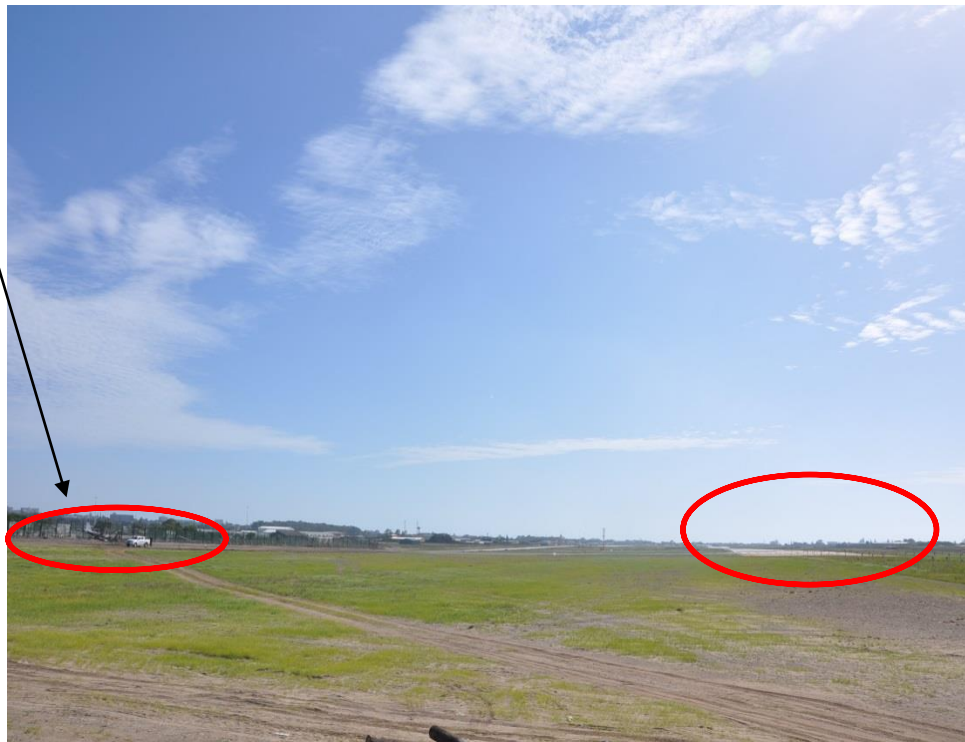
Figure 10: Accident site relative to runway in use at the time of the accident

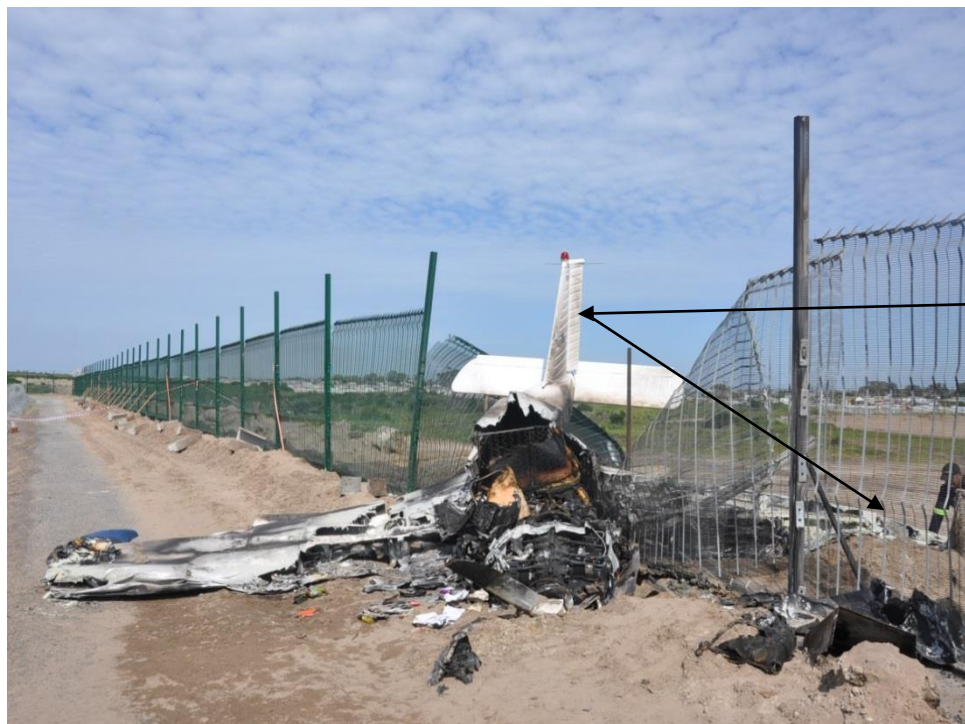
Figure 11: The remains of ZS-FHG

The position of the left wing and the tail section outside the airport perimeter

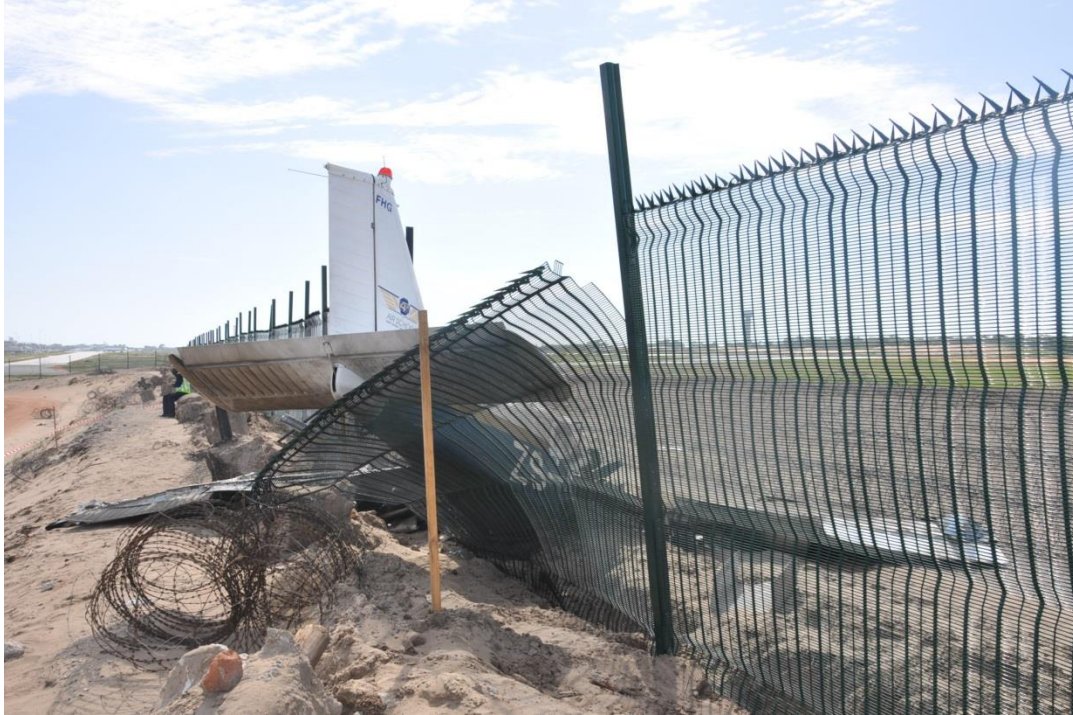
1.12.3 The aircraft landing gears broke. The position of wing the flaps could not be determined. The entire cockpit and all cabin seats and structures, along with the seat belts and their attachments, were destroyed by the fire. The cockpit, including instrumentation and switches were destroyed. The damage to the switches was such that their position prior to the ground impact could not be ascertained. The tail section survived the fire with the rudder in a neutral position. The aircraft remained essentially intact, but was destroyed by the impact and post impact fuel-fed fire.

Figure 12: Aircraft tail section view and the damaged airport perimeter fence

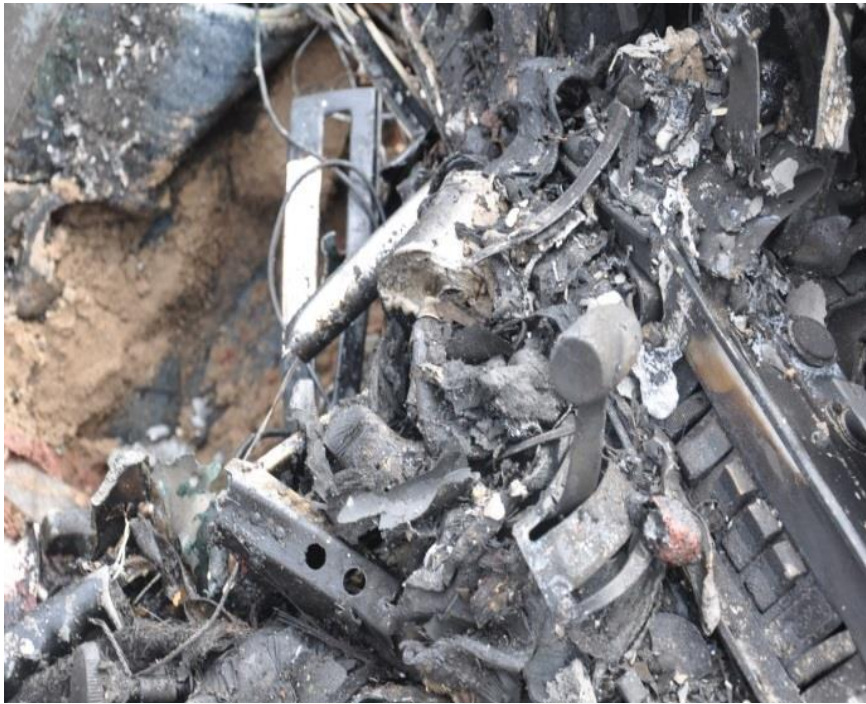
Figure 13: A photograph showing the engine controls

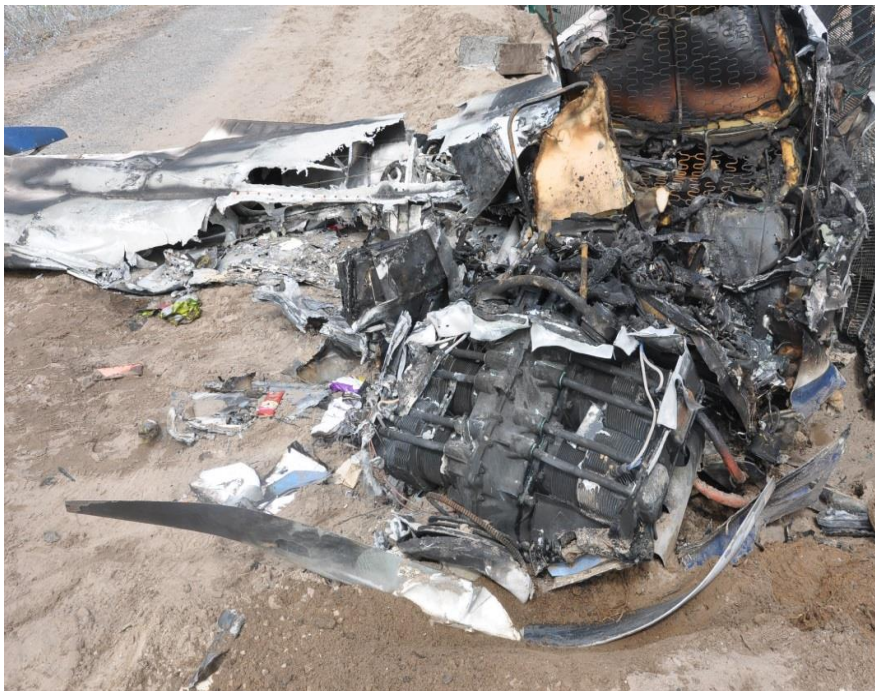
1.12.4 The aircraft was structurally intact prior to the accident. The wreckage was thoroughly examined before recovery from the site. The wings leading/trailing edges, together with the wing attachments and associated structure, the cast-aluminium fuselage frames, and most of the flying control system cranks and levers were destroyed by the forces generated during the accident sequence. The engine controls (power lever/melted mixture control lever), and the cockpit instruments and radios were severely damaged. The propeller was still attached to the hub, but one blade was curved.

Figure 14: Condition of the propeller at the accident site

- 3.1.9 The propeller blade damage was consistent with the engine not producing power.
- 3.1.10 The accident was considered not survivable.

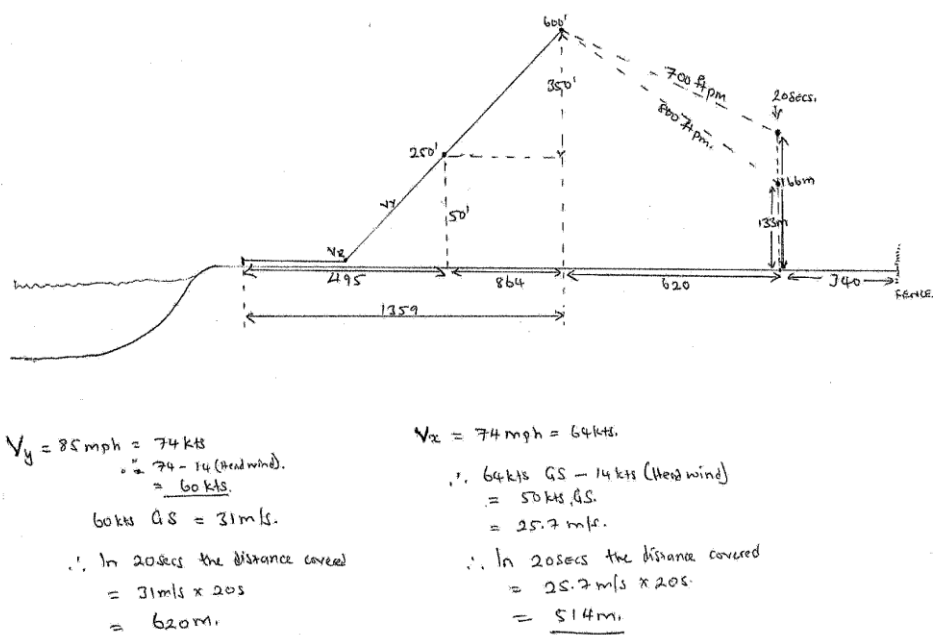
The response from the control tower was made at 10:47:56 (AVQ327 you can land back on the runway), 20 seconds later. At this stage, the aircraft was on track still travelling at 85 miles per hour. The investigators with the aid of one of SACAA reputable flight schools flight instructors worked out the twenty seconds time lapse relative to the aircraft track leading up to the accident. The calculations were made considering the PA28-180 pilot operating handbook (POH) and the recent conditions for the day as per the official weather report. Temperature, 22°C: QNH, 1013 hectopascals (Hpa): Wind speed, 14 knots: Wind direction, 240 Density Altitude, zero (0) ft and the aircraft mass and balance which was within limits (standard aircraft weight with full tanks and 1 crew/pilot). From adding full power to rotate and to climb to 50 feet above the runway, 1 625 feet (495 meters) was used. Rate of climb for current conditions was 750 ft per minute. Vertical travel 350 ft @ 750 ft per minute {(0.46 minutes) (28 seconds)}. This was to climb from the end of the take-off distance at 50 ft above the runway to 400 ft above aerodrome level (ATC transcript indicated at 600 feet altitude, airfield elevation was 200 ft AMSL) best rate of climb (VY) 74 knots (recommended climb speed), headwind 14 knots. Therefore 60 knots ground speed = 6 080 feet per minute @ 28 seconds = 2 837 ft (864 meters). 864 meters travelled + take-off distance of 495 meters = 1 359 metres. Runway 26 length as publicised on the aeronautical information publication (AIP) was 1 980 metres - **1 359** metres = **620** metres short of the threshold. Therefore the investigation determined that the aircraft would have been 620 meters before the runway end when the aircraft report an engine failure at 600 ft altitude, assuming reported conditions were correct and flying accuracy was maintained. According to FAPE apron manager, the clear way/grass area available from the threshold to the airport perimeter fence was **340.4** metres. The 620 meters short of runway end + 340.4 clear way/grass area = 960.4 meters. The aircraft travelled additional **514** meters before a call “you can land back on the runway” (10:47:56) was made. Meaning that the aircraft was right at the runway end when a call was made heading towards the airport perimeter fence before commencing a 180° turn to the right. Nine seconds later (illustrated on figure 2) the aircraft lost height and dropped to 400 feet AGL. Seconds later, the aircraft disappeared from the radar, suggesting that during the series of turns, it entered into a stall condition, from which it impacted the airport perimeter fence before bursting into flames. The accident scene also revealed that the aircraft did not have forward speed at the time of the accident. Below is the Google earth map depicting FAPE aerodrome layout and the calculated aircraft performance/travel.

Figure 17: Calculated distance verses performance of the aircraft at the time of the accident

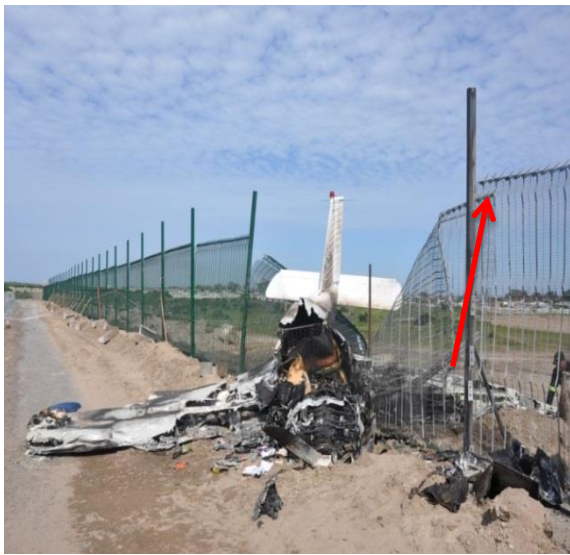
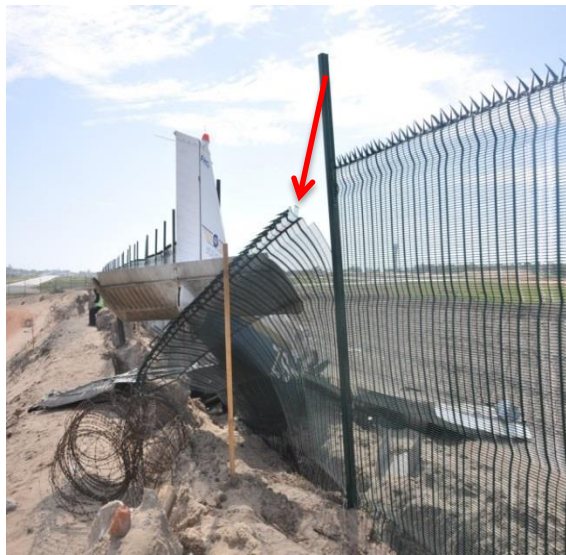
(a) Front view of the wreckage

(b) Rear view of the wreckage

Figures 17: Photographs showing how the aircraft impacted the fence. The fence was found to have been pushed outside but not inside towards the direction of the aircraft flight path, suggesting that the aircraft did not have forward speed at the time of the accident
