AIRCRAFT ACCIDENT REPORT AND EXECUTIVE SUMMARY

Reference:	CA18/2/3/9503	
Aircraft registration	ZS-SDJ	Date of accident	2 December 2015		Time of accident	0329Z
Type of aircraft	Robinson R44 Raven II		Type of operation		Private (Part 91)	
Pilot-in-command licence type		Commercial	Age	30	Licence valid	Yes
Pilot-in-command flying experience		Total flying hours	1 058,7		Hours on type	1 024,5
Last point of departure		Farm Uitenpas near the town of Musina, Limpopo province				
Next point of intended landing		Farm Ehrenbreitstein, Limpopo province				
Location of the accident site with reference to easily defined geographical points (GPS readings if possible)						
Portion 66 of the farm Musina (GPS position; 22°20.242' South 030°02.891' East), elevation 1780 ft AMSL						
Meteorological information		Surface wind: Light and variable; Temperature: 22°C; CAVOK				
Number of people on board	1 + 1	No. of people injured	0	No. of people killed	2	
Synopsis

AIRCRAFT ACCIDENT REPORT

Name of Owner : Central Africa Transport (Pty) Ltd
Name of Operator : Private (Part 91)
Manufacturer : Robinson Helicopter Company
Model : R44 Raven II
Nationality : South African
Registration : ZS-SDJ
Place : Musina

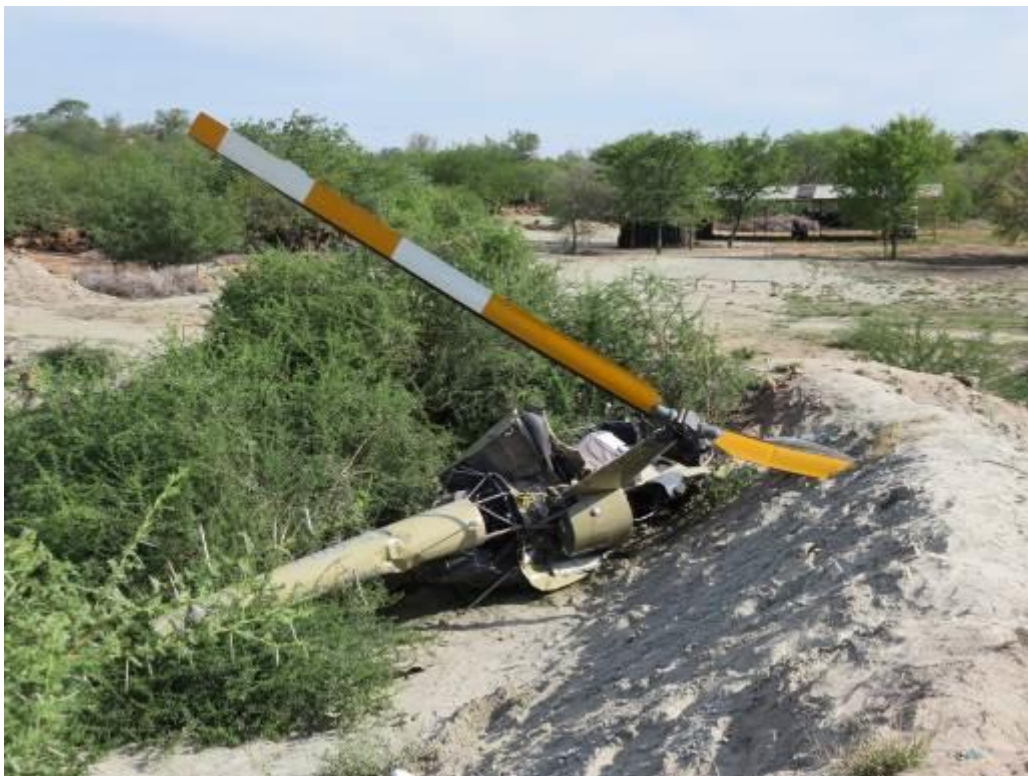
1.3.1 The helicopter was destroyed during the impact sequence.

Figure 1. The main wreckage as it came to rest

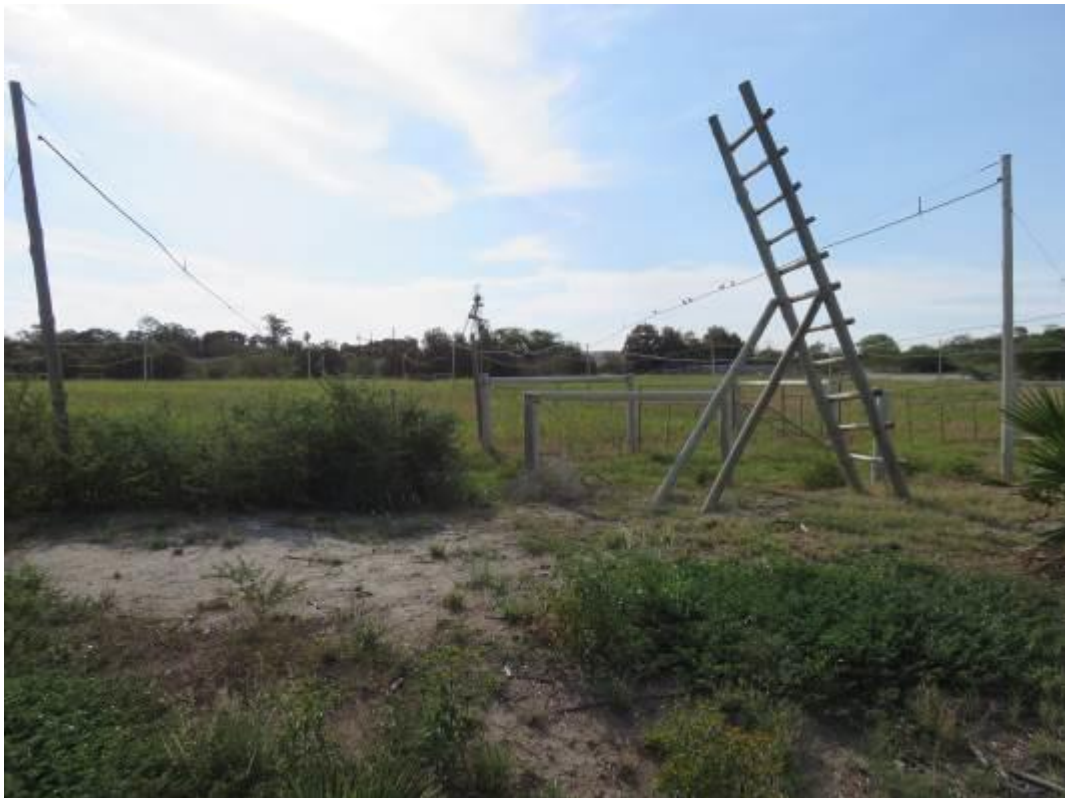
1.12.2 The helicopter crashed into the ground in a south-easterly direction after it cleared an elevated irrigation system, which was supported by 5 m high wooden poles (Figure 4 and 5).

Figure 4. View from point of impact looking towards irrigation system and mine shaft

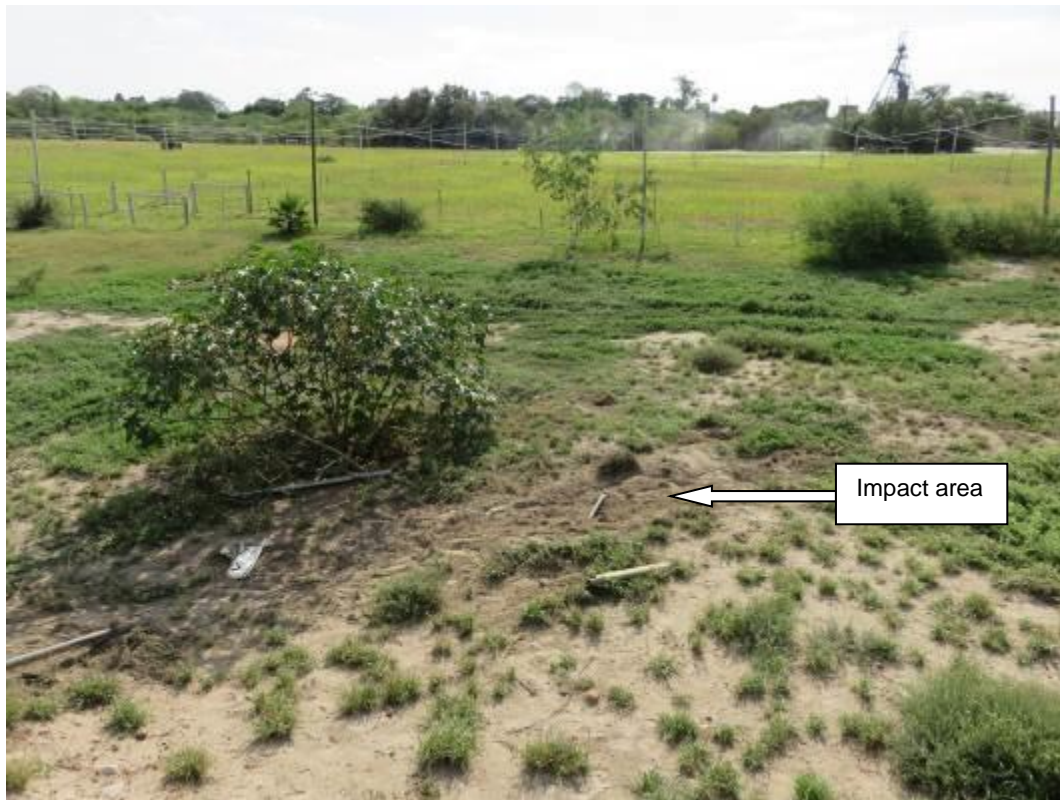
Figure 5. View of elevated irrigation system and impact area

The landing area that was selected by the pilot might have appeared to be an open or clear area from some distance away, but when he came closer, he would have seen the elevated irrigation structure. The structure was found to blend in with the environment as most of the wooden poles were light grey, blending in with the white sand.

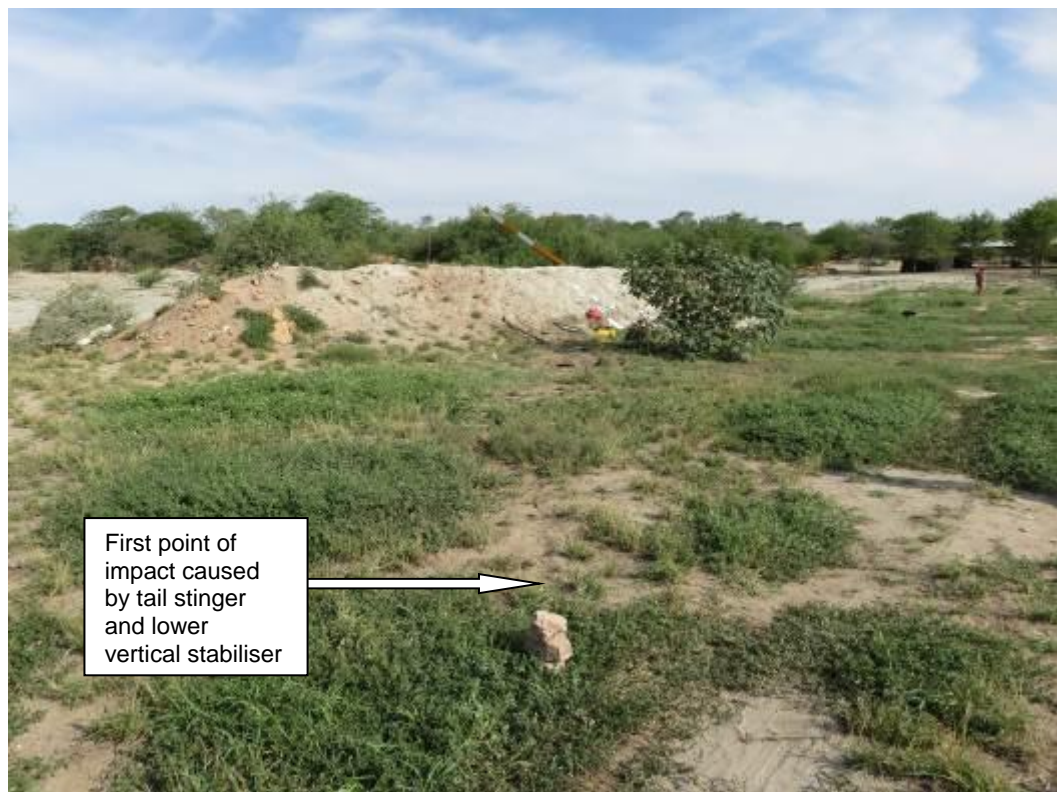
1.12.3 The first ground impact marking was caused by the tail stinger and lower vertical stabiliser (Figure 6). From that point, it was observed that the helicopter had crashed heavily into the ground in a slight right skid low, upright attitude, with the right skid gear imprint visible in the soil at the point of impact, followed by the left skid. From this point onwards (looking forward), the airframe was destroyed, with the skid gear assembly breaking off and objects from inside the cockpit/cabin being propelled forward, until the helicopter hit the backstop sand embankment of the shooting range.

Figure 6. First point of ground impact

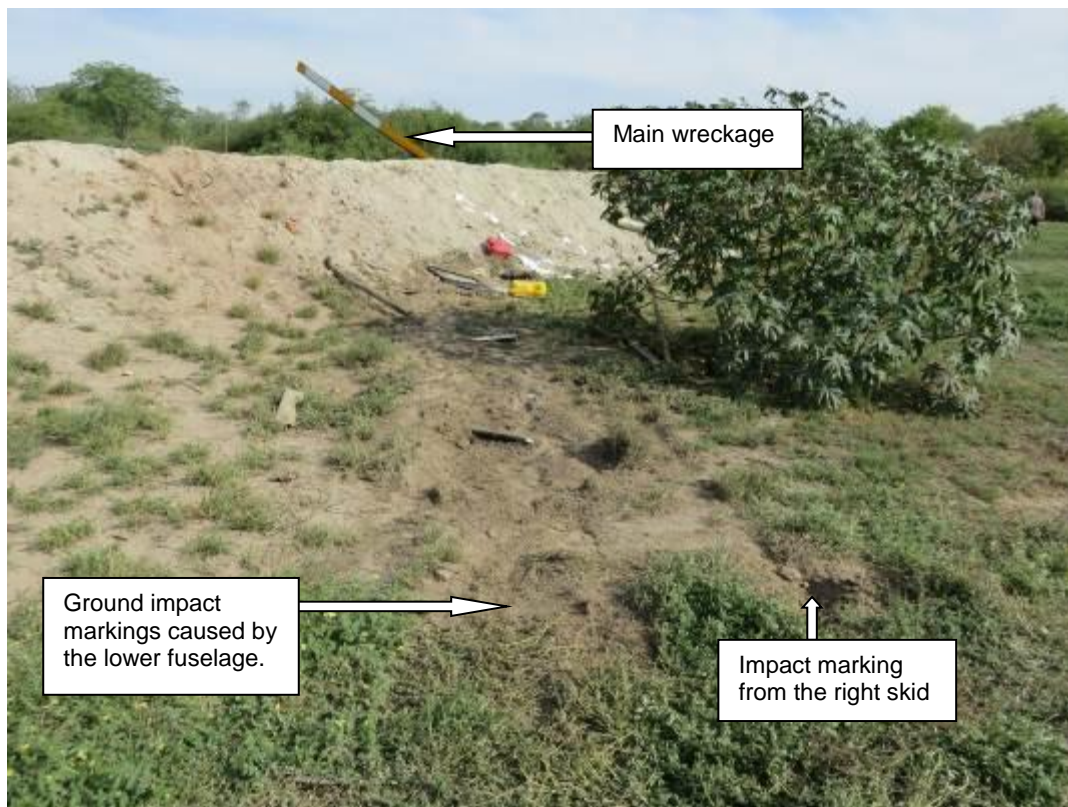
Figure 6: Ground impact markings

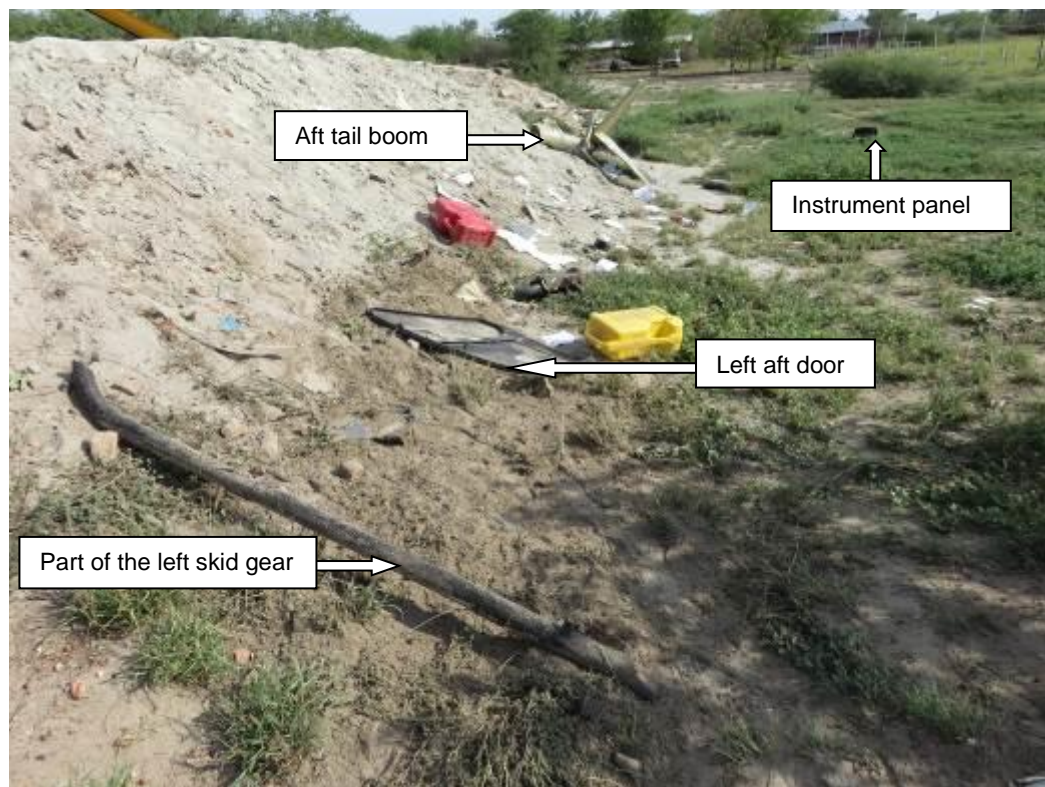
1.12.5 The left aft door was accounted for (Figure 7, 8). Both 25-litre containers of Avgas ruptured on impact when they were propelled from the cabin. The instrument panel as a unit (Figure 7) was located approximately 20 m to the right of the point of impact.

Figure 7. Debris spread across the side backstop wall

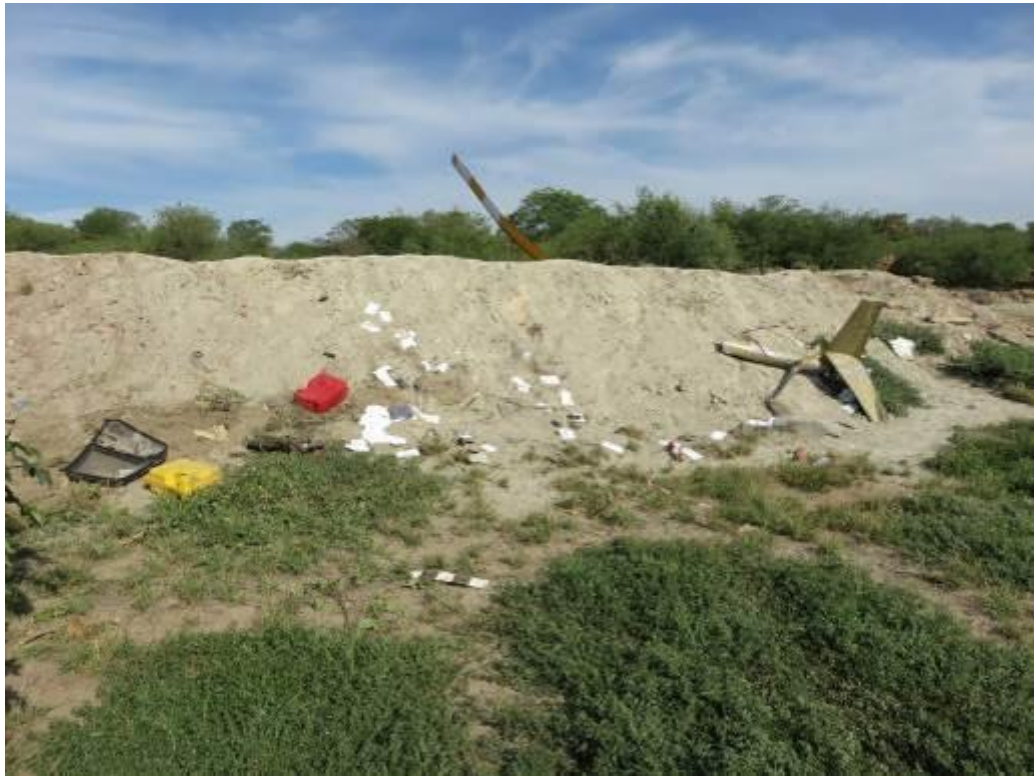
Figure 8. Debris spread – different angle

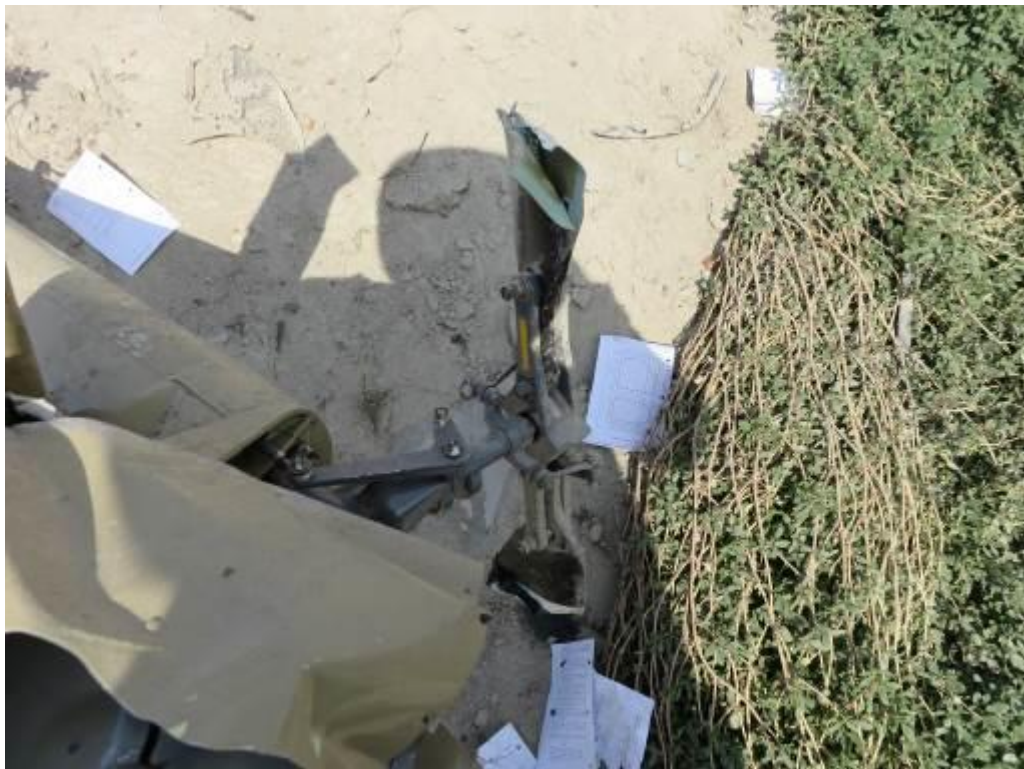
Figure 9. Tail rotor assembly still attached to aft tail boom structure

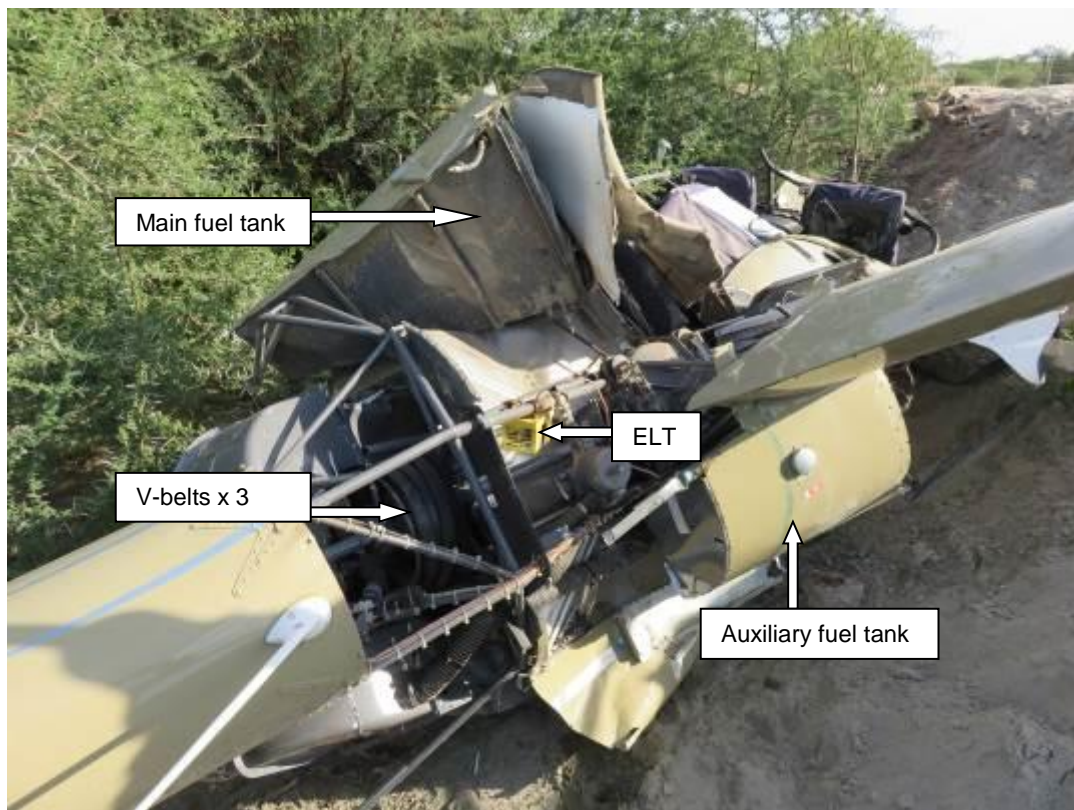
1.12.6 The position of both fuel tanks can be seen in Figure 10. The main tank, which is also the tank that supplies fuel to the engine via gravity flow, was partially ripped out of the fuselage structure. The tank was ruptured and did not contain any fuel. The auxiliary tank remained attached and contained some fuel. This tank also had some rupture holes which would have allowed fuel to leak out.

Figure 10. Main wreckage as it came to rest

There was no evidence of any pre- or post-impact fire. Fuel was evident in the auxiliary fuel tank, which was still secured to the airframe although it contained several rupture holes. The main fuel tank from which fuel is supplied to the engine suffered such severe impact damage that it broke out of the fuselage frame structure.

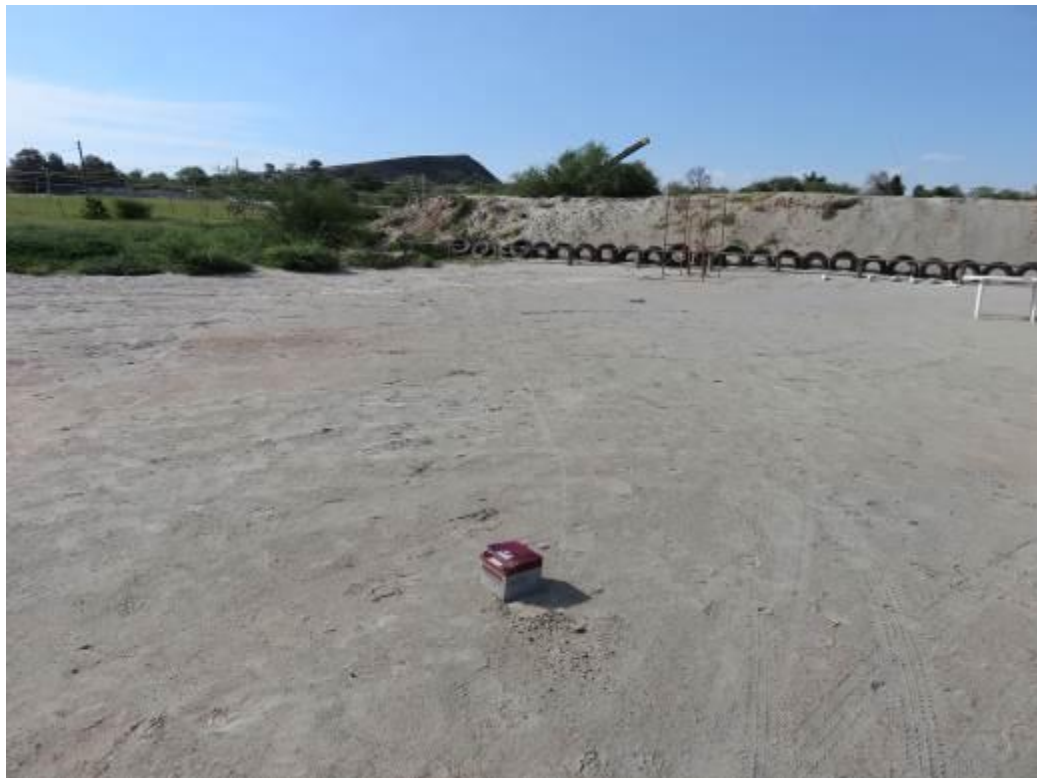
1.12.7 The battery of the helicopter was propelled approximately 45 m from the point of impact and landed on the shooting range (Figure 11). During normal operations the battery is mounted inside the engine compartment on the left side. The instrument panel (Figure 12) had been separated from its installation and was located approximately 20 m to the right of the point of impact.

Figure 11. Battery of helicopter

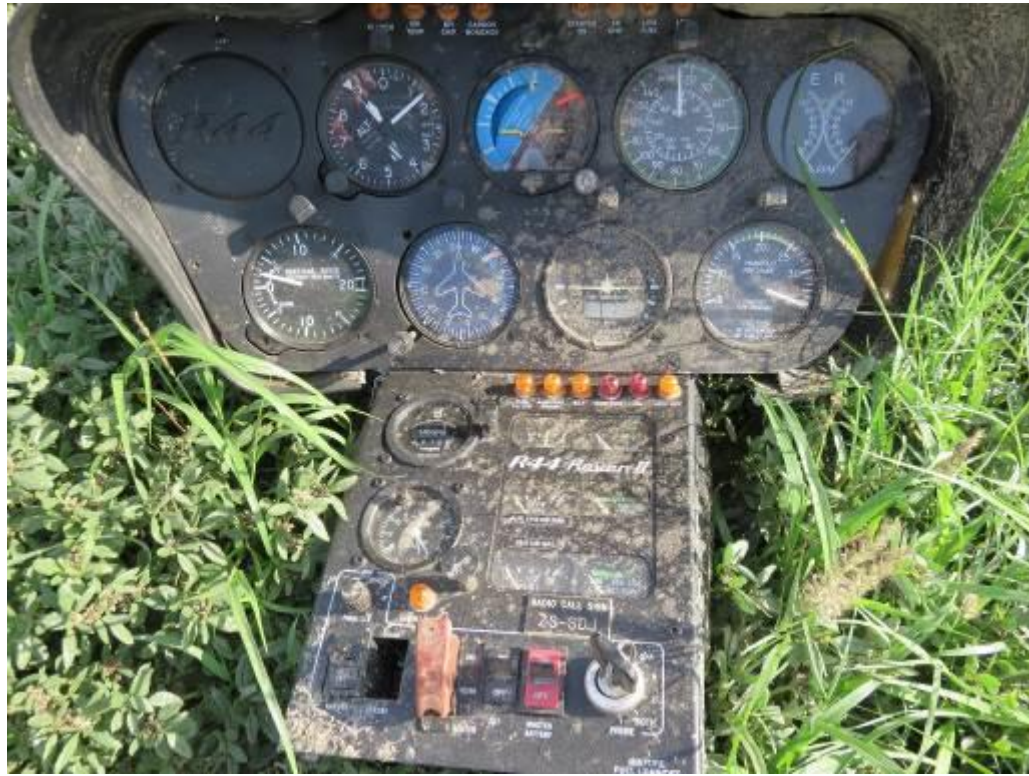
Figure 12. Instrument panel as found on site

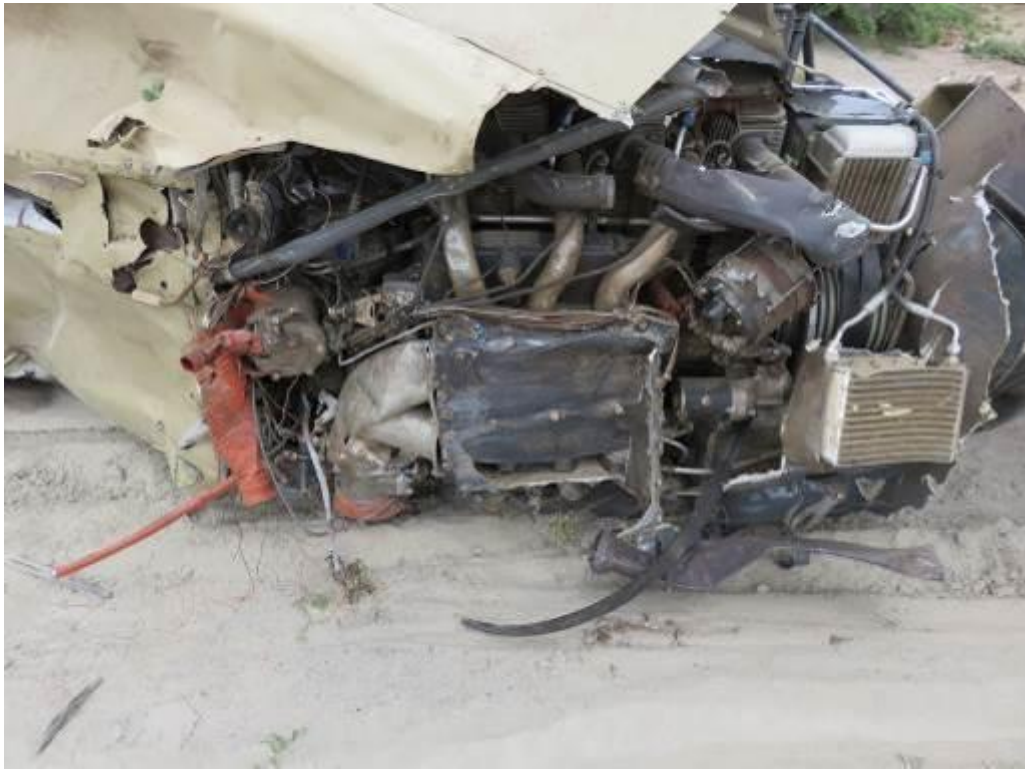
1.12.8 The main fuselage (Figure 13) was severely disrupted. All failures, which include the push-pull tubes of the flight control system, were associated with the impact sequence. The drive system was inspected and no evidence could be found of a malfunction of the system, which includes both gearboxes (main rotor and tail rotor) as well as the clutch actuator which raises the upper drive sheave. The V-belt sheave that was bolted directly to the output shaft of the engine was intact, and the three V-belts were accounted for. The forward tail rotor drive shaft flexible coupling had fractured in the torsional overload. The primary components of the hydraulic system were accounted for, including the pump, the three servo actuators, connecting lines and the reservoir, which is mounted on a steel tube frame behind the main rotor gearbox. The emergency locator transmitter (ELT) was also found intact. Figure 13 displays the damage to the lower fuselage and the lower engine during the impact sequence.

Figure 13: Engine still within fuselage. Photograph taken during recovery

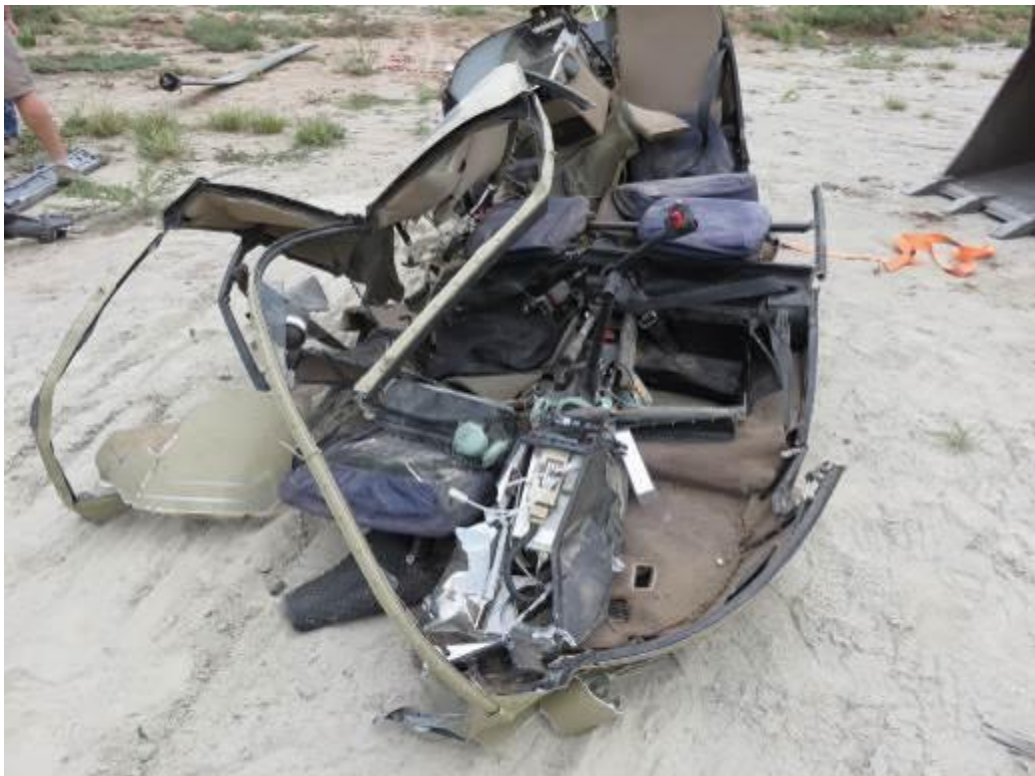
1.12.9 In Figure 14, the destruction of the cockpit/cabin area can be seen, with the floor structure on the pilot's side (on the right side when looking at the helicopter from behind) completely destroyed/missing. The fuel shut-off valve, which was located in the cabin between the two front seats, was in the ON position.

Figure 14. The cockpit/cabin area, photographed during recovery

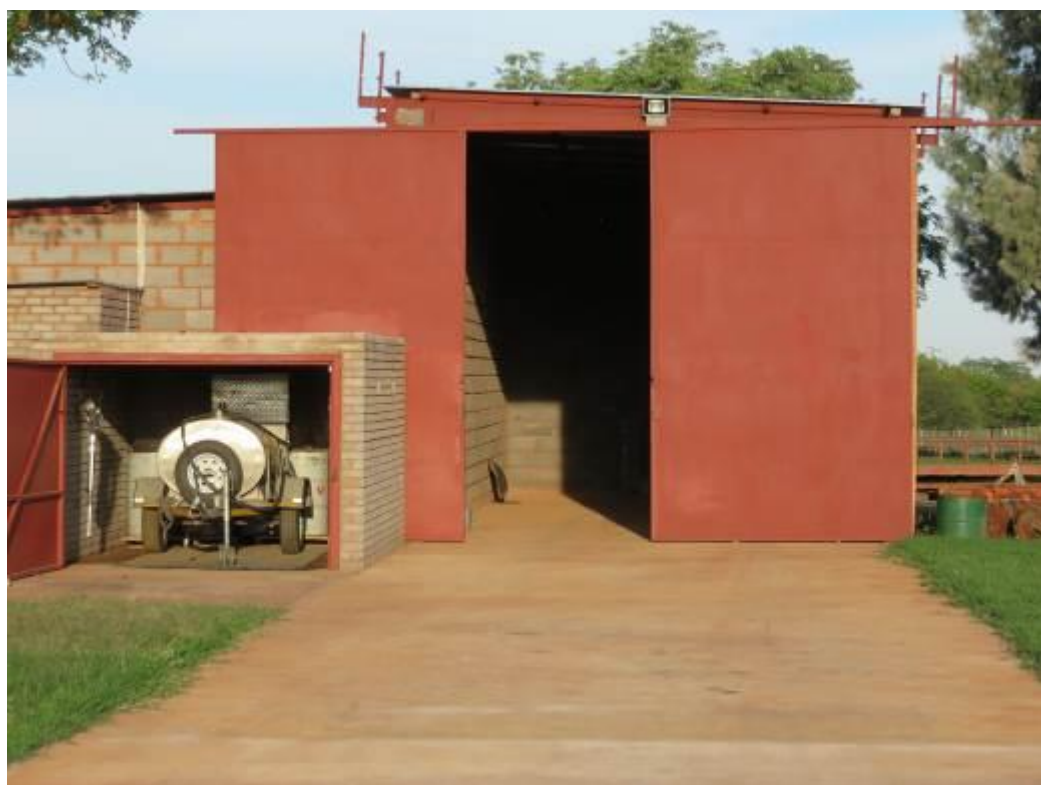
The helicopter was parked in a hangar on the farm Uitenpas on the night before the accident flight. Also available was an Avgas fuel trailer, which was parked in its own secure location (Figure 15). During an inspection of the hangar facility, three of the four helicopter doors were found stored inside the hangar.

Figure 15. The hangar and the fuel trailer, parked in its own secure area

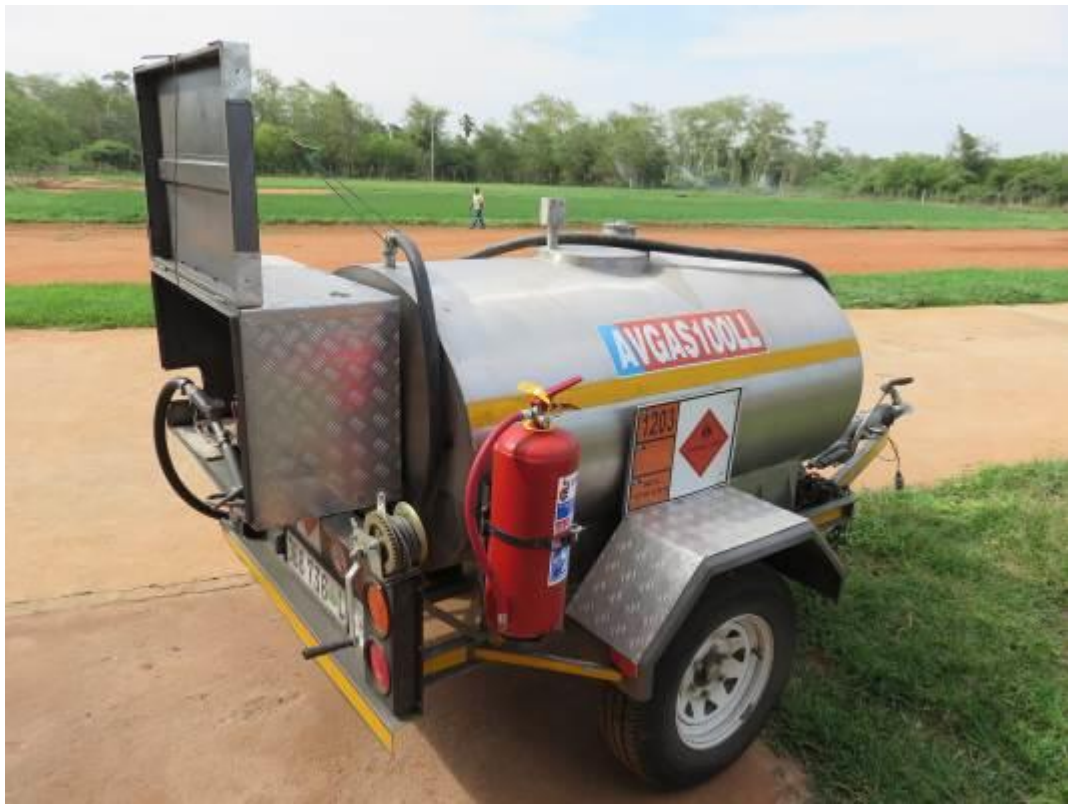
Figure 16 Avgas fuel trailer

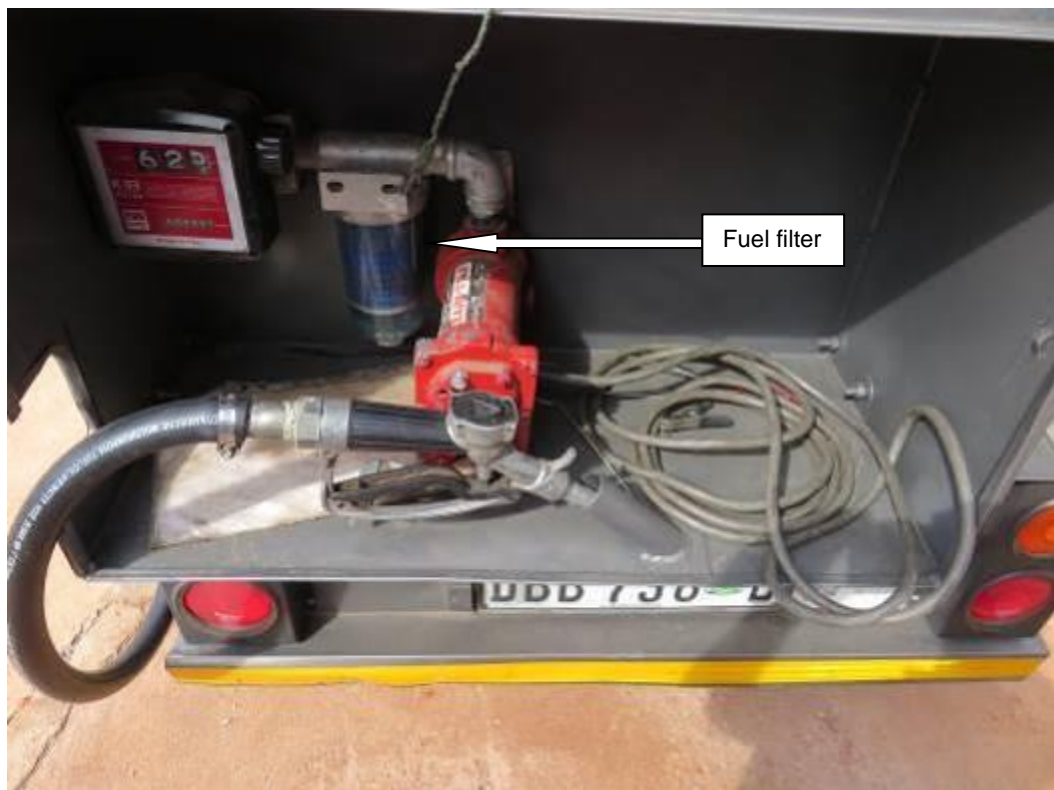
An inspection of the fuel trailer was also conducted and it was found to be equipped with a proper fuel filter mechanism. The fuel filter contained a transparent housing with a water trap at the lowest point. No evidence of dirt or contamination could be detected in the fuel in the filter (Figures, 17).

Figure 17. Electric fuel pump, refuelling nozzle and fuel filter in the aft fuel trailer

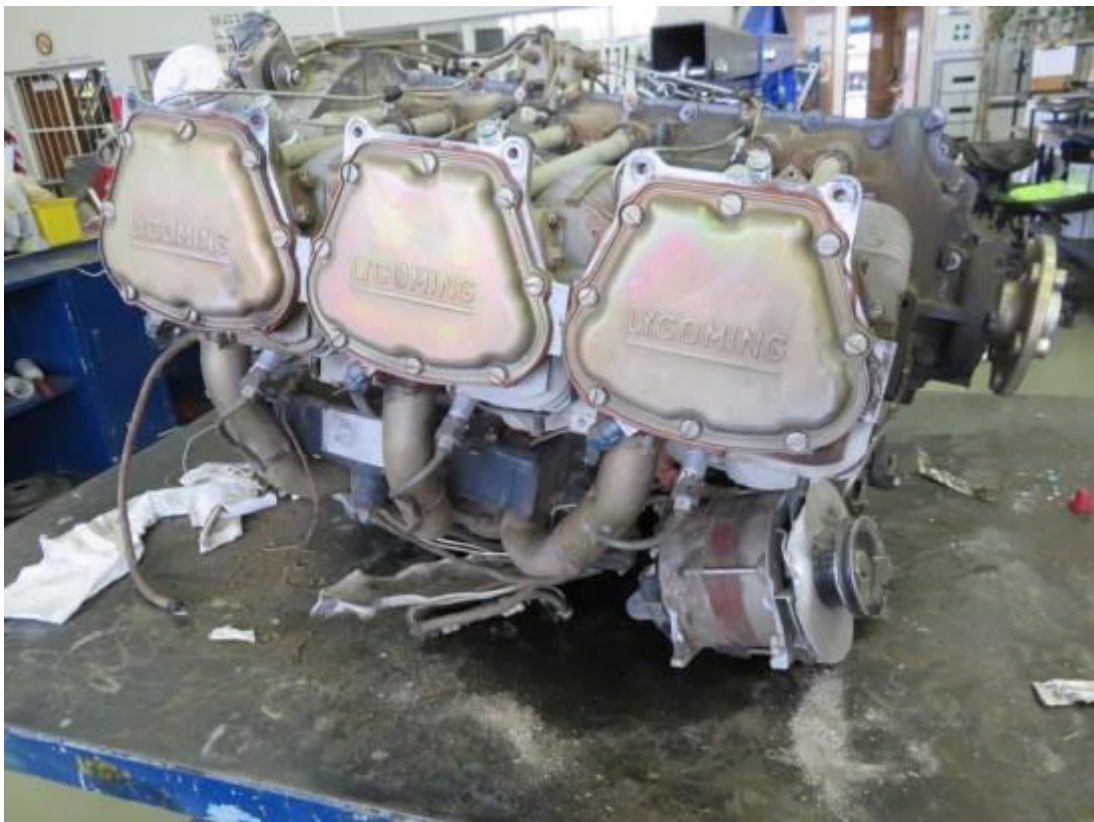
The engine, a Lycoming IO-540-AE1A5, Serial No. L-28803-48A, was removed from the wreckage after recovery and taken to an approved engine maintenance facility (Figure A1), where a teardown inspection was performed on Wednesday, 17 February 2016. The engine sustained substantial impact damage and could not be bench-tested (Figure A2). The purpose of the teardown inspection was to assess the mechanical integrity of the engine. The following observations were made:

Figure A1: Engine before teardown inspection

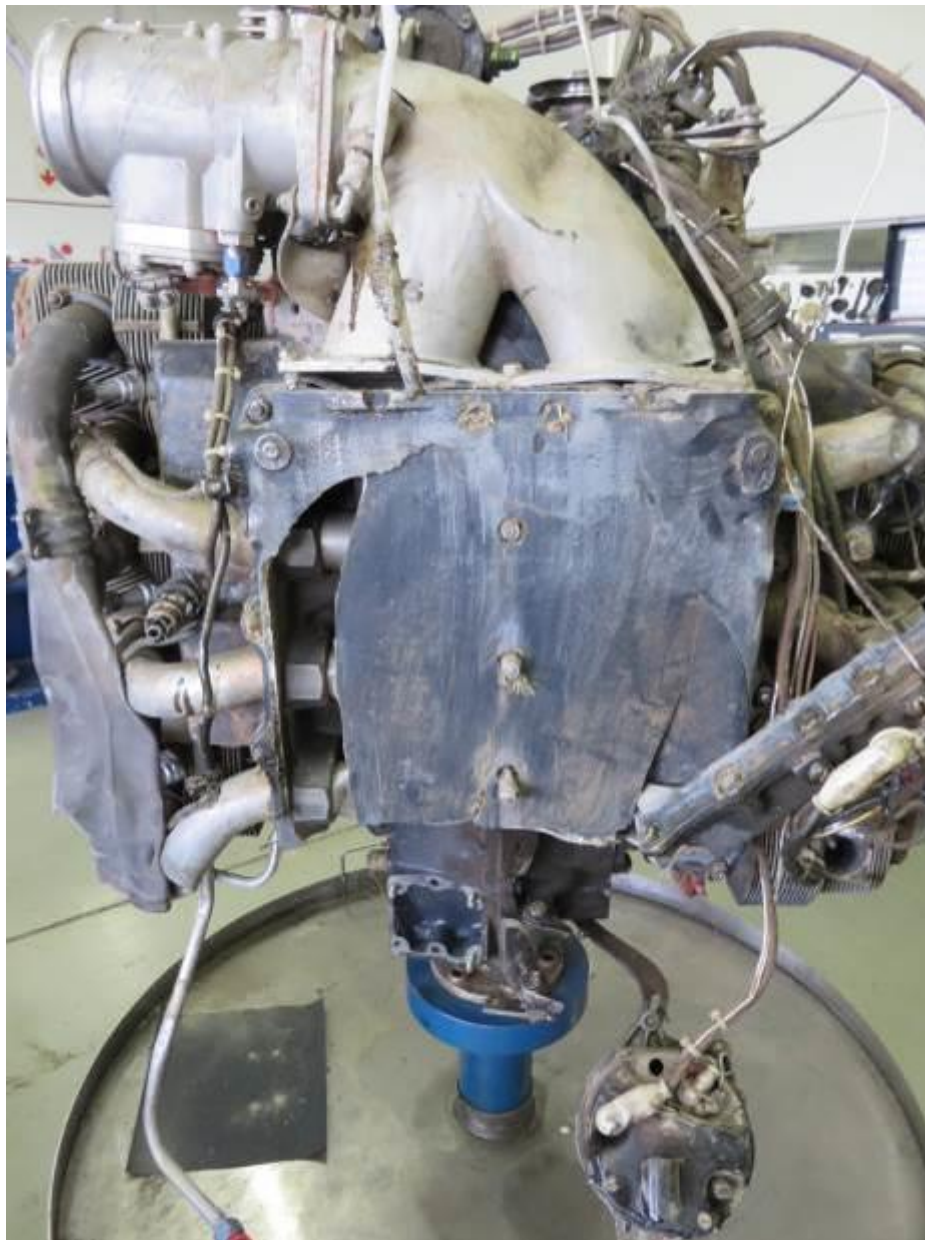
Figure A2: Impact damage visible to bottom of engine

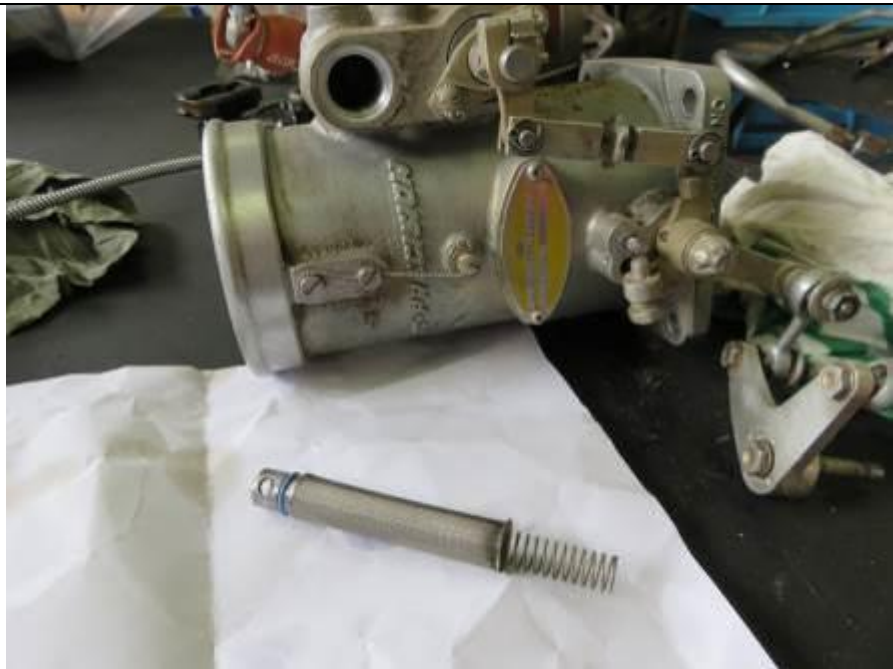
Fuel pump

The fuel pump was undamaged and was removed from the engine.

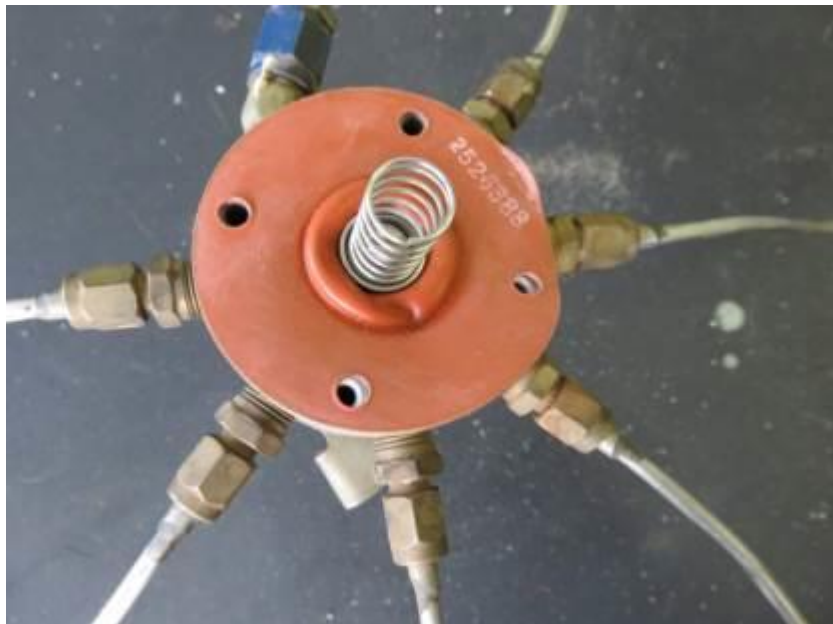
The six fuel lines that attached to the fuel flow divider were found to be intact and the fuel lines were secured to the fuel nozzles. The wire lockings were cut and the unit opened. The unit did not display any internal damage or dirt and the diaphragm was found to be intact (see photograph).

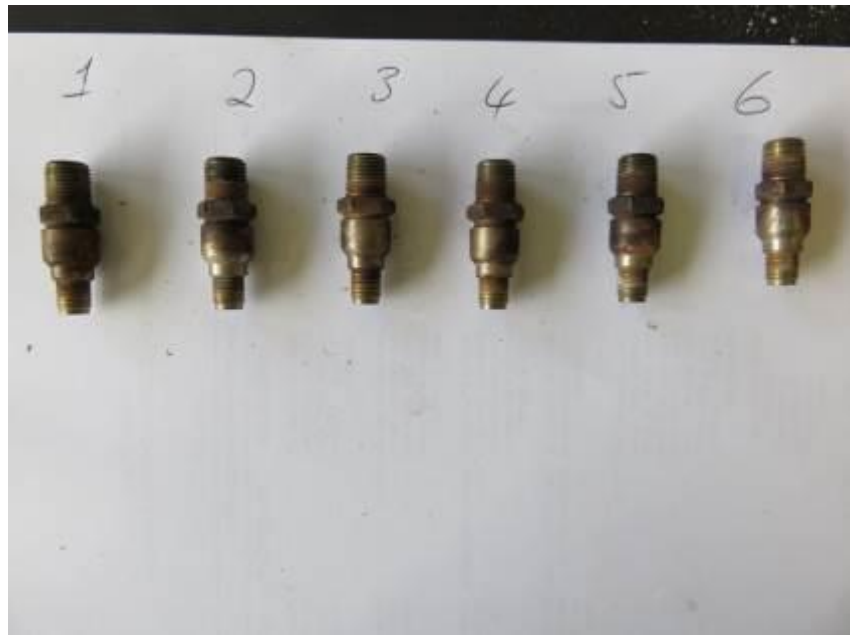
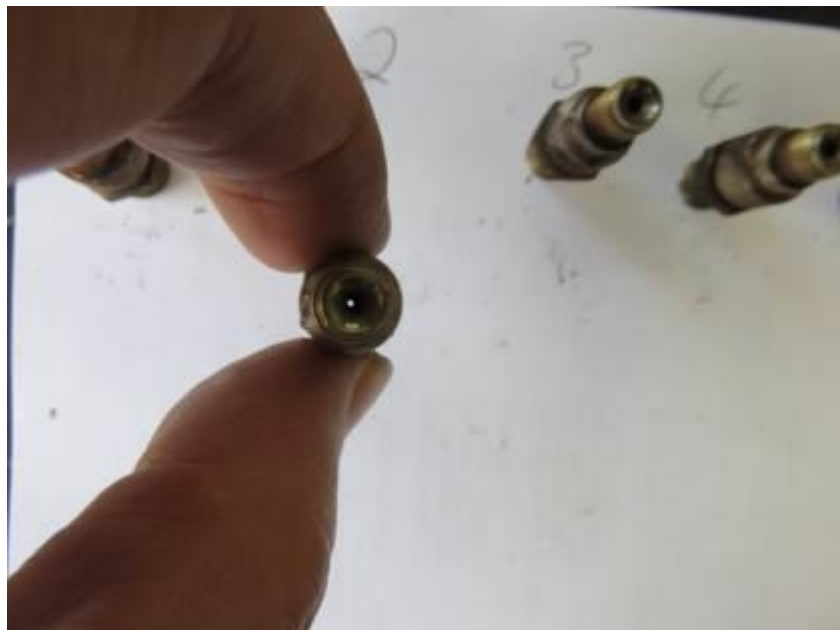
Fuel
nozzles/
Injector
nozzles

All six fuel nozzles were removed from the engine and were inspected; they were found to be clean (free from any obstructions as can be viewed in the second photo below).

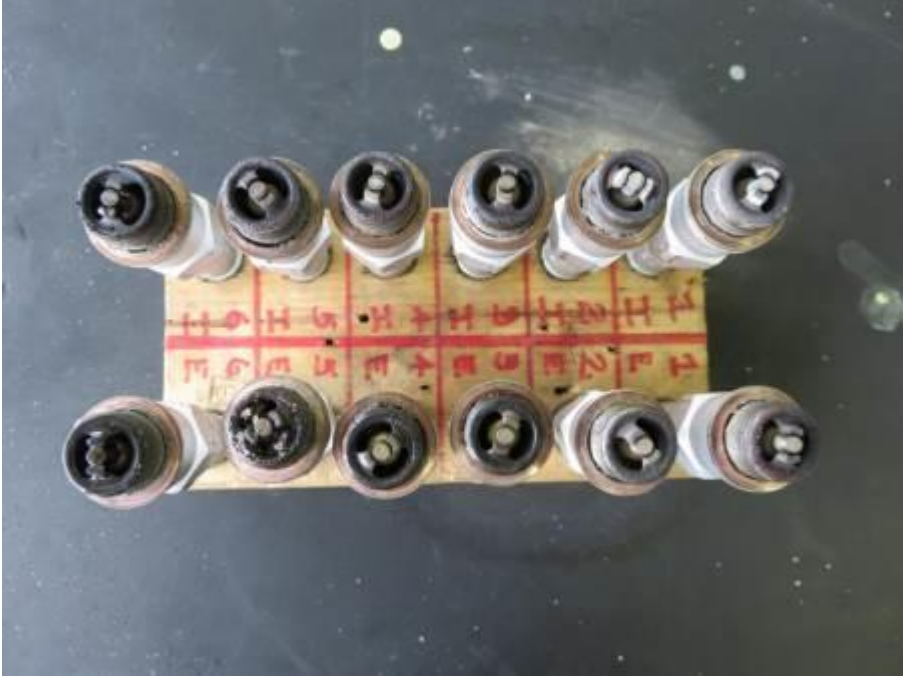
Spark plugs:
Champion
REM-38E

The spark plugs were removed from the cylinders and found to be in good overall condition, displaying a light brownish colour, which were associated with normal engine operation. The lower spark plug on cylinder 5 displayed evidence of oil and a small amount of sand on the electrodes.

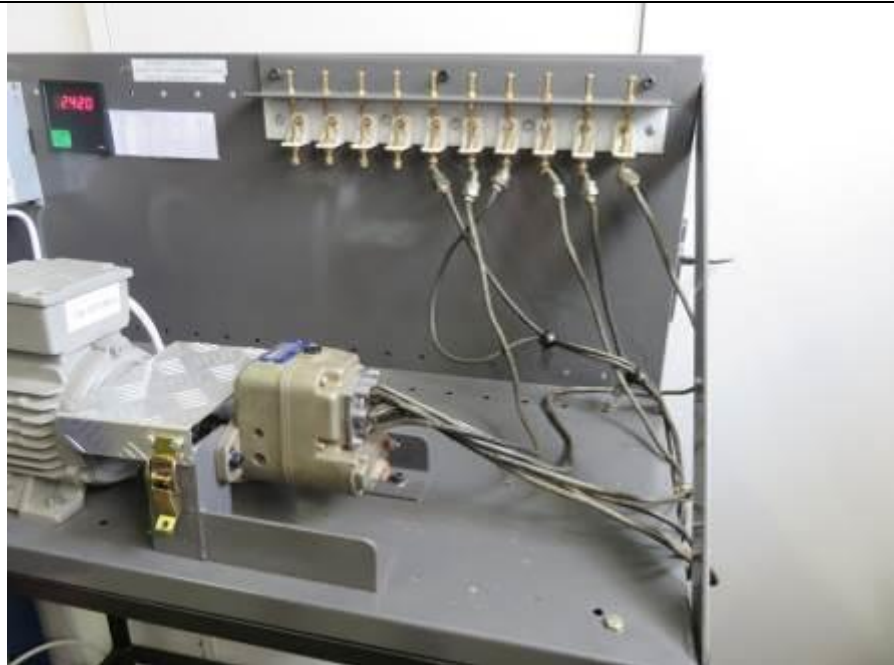
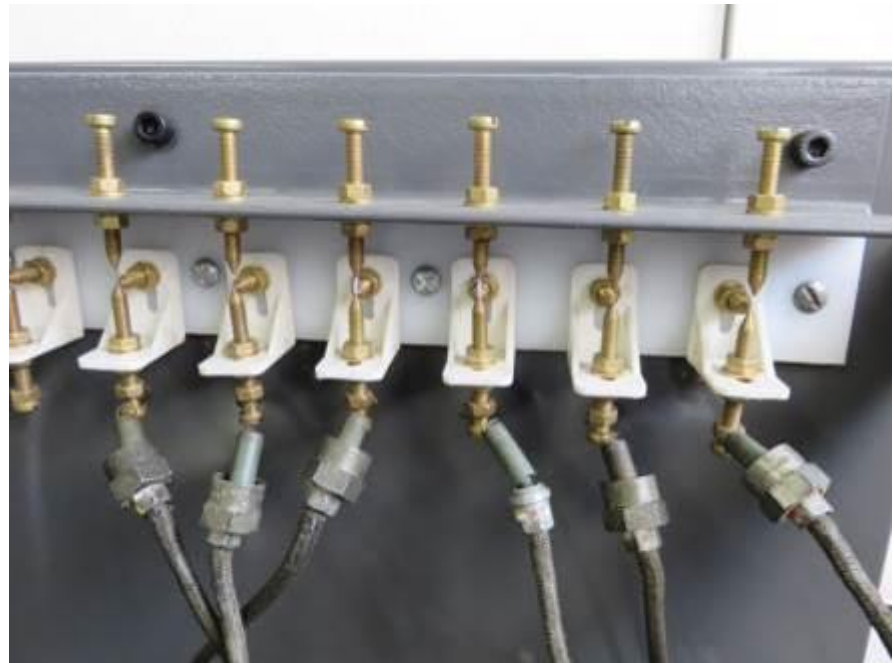
<p>HT harness: Slick</p>	<p>The high-tension harnesses were in good overall condition and were secured to both magnetos and all the spark plugs.</p>
<p>Magnetos: Alpha Systems #66B21784 (right side), #66B21783 (left side)</p>	<p>Both magnetos were still attached to the engine. The units did not sustain any damage and it was possible to bench-test both. The units were removed from the engine and subjected to a bench test at an approved electrical maintenance facility. During the bench test, both magnetos were found to function satisfactorily, providing spark over the entire rpm range tested.</p> <p>The photograph on the next page displays one of the magnetos being bench-tested.</p>

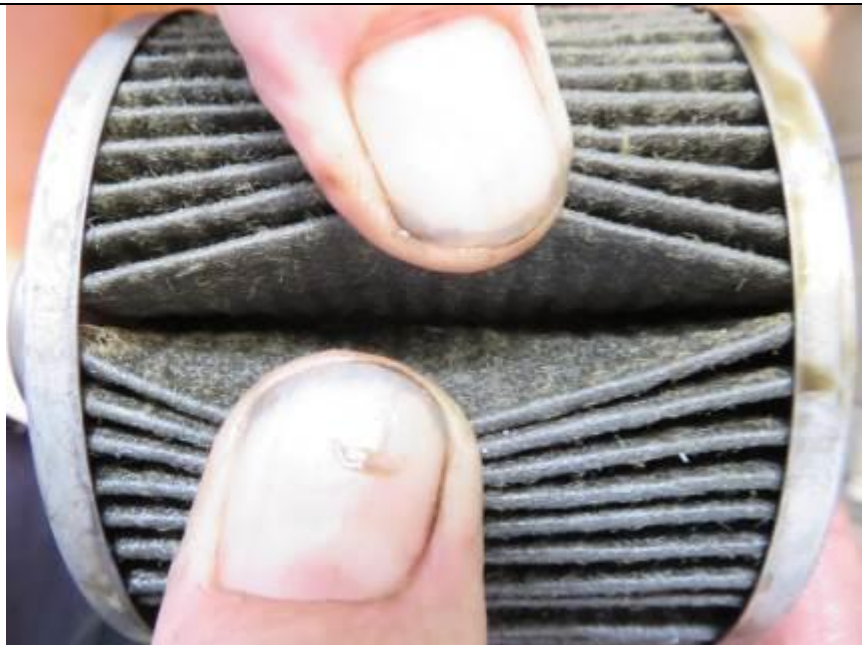
Oil filter

The filter unit was still attached to the engine and sustained minor impact damage. It was removed and the filter housing cut open. No evidence of dirt/debris was found in the filter element.

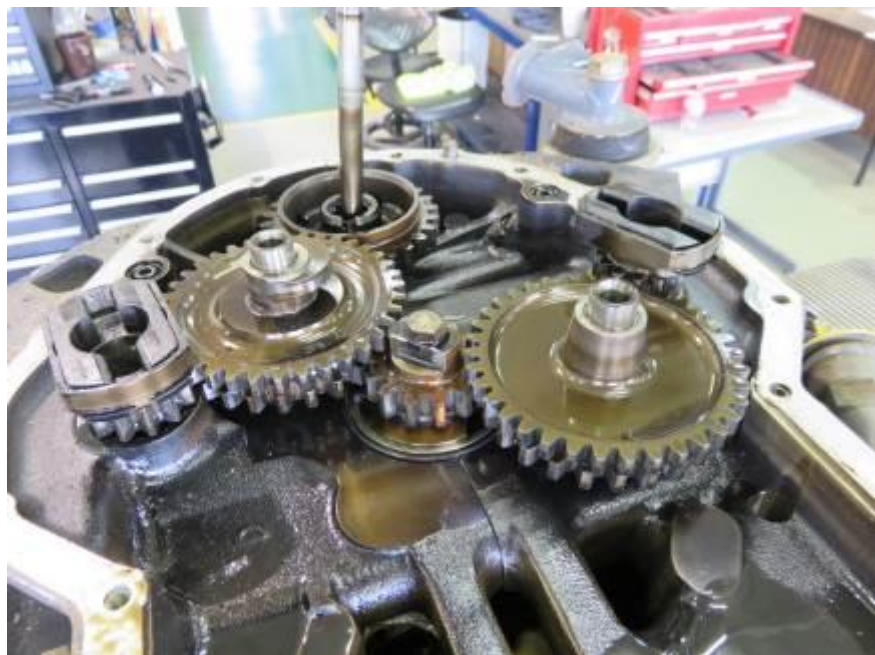
Gear drive
train

The gear drive train was undamaged (see photograph below).
