AIRCRAFT ACCIDENT REPORT AND EXECUTIVE SUMMARY

Reference:	CA18/2/3/9503	
Aircraft registration	ZS-SDJ	Date of accident	2 December 2015		Time of accident	0329Z
Type of aircraft	Robinson R44 Raven II		Type of operation		Private (Part 91)	
Pilot-in-command licence type		Commercial	Age	30	Licence valid	Yes
Pilot-in-command flying experience		Total flying hours	1 058,7		Hours on type	1 024,5
Last point of departure		Farm Uitenpas near the town of Musina, Limpopo province				
Next point of intended landing		Farm Ehrenbreitstein, Limpopo province				
Location of the accident site with reference to easily defined geographical points (GPS readings if possible)						
Portion 66 of the farm Musina (GPS position; 22°20.242' South 030°02.891' East), elevation 1780 ft AMSL						
Meteorological information		Surface wind: Light and variable; Temperature: 22°C; CAVOK				
Number of people on board	1 + 1	No. of people injured	0	No. of people killed	2	
Synopsis

AIRCRAFT ACCIDENT REPORT

Name of Owner : Central Africa Transport (Pty) Ltd
Name of Operator : Private (Part 91)
Manufacturer : Robinson Helicopter Company
Model : R44 Raven II
Nationality : South African
Registration : ZS-SDJ
Place : Musina

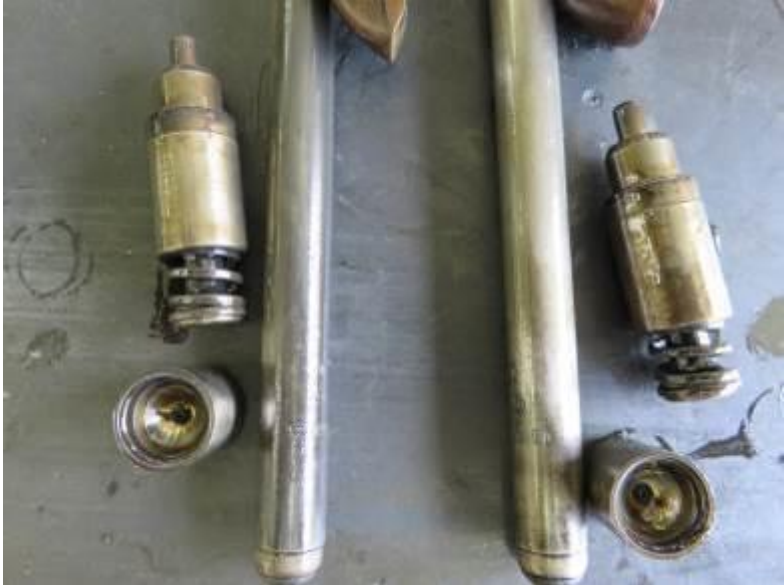
<p>*NOTE: The spark plugs were removed during the initial teardown examination before the cylinders were removed from the engine.</p>  
Pistons and rings	<p>The pistons were in a good overall condition and displayed evidence of carbon build-up associated with normal engine operation. None of the rings were broken and all of them could be freely rotated. The photograph below is of the No. 1 piston. The other pistons display a similar operational pattern.</p>  
Hydraulic lifters	<p>All the hydraulic lifters were removed. They were found to be in a good overall condition as displayed on the photograph on the next</p>

<p>page. The other lifters display a similar operational pattern.</p>

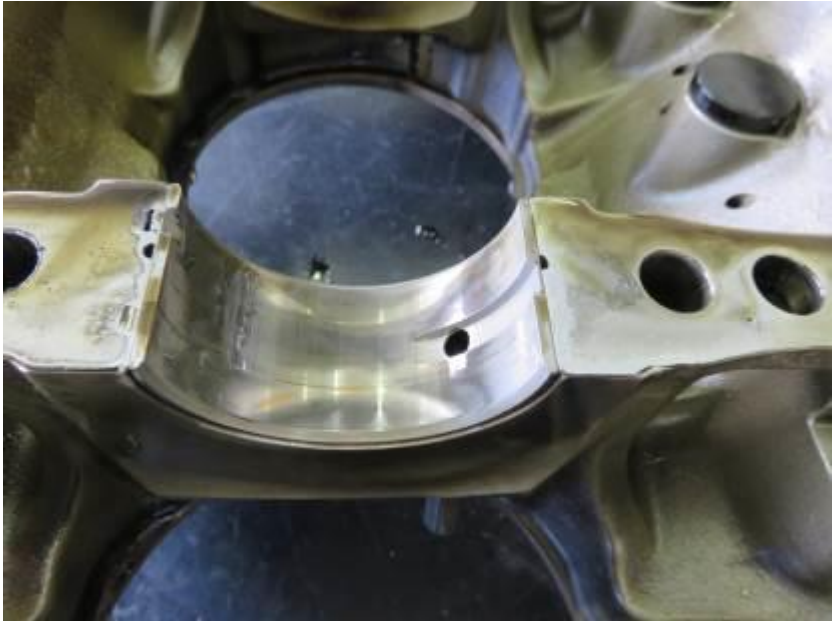
<p>Main bearings and big-end bearings</p>	<p>All the bearings were found to be in good overall condition and displayed evidence of adequate lubrication.</p>

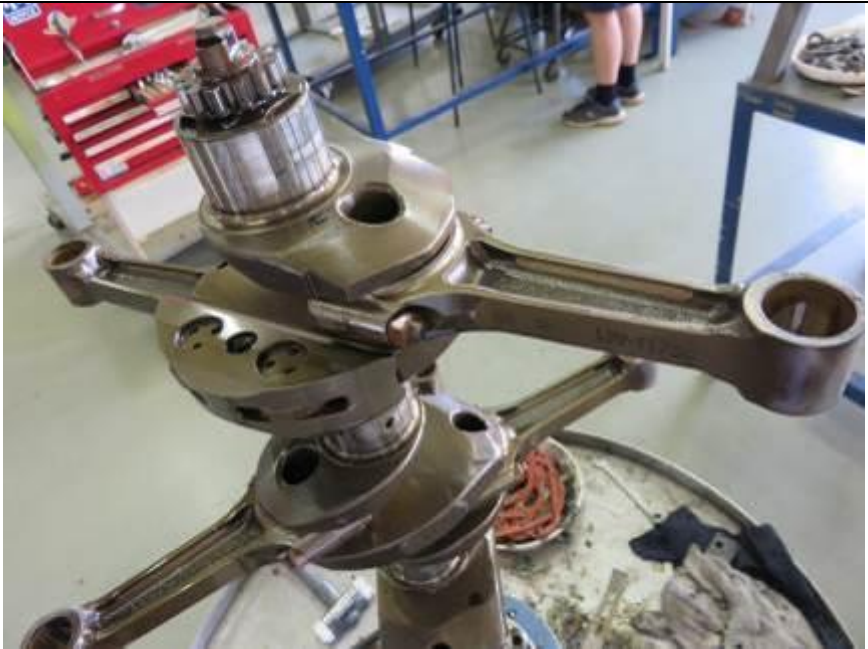
<p>Crankshaft</p>	<p>The crankshaft was found to be in overall good condition. In the photograph below the connecting rods are still attached to the crankshaft.</p>

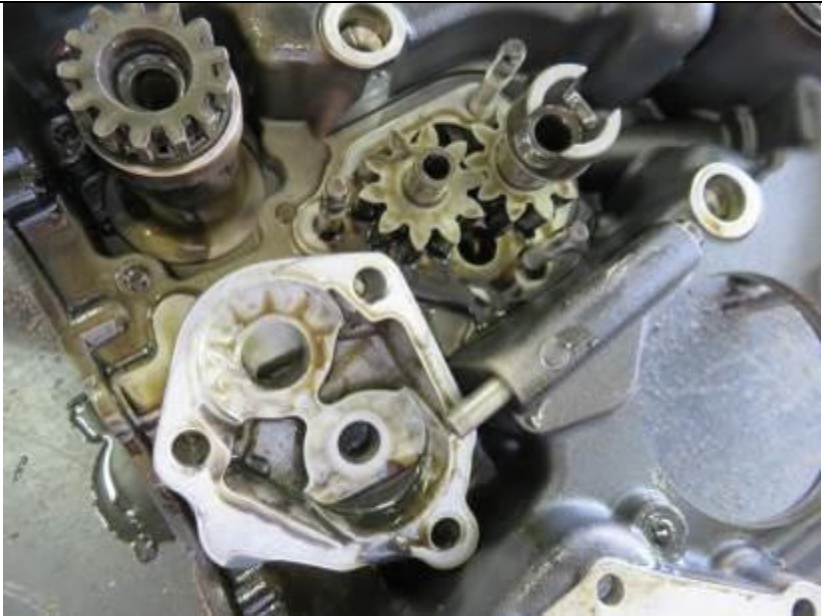
Camshaft	The camshaft was removed, including the gear drive assembly. All the lobes on the camshaft displayed evidence associated with normal engine operation.
Cylinder head/valve assembly	All the rocker covers were intact. The covers were removed and the valves with their associated valve springs were found to be intact and in good condition.
Oil cooler	The unit sustained minor impact damage.
Oil pump	The oil pump was found undamaged and in good condition. The oil in the engine was drained before disassembly.

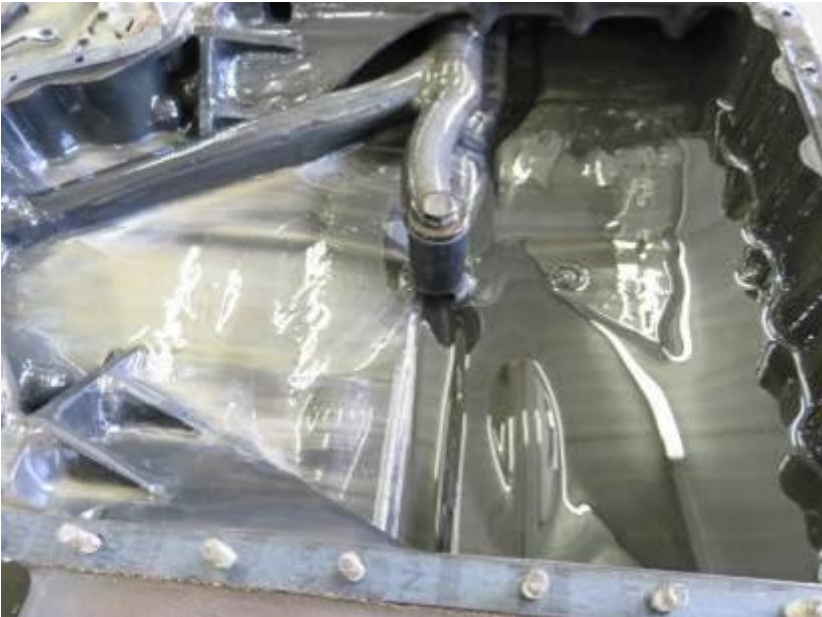
Oil sump	<p>The sump sustained minor impact damage but no oil leaked from the sump assembly. The oil was drained from the engine before disassembly. The oil pick-up in the sump was intact and free of any obstructions. The colour of the oil was dark (blackish).</p>

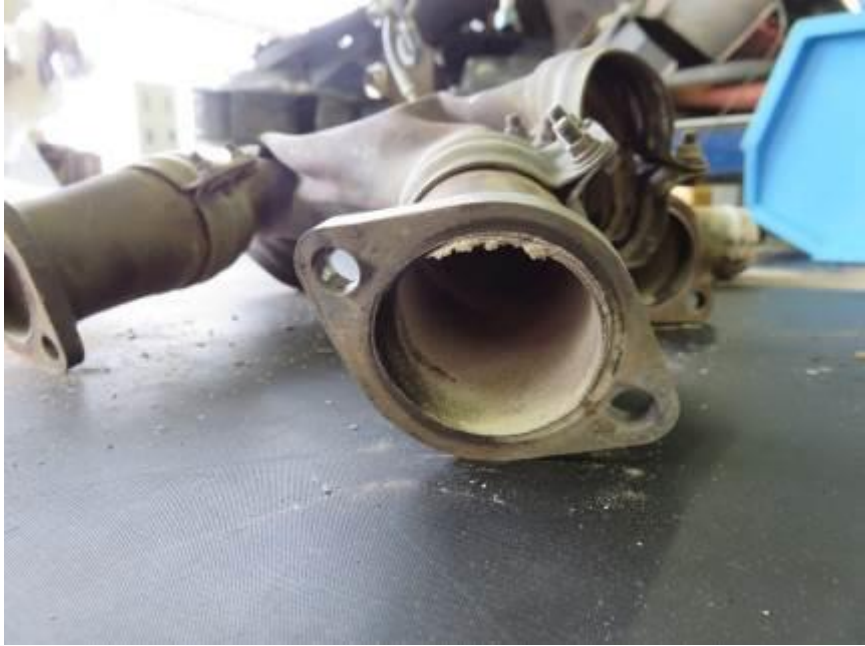
Alternative observations	<p>The exhaust stacks were inspected and were found to display a light brownish colour on the inside, which was associated with normal engine operation.</p>
