DUTCH
SAFETY BOARD

Loss of control during go-around

at Amsterdam Airport Schiphol

The Hague, June 2016

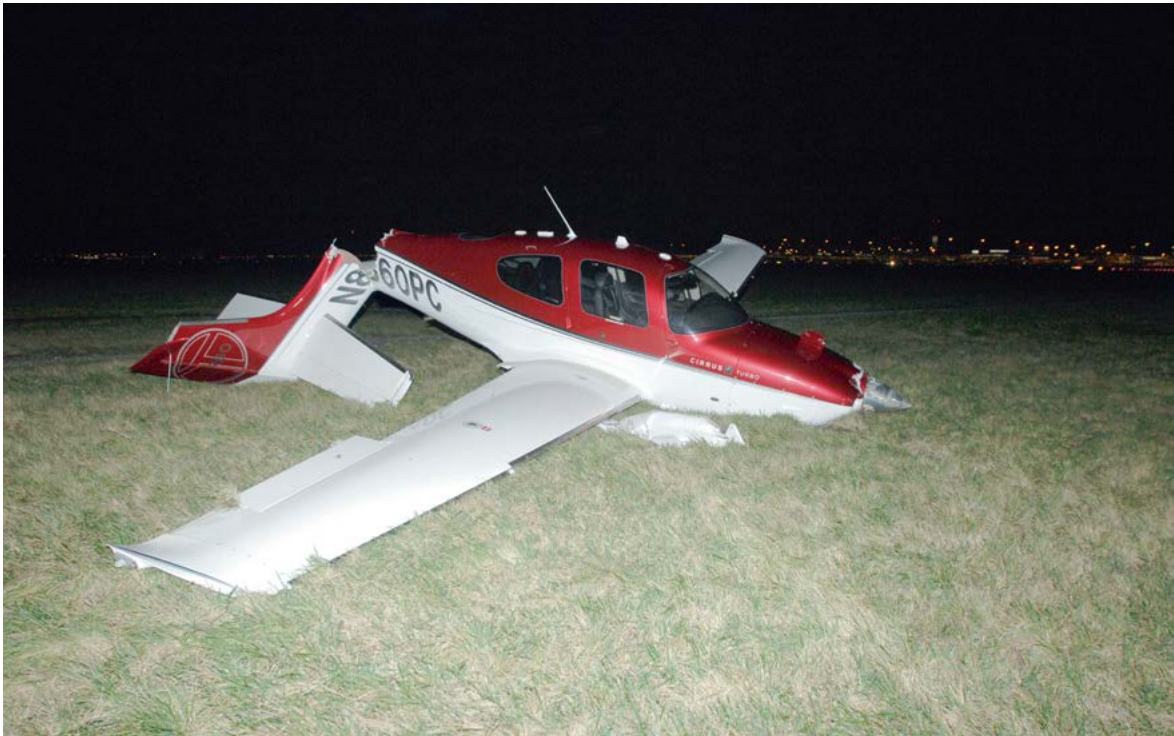
The aircraft sustained major damage during the accident. The left wing, nose cowling, propeller and main landing gear were damaged severely. The aircraft broke in two just behind the cockpit. The damage was such that the aircraft was considered beyond repair.

Figure 2: The damaged aircraft after the mishap. (Photo: Dutch Military Police)
