## AIRCRAFT ACCIDENT REPORT AND EXECUTIVE SUMMARY

CA18/2/3/9520

<b>Aircraft Registration</b>	ZS-PME	<b>Date of Accident</b>	3 February 2016		<b>Time of Accident</b>	0945Z
<b>Type of Aircraft</b>	Piper PA-32-300			<b>Type of Operation</b>	Private (Part 91)	
<b>Pilot-in-command Licence Type</b>	Private Pilot Licence	<b>Age</b>	63	<b>Licence Valid</b>	Yes	
<b>Pilot-in-command Flying Experience</b>	<b>Total Flying Hours</b>	4130.90		<b>Hours on Type</b>	388.6	
<b>Last Point of Departure</b>	Brakpan Aerodrome (FABB), Gauteng Province					
<b>Next Point of Intended Landing</b>	Entabeni Lodge, Limpopo Province					
<b>Location of the accident site with reference to easily defined geographical points (GPS readings if possible)</b>						
500m past the end of Runway 36 at FABB (GPS position 26° 13, 35.54"S 028° 17' 54.06"E) Elevation 5300ft AMSL						
<b>Meteorological Information</b>	Wind: 300°/10°kt; Temperature: 27°C; Dew point: 10°C; Visibility: CAVOK; Clouds: Few

**AIRCRAFT ACCIDENT REPORT**

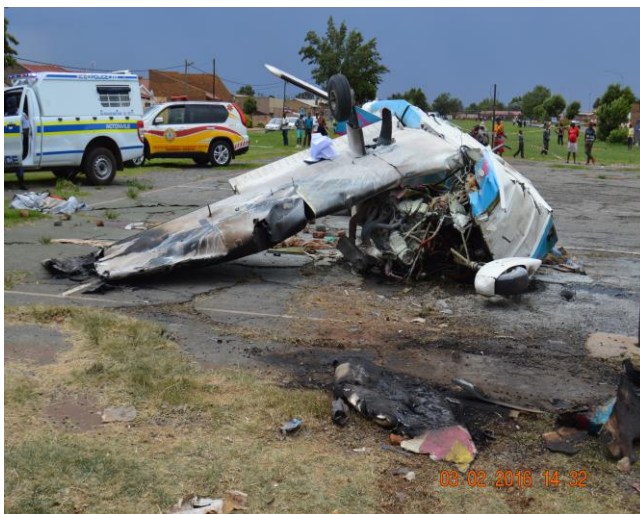
1.3.1 The aircraft was destroyed during the impact sequence and by the post-impact fire that erupted.

**Figure 2:** The aircraft in an inverted attitude.

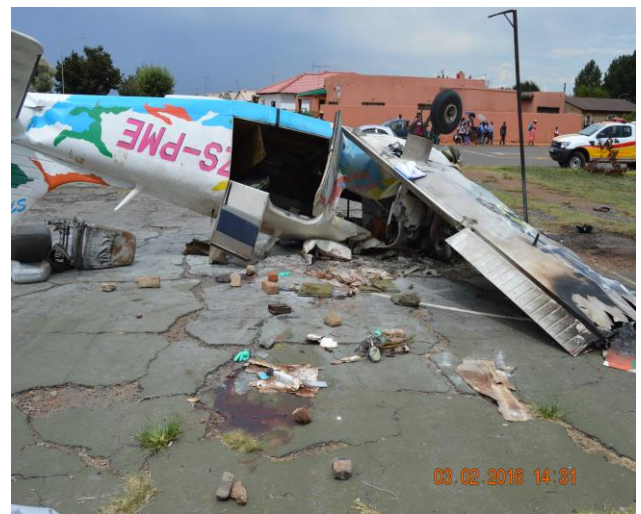
**Figure 3:** Another view of the aircraft.

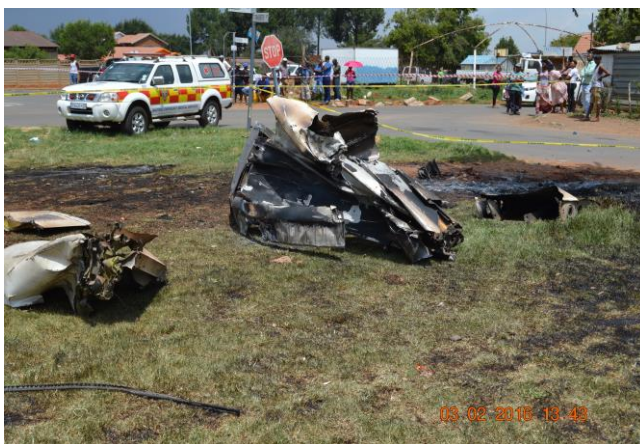
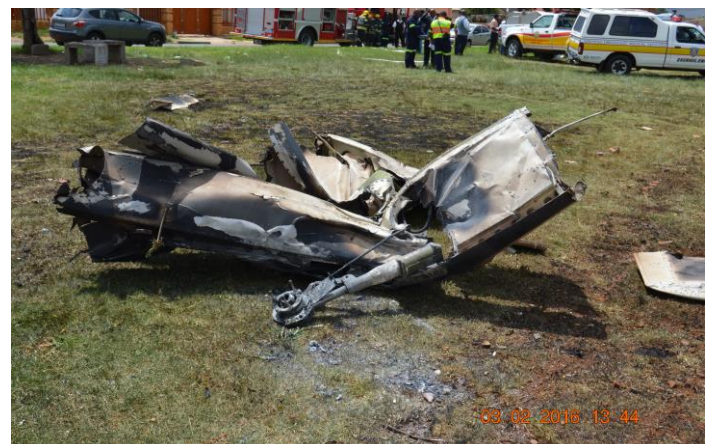
**Figures 4 and 5:** The left-hand wing at the accident site.

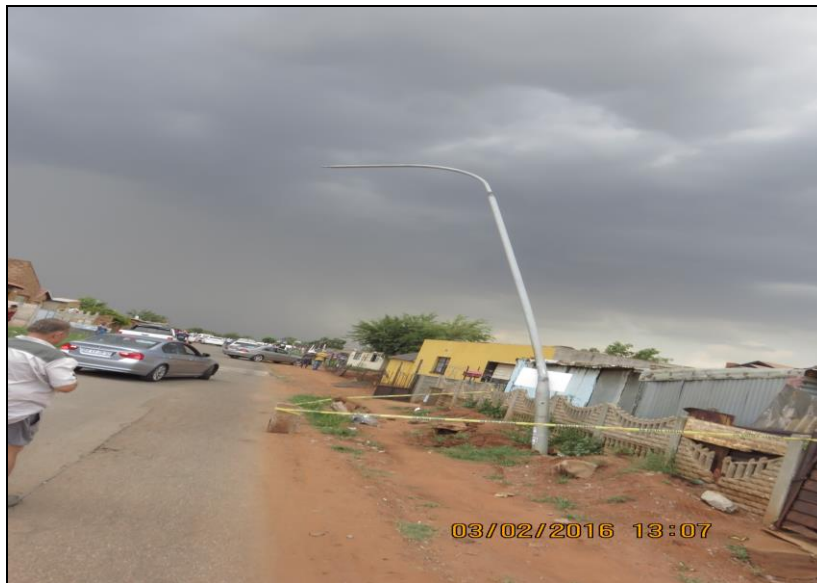
- 1.4.1 A street light pole, a brick wall and the roof of a shack were damaged during the accident sequence.

**Figure 6:** A street light pole that was impacted by the aircraft.

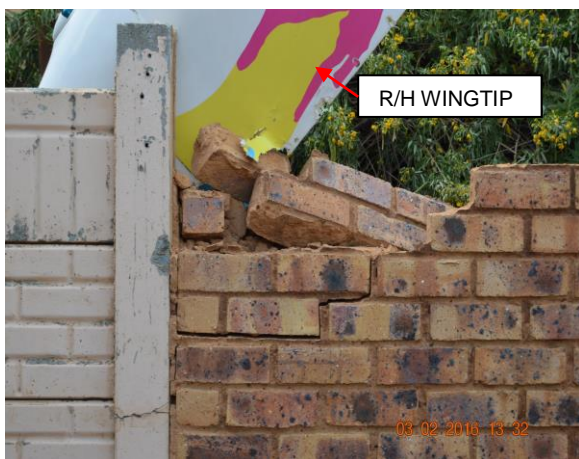
**Figure 7:** Damage to the brick wall.

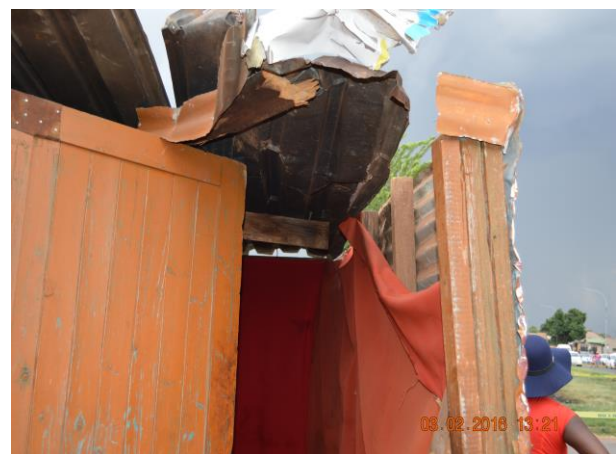
**Figure 8:** The damaged shack.

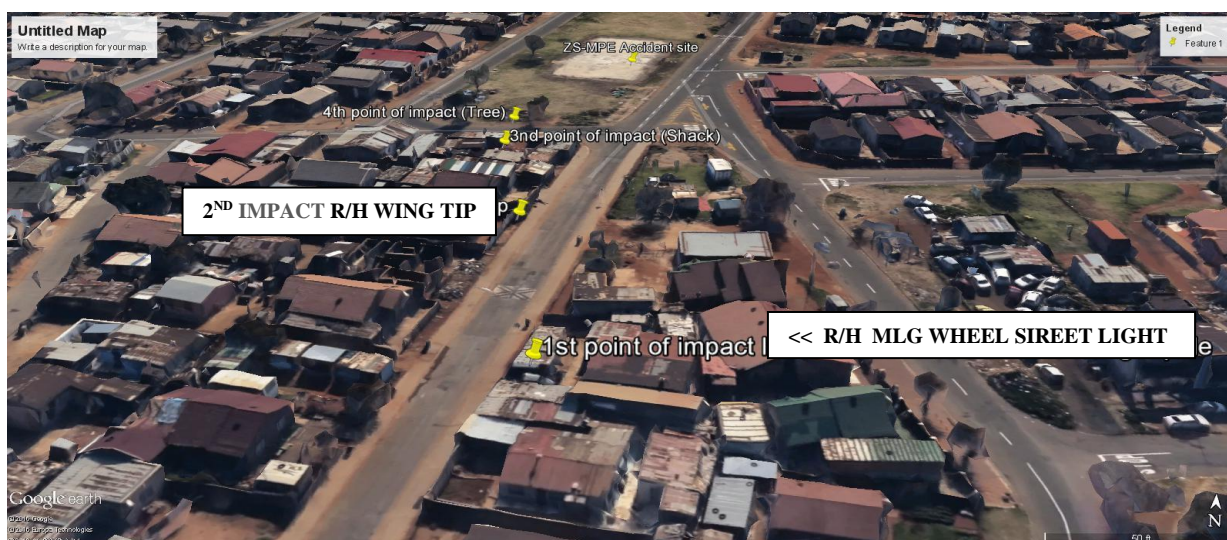
- 1.12.1 The aircraft's right-side main landing gear wheel initially impacted a street light pole approximately 500m past the end of the runway after the aircraft took off from Runway 36 at FABB. The aircraft's right-side wing-tip then collided with a brick wall 60m from the first point of impact, causing the wing-tip to break off.
- 1.12.2 The aircraft then impacted the roof of a shack, approximately 30m further on before the right-side wing impacted a tree and then the ground. The right-side wing was severed from the aircraft during the impact sequence with the tree, where after, the main wreckage skidded for approximately 28m before it came to rest in an inverted attitude. A post-impact fire erupted, which destroyed the main wreckage.

**Figure 9:** Illustration of points of impact during the accident.

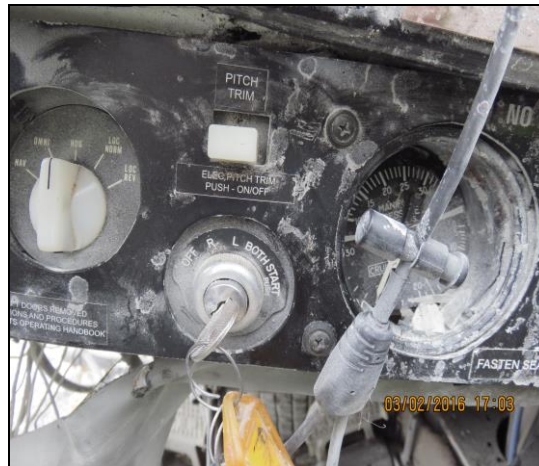
**Figure 10:** The image shows the ignition key and its position.

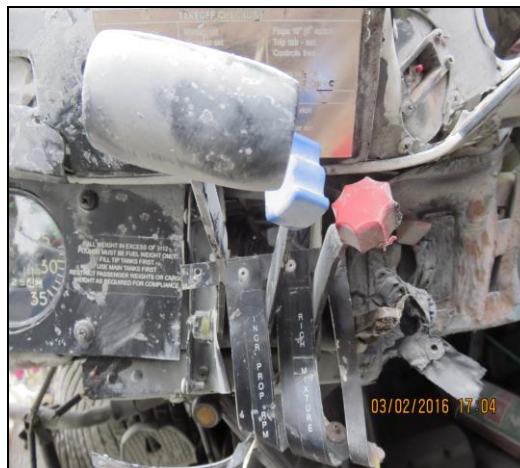
**Figure 11:** The engine and propeller controls and their positions.

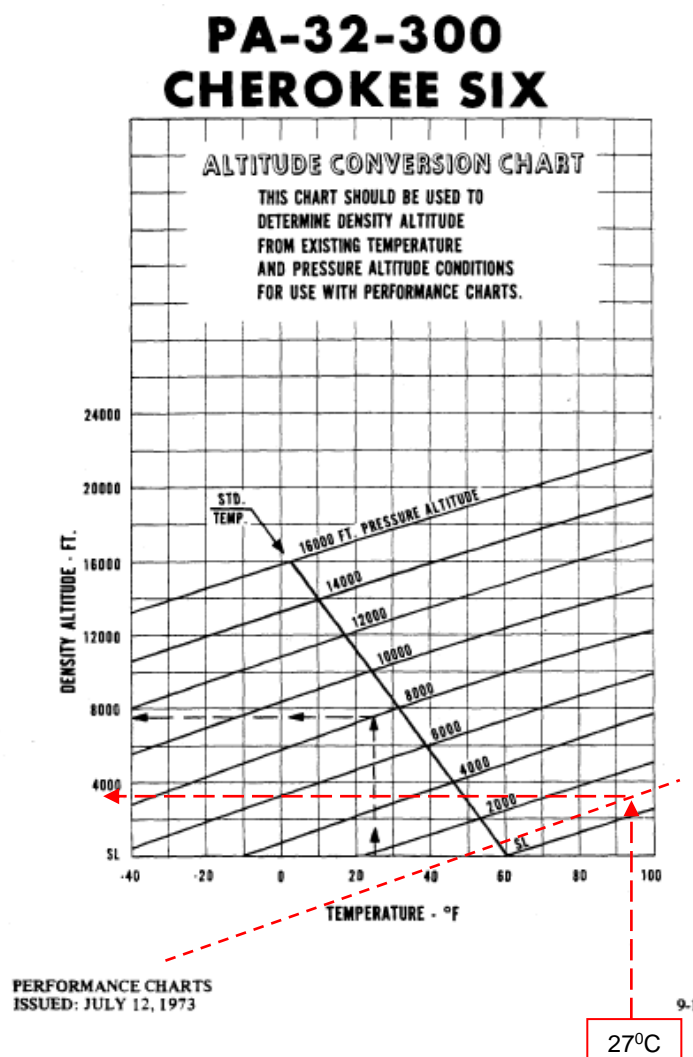
Chart 1: Density Altitude Graph.

1.18.2 The density altitude was determined using a standard density altitude chart which determined it to be 8100ft (see Chart 1).

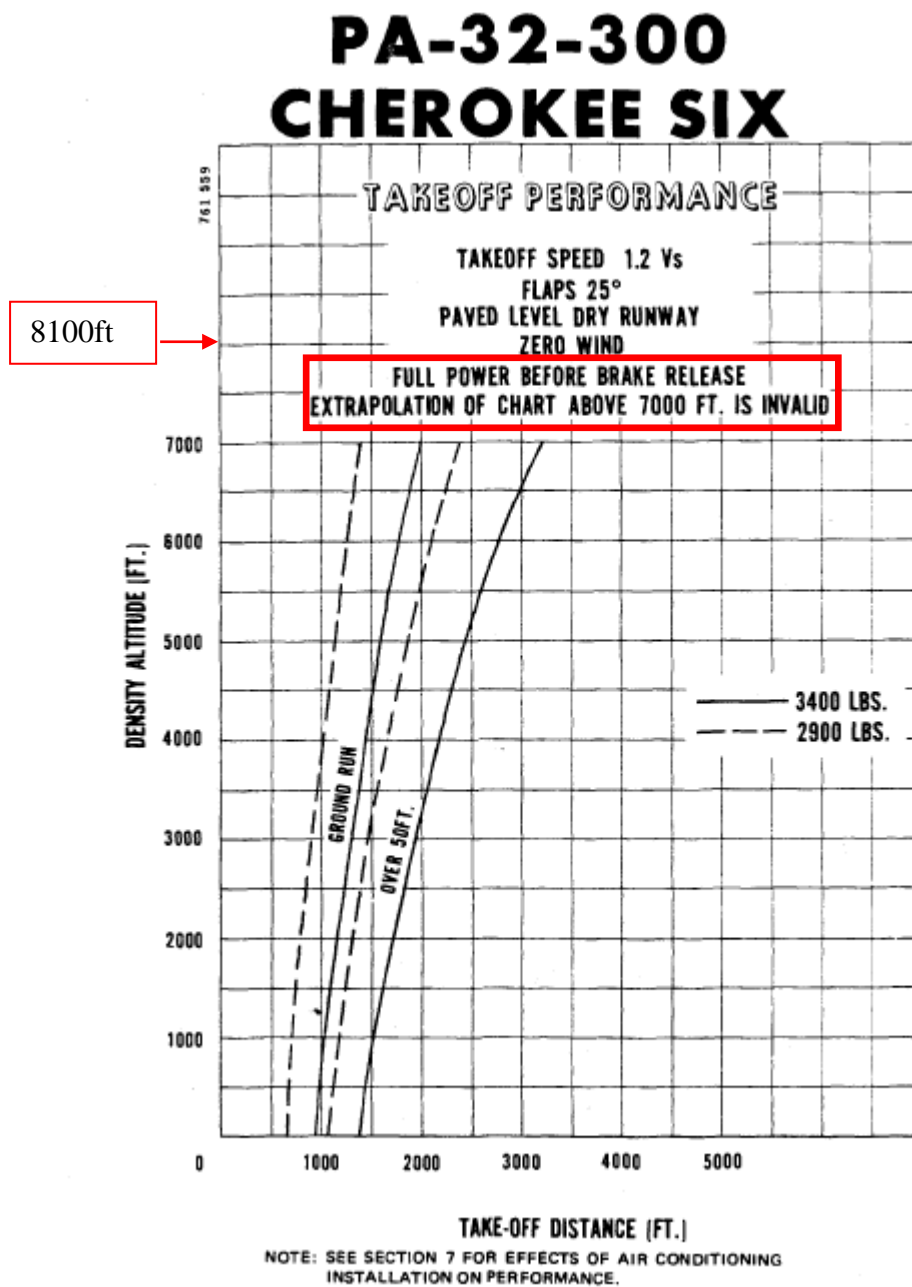
Chart 2: Take-off performance chart

1.18.3 The investigation determined that the PA 32-300 take-off performance chart invalidates any operations above 7000ft density altitude and the density altitude was calculated to be at 8100ft (see the take-off performance chart).

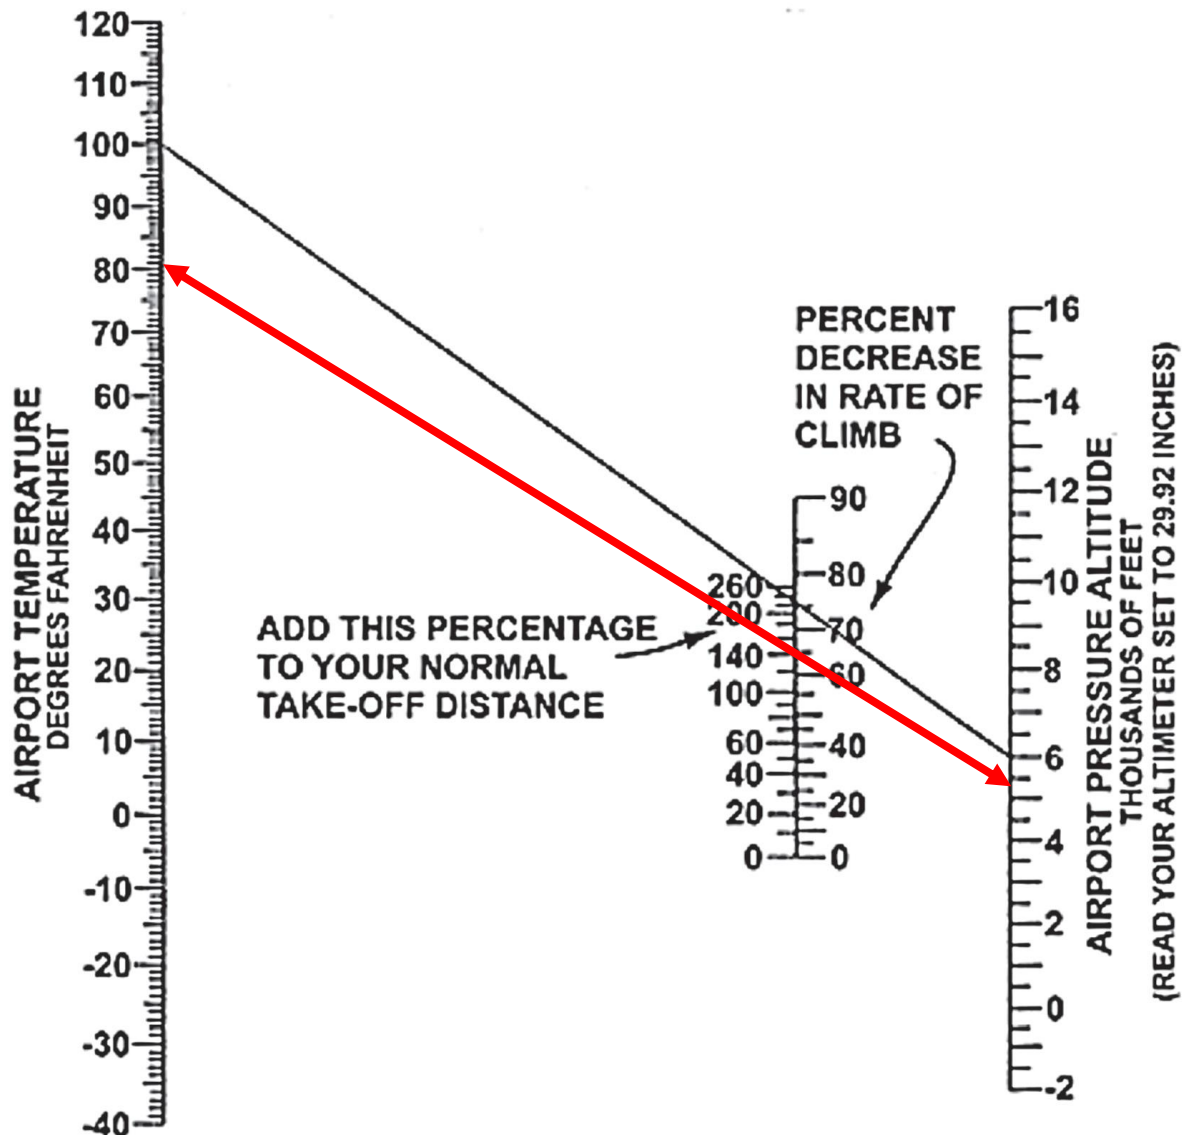
Koch graph

1.18.5 The Red diagonal line shows that 140% must be added for a temperature of 27°C (80.6°F) and a pressure altitude of 5300ft (1615.4m). Therefore, with the standard temperature for the sea level take-off distance requiring 1500 feet of runway to climb to 50 feet, it would become 3600 feet under the conditions shown in the chart. In addition, the rate of climb would be decreased by 65 percent. Which means this aircraft normal sea level rate of climb is 1050 feet per minute, it would become 368 feet per minute.
