AIRCRAFT ACCIDENT REPORT AND EXECUTIVE SUMMARY

Reference:	CA18/2/3/9528	
Aircraft Registration	ZU-EFO	Date of Accident	13 March 2016		Time of Accident	1530Z
Type of Aircraft	Ela-08 Gyrocopter		Type of Operation		Private (Part 91)	
Pilot-in-command Licence Type		National Pilot License	Age	46	Licence Valid	Yes
Pilot-in-command Flying Experience		Total Flying Hours	unknown		Hours on Type	unknown
Last point of departure		Ellisras Airport (FAER), Lephalale, Limpopo Province				
Next point of intended landing		Ellisras Airport (FAER), Lephalale, Limpopo Province				
Location of the accident site with reference to easily defined geographical points (GPS readings if possible)						
On the private farm, Fancy Farm in the Lephalale area approximately 17km from Lephalale Aerodrome (GPS coordinates: S23°52'38.44" E27°38'47.01")						
Meteorological Information		Temperature: 29°C; Dew point: 21°C; Wind 240°/01 kt; Visibility: 10 000 m; Cloud Cover: None

AIRCRAFT ACCIDENT REPORT

Name of Owner : D. Du Plessis
Name of Operator : Private
Manufacturer : Ela Aviacion
Model : Ela-08
Nationality : South African
Registration Marks : ZU-EFO
Place : Lephalale, Limpopo Province
Date : 13 March 2016
Time

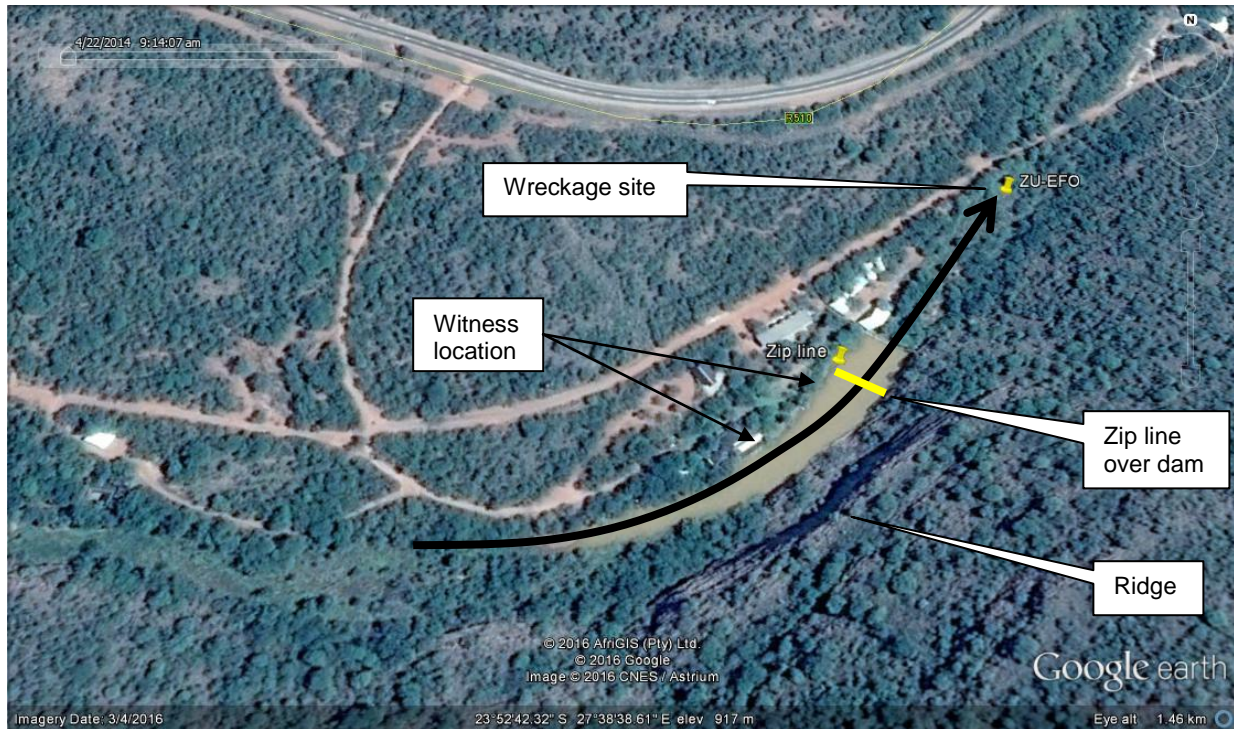
1.1.1 On Sunday, 13 March 2016 the pilot and a passenger took off from Ellisras Airport (FAER) in Lephalale, Limpopo Province, with the intention of conducting a private flight in the area and then landing back at Ellisras Airport. Witnesses who were sitting on the sundeck of a guest lodge next to the dam saw the aircraft flying past them low and fast, approximately two metres above the water's surface.

Figure 1: View of aircraft flight path

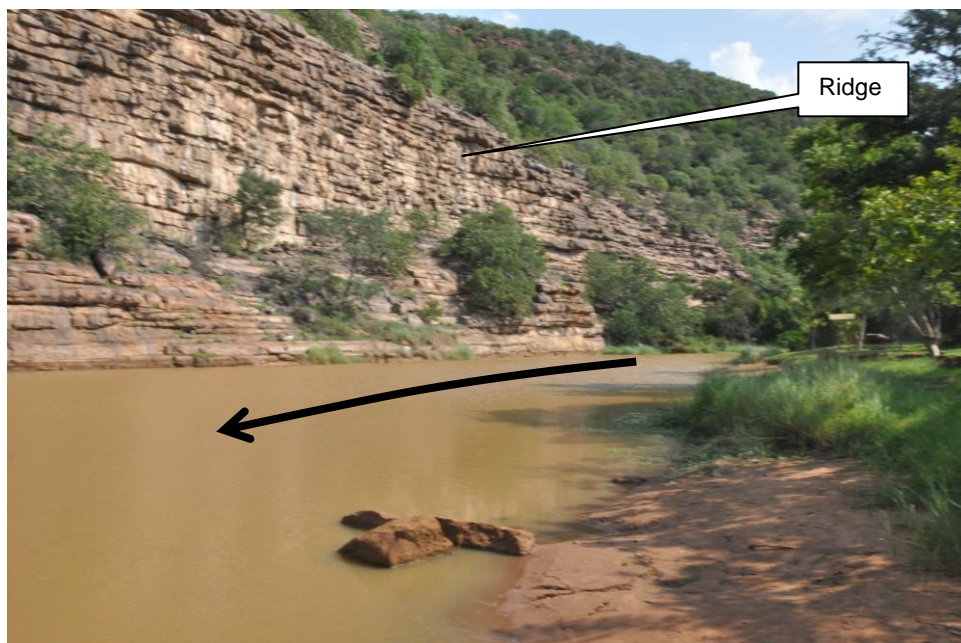
1.1.2 The aircraft was seen flying over the length of a dam situated on the private farm, Fancy Farm in the Lephalale area. The left side of the dam was lined with trees and a mountain ridge was lining the right side of the dam. The unobstructed flight path width was 10 metres at the narrowest part and 35 metres at the widest section. Three other witnesses who were busy fishing at the dam stated that the aircraft was flying low and fast, approximately two metres above the water's surface when it impacted the zip line cable which spanned across the dam. The pilot then lost control of the aircraft where after it crashed into a bushy terrain on the farm.

Figure 2: View of aircraft flight path

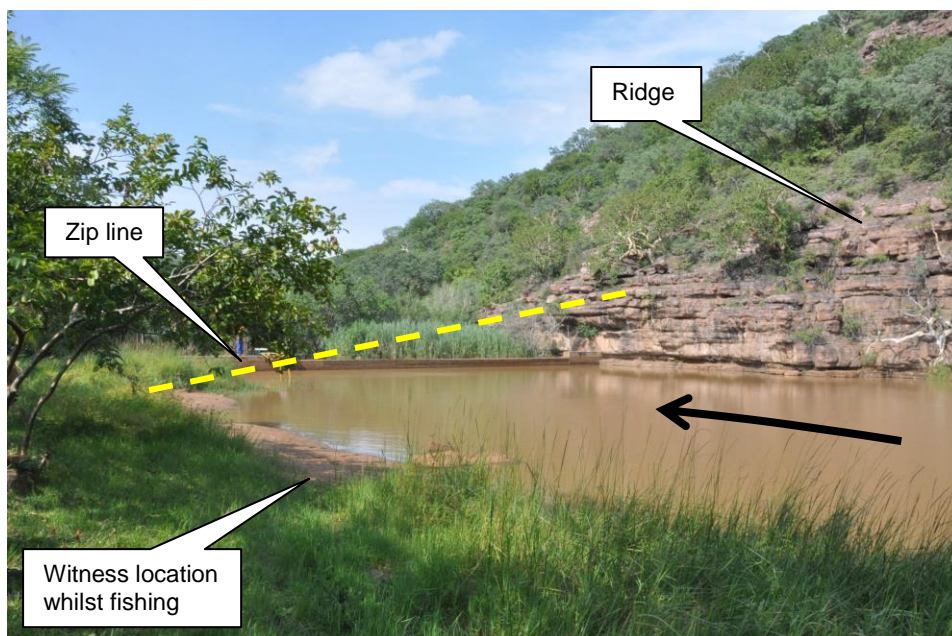
Figure 3: View of aircraft flight path and zip line

1.12.1 The aircraft was seen flying over a farm dam in a north easterly direction at approximately two metres above the water's surface when it impacted a zip line cable which spanned across the dam. The aircraft then crashed into a bushy terrain on the private farm.

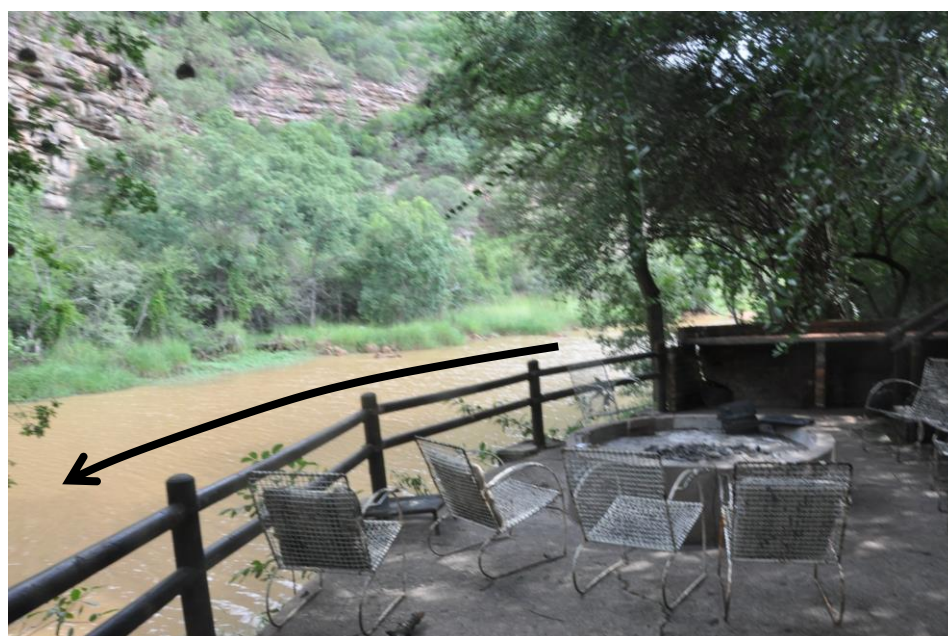
Figure 4: View of where the witnesses were sitting when the aircraft flew pass

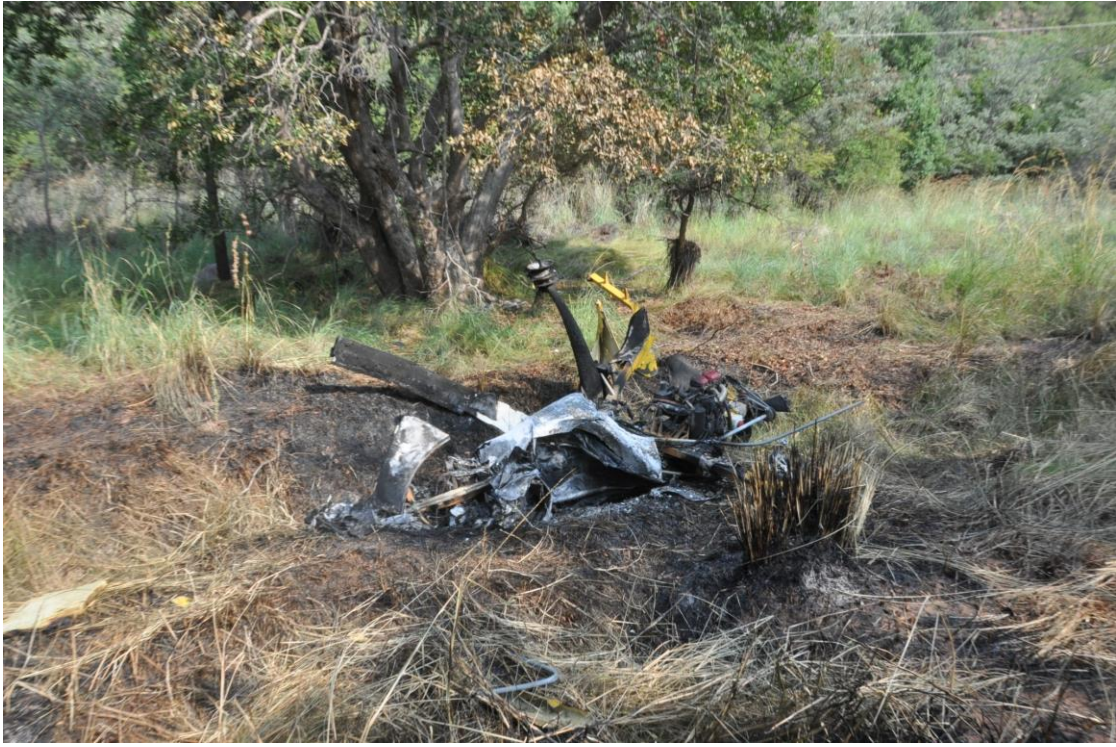
1.3.1 The aircraft was destroyed during the accident.

Figure 5: View of aircraft wreckage

1.12.3 The fuselage including landing gear and fuel tank was destroyed by a post-impact fire. The engine was also partially burnt by the post-impact fire. The tail of the aircraft was found approximately 4 metres from the main wreckage. The damage on the propeller indicated impact with the zip line cable. Propeller blade damage was consistent with the engine producing power at impact.

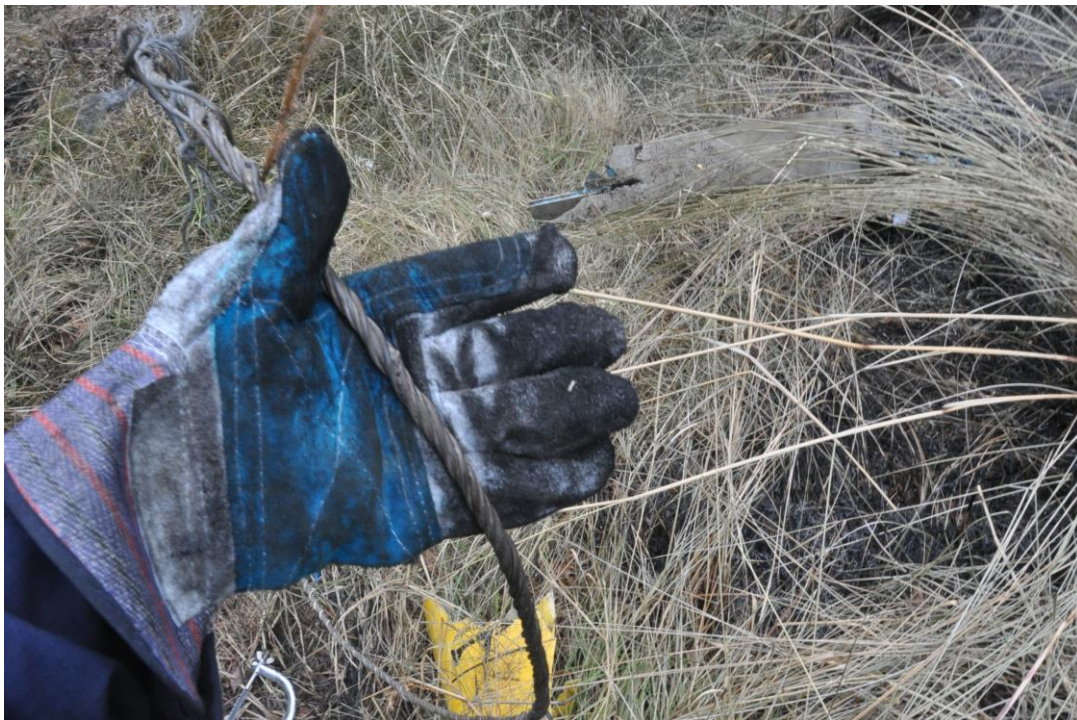
- 1.4.1 The vegetation in area where the aircraft crashed burnt and a zip line was damaged.

Figure 6: The zip line cable that the aircraft impacted

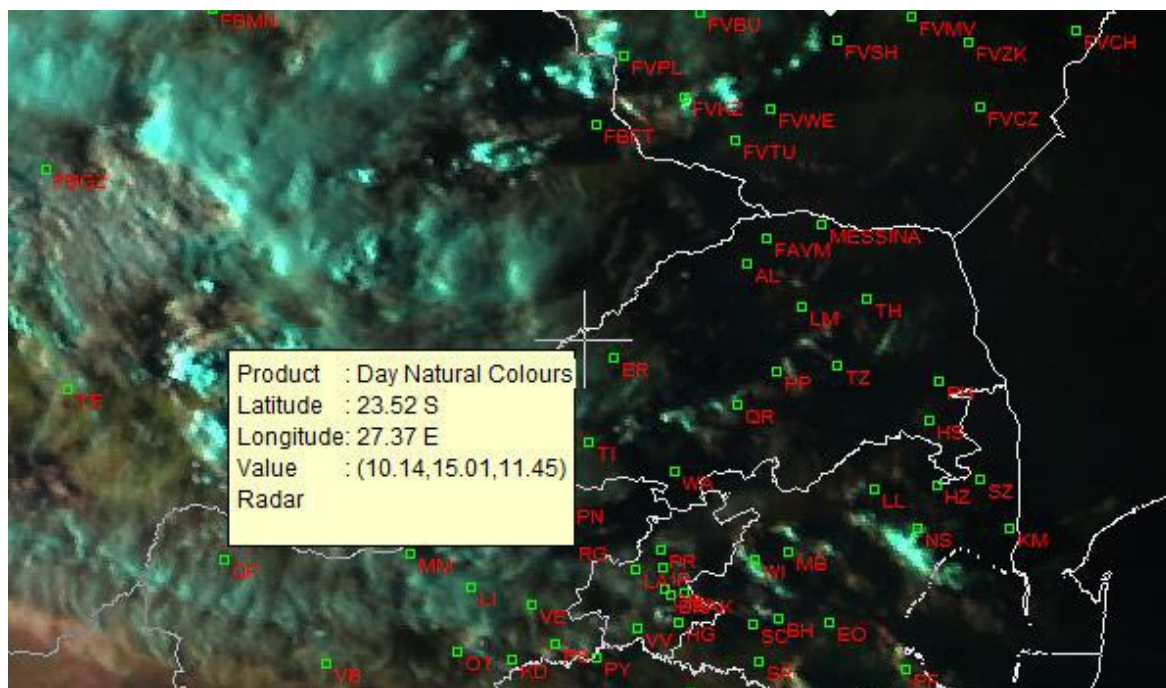
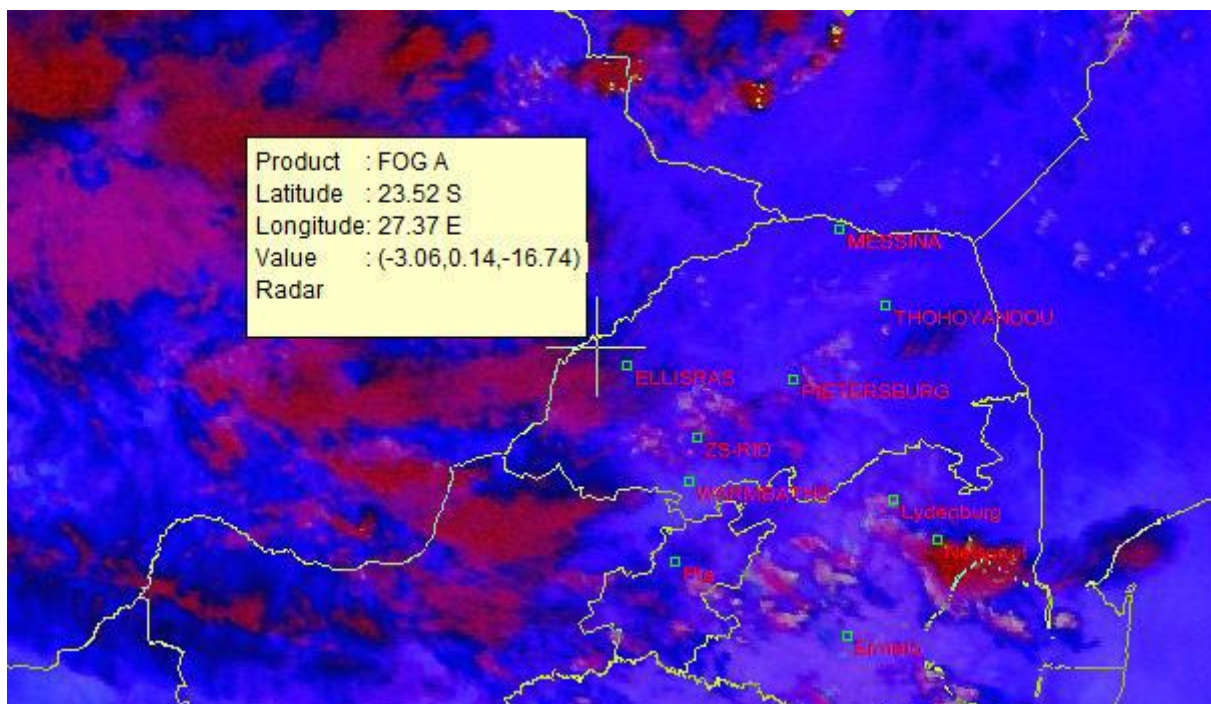
The cross on the above satellite images indicates the GPS position of the accident scene (both images are valid for 16H00 UTC). It can be seen that there were active thunderstorms over south eastern Botswana during this time. No active thunderstorm is visible at the accident site, although it looks like a thunderstorm dissipated to the south west not long ago. The proximity of this decaying thunderstorm to the accident site could've caused turbulence in the area as the updraft within the cell "collapsed", possibly causing a strong downdraft. No low cloud is visible in the satellite images (the surface observations support this).

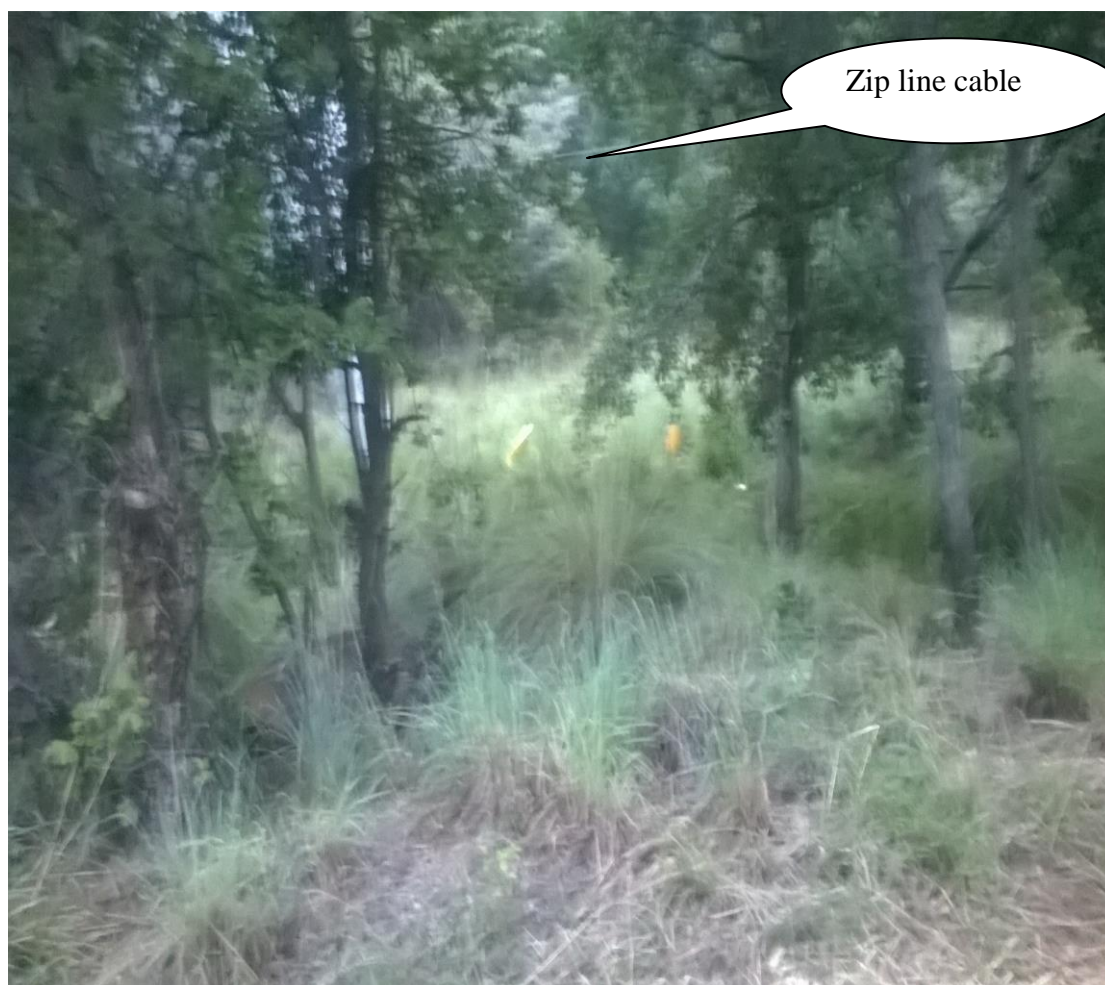
1.12.2 The wreckage path indicated that after the aircraft impacted the zip line cable, it crashed into tree tops and to the ground approximately 180 metres from the zip line cable.

Figure 10, Zip line cable position image
