AIRCRAFT ACCIDENT REPORT AND EXECUTIVE SUMMARY

Reference: CA18/2/3/9550	
Aircraft Registration		ZS-PYJ	Date of Accident		11 May 2016
Type of Aircraft		Cessna C172	Type of Operation		Training Part 91
Pilot-in-command Licence Type		PPL	Age	26	Licence Valid Yes
Pilot-in-command Flying Experience		Total Flying Hours	141,2	Hours on Type	66,8
Last point of departure		Grand Central Airport FAGC – Gauteng			
Next point of intended landing		Grand Central Airport FAGC – Gauteng			
Location of the accident site with reference to easily defined geographical points (GPS readings if possible)					
Open field at 550m in the direction 120 degree from the threshold at GPS: S25° 59' 48.53", E028° 08' 58.03"					
Meteorological Information		Wind direction: 340; Wind speed: 6 kt; Wind Temperature: 12 °C; Visibility: Night (IFR).			
Number of people on board	1+1	No. of people injured	2	No. of people killed	0
Synopsis					
<p>A pilot accompanied by a passenger was engaged on an hour-building exercise when the accident occurred. On the day of the accident, the pilot was conducting a navigational exercise during night visual meteorological conditions. The pilot intended to do a full stop landing at FAGC

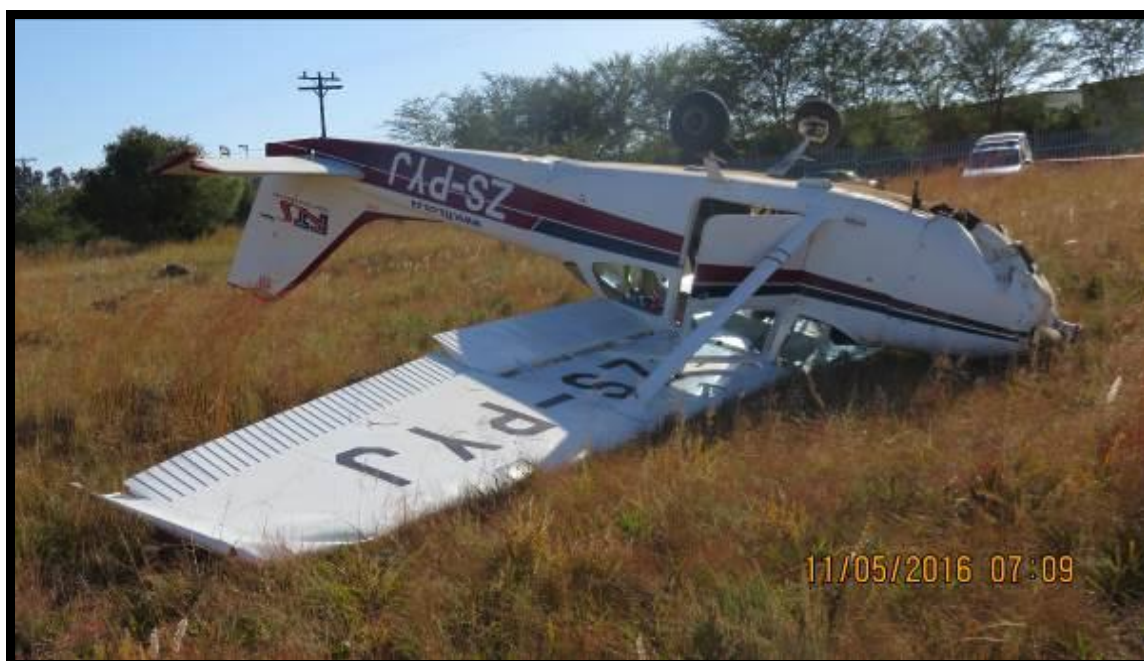
Figure 2: Aircraft damage

- 1.13.1 The aircraft sustained substantial damage to the nose landing gear, nose section, left wing struts and the vertical stabiliser.

1.12.3 Apart from the damage to the collapsed landing gear, the engine mountings and cowlings were also damaged when the nose landing gear was ripped off. The aircraft then flipped over on its roof, with its nose facing the opposite direction. This caused the vertical stabiliser to hit the ground hard and caused compression damage. The propeller remained intact and undamaged, indicating that it was not turning at the time of the accident sequence. The aircraft engine was turning freely with no signs of anomalies following the post-accident on-site inspection. According to the flight accident assessor, the aircraft was considered a write-off. The on-site

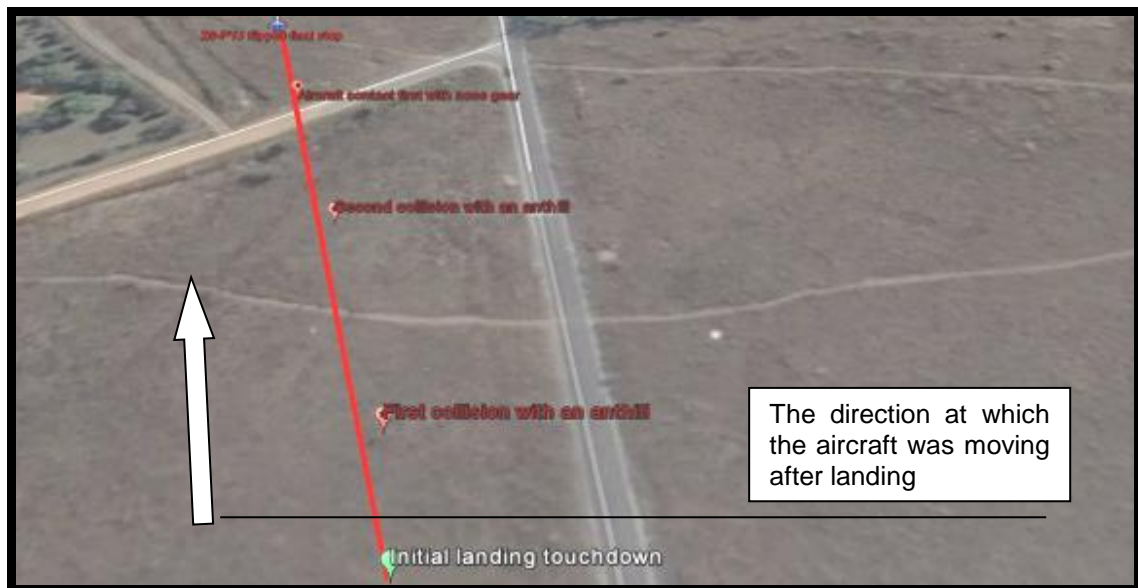
Figure 3: Google view of the aircraft touchdown path

1.12.1 The aircraft accident occurred on a short final during landing approach for Runway 35 at a distance of approximately 550 m at an angle 120 degrees from the threshold. The aircraft landed in an open area with an uneven surface, on a route next to electrical power lines. There are several anthills along the aircraft's route path. The aircraft's initial touchdown was at approximately 180 metres (GPS: S 25 59 52.76, E 028 9 1.05) away from the final resting point. According to the pilot's statement, he was aware of the area that he chose for the forced landing.

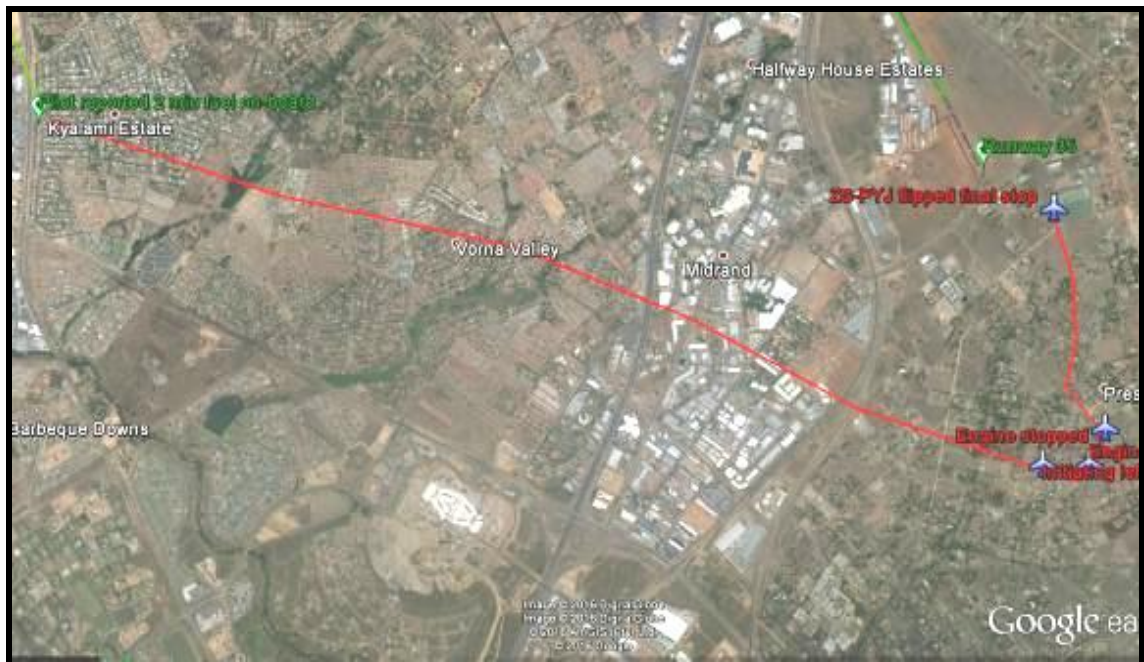
Figure 4: Google view of the final aircraft path

1.12.2 After the initial touchdown during the forced landing, the aircraft bounced over some anthills on its main wheels whilst the nose gear was still in the air. Another two bounces over more anthills followed, along its landing roll path. On the last bounce, the nose-gear hit the ground hard and collapsed, upon which the aircraft flipped over. The nose landing gear broke the wheel fork assembly before it collapsed.

3.3.3 Uneven landing surface (The aircraft flipped over subsequent to nose landing gear collapsed after it collided several time with the anthills along its forced landing roll path)

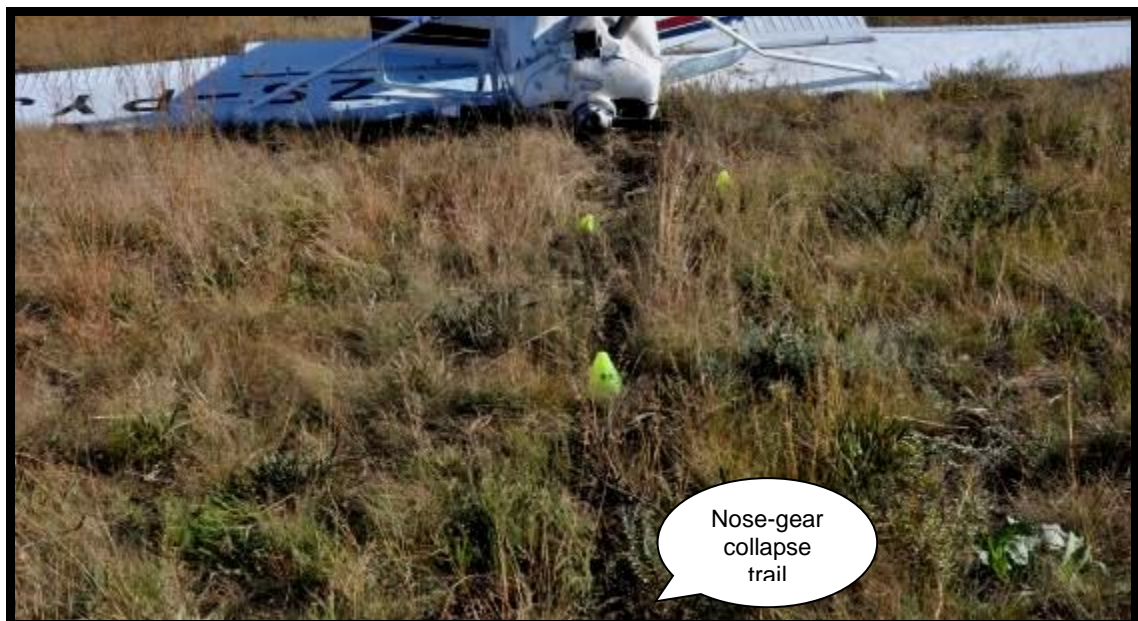
Figure 5: Shows the nose landing gear trail as it rips off
