AIRCRAFT ACCIDENT REPORT AND EXECUTIVE SUMMARY

Reference: CA18/3/2/9567

AIRCRAFT ACCIDENT REPORT

Name of Owner/Operator : Muller M
Manufacturer : Aviate Products CC
Model : Raptor 582 Trike
Nationality : South African
Registration Marks : ZU-CEA
Place : Open field on the corners of Langkloof and Rogers in Alrode
Date : 31 August 2016
Time : 1352Z

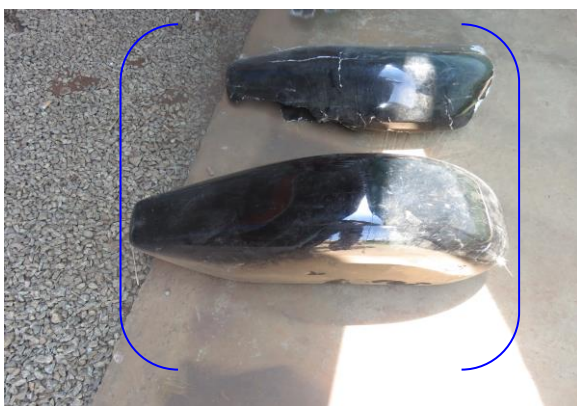
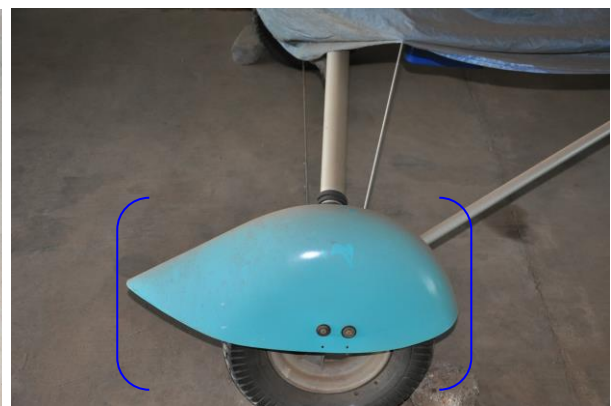
Figures 1: Main wheel fairings found at the accident site. *NOTE: Both fairings did not have attachment points to allow fitment to the wheel axles. The picture on the right illustrates how the fairing looks when fitted

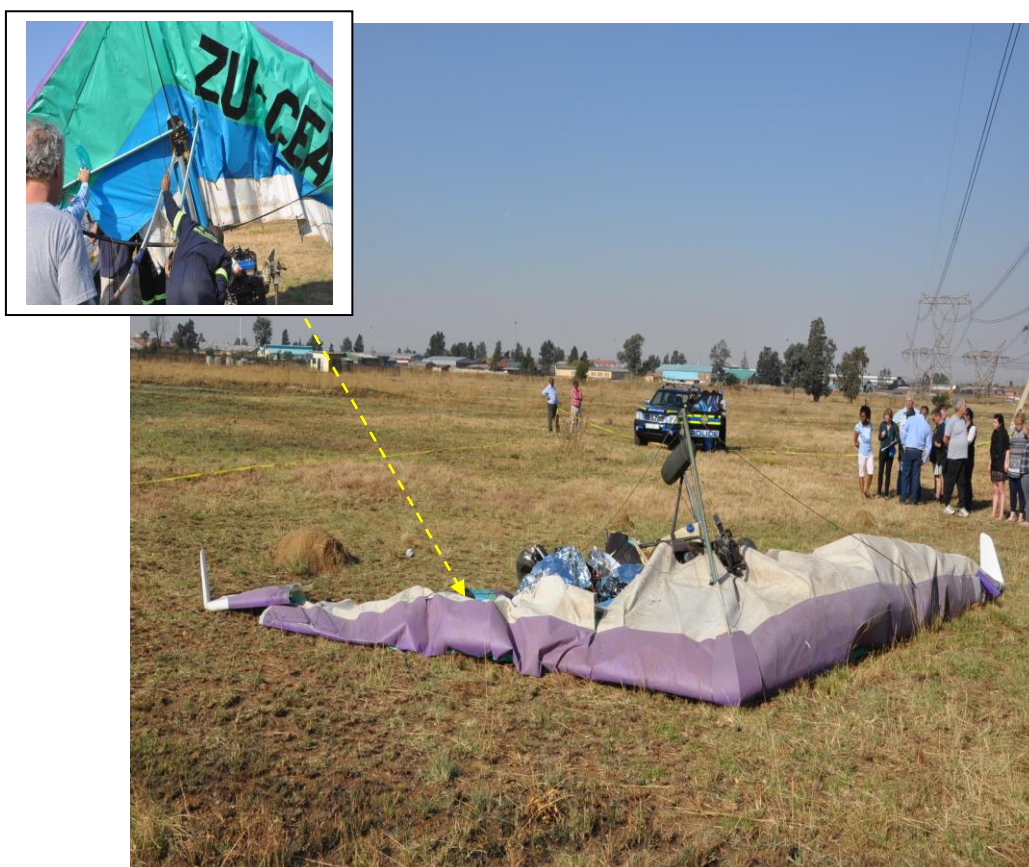
1.3.1 The aircraft was destroyed during the accident sequence.

Figure 3: ZU-CEA wreckage at the accident

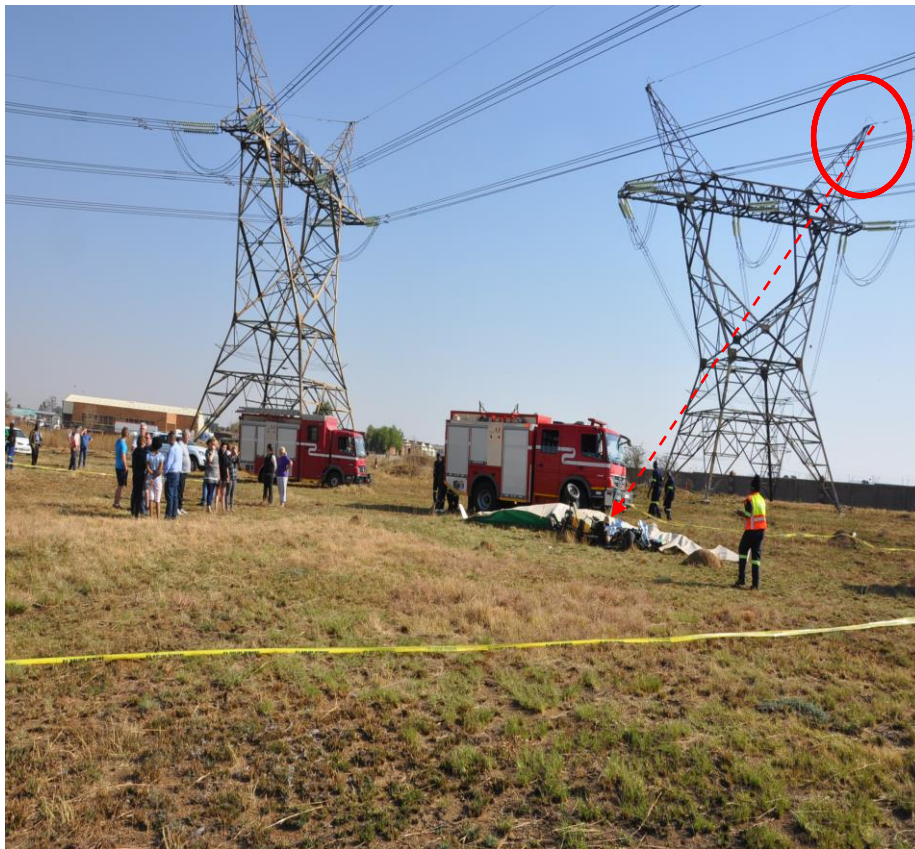
Figure 4: The accident site showing the pylon the aircraft collided with

1.12.1 The accident happened onto an open field, corners of Langkloof and Rogers in Alrode. The aircraft flight path comprises of three high voltage power lines pylons. Examination of the accident site revealed that the aircraft had struck the top section of the middle pylon with the right wing before crashing onto the ground. The aircraft impacted the ground in a flat attitude, with no significant horizontal travel. Apart from the failure of the monopole and forward strut, the damage to the trike was consistent with a vertical impact with the ground. The wreckage was contained within a three meter radius of the impact point. There were no signs of any pre-impact loss of integrity with the microlight's flying wires or 'A' frame. The wing's right leading edge tube had failed outboard of the cross tube and the wing's fabric was torn and frayed in that area, showing in-flight damage consistent with collision with the pylon. The base frame was severely damaged, but all indications were that it was as a result of ground impact. A visual assessment of the fuel remaining in the tank indicated about twenty five (25) liters of 95 unleaded fuel.

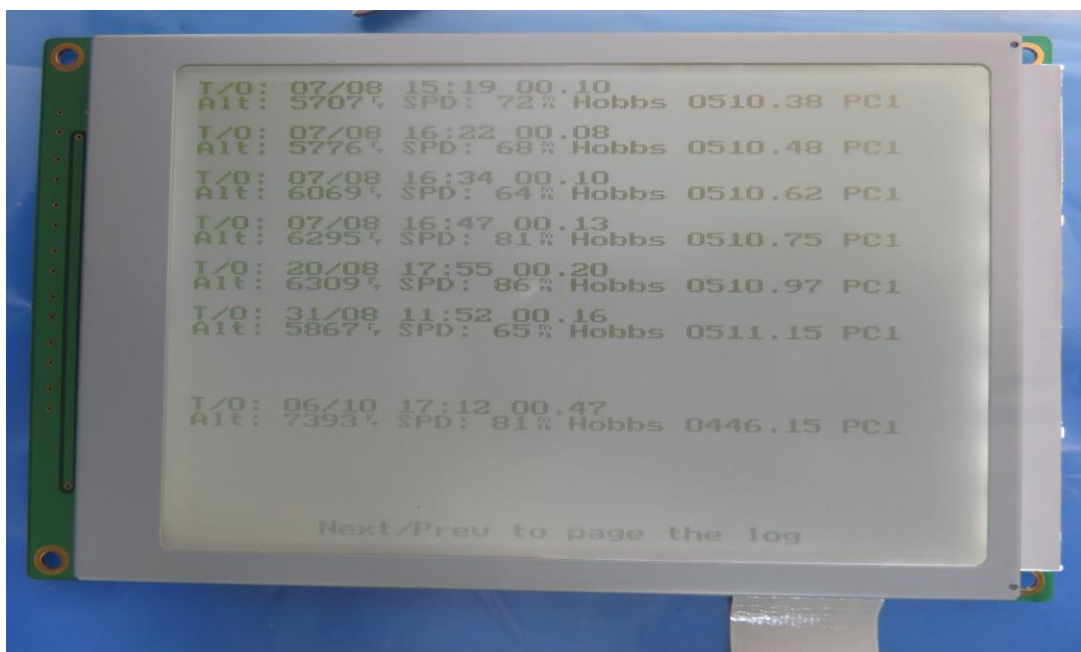
Figure 10: The last entries of the flight log

1.11.2 The flight log did not show anything out of ordinary. From the log it was apparent that the aircraft was used mostly for flight training as it shows a multitude of short flights lasting around minutes, consistent with circuit training work. All the hours counted together gave a total of 12.5 flight time. All the flight log information was not logged in the aircraft flight-folio/pilot logbook. According to the last flight-log entry the accident flight lasted for less than twelve minutes.

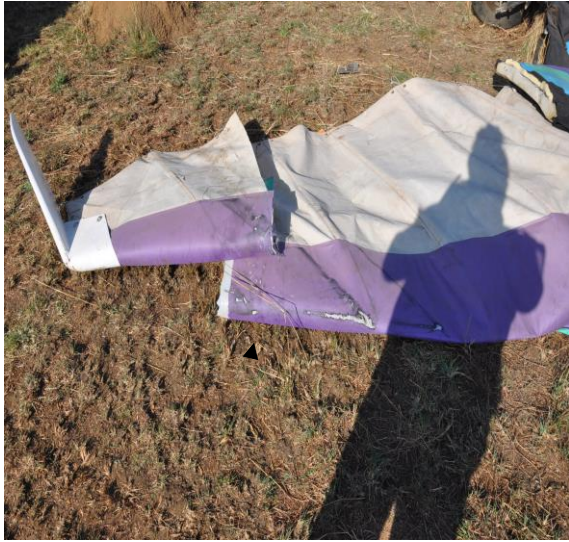
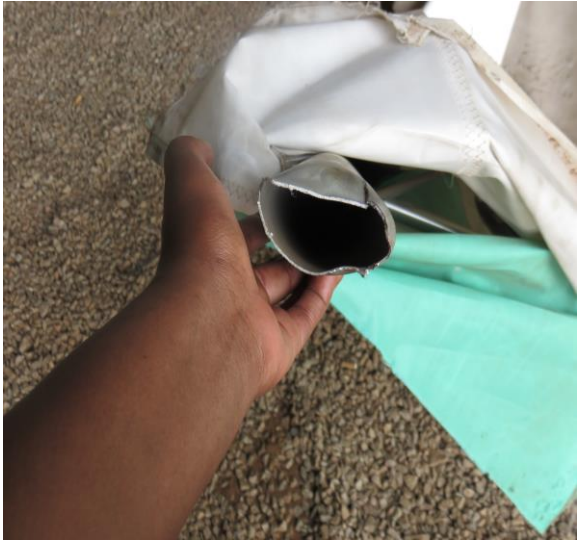
Figures 12: Failed rightwing displaying witness marks sustained after the collision

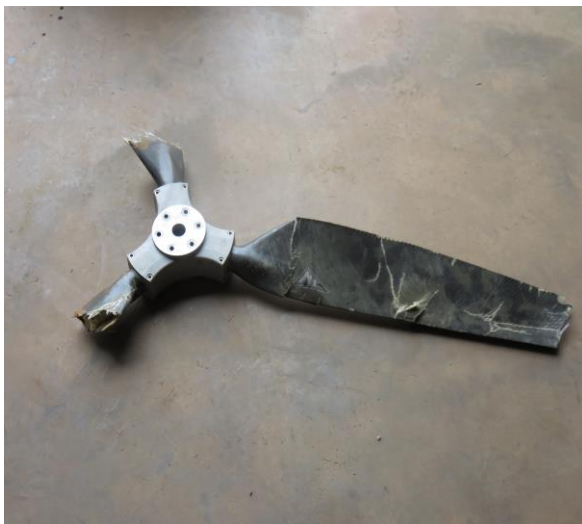
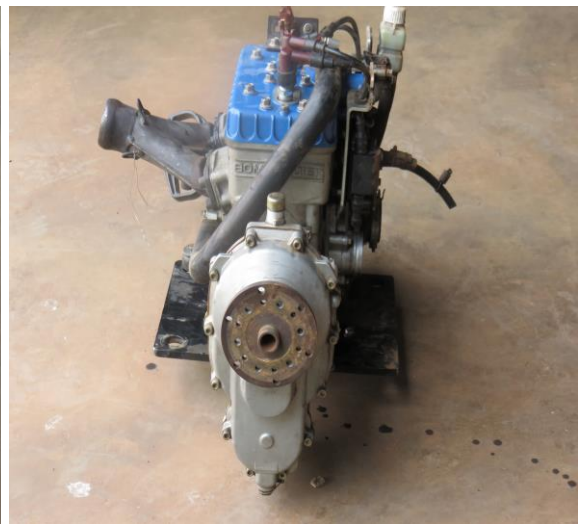
1.12.2 The right carburetor bowl was removed from the carburetor and examined. About one ounce of fuel was drained. The engine had not sustained any visible damage apart from the propeller blades and the right carburetor, which had separated from the attachment flange. Two propeller blades had been sheared from the blade root. Two pieces of the propeller blade tip, identified as being from the two sheared blades, were recovered from the northern side of the pylons. The third blade fragmented diagonally down the length of the blade consistent with it rotating when the accident occurred. The undercarriage was severed due to impact. The wreckage was recovered to Panorama aerodrome for detailed examination. The propeller was removed from the engine to facilitate crankshaft rotation. The top spark plugs were removed and examined; their electrodes were intact and light gray in color indicating the engine mixture was correct. The magneto drive was intact and a strong spark was observed at each of the spark plug connectors. The crankshaft was then rotated by hand. Camshaft, crankshaft, and valve train continuity were confirmed. Compression was attained on all cylinders. The ignition switch and the magnetos were found to be in the “on” position. All of the major components of the aircraft were accounted for and the aircraft appeared to have been correctly assembled or rigged; was structurally intact and that the engine was producing power at the time of the accident. Attached below is the Google Earth map showing the distance from the departure aerodrome up to the accident site.

Figures 13: Accident severed propeller blades and the engine after they were separated

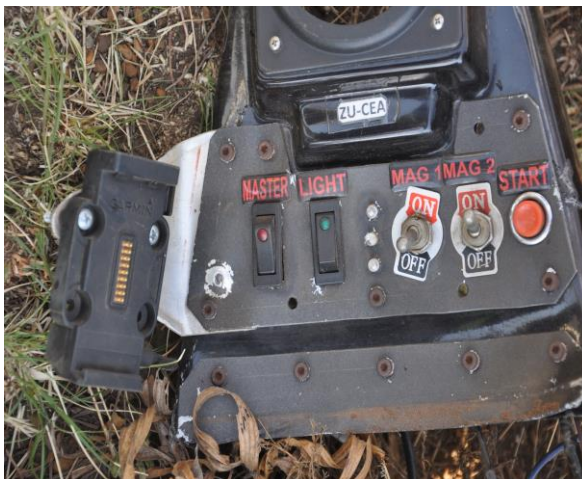
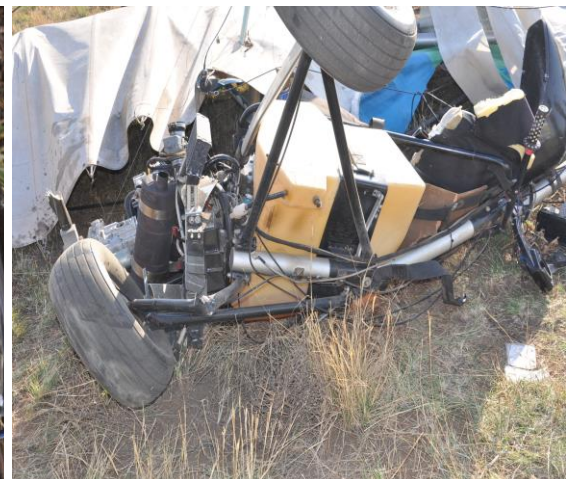
Figures 14: The aircraft dash showing the master with the magneto switches and the main landing gear with no fairings fitted to them

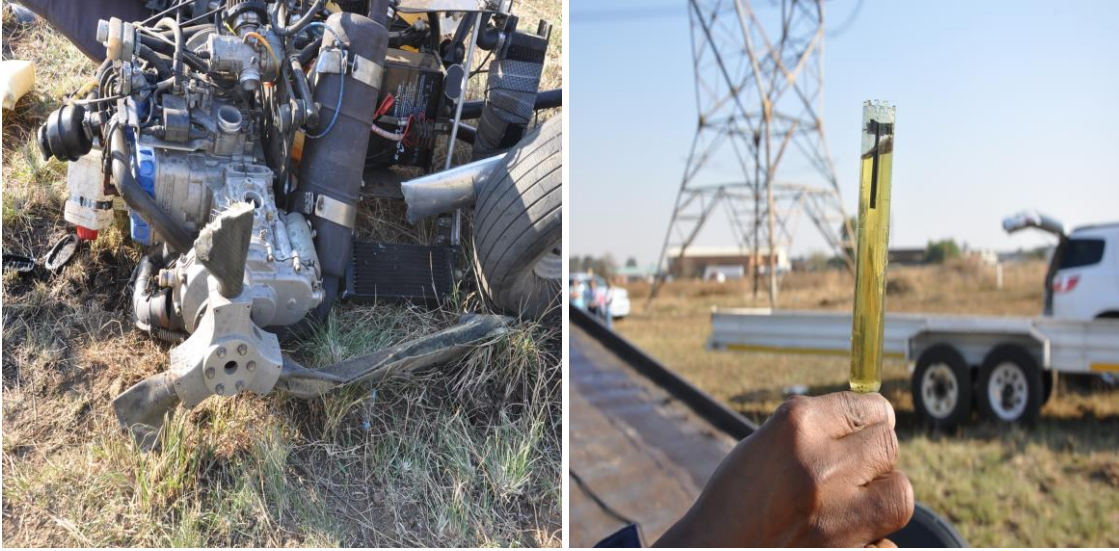
Figures 15: Accident severed propeller blades and the fuel sample taken during the on-site investigation

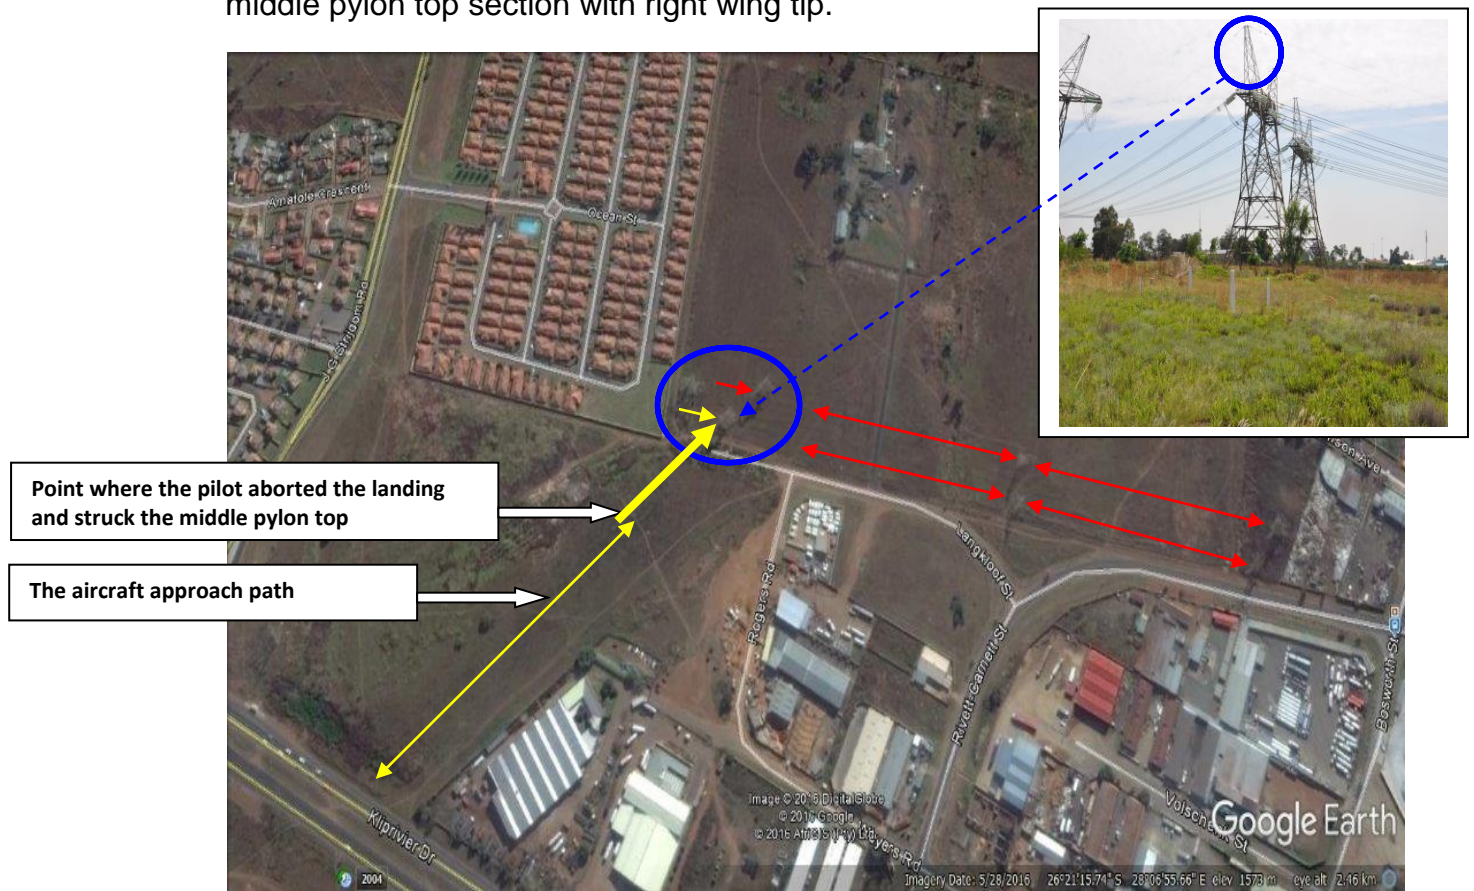
1.16.1 No flight activity to Alrode industrial site was permitted. Inferring that the pilot had in totality contravened the South African civil aviation authority "SACAA" regulation 91.06.32 of 2011 as amended. The investigators examined the field the pilot intended to land on. The field was about 230 meters in length. Towards the end of the field, in the direction of the flight were construction rubbish dump and other obstacles (Figure 18). The pilot aborted the landing roughly 80 meters short of the rubbish dump and obstacles in the direction of the power lines/pylons from which the aircraft struck the middle pylon top section with right wing tip.

Figure 17: Google Earth map showing the accident site and the power lines/pylons "red" and the obstacles

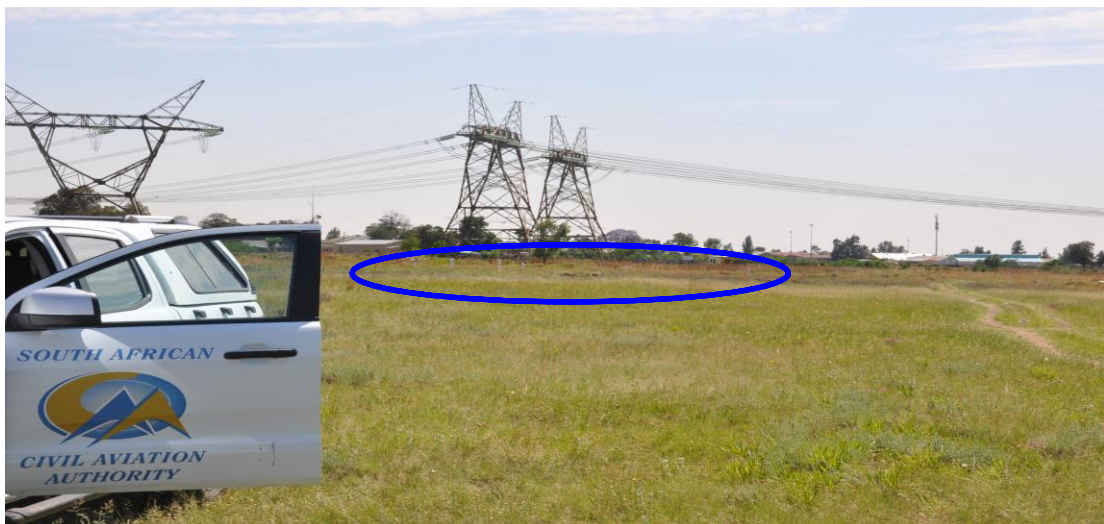
Figure 18: Obstacles and construction rubbish dump towards the end of the field
