**FINAL REPORT ON SERIOUS INCIDENT INVOLVING
M/S INDIGO AIRCRAFT VT-IFP (A320)
AND
M/S KUWAIT AIRWAYS AIRCRAFT 9K-APA (A330-200)
AT
MUMBAI
ON
30.11.2016**

**FINAL REPORT ON SERIOUS INCIDENT INVOLVING M/S INDIGO
AIRCRAFT VT – IFP (A320) AND KUWAIT AIRWAYS AIRCRAFT
9K-APA (A330-200) AT MUMBAI ON 30.11.2016**

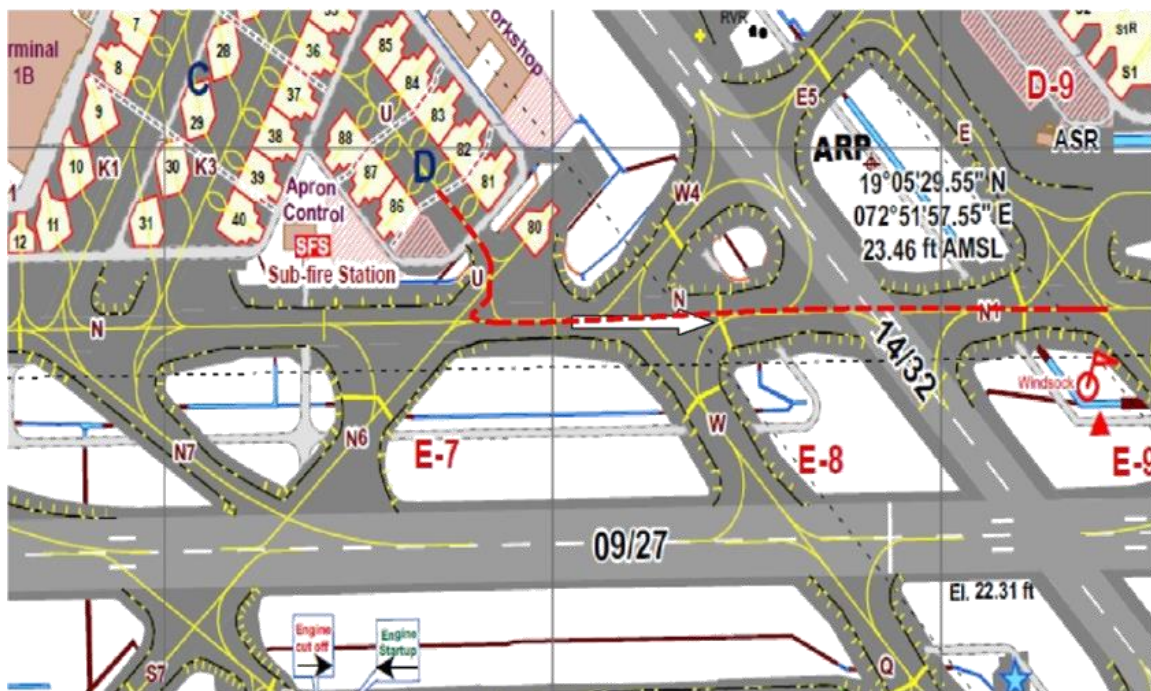
Taxi route followed by aircraft 1 for departure

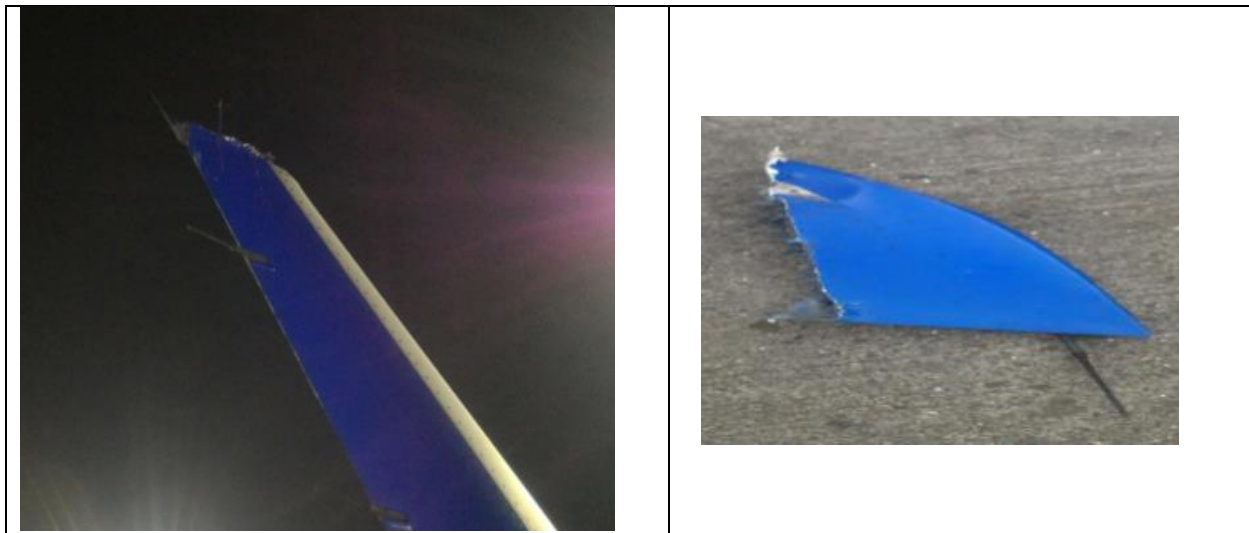
Aircraft 1

Upper section of LH Sharklet was found sheared off from the main wing structure. Leading Edge stainless steel cap of sharklet was damaged from the top edge. Both outer and inner skin of the sharklet was damaged.

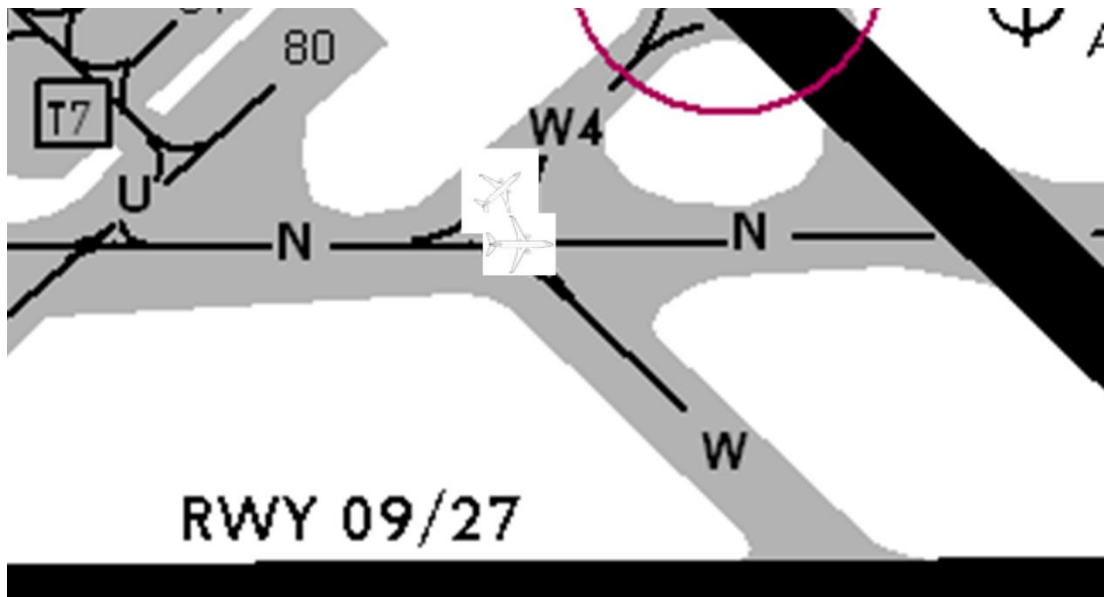
rear of any holding aircraft cannot be guaranteed. The position of the two aircraft at the time when the wings came in contact with each other is as shown in the following figure:

The taxing restriction were in place as per the AIP(for VABB) dated 01 April 2012 AD 2.20 para 4.2. As per the restrictions *“Aircraft holding on TWY W4 at holding position RWY 14/32 will prohibit aircraft taxing on TWY N.”*

As per the Aerodrome Manual MIAL/AO/DOC/01.01 Issue 06, Rev 00 dated 30.07.2016, *“Aircraft holding on TWY N11. N10, N6, W and W4 will prohibit aircraft to taxi on TWY N.”*

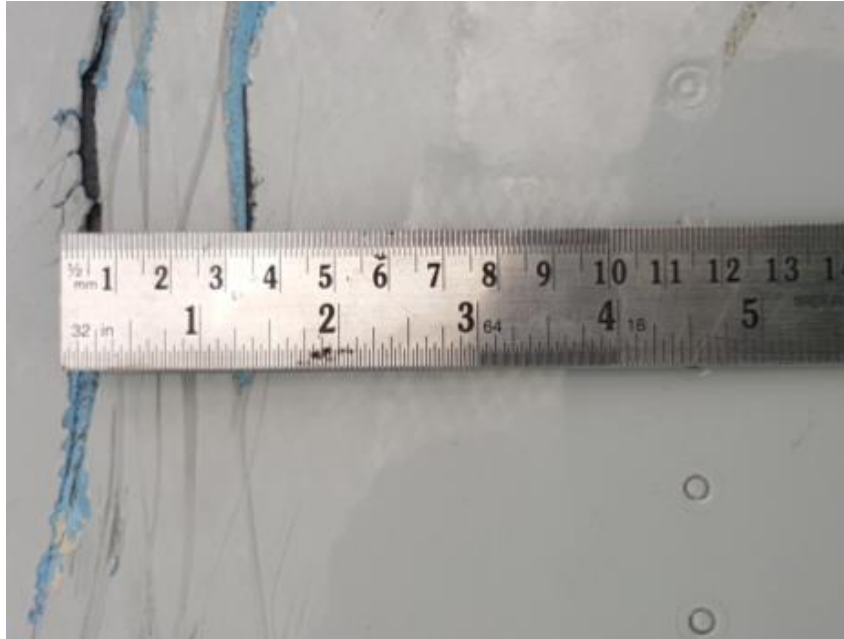
The upper section of LH wing sharklet of aircraft 1 had come in contact with the lower surface of the wing of the aircraft 2. Leading edge stainless steel cap of sharklet sheared off from the top. Both outer and inner skin of the sharklet was

damaged. The scrapping of the wing sharklet with the wing of aircraft 2 has damaged outboard aileron lower skin, outboard aileron trailing edge wedge structure and lower wing surface/ wing trailing edge fairings. The main wing bottom surface had superficial paint scratches. Repairs and maintenance action was carried out on both the aircraft and were released after clearance by OEMs.

Scratch Marks on lower surface of wing of aircraft 2

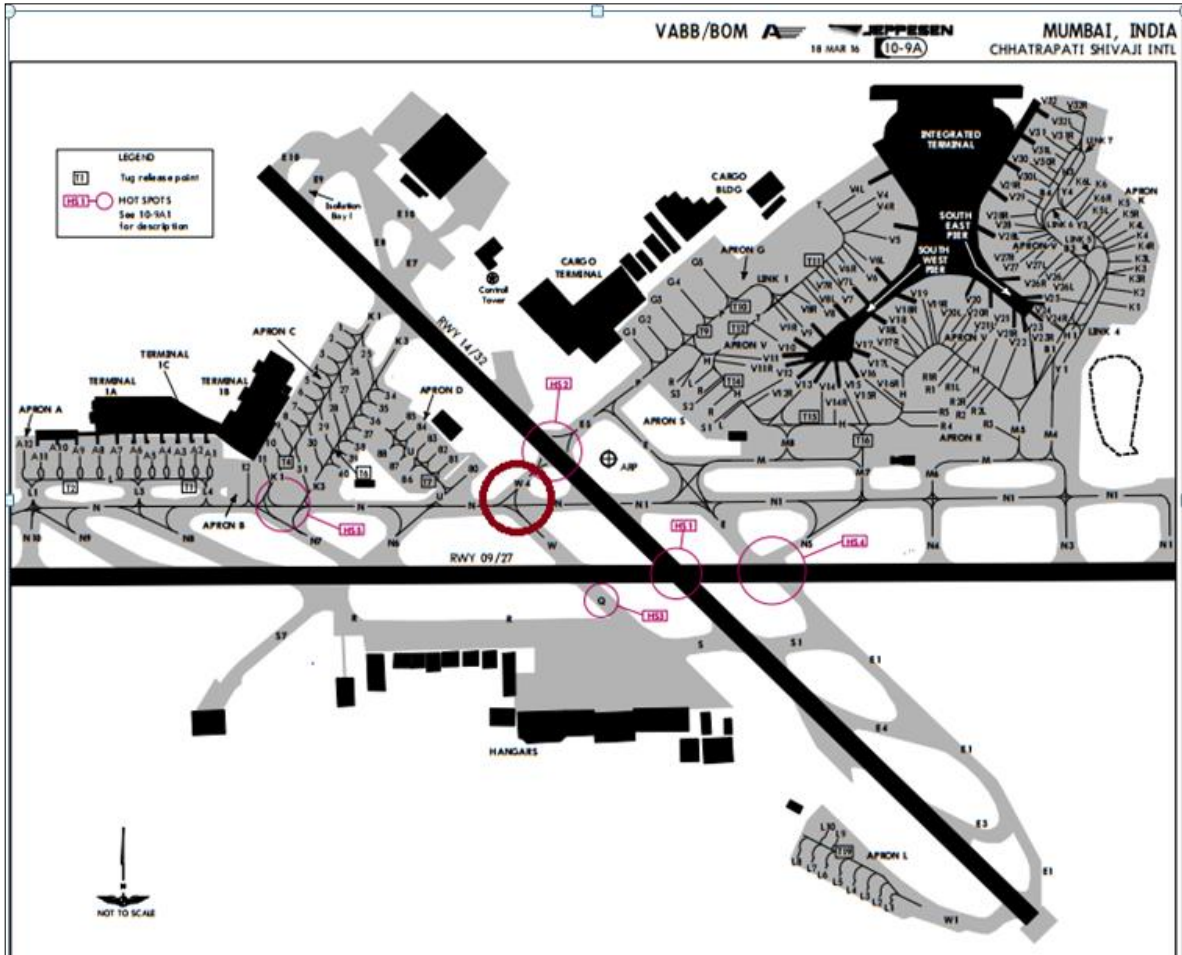
CSIA Mumbai is an International airport and is approved by DGCA. As per the approved Aerodrome Manual of CSIA, the *aircraft holding on TWY N11, N10, N6, W and W4 will prohibit aircraft to taxi on TWY N*. The taxing restrictions as per the AIP (for VABB) were existing as “*Aircraft holding on TWY W4 at holding position RWY 14/32 will prohibit aircraft taxiing on TWY N.*”

ATC instructions to aircraft 1 were therefore in conflict with the above mentioned Taxi Restriction as mentioned in the AIP. Though, flight crew of aircraft 1 had in their statements mentioned that they were aware of the Taxi restrictions on taxiway N, when another aircraft is holding on taxiway W4. Further the flight crew of aircraft 1 also mentioned that a portion of W4 / N is dark and is not well lit up. The visibility at the time of incident was 2200 m in haze with no significant change.

1. Indigo Airlines may provide guidance material to the flight crew regarding the difficulty associated with assessing wing tip clearance.
2. MIAL/ AAI may review the procedure for taxiing on taxiway N when an aircraft is holding on taxiway W4, short of Runway 14.
3. MIAL/ AAI may declare the W4/ N as hot spot till a permanent fix is available for the point.
4. MIAL may carry out assessment of the visibility conditions in the portion of W4 / N and take necessary corrective action if required.
