AIRCRAFT ACCIDENT REPORT AND EXECUTIVE SUMMARY

Reference:	CA18/2/3/9587	
Aircraft Registration	ZS-OWB	Date of Accident	10 December 2016		Time of Accident	1118Z
Type of Aircraft	Piper PA-28-181		Type of Operation	Private (Part 91)		
Pilot-in-command Licence Type	Private Pilot Licence		Age	20	Licence Valid	Yes
Pilot-in-command Flying Experience	Total Flying Hours		100.7		Hours on Type	100.7
Last point of departure	Kruger International Airport (FAKN), Mpumalanga Province.					
Next point of intended landing	Rand Airport (FAGM), Gauteng Province.					
Location of the accident site with reference to easily defined geographical points (GPS readings if possible)						
At Ngodwana, Mpumalanga in a mountainous area about 30NM west of Kruger International Airport (FAKN) at position GPS 25°30'55.3"S 30°31'30.7"E, elevation 4724 ft AMSL.						
Meteorological Information	Wind direction: 040°, Wind speed: 02 knots, Temperature: 24°C, Dew point: 15°C, Cloud: BKN 025 and Visibility: Good.

Probable Cause						
The aircraft collided with terrain in cloudy and overcast weather conditions. Controlled flight into terrain (CFIT) due to adverse weather.						
SRP Date	10 October 2017		Release Date	05 A

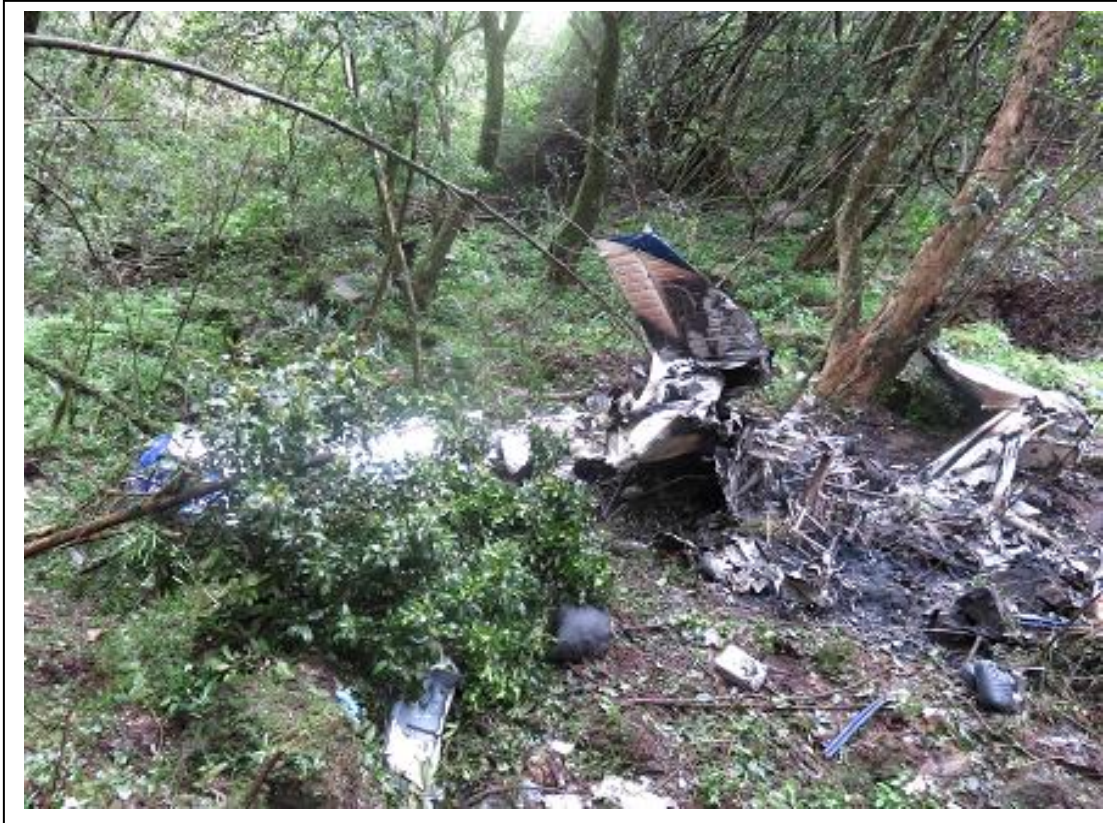
1.3.1 The aircraft was destroyed.

Figure 1 indicates wreckage of the destroyed aircraft.

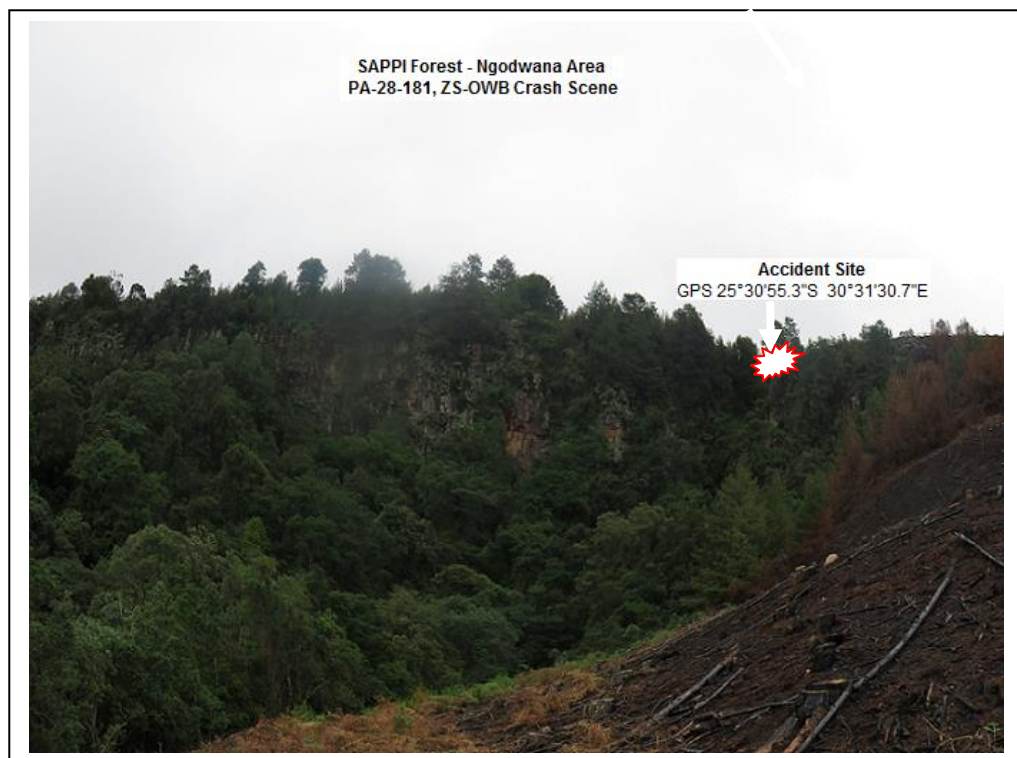
1.12.1 The impact and destruction of the aircraft indicated that the aircraft collided with the mountain during a straight and level flight. There was no indication of an in-flight break up or component/part separation prior to the collision with the mountain. The aircraft was completely intact prior to the accident.

1.12.2 The wreckage investigation indicated that the pilot experienced what is believed to be a controlled flight into terrain (CFIT) condition.

Figure 10 indicates the accident site

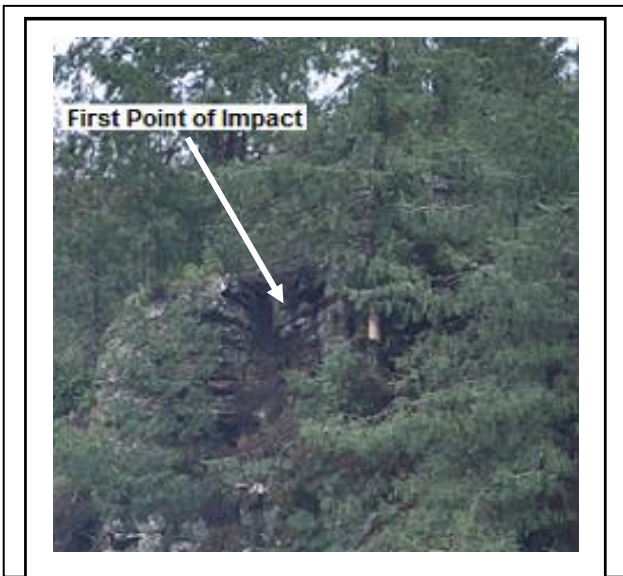
Figure 10

- (i) The aircraft collided with the mountain with its nose section first and wings level attitude. The evidence on the propeller indicated that the engine was producing power at the time of it impacting the mountain. Due to extend of damage caused to the engine and propeller, it is reasonable to assume that the aircraft had sufficient power at the time of impact.

(ii) Further evidence of this can be noted by the impact marks on the rocks and damage caused to the two bladed propeller. The aircraft over turned and ended up in an inverted position. The airframe structure was destroyed by impact and post impact fire. (See figure 10-14 below)

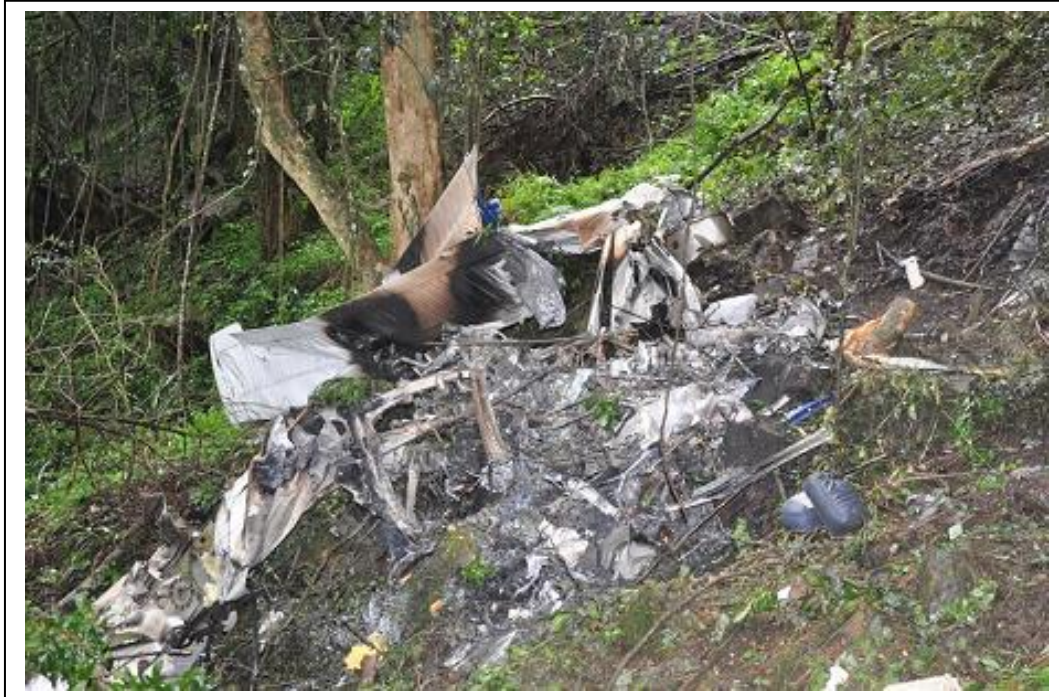
Figure 15

1.14.1 The wreckage was examined and found that the fuselage was completely burned. The debris of burned pieces of tree branches found at the collision point indicates that the post impact fire started from the nose section in the engine compartment. The trail of the fire damage was caused to the trees tops down to where the wreckage settled on the ground. (See figure 15 below indicating the presence of a post impact fire damage)

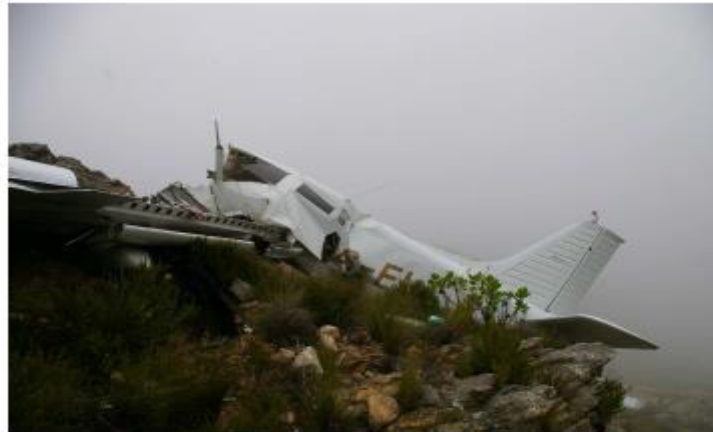
The aircraft collided with mountainous terrain during Instrument Meteorological Conditions (IMC).

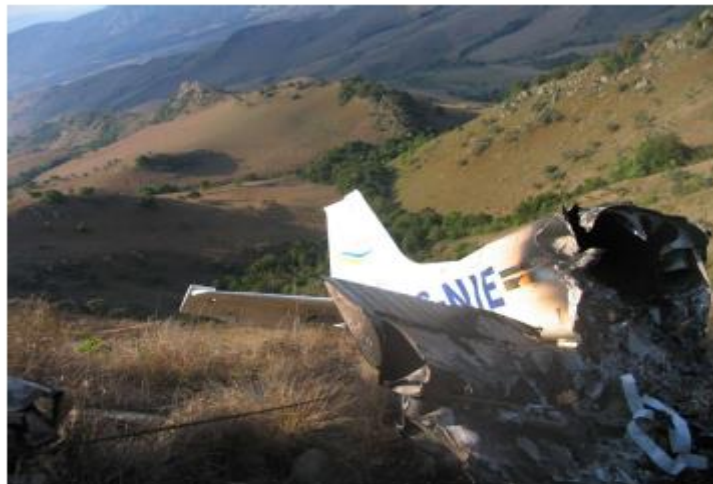
The aircraft collided with mountainous terrain during Instrument Meteorological Conditions (IMC) on a flight from Nelspruit Aerodrome to Rand Aerodrome.
