## SHORT REPORT AND EXECUTIVE SUMMARY

Reference:	CA18/2/3/9591	
<b>Aircraft Registration</b>	<b>ZS-HXX</b>	<b>Date of Accident</b>	26 December 2016		<b>Time of Accident</b>	0940:Z
<b>Type of Aircraft</b>	Robinson R44 II Helicopter		<b>Type of Operation</b>	Private- Part 91		
<b>Pilot-in-command Licence Type</b>		Private Pilot Helicopter	<b>Age</b>	53	<b>Licence Valid</b>	Yes
<b>Pilot-in-command Flying Experience</b>			585.9	<b>Hours on Type</b>	253.2	
<b>Last point of departure</b>		Stellenbosch Airfield (FASH) : Western Cape				
<b>Next point of intended landing</b>		Worcester Airfield (FAWC): Western Cape				
<b>Location of the accident site with reference to easily defined geographical points (GPS readings if possible)</b>						
De Zalze Estate 0.5nm north east of FASH (GPS S 33° 58' 23.69" E 018° 49' 41.88") elevation 246 feet						
<b>Meteorological Information</b>		Wind direction and speed: 019/02 knots CAVOK Temperature: 30°

## AIRCRAFT ACCIDENT REPORT

**Name of Owner/Operator** : Arnold Du Bruin and Associates (PTY) LTD  
**Manufacturer** : Robinson Helicopter Company  
**Model** : R44II  
**Nationality** : South African  
**Registration Marks** : ZS-HXX  
**Place** : De

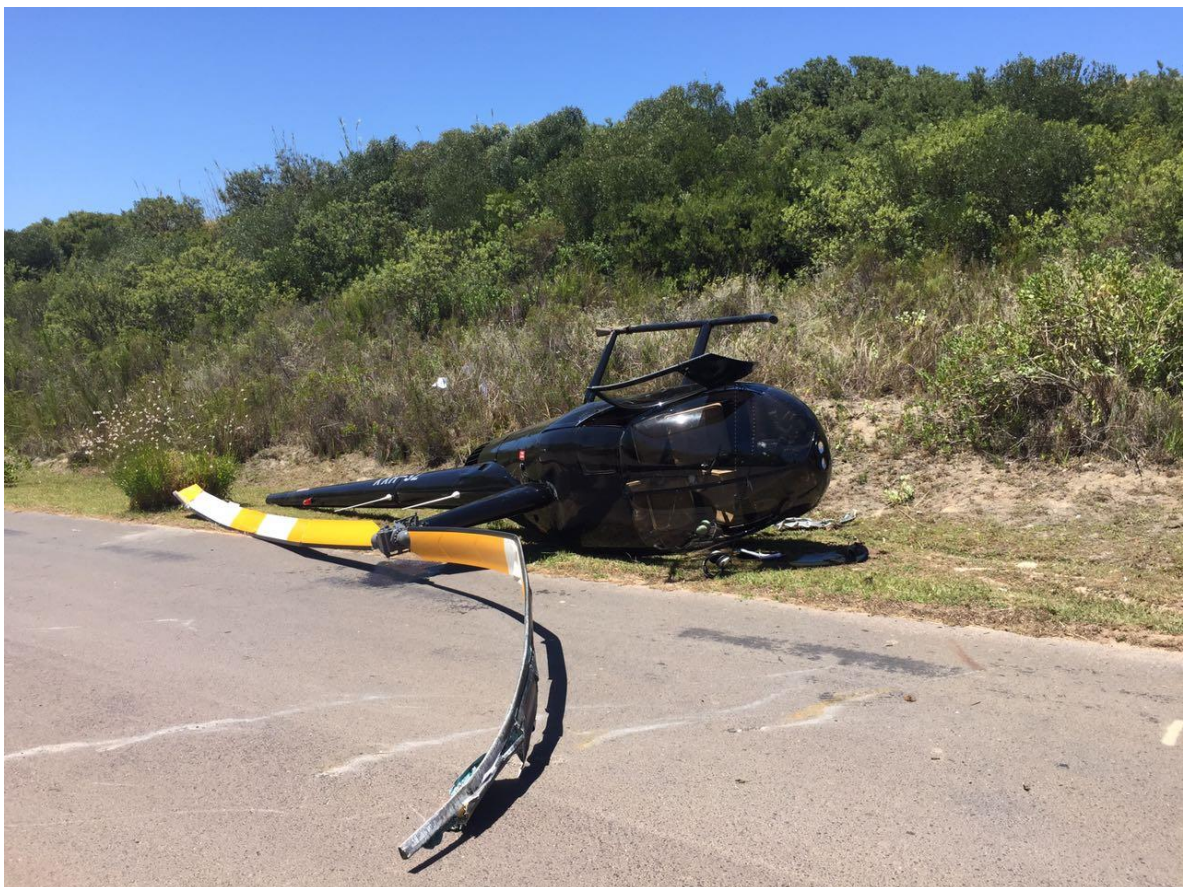
- 1.1.4 The pilot reported that during the turn for final approach for runway 19 the low rotor RPM warning sounded. Since the helicopter was low the pilot decided to land on De Zalze Golf Estate 0.5nm north east of FASH airfield. The pilot reported that during landing the helicopter landed hard and rolled onto its right hand side as shown in figure 1 below. The main rotor blades struck the ground as the helicopter came to rest.

Figure 1: View of the helicopter after it came to rest.

- 1.2.1 Pilot licence was valid from 31 July 2009 to 30 July 2019 and his medical was valid, with an expiry date of 30 June 2017.
- 1.2.2 The pilot had no restrictions in terms of the issuance of his licence by the regulator.
- 1.2.3 The pilot and passenger had to divert back to FASH due to the governor failure. While turning final approach for runway 19 the low rotor RPM warning sounded. Since the helicopter was low the pilot decided to land on De Zalze Golf Estate 0.5nm north east of FASH airfield. During landing the helicopter landed hard and rolled onto its right hand side. The main rotor blades struck the ground as the helicopter came to rest.

- 1.2.6 The helicopter was manufactured by the Robinson Helicopter Company.
- 1.2.7 The helicopter had a total of 231 airframe hours at the time of the accident.
- 1.2.8 The last annual inspection on the helicopter was carried out on 21 October 2016 at 226.7 hours. The helicopter had flown 4.3 since the last inspection.
- 1.2.9 The Lycoming IO-540-AE1AS engine (SN# L-33739-48E) hours since new were 231
- 1.2.10 The Main rotor (SN #:5935) hours since new were unknown.
- 1.2.11 The helicopter sustained damages the skids, main rotor blades, and tail rotor.

- 2.1.1 Unsuccessful forced landing following a low rotor RPM
- 2.1.2 Contributory Factor  
Governor failure
