SHORT REPORT AND EXECUTIVE SUMMARY

Reference:	CA18/2/3/9595	
Aircraft registration	ZU-SWL	Date of accident	29 January 2017		Time of accident	0745Z
Type of aircraft	Falcon 402		Type of operation		Private (Part 91)	
Pilot-in-command licence type		Commercial	Age	25	Licence valid	Yes
Pilot-in-command flying experience		Total hours	1 628.4		Hours on type	450.8
Last point of departure		Wonderboom Aerodrome (FAWB), Gauteng Province				
Next point of intended landing		Rustenburg Aerodrome (FARG), Northwest Province				
Location of the accident site with reference to easily defined geographical points (GPS readings if possible)						
Clearway Runway 11, FAWB (GPS position; 25°39'13.28" South 028°14'25.66" East) elevation 4095ft AMSL						
Meteorological information		Surface wind; 100°/7 knots, Temperature; 27°C, Visibility; + 10km				
Number of people on board	1 + 0	No. of people injured	0	No. of people killed	0	
Synopsis						
<p>On Sunday morning, 29 January 2017 at approximately 0745Z, the pilot, who was the sole occupant on board the Falcon 402 aircraft with registration markings ZU-SWL, took off from Runway 11 at FAWB when the engine lost power shortly after the aircraft became airbor

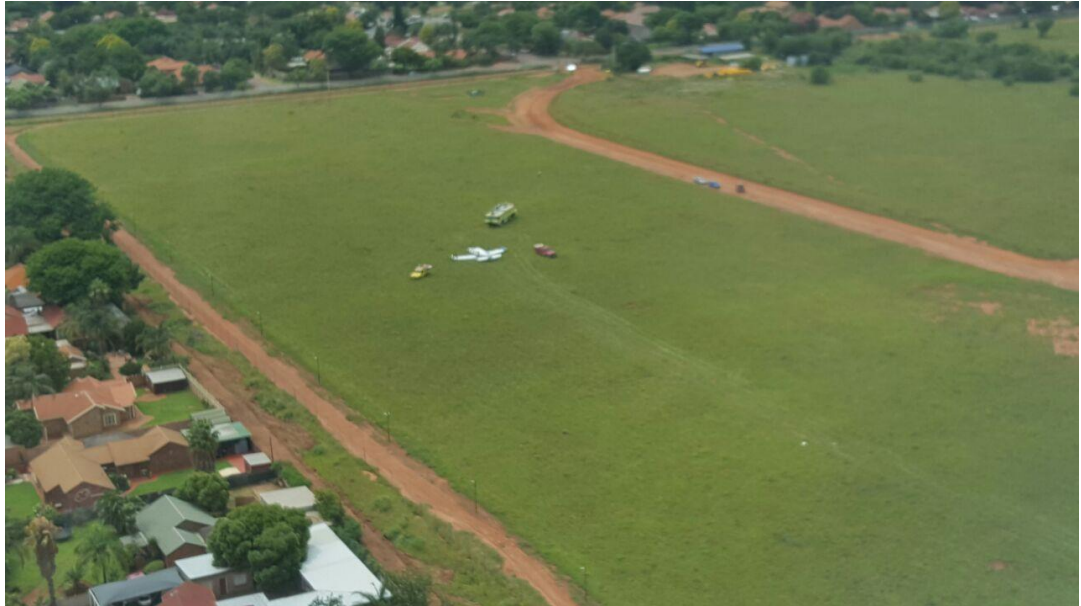
Figure 1. Aerial view of the aircraft as it came to a halt on the clearway - extended centre line runway 11

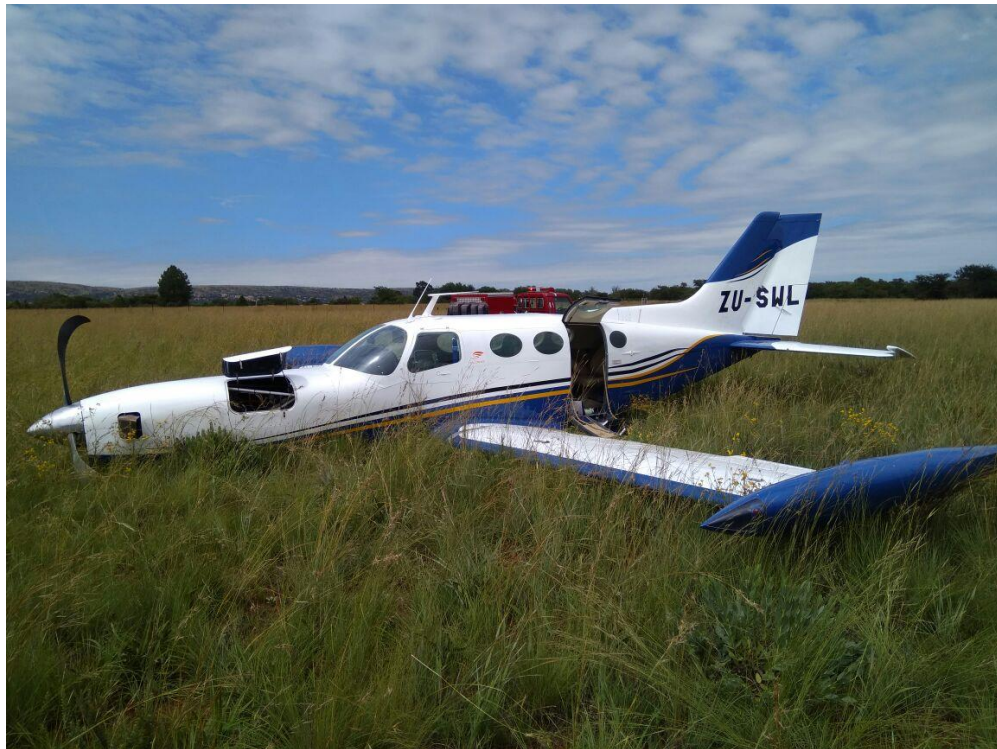
Figure 2: The aircraft as it came to rest on its lower fuselage

- 1.2.6 The aircraft was in possession of a valid Authority to Fly.
- 1.2.7 The aircraft sustained substantial damage during the forced landing.
- 1.2.8 There was ample fuel on board the aircraft.
- 1.2.9 Due to substantial damage during the accident it was not possible to conduct a functional engine test run.
- 1.2.10 The Falcon 402 was a non-type certified aircraft (NTCA) that was designed and manufactured in South Africa. The Walter M601 turboprop engine was installed on the aircraft type..
- 1.2.11 The weather conditions had no bearing on the accident flight.
- 1.2.12 No on site investigation was conducted by the Accident and Incident Investigation Division (AIID).

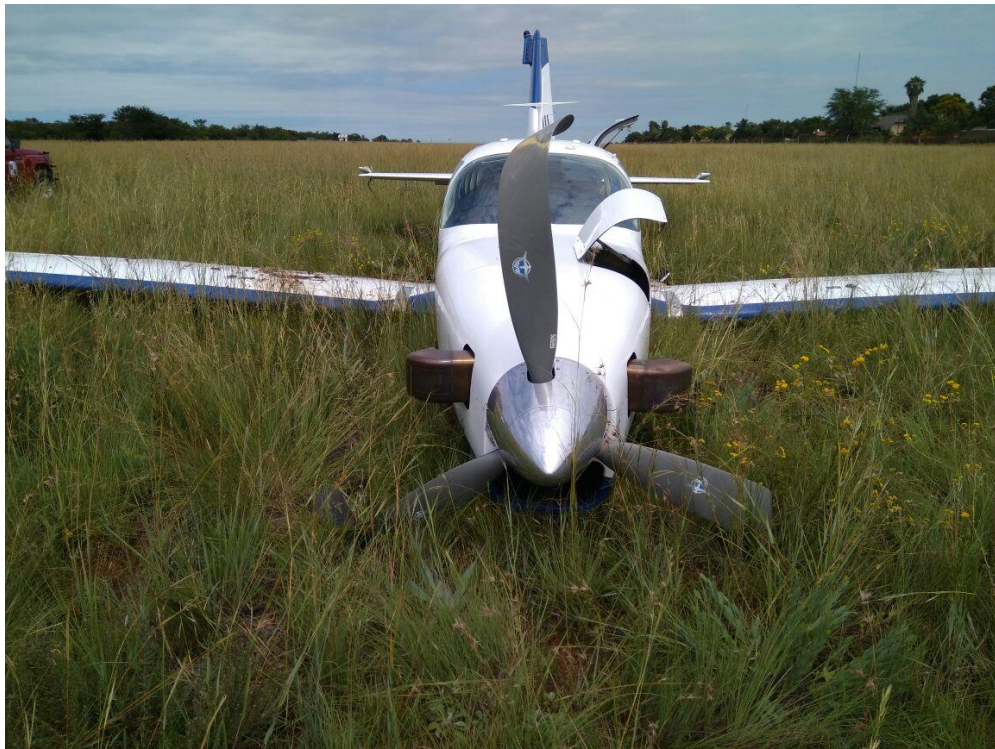
Figure 3: A front view of the aircraft as it came to rest

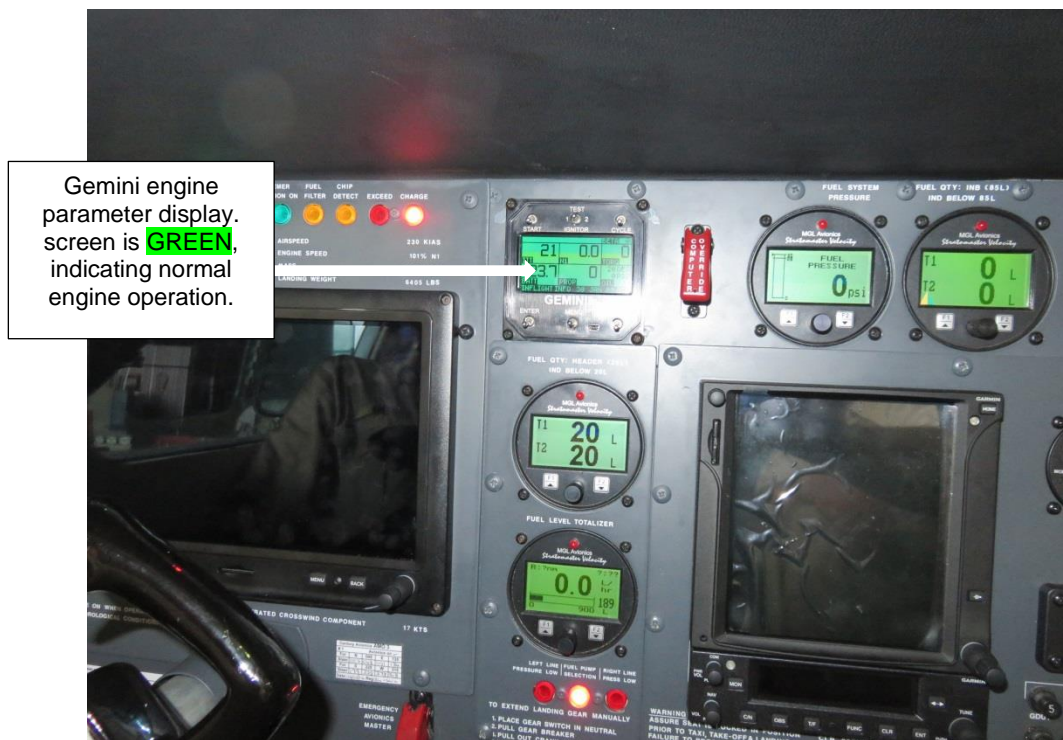
Figure 4: Engine parameter display screen (GREEN)

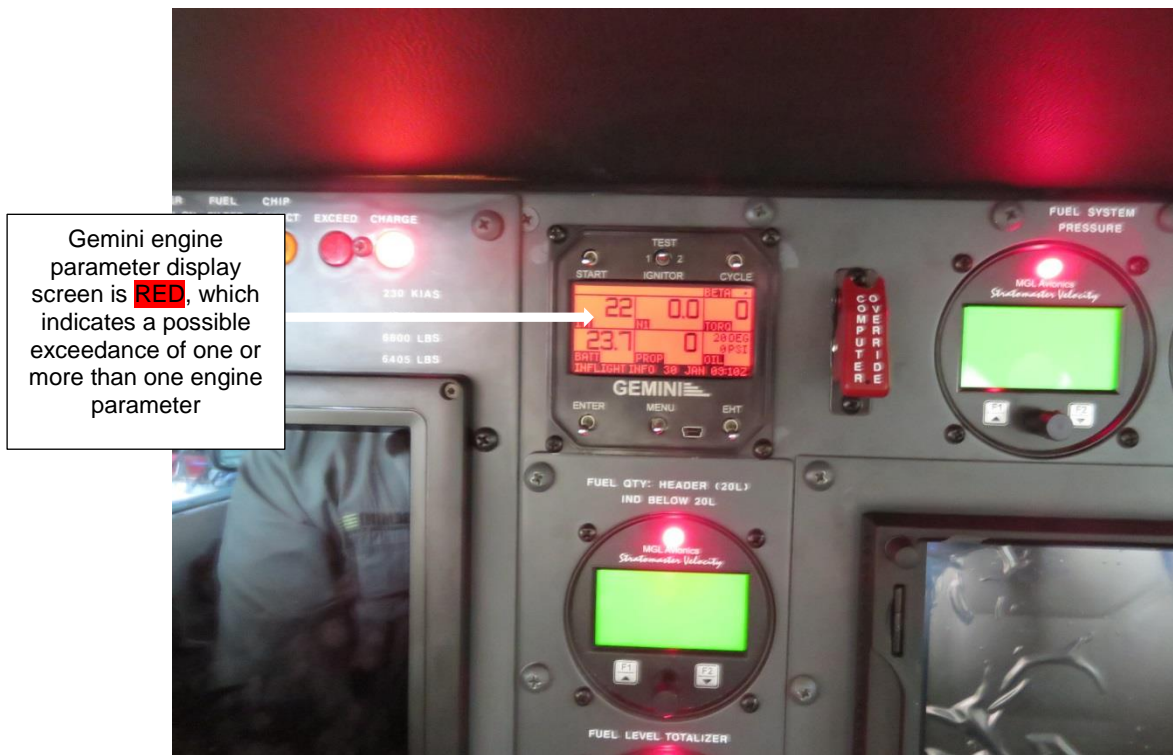
Figure 5: Engine parameter display screen (RED)

- 2.1.1 Unsuccessful forced landing due to a loss of engine power, associated with the engine display screen that turned from green to red. This was an indicative of a possible exceedance of engine parameters the pilot opted to execute a forced landing straight ahead.

- 3.1 In the interest of aviation safety it is recommended to the Director of Civil Aviation that the division Aviation Safety Operations conduct airworthiness assessment of this aircraft type following similar accidents in a short period of time.
