AIRCRAFT ACCIDENT REPORT AND EXECUTIVE SUMMARY

Reference:	CA18/2/3/9606	
Aircraft Registration	ZS-JTC	Date of Accident	18 March 2017		Time of Accident	1245Z
Type of Aircraft	Cessna 172N (Aeroplane)		Type of Operation		Part 141	
Pilot-in-command Licence Type	Student Pilot	Age	20	Licence Valid	Yes	
Pilot-in-command Flying Experience	Total Flying Hours	49.4		Hours on Type	26.4	
Last point of departure	Vereeniging aerodrome (FAVV): Gauteng province					
Next point of intended landing	Potchefstroom aerodrome (FAPS): North West province					
Location of the accident site with reference to easily defined geographical points (GPS readings if possible)						
177m right of runway 21 threshold at GPS co-ordinates determined to be S26° 40. 14.8" E27° 04. 29.4" at an elevation of approximately 4 520 ft AMSL.						
Meteorological Information	Temperature, 27°C: Dew point, 7°C: Wind speed, 12 knots: Wind direction, 200° magnetic: Visibility, 10 km: CAVOK.

AIRCRAFT ACCIDENT REPORT

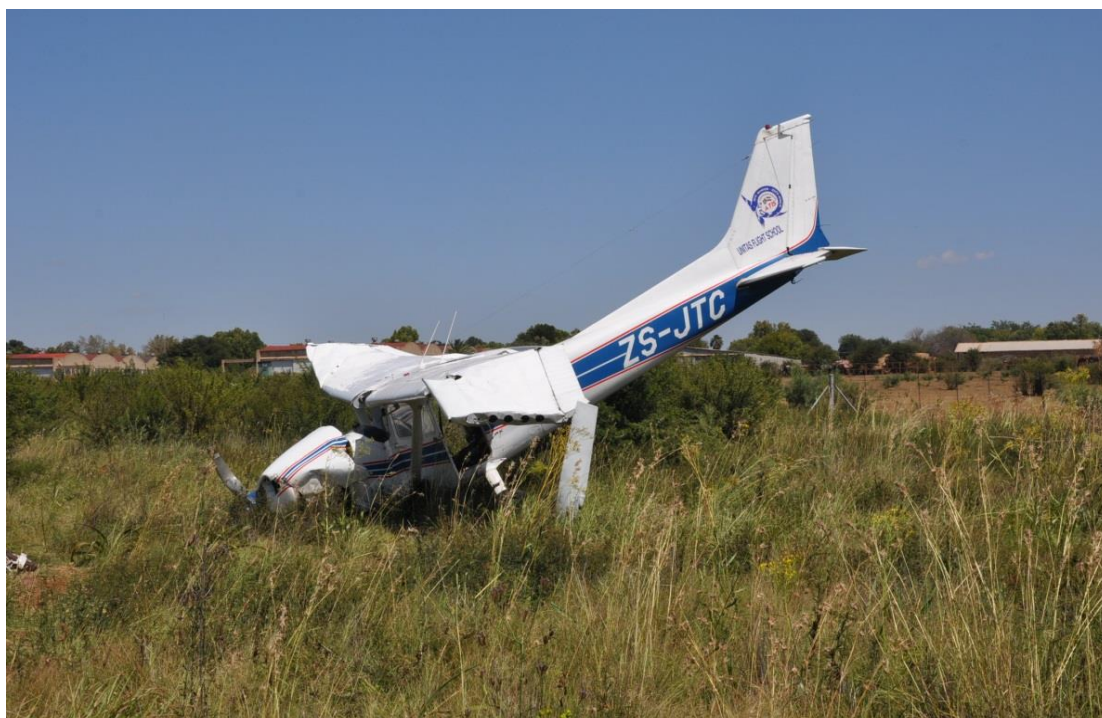
- 1.3.1 The aircraft was substantially damaged.

Figure 2: The wreckage as found at the accident site

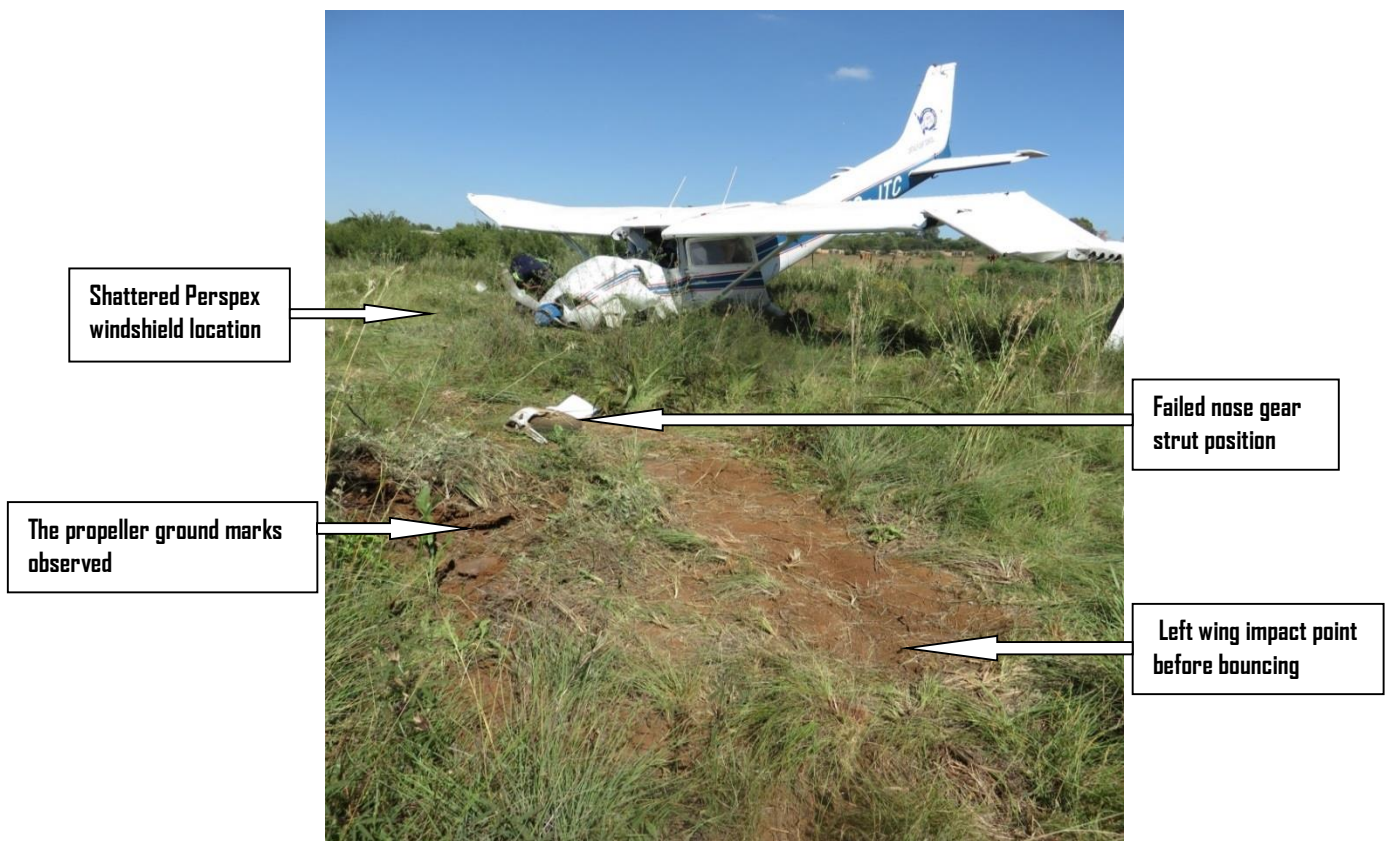
1.12.1 The wreckage was located on the eastern side of the runway boundary fence of FAPS aerodrome, approximately 177 meters parallel to the threshold of runway 21. During the impact sequence, the aircraft structure and airframe received progressively more damage as it impacted the ground surface. However, the aircraft structure remained intact except for the failed nose gear strut. The nose wheel was properly secured into the wheel axle/fork with the tyre properly inflated with nitrogen dry air as recommended by the manufacturer. The aircraft spring loaded main gear was examined and found to be intact, with both main wheel tires properly inflated with nitrogen dry air following the manufacture's specifications. The aircraft structure was thoroughly examined and nothing was missing. Visual inspection showed no evidence of a possible engine oil leak on the aircraft structure and the underbelly. All antennas and the navigation lights were accounted for and were properly secured to their respective mounting areas.

Figure 5: The first point of impact and the final position of the wreckage

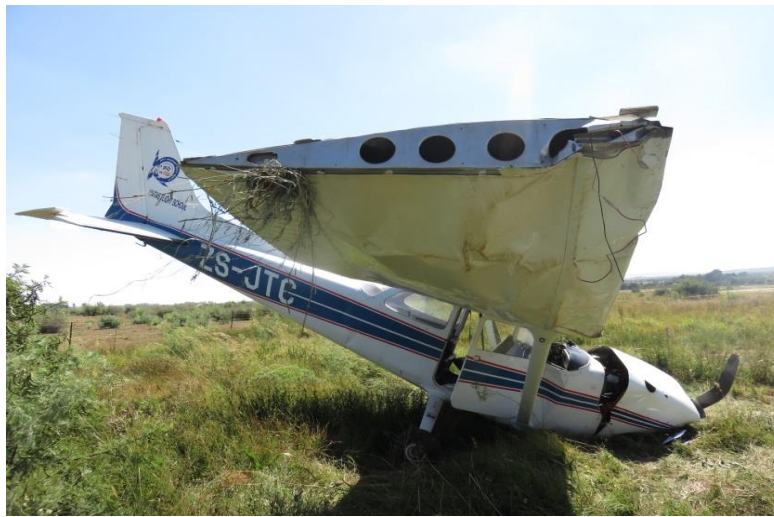
1.12.2 The outboard wing stations suffered severe damage on the upper and bottom surfaces. Both wings tips were severely damaged during the accident sequence. Portions of the wing debris were observed at the accident site; on the other hand no evidence of fuel spillage was discovered. The aft fuselage did not have any deformation. The front Perspex glass windshield had shattered during the accident sequence. The left hand door was slightly distorted. The engine couplings remained undamaged. The engine/propeller remained intact and secured to the aircraft structure. The spinner was attached to the propeller hub, but it was crushed. The engine mount trusses were deformed to the left, with the engine alignment about fifteen degrees off the centreline. There were several propeller strike marks on the ground along the wreckage trail; the marks were consistent with the propeller being powered at impact. The nose section was damaged, which compromised the instruments panel and cabin integrity. The floor structure, including the front seats tracks, had buckled, and the rudder pedals and surrounding floor/firewall structure were damaged by crushing. The pilot seat derailed due to impact forces. The cockpit controls were positioned as follows: engine mixture control full rich; throttle control displaced at a near idle position; carburetor heat full cold; engine primer in and locked; magnetos both on and fuel selector on the right tank “according to the rescuers reports”. Photographs attached below.

Figure 6: Right-hand side picture of the aircraft showing damage as found

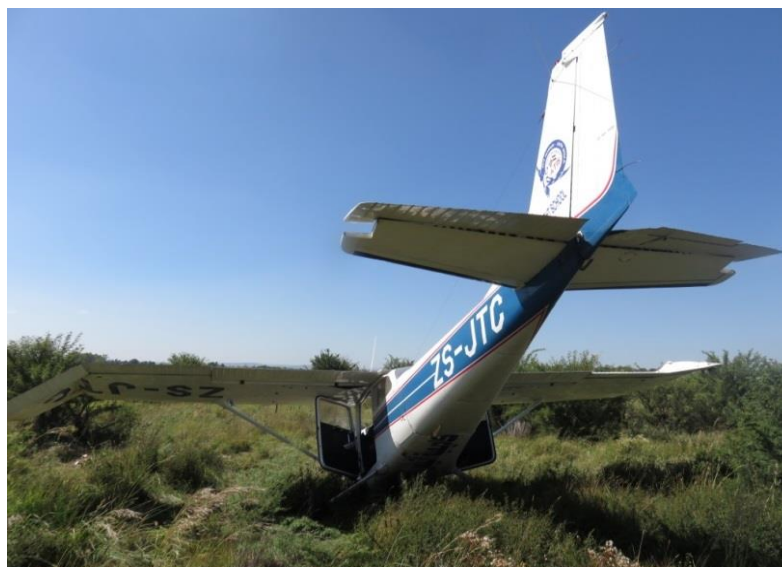
Figure 7: Rear view of the aircraft with the wing flaps in a retracted position "as found"

1.12.3 The flight control cable system continuity was confirmed, with some pre-impact anomalies consistent with overload. The elevator trim tab actuator was in a 5 degree down position, and the wing flaps were fully retracted. The propeller blades showed evidence of rotation with leading edge nicks. The engine's crankshaft flange was intact from the crankshaft, and the crankshaft could be rotated. The fuel strainer bowl was inspected and was clear of debris. The oil level dip stick/gauge showed enough oil was present inside the engine. The oil was clean and showed no evidence of metal chips or failure of the engine accessories. No evidence of pre-impact abnormalities was noted on the engine case and components.

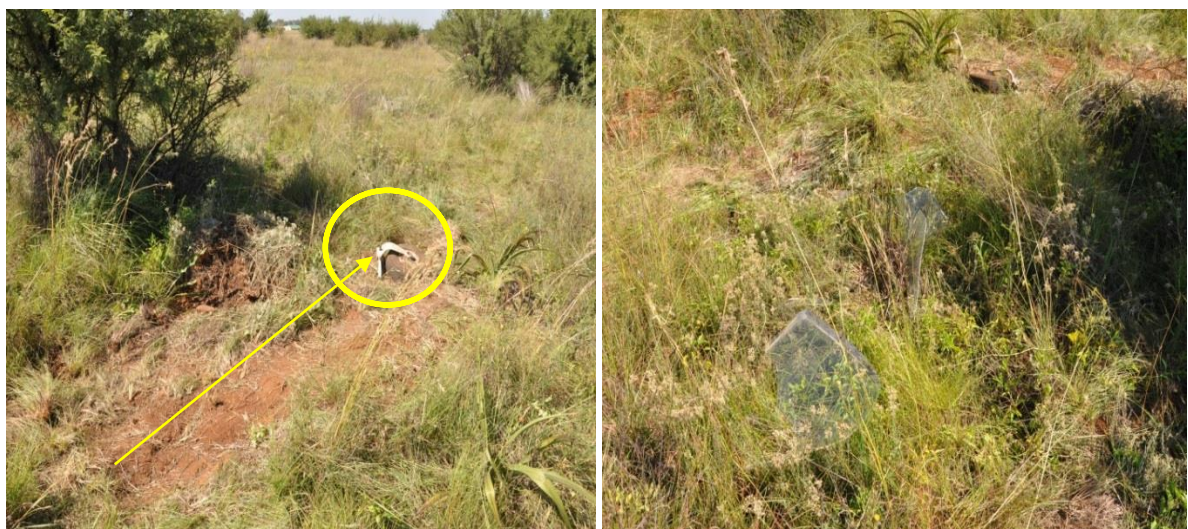
Figures 8: Sheared nose wheel strut and the shattered windshield

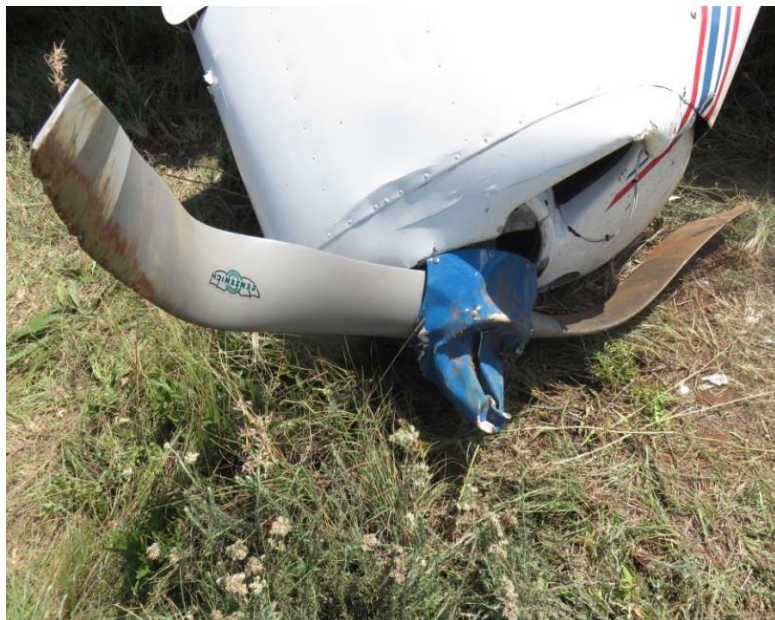
Figure 9: The propeller as found at the accident site

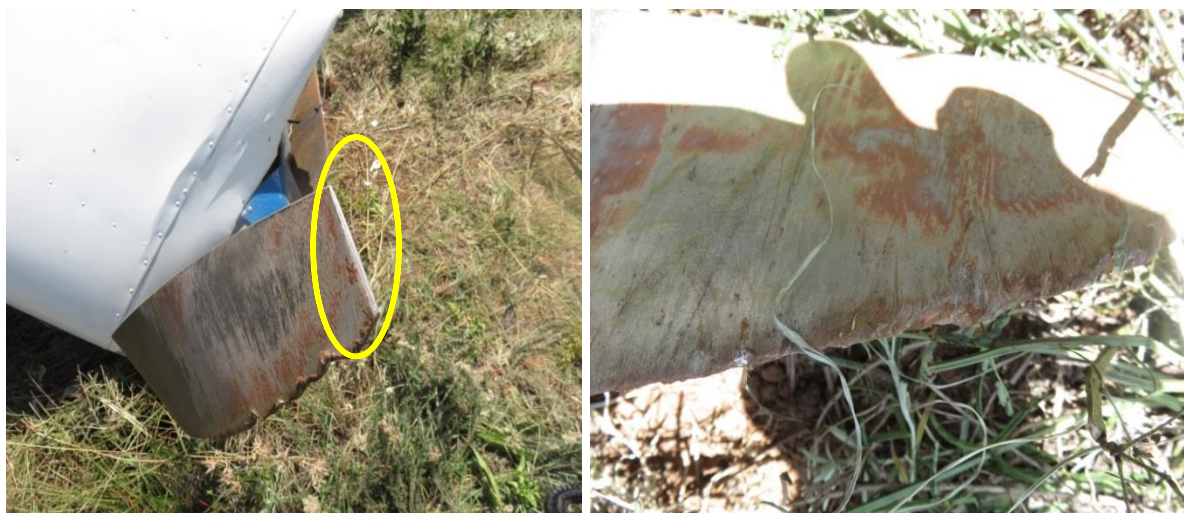
Figures 10: The scoring marks on the propeller blade tips
