## HELICOPTER ACCIDENT REPORT AND EXECUTIVE SUMMARY

Reference:	CA18/2/3/9618	
<b>Helicopter Registration</b>	ZS-HFF	<b>Date of Accident</b>	19 May 2017		<b>Time of Accident</b>	1512Z
<b>Type of Helicopter</b>	Robinson R44 Raven II		<b>Type of Operation</b>	Private (Part 91)		
<b>Pilot-in-command Licence Type</b>	PPL	<b>Age</b>	47	<b>Licence Valid</b>	Yes	
<b>Pilot-in-command Flying Experience</b>	Total Flying Hours	561		Hours on Type	512.20	
<b>Last point of departure</b>	Nampo Park near Bothaville, Free State Province					
<b>Next point of intended landing</b>	De Hoop private farm near Frankfort, Free State Province					
<b>Location of the accident site with reference to easily defined geographical points (GPS readings if possible)</b>						
On Ongegund Farm near Heilbron, Free State Province (GPS S27°17'28.85" E027°51'45.12" at an elevation of 4 745 ft)						
<b>Meteorological Information</b>	Wind: 045° at 4 kt, temperature: 23.3°C, visibility: CAVOK

## HELICOPTER ACCIDENT REPORT

**Name of Owner** : Wenzel Boerdery Trust  
**Name of Operator** : D.S. Wenzel  
**Manufacturer** : Robinson Company  
**Model** : R44 Raven II  
**Nationality** : South African  
**Registration Marks

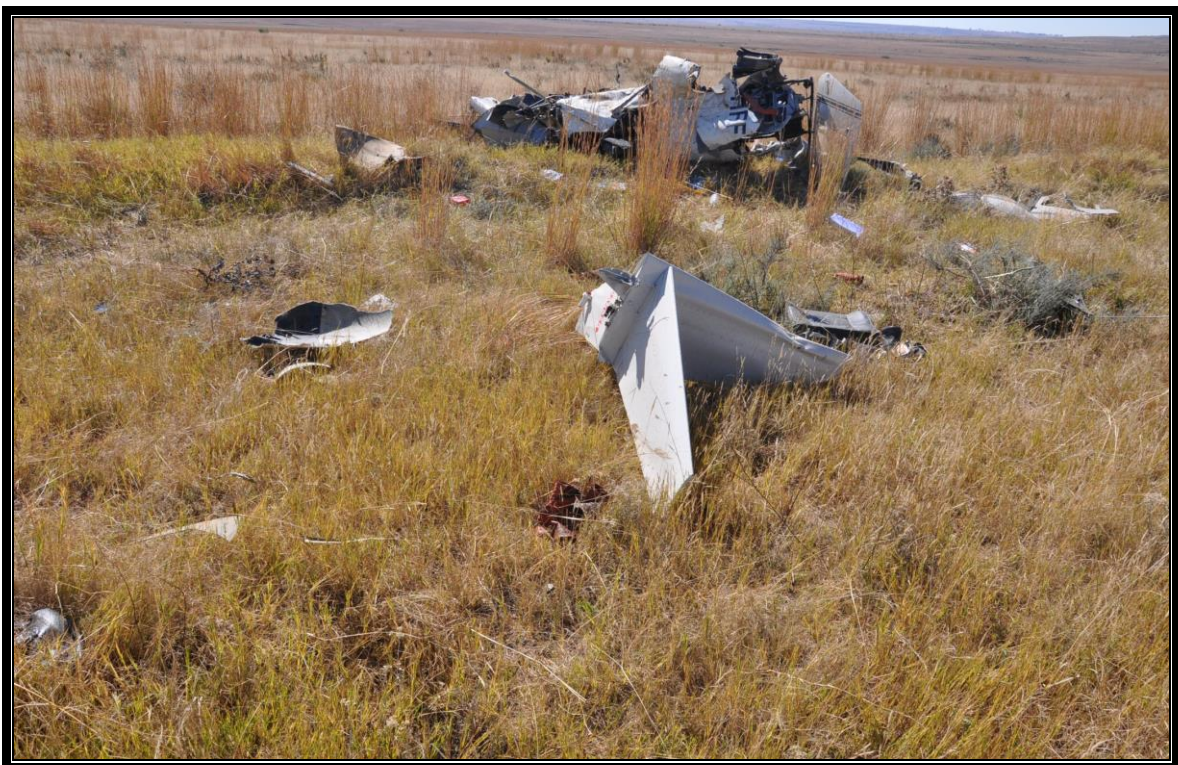
1.1.6 The wreckage was found resting on its left-hand side in the southerly direction, with the tail boom twisted slightly. The main rotor head cowling assembly was resting on its left-hand side.

**Figure 2:** The helicopter as it came to rest after the impact sequence

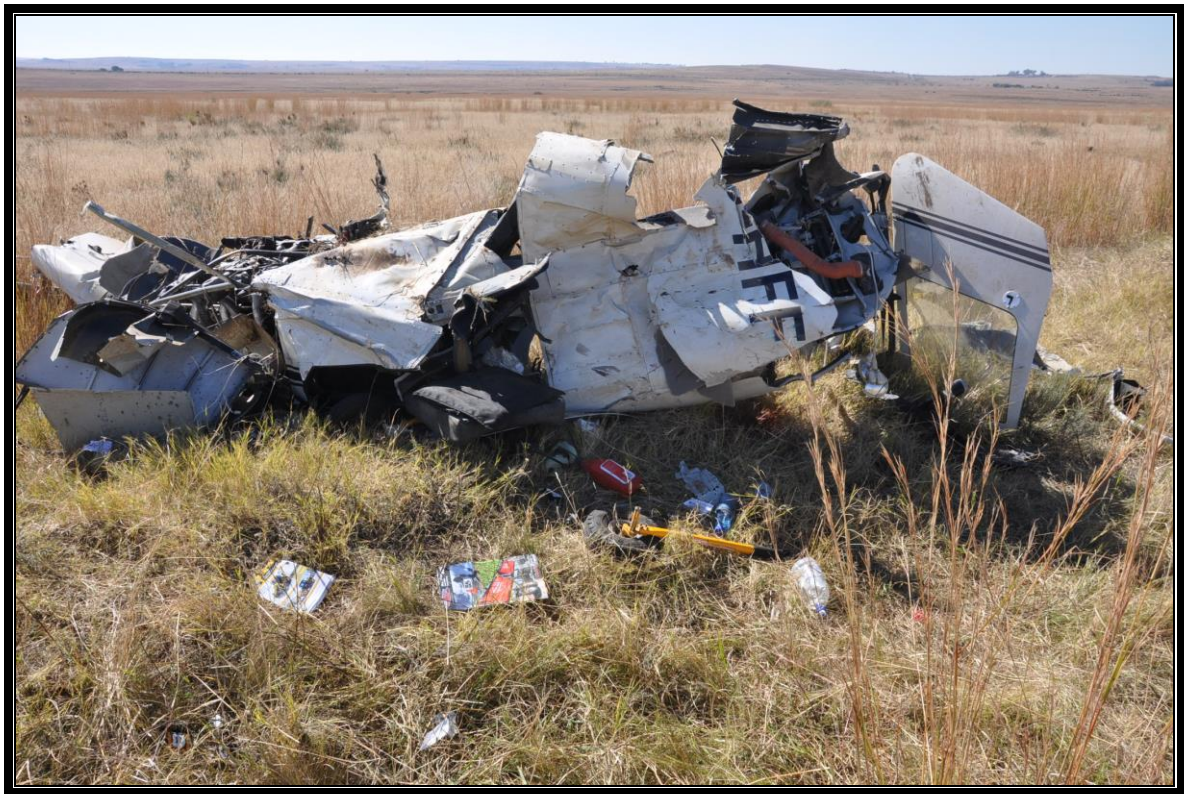
1.3.1 The helicopter was destroyed by impact forces.

**Figure 3:** The main wreckage after the impact sequence

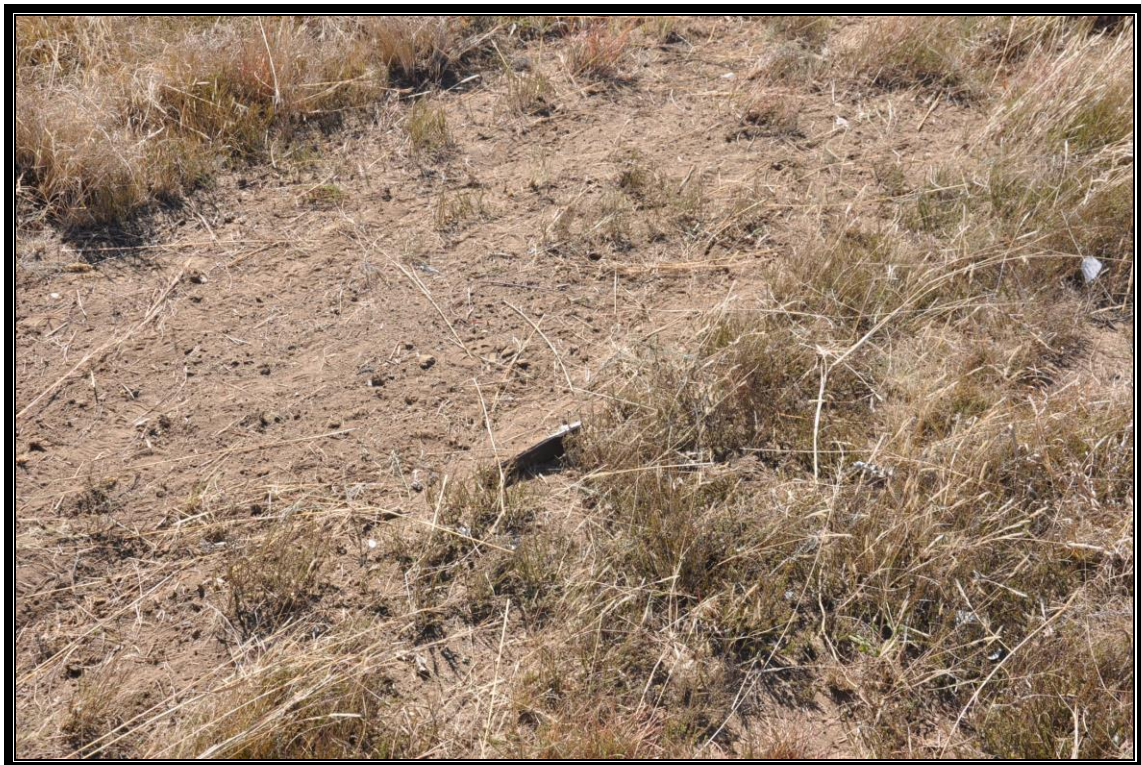
- 1.12.1 Following an unsuccessful autorotation, the helicopter impacted the ground hard, resulting in both skids collapsing, and the helicopter nosing over and coming to rest on its left-hand side. After the impact, the helicopter bounced and skidded for about 50 m before it came to rest in an almost inverted position with the fuselage twisted, resting on its left side with the nose facing a southerly direction. On-site investigation revealed that the helicopter appeared to have been autorotating after an undetermined engine stoppage.

- 1.12.2 The witness mark observed on the ground was of the tail rotor guard, the main rotor blade and the belly of the aircraft, with skids gear marks next to it. As a result of high descent speed at impact, the skids opened wide and broke off while separating, with the cross tube, from the aircraft; this resulted in the belly of the helicopter coming into contact with the ground. The left and right front pieces of the skids broke off on the midsection. The main rotor blades severed the tail boom during impact with the ground, and one blade came into contact with the ground. The damage that was observed on the main and tail rotor blades indicated wear that can be attributed to damage sustained when not turning at full RPM. The windshield disintegrated and shattered in the direction of impact. Pieces of helicopter parts were scattered at an angle of 90° in the direction of impact, which was in an easterly direction at a radius of 50 m from the main wreckage.

**Figure 5:** Impact by the belly of the helicopter

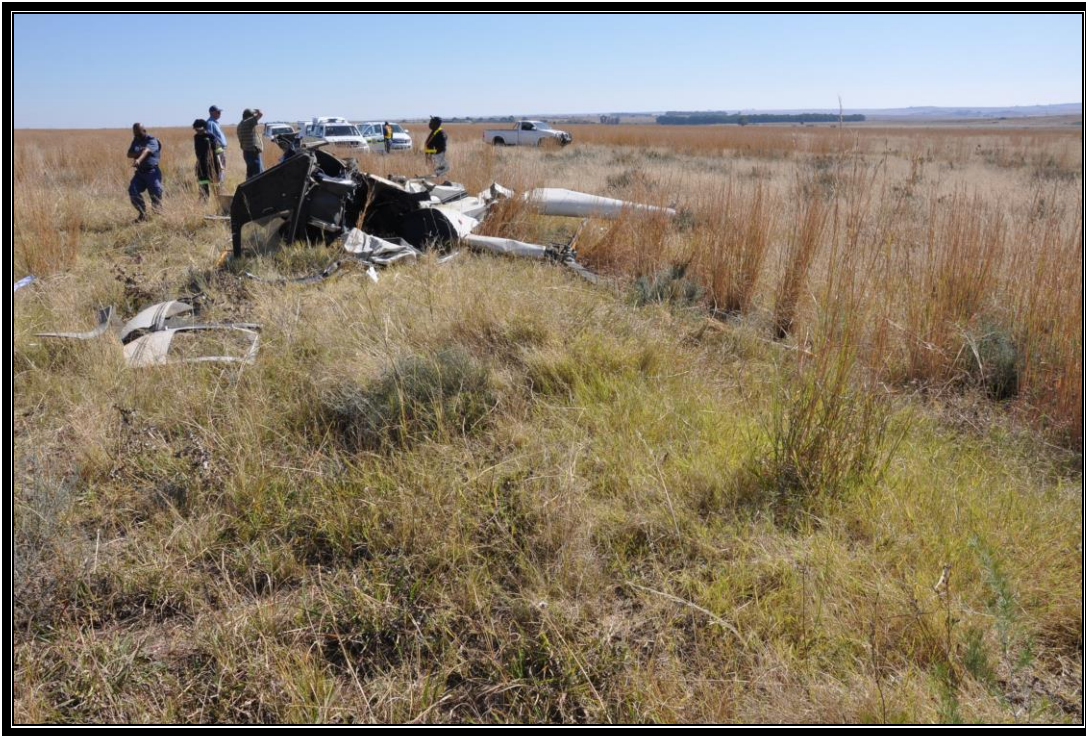
1.12.4 The tail drive shaft flex plate broke off, consistent with sudden stoppage of the tail rotor drive system on impact. The engine was still secured on the fuselage although rear engine mounting struts were broken off. The ring gear made teeth marks on the side of the oil cooler, which indicates signs of no rotation at impact. The alternator that provides alternating current to the helicopter electrical system revealed signs of no rotation on the pulley.

**Figure 6:** The fuselage lying on its left-hand side

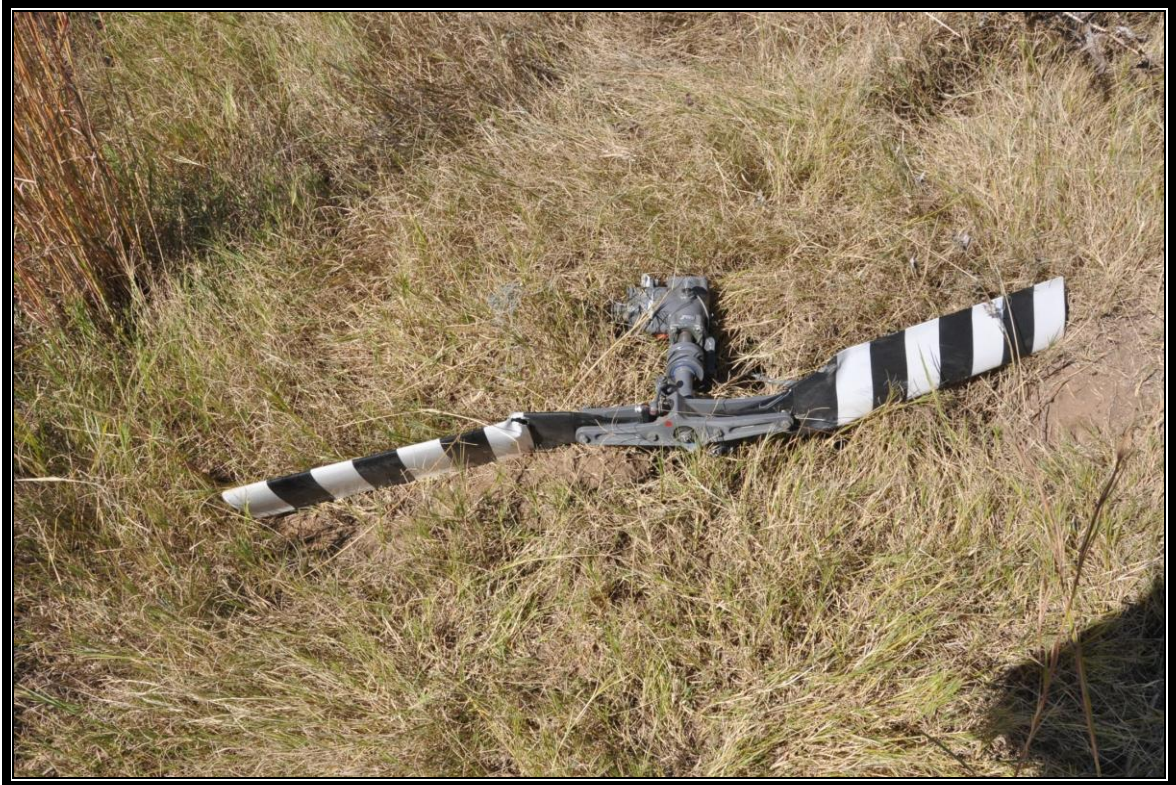
1.12.5 The tail rotor gearbox, still attached with the tail rotor blades, broke off and separated from the tail cone, falling 10 m from the main wreckage. The damage on the tail rotor blades root was consistent with the high rotation velocity impact (Figure 7). The tail cone piece also separated and was projected 100 m from the first impact mark.

**Figure 7:** The tail rotor gearbox and the blades assembly

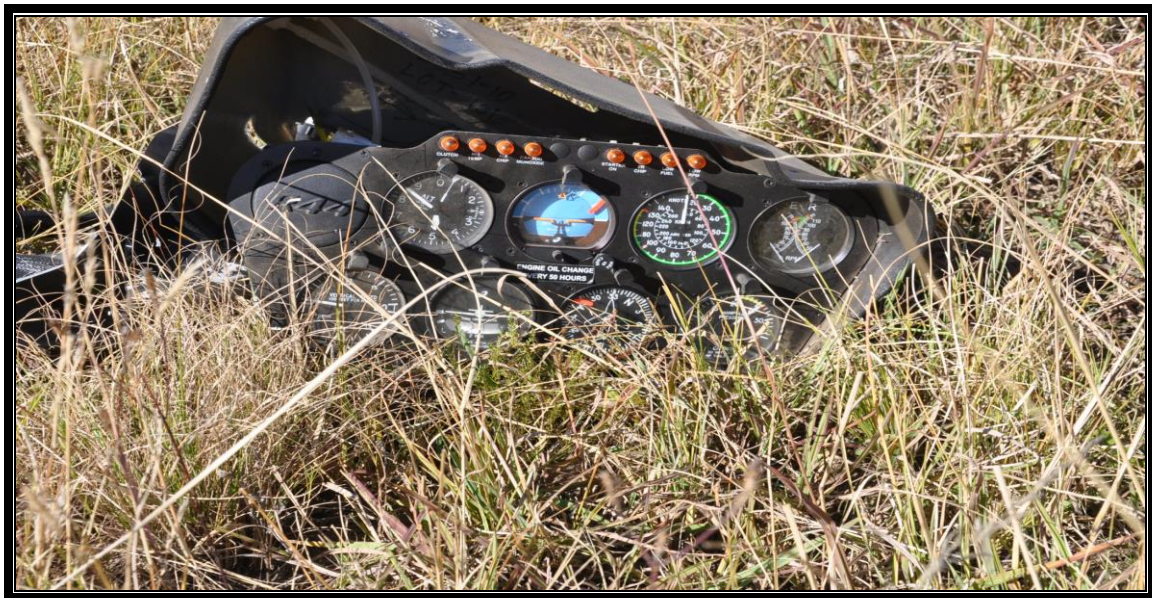
1.12.8 The instrument panel separated from the helicopter and fell 15 m from the wreckage. The auxiliary panel was still attached to the instrument panel with its components still attached. None of those components showed signs of malfunction before impact. The chronometer was indicating the time when it stopped running, which can be considered the time of impact referenced with the time the accident was reported. The Hobbs meter was still intact and indicated operation before impact; it stopped at 0909.6. The magneto switch key was selected on both magnetos.

**Figure 8:** The instrument panel with its gauges and warning lights

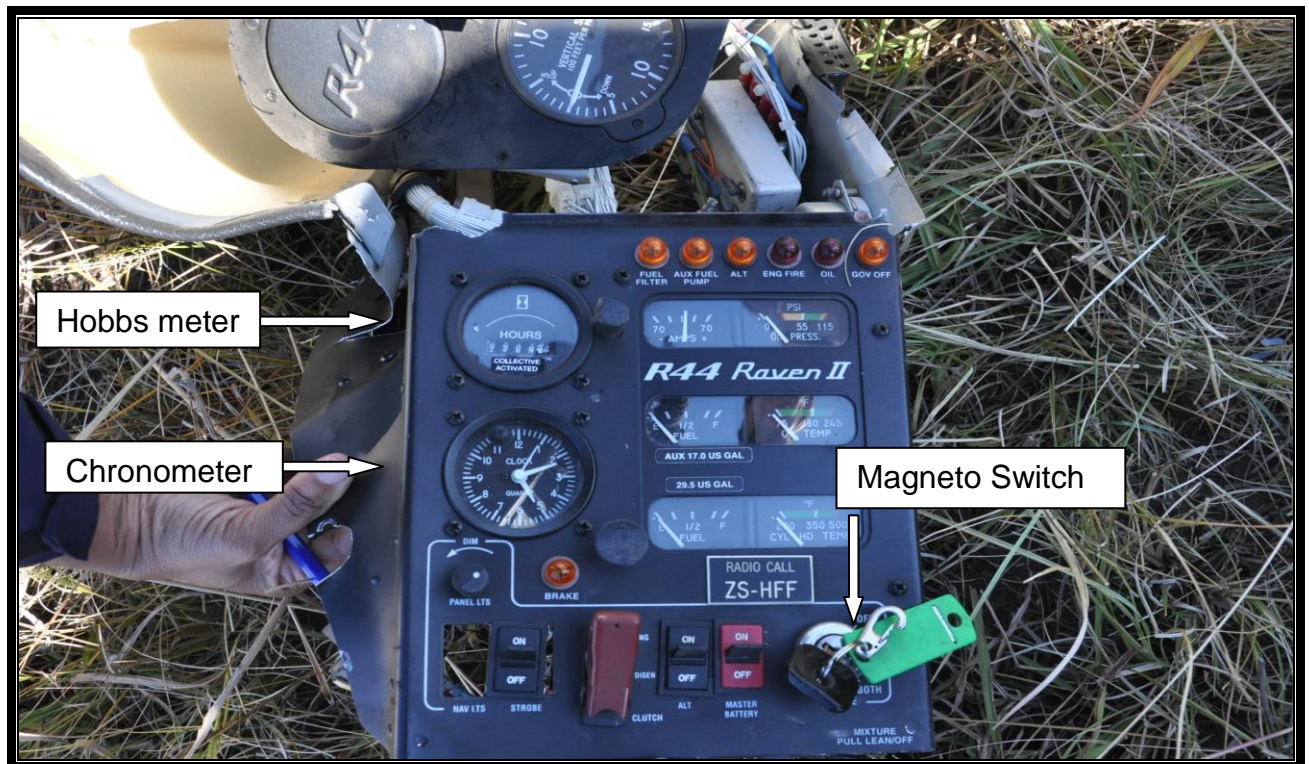
**Figure 9:** The auxiliary instrument panel with arrows indicating the Hobbs meter, chronometer and magneto switch
