AIRCRAFT ACCIDENT REPORT AND EXECUTIVE SUMMARY

Reference:	CA18/2/3/9620	
Aircraft Registration	ZU-ULU	Date of Accident	21 May 2017		Time of Accident	0810Z
Type of Aircraft	Aerostar Yak-52		Type of Operation	Private (Part 94)		
Pilot-in-command Licence Type	PPL	Age	54	Licence Valid	Yes	
Pilot-in-command Flying Experience	Total Flying Hours	946.5		Hours on Type	78.1	
Last point of departure	Rand Airport (FAGM): Gauteng Province					
Next point of intended landing	Rand Airport (FAGM): Gauteng Province					
Location of the accident site with reference to easily defined geographical points (GPS readings if possible)						
Open field next to Thinasonke Township 3,35nm South East of Panorama Airfield (GPS S 26° 22' 28.65" E 028° 5' 51.3528"); Elevation 5020 feet above mean sea level (AMSL).						
Meteorological Information	Wind: 200°/5kts, Temperature: 19°C, Dew point: 2°C, CAVOK					
Number of people on board	1+0	No. of people injured	0	No. of people killed	1

AIRCRAFT ACCIDENT REPORT

Name of Owner /Operator : Dr H G de Wet
Manufacturer : Aerostar
Model : Yak-52
Nationality : South African
Registration Marks : ZU-ULU
Place : Thinasonke near Panorama Airfield
Date : 21 May 2017
Time : 0

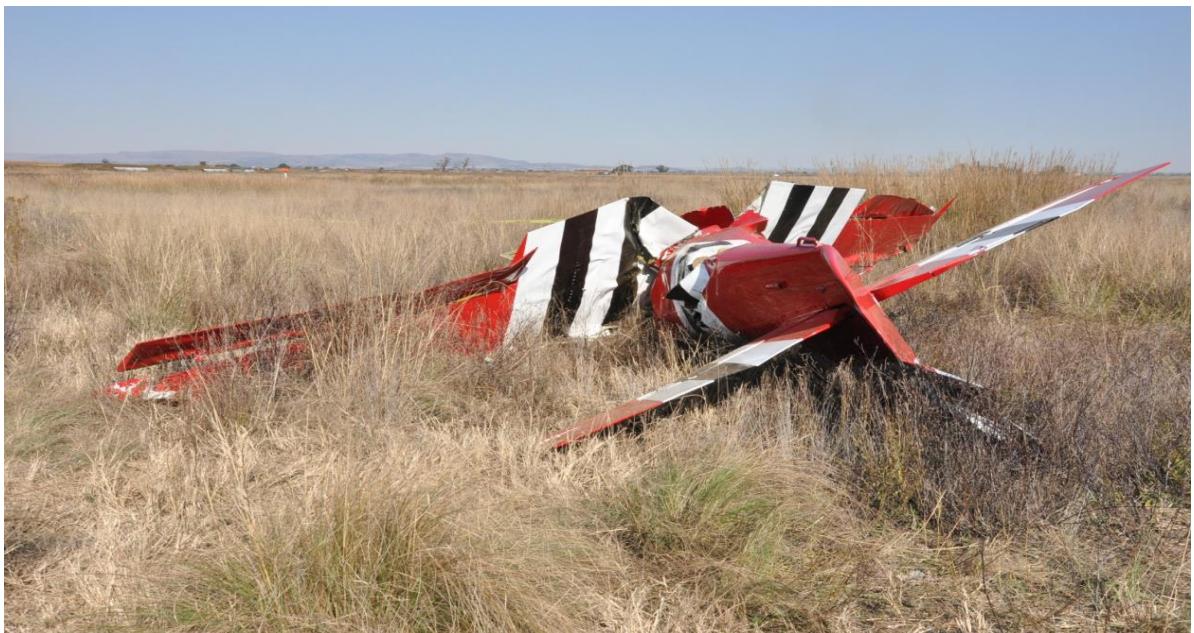
- 1.1.4 The pilot was fatally injured and the aircraft was destroyed during the accident.
- 1.1.5 The accident happened during day-light conditions in an open field near Thinasonke Township, at GPS coordinates determined to be S 26° 22' 28.65" E 028° 5' 51.3528", at an elevation of 5 029 feet above mean sea level (AMSL).

Figure 1: Showing the aircraft as found at the accident site

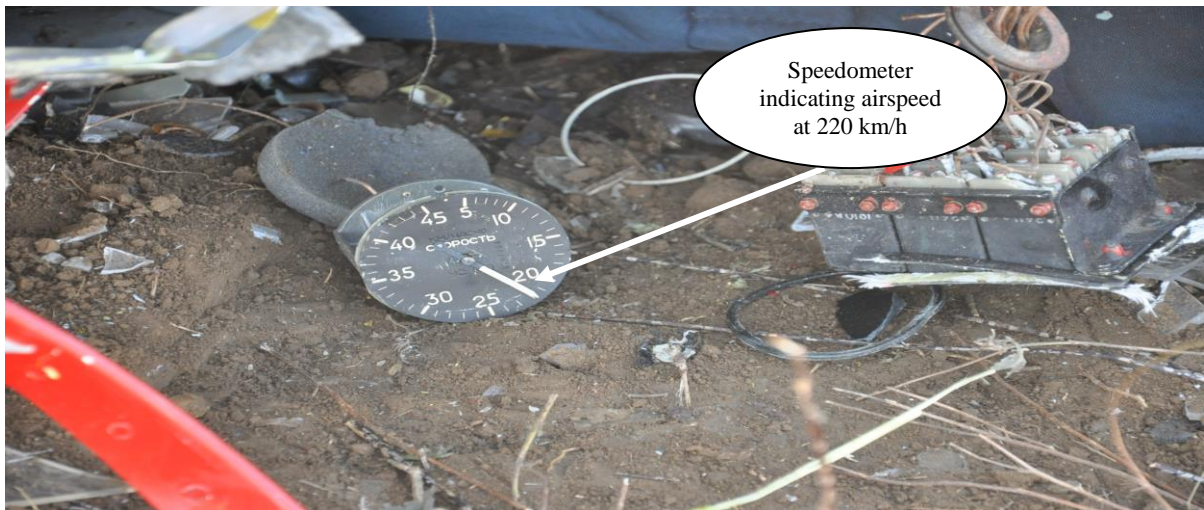
1.12.2.2 The engine was found deep into the ground, about 0.5 metres deep, and the RPM indicator was found positioned at 100%, indicative that the engine was producing power at the point of impact with the ground. The speedometer was found pointing at 220km/h, which indicated that the aircraft impacted the ground at high speed. One propeller blade broke off from the hub and was found lying about 50 metres away from the main wreckage. The evidence on the propeller blades hub after it was exhumed from the ground also indicated that the engine was producing power at impact with the ground.

Figure 2: Showing the speedometer as found at the accident site

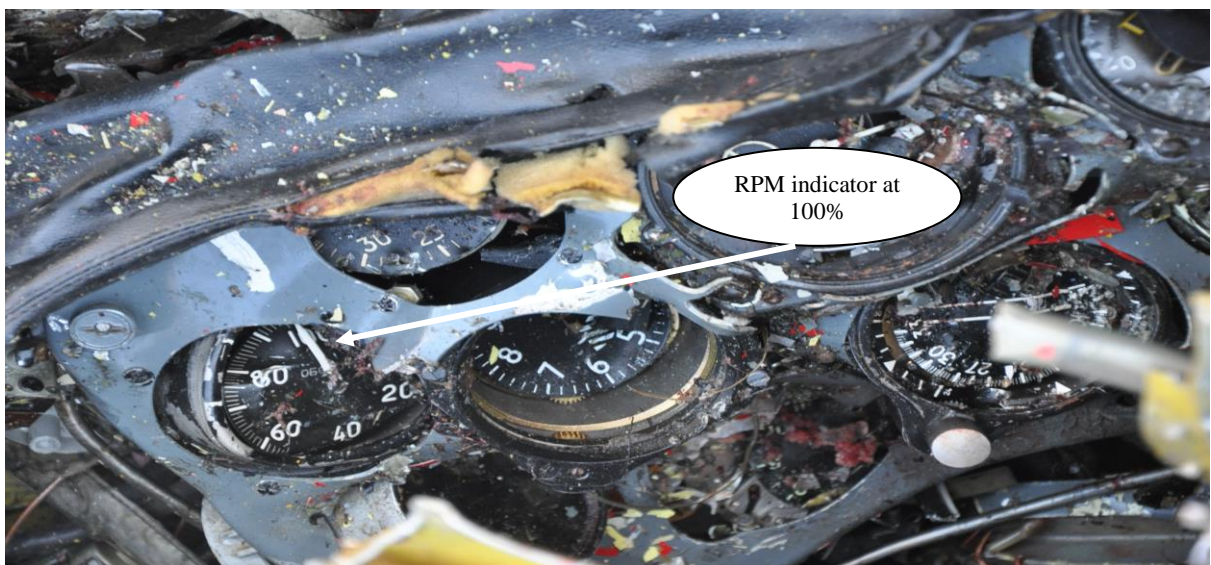
Figure 3: Showing the RPM indicator at 100%

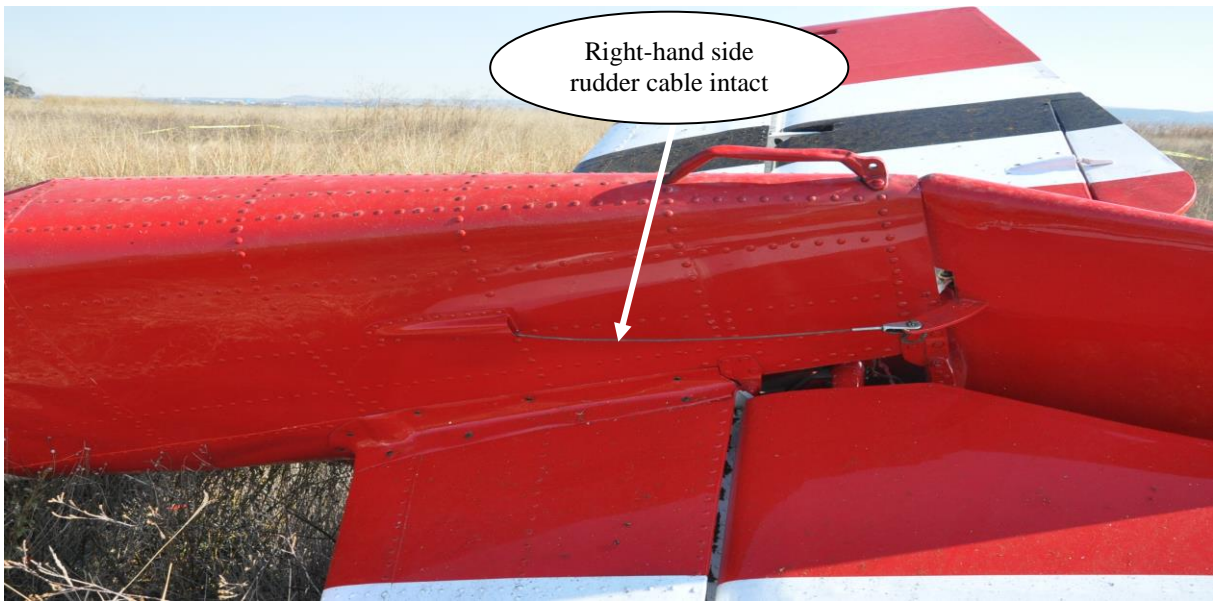
Figure 4: Showing the rudder cable on the right hand side still intact

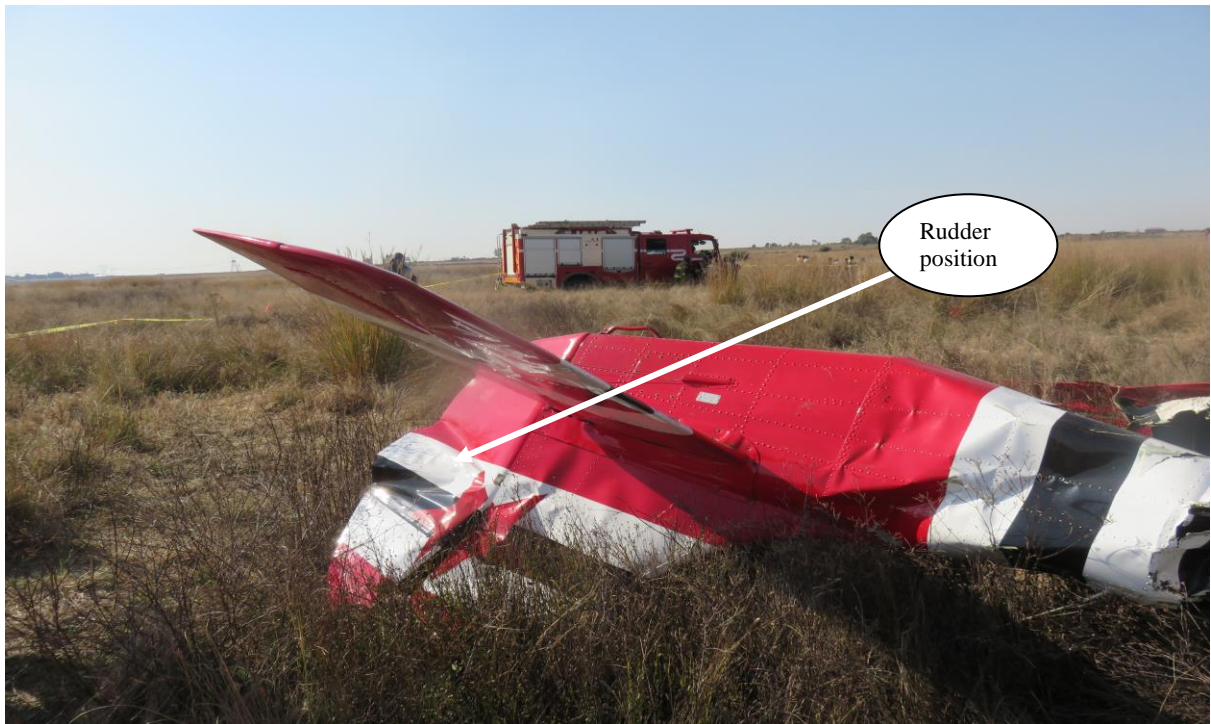
Figure 5: Arrow showing the rudder position as found after impact with the ground

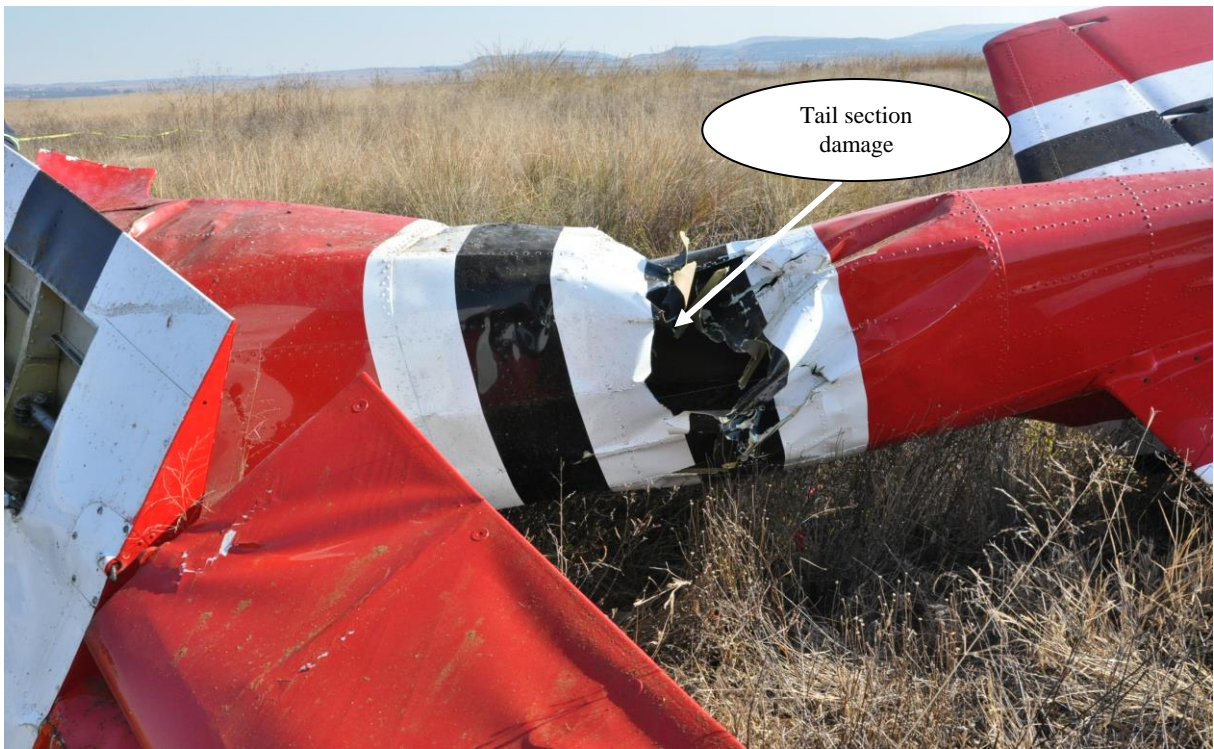
1.12.2.3 The empennage was inspected and found to have sustained compression damage on the tail section due to impact with the ground; it got twisted around see figures below. The horizontal stabiliser and both its elevators sustained minor damages. The vertical stabiliser also sustained minor damages and the rudder was found in a right-hand side position. The rudder position could not be checked, because the control stick had broken off due to the impact with the ground and its position could not be determined

Figure 6: Tail section showing compression damage

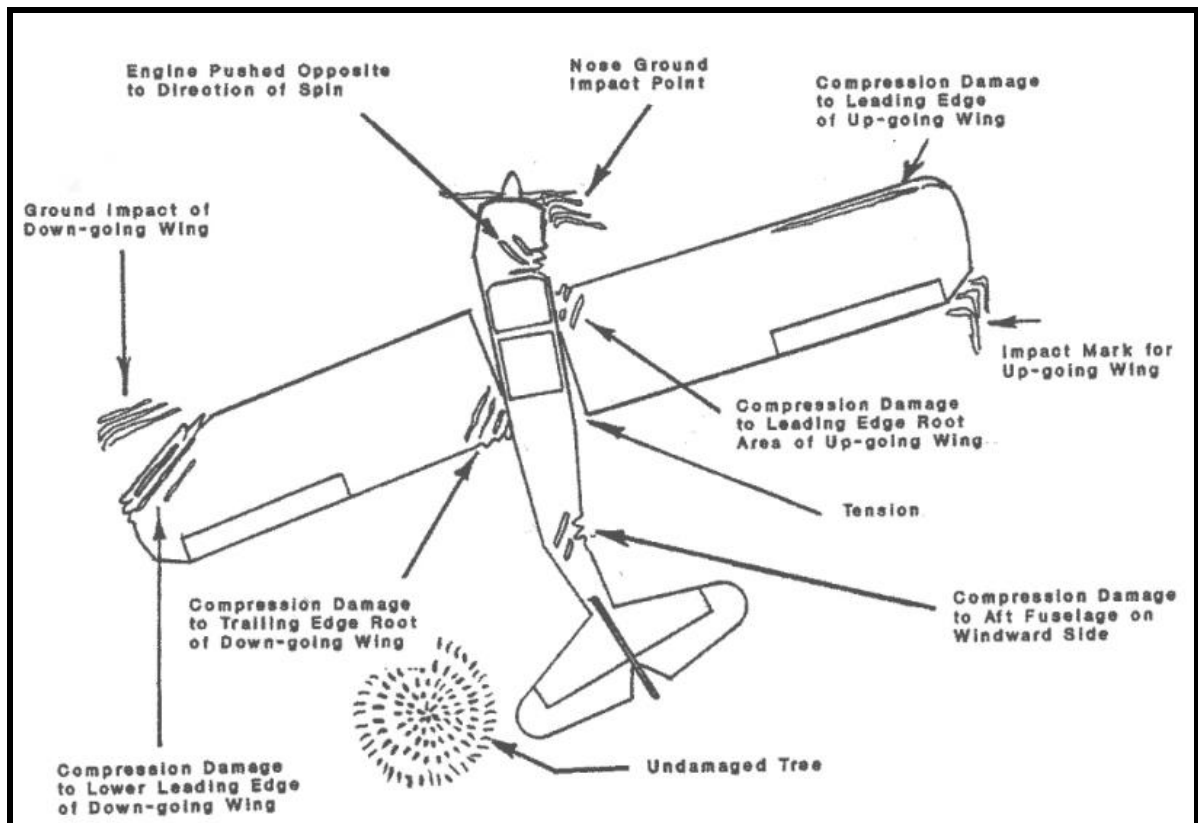
Figure 7 Wreckage pattern of a spinning aircraft (Source: Aircraft Accident Investigation-second edition by Richard H.Wood /Robert w. Sweginnis)

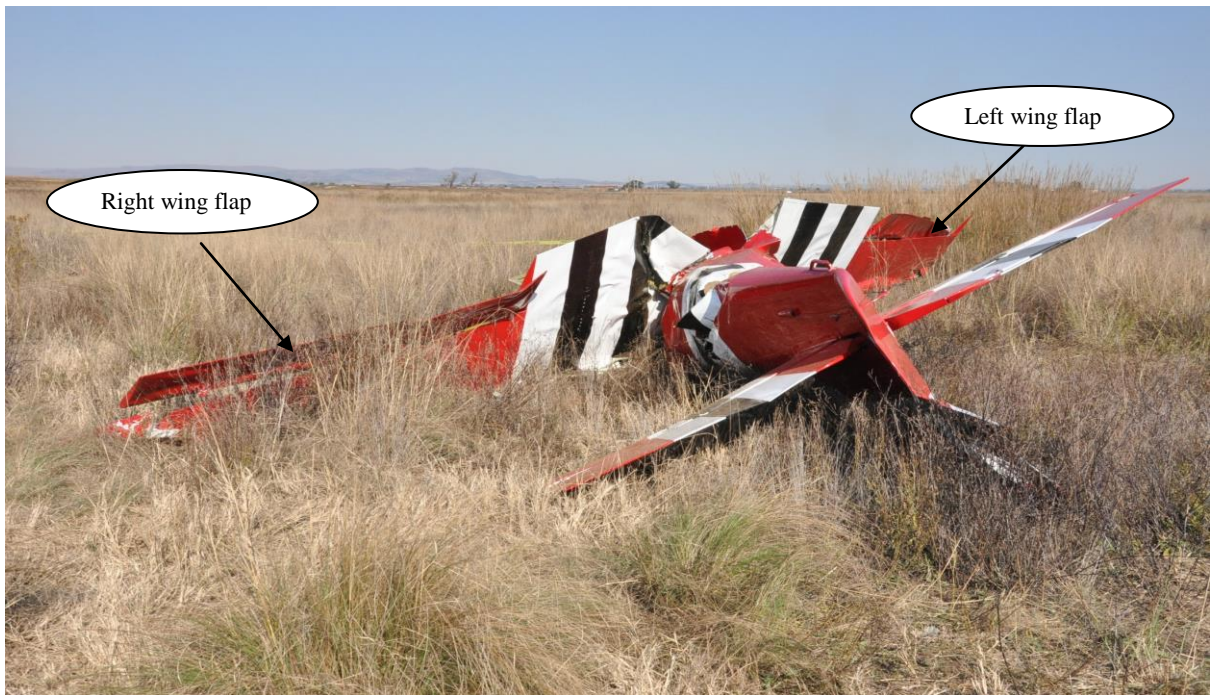
1.12.2.4 Both wings were inspected and found damaged due to the impact. The flaps positions could not be determined due to the fact that the selector inside the cockpit was destroyed. Both fuel tanks were found ruptured, with a strong smell of fuel present, indicating that there was an amount of fuel on board.

Figure 7: Showing damage and the position of the wing flaps
