**Air, Maritime and Railway Traffic Accident Investigation Agency**

# **FINAL REPORT**

**ON ACCIDENT OF THE AIRCRAFT PIPER PA-28,  
REGISTRATION D-EERD**

**16 JUNE 2017,  
NEAR MALI LOŠINJ AIRPORT**

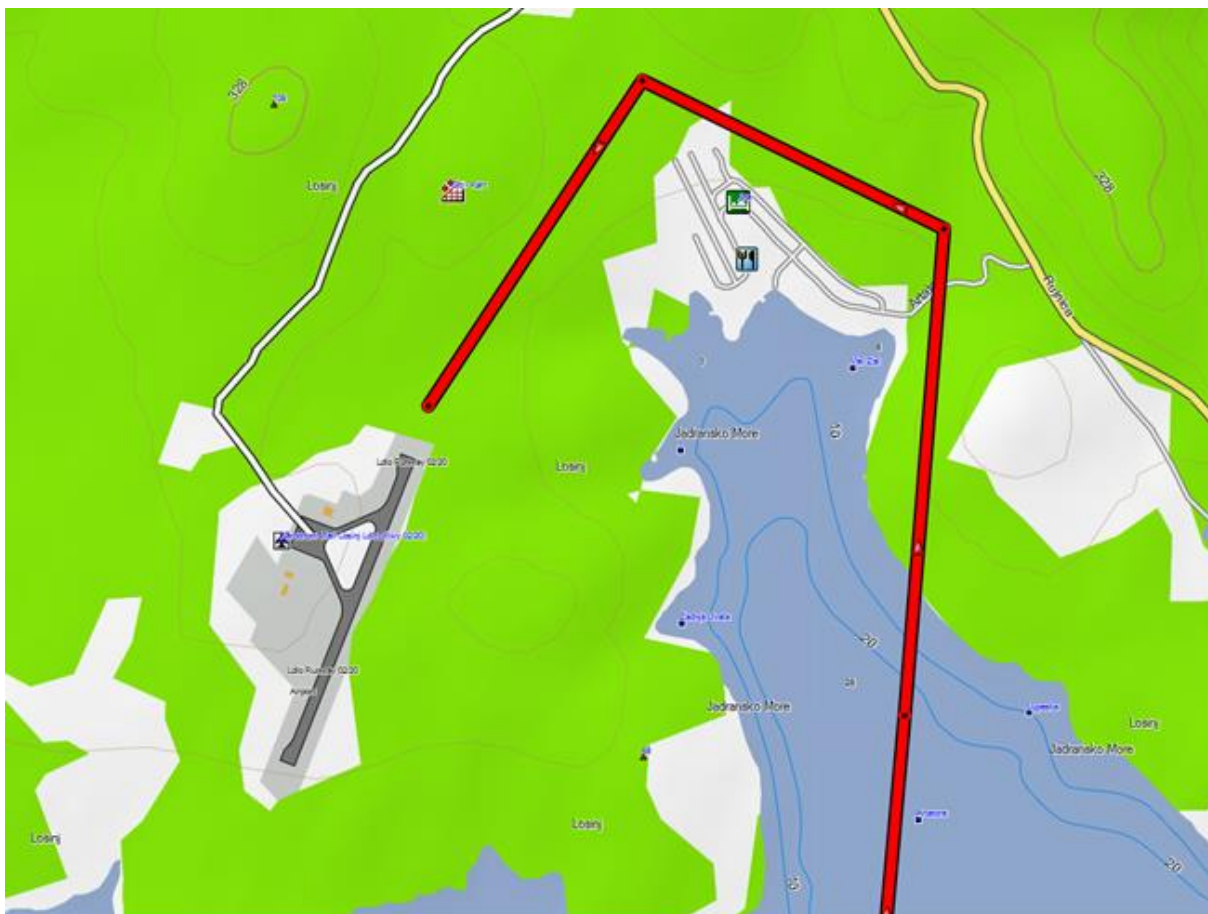
On the day of the accident, the pilot and two passengers took off from Tivat Airport, Montenegro, towards Mali Lošinj Airport. The flight was reported under VFR conditions. The flight proceeded according to the plan along the Dalmatian coast without difficulty. Upon arrival at Mali Lošinj Airport pattern from south direction and upon contacting the airport tower control, the aircraft began approach to the runway direction 20. The aircraft entered downwind leg, then the cross wind leg and the base leg to the runway, direction 20 (Picture 1).

**Picture 1** The approach path of the aircraft towards Mali Lošinj Airport (GPS device)

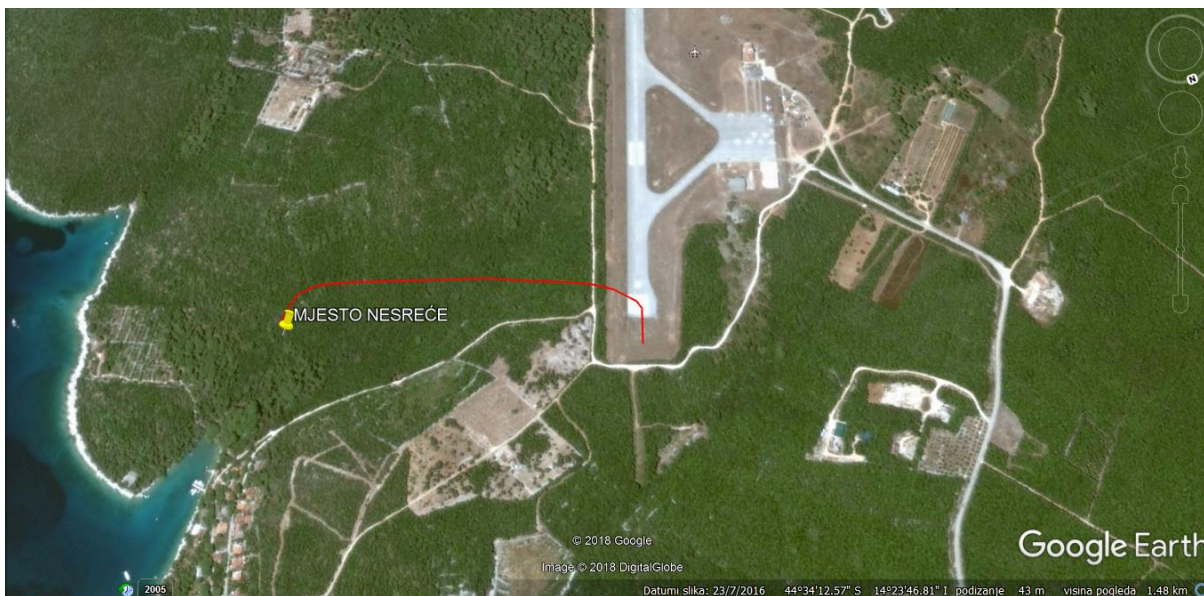
The pilot added full power to the engine and immediately turned left. The aircraft began climbing in a straight flight line at a small climbing angle, after which it started the second left turn and then fell to the left tailspin. At that time, the aircraft did not have enough altitude to pull out from the tailspin and crashed in a hilly terrain covered with forest and low vegetation.

Based on an eyewitness statement, also a pilot with a valid pilot license, who observed the accident from the airport, a reconstruction of the aircraft flight path after the pilot's decision to go around was made (Picture 2).

Picture 2 Reconstructed path of the aircraft marked in red, as it's described by the eyewitness

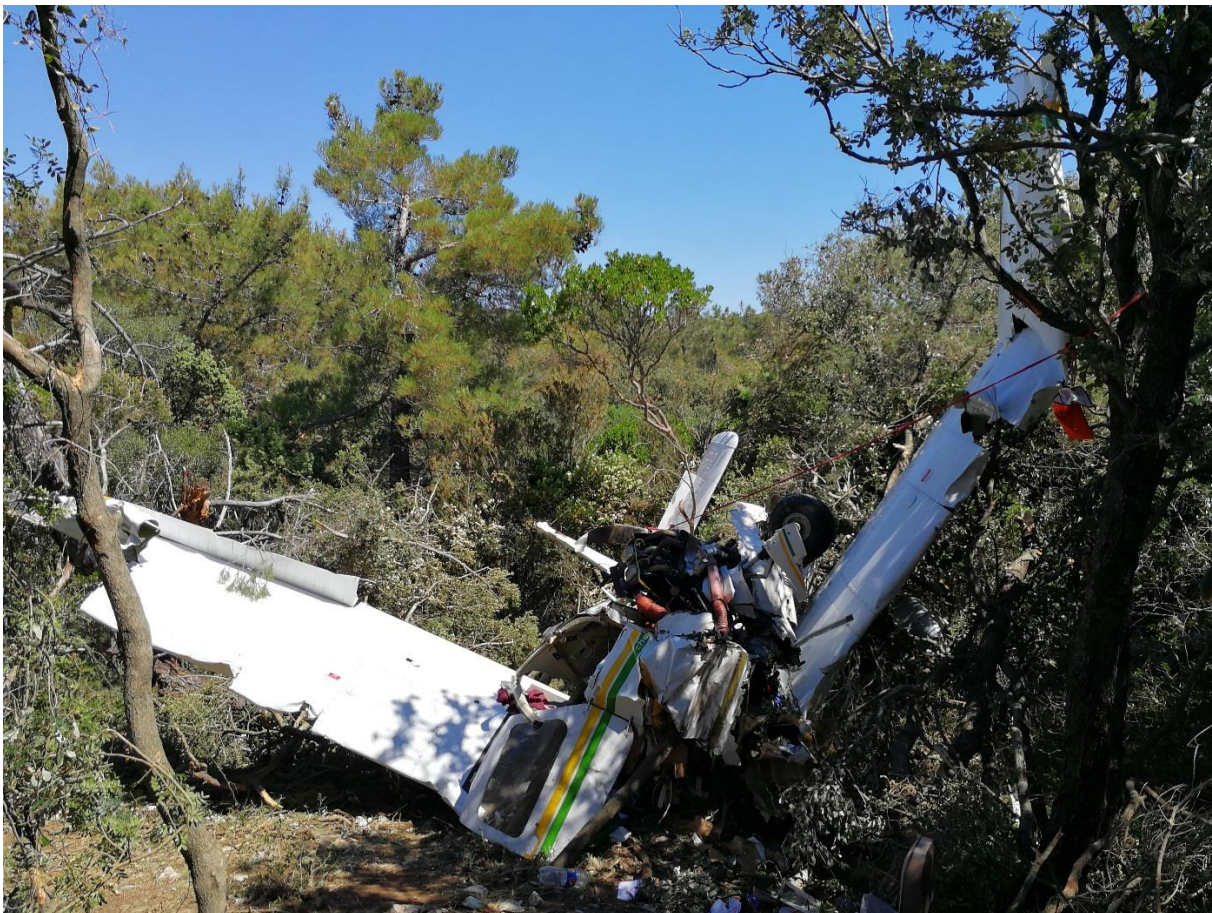
The aircraft suffered significant structural damage (Picture 3), listed below:

- the aircraft fuselage was deformed throughout its length,
- the engine mount broke in several joints,
- both propeller blades were bent,
- the instrument panel was deformed in several places.

There were several structural damages on the right wing:

- detaching of skin from the wing ribs at the very top of the wing,
- separating of the right aileron from the wing,
- bent wing spar,
- breakage of the skin at several places along the entire length of the wing.

There were several structural damages on the left wing:

- skin was bent in several places along the entire length of the wing,
- skin was detached from the wing ribs in several places.

**Picture 3** Aircraft D-EERD at the crash site

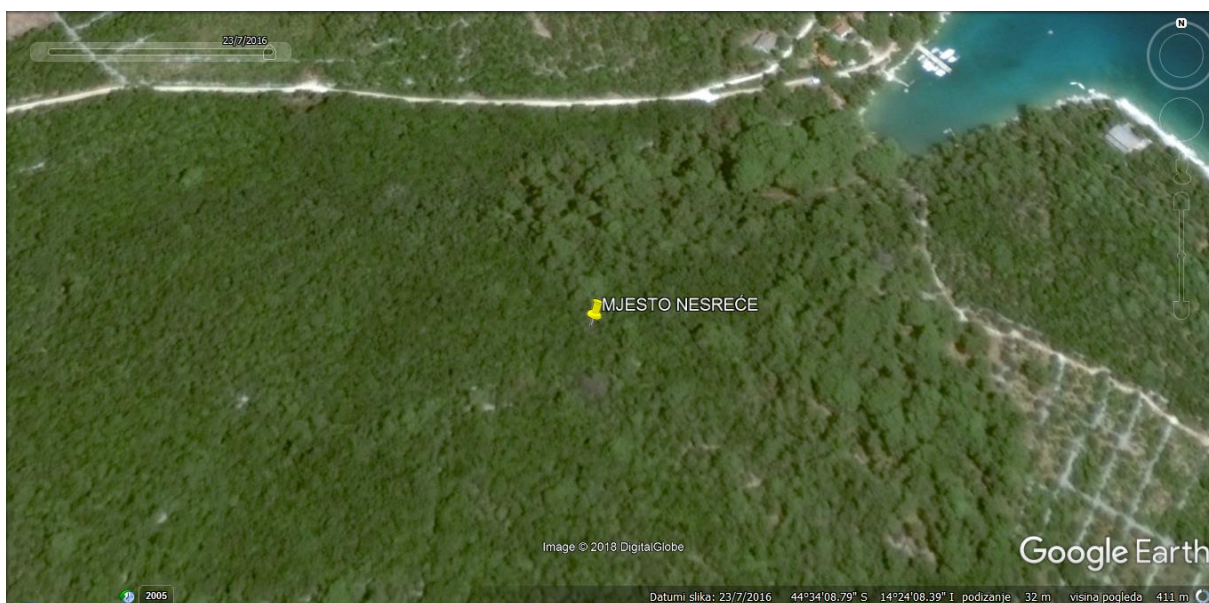
Due to the insufficient altitude for pulling the aircraft from the tailspin, the aircraft crashed on a steep, woody, low vegetation terrain (Picture 4). The distance of the aircraft crash site to the runway 20 threshold is approximately 500 meters.

Picture 4 Aircraft D-EERD crash site

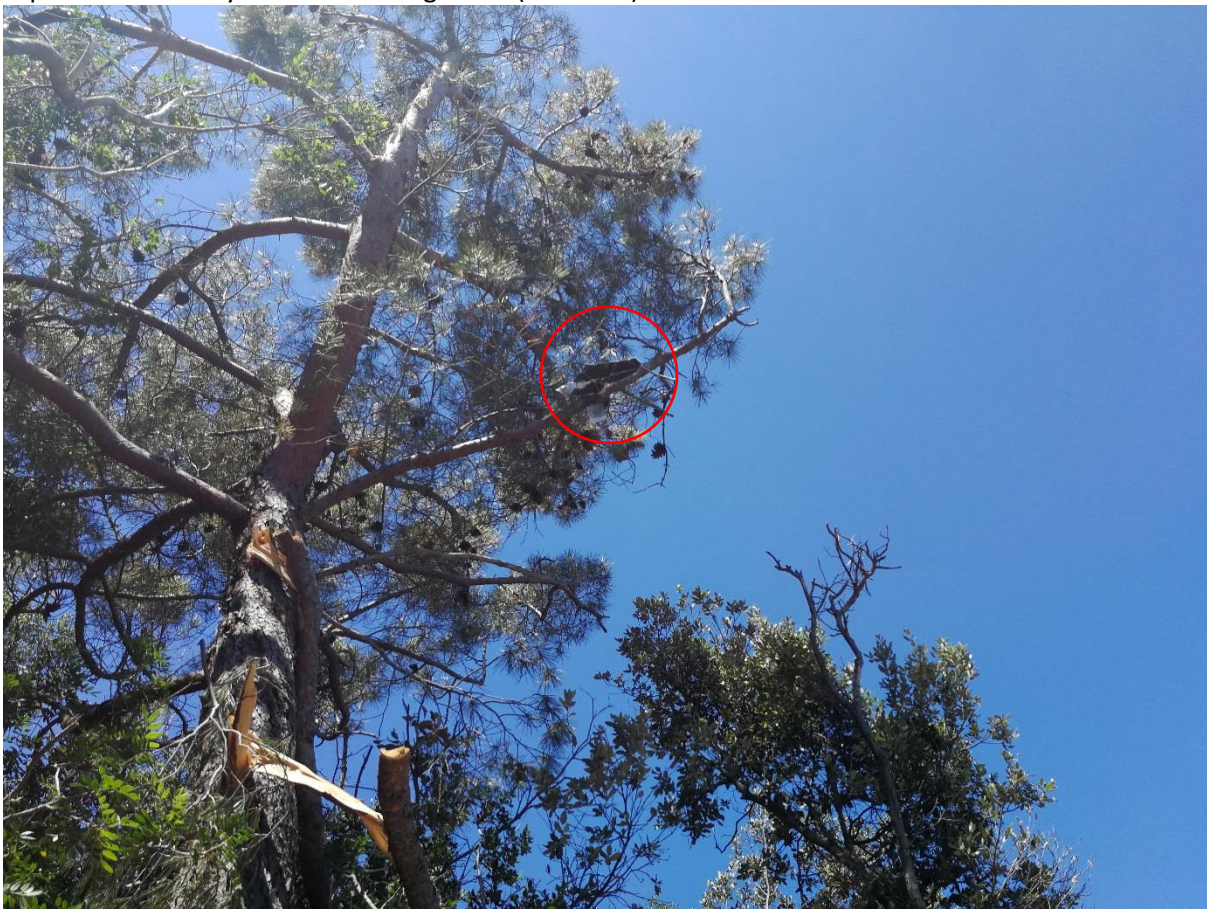
Damage to the aircraft and the surrounding trees indicate that the aircraft passed through the tree tops and eventually crashed to the ground (Picture 5).

**Picture 5** Overview of broken branches and parts of aircraft on the top of surrounding trees (marked with a red circle in the picture)
