AIRCRAFT ACCIDENT REPORT AND EXECUTIVE SUMMARY

Reference:	CA18/2/3/9635	
Aircraft registration	ZS-JDN	Date of accident	3 September 2017		Time of accident	0930Z
Type of aircraft	Cessna 172M (Aeroplane)		Type of operation		Private (Part 91)	
Pilot-in-command licence type		Commercial	Age	23	Licence valid	Yes
Pilot-in-command flying experience		Total flying hours	291.0		Hours on type	215.1
Last point of departure		Wonderboom Aerodrome (FAWB), Gauteng province				
Next point of intended landing		Wonderboom Aerodrome (FAWB), Gauteng province				
Location of the accident site with reference to easily defined geographical points (GPS readings if possible)						
Magaliesberg Mountain Range (GPS position: 25°51'13.30" South 027°32'03.06" East) elevation of 5501 ft						
Meteorological information		Surface wind: 010°/3kt, Temp: 20°C, Dew point: 6°C, Visibility: CAVOK				
Number of people on board	1 + 1	No. of people injured	0	No. of people killed	2	
Synopsis

AIRCRAFT ACCIDENT REPORT

Name of Owner : TR Eagle Air (Pty) Ltd
Name of Operator : Private (Part 91)
Manufacturer : Cessna Aircraft Company
Model : 172M
Nationality : South African
Registration markings : ZS-JDN
Place : Magaliesberg Mo

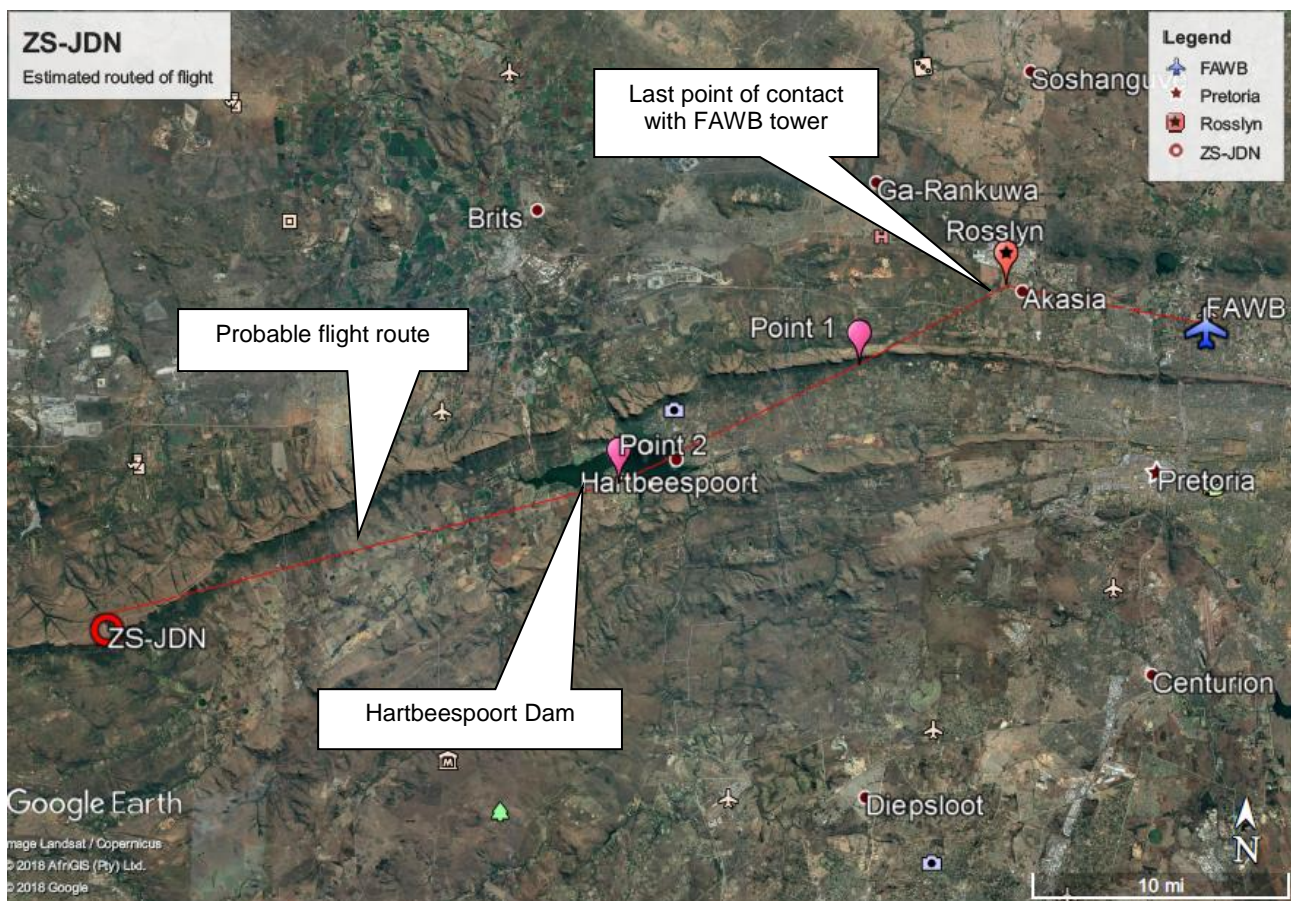
Figure 1: The most probable aircraft routing from FAWB to the point of impact

- 1.1.5 The aircraft routed towards the Hartbeespoort Dam area by remaining south of the Magaliesberg Mountain range. In order to remain outside the Lanseria International Aerodrome (FALA) airspace, the aircraft routed to the north of FALA while en route to the Magaliesberg Flight Training Area (FAD 70-E).

- 1.1.9 A bird sanctuary for the Cape Griffon species and high-tension cables were present near the accident site.
- 1.1.9 The accident occurred during daylight conditions at a geographical position that was determined to be 25°51'13.30" South 027°32'03.06" East, at an elevation of 5 501 feet above mean sea level (AMSL). The accident site was approximately 4.7 nm to the north-east of Hekpoort town.

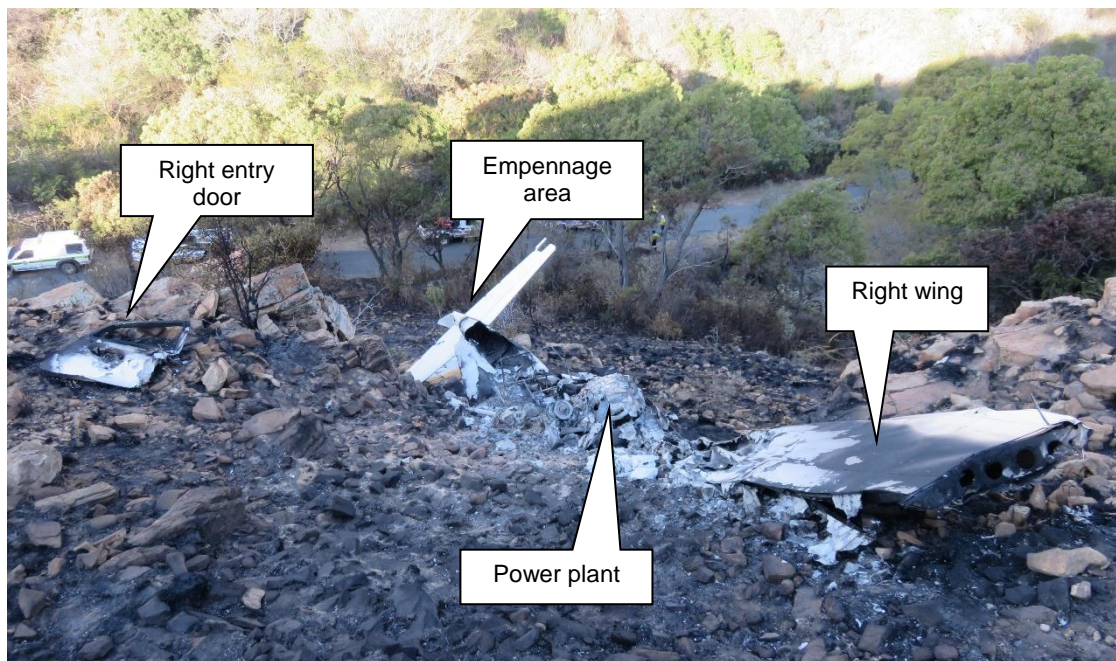
Figure 2: The aircraft as it came to rest on the side of the mountain

1.3.1 The aircraft was largely consumed by the post-impact fire. The fuel in the tanks leaking out and igniting may have caused the fire. The empennage area and a portion of the right wing sustained impact damage but no fire damage. The aircraft was destroyed due to the impact and ensuing post-impact fire.

- 1.12.1 The area of impact was a rocky mountainous area, covered by savannah type shrubbery.
- 1.12.2 The aircraft came to rest in an inverted position.
- 1.12.3 The configuration of the aircraft was unable to be determined due to the extensive fire damage.
- 1.12.4 There is no wreckage trail and the entire aircraft is located within a 5 m radius.
- 1.12.5 The aircraft may have impacted the terrain with a high vertical speed and a low forward airspeed.

1.12.6 A post-impact, fuel-fed fire erupted after the accident. This destroyed a large portion of the aircraft.

1.14.1 Most of the aircraft structure was destroyed by the fuel-fed, post-impact fire that erupted. The post-impact fire did not consume the empennage and a portion of the right wing.

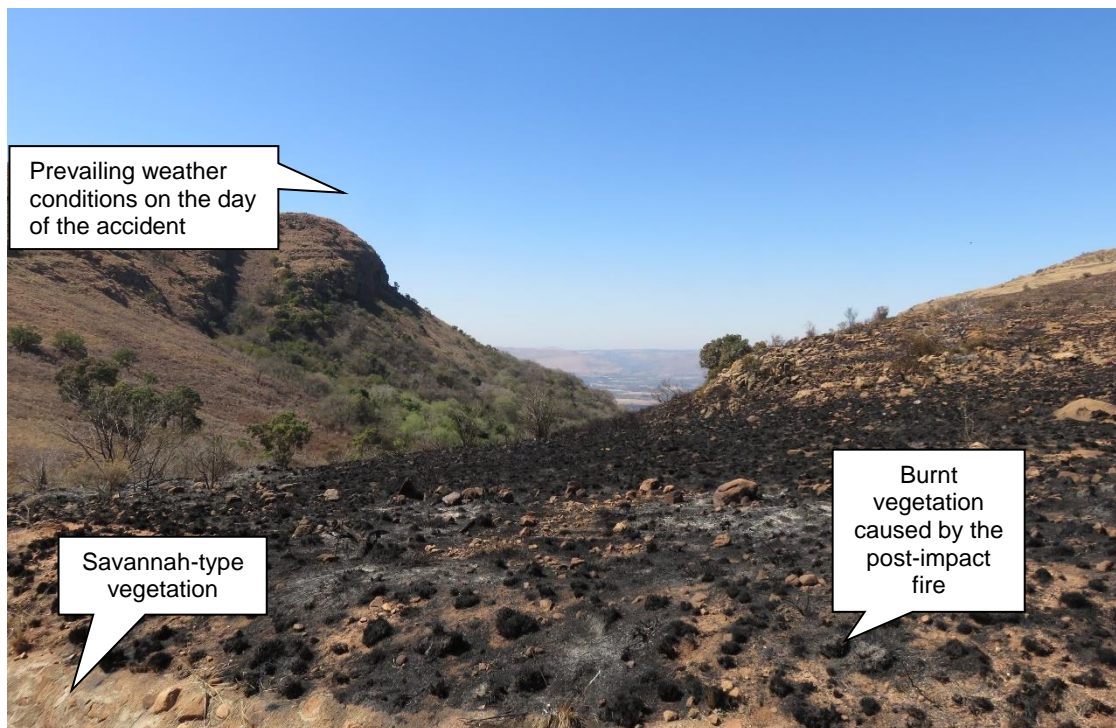
Figure 3: Burnt vegetation caused by the post-impact fire

- 1.4.1 A large section of vegetation was destroyed by the post-impact fire that set the dry savannah-type vegetation alight. Fire and rescue services were informed of the fire. They responded from Krugersdorp and the fire was extinguished several hours later. No other damage was reported due to the accident.

1.14.2 The post-impact fire set the savannah type vegetation alight. The assistance of the Krugersdorp fire and rescue services was obtained and they were dispatched to the scene and contained the fire, which had consumed a large part of vegetation.

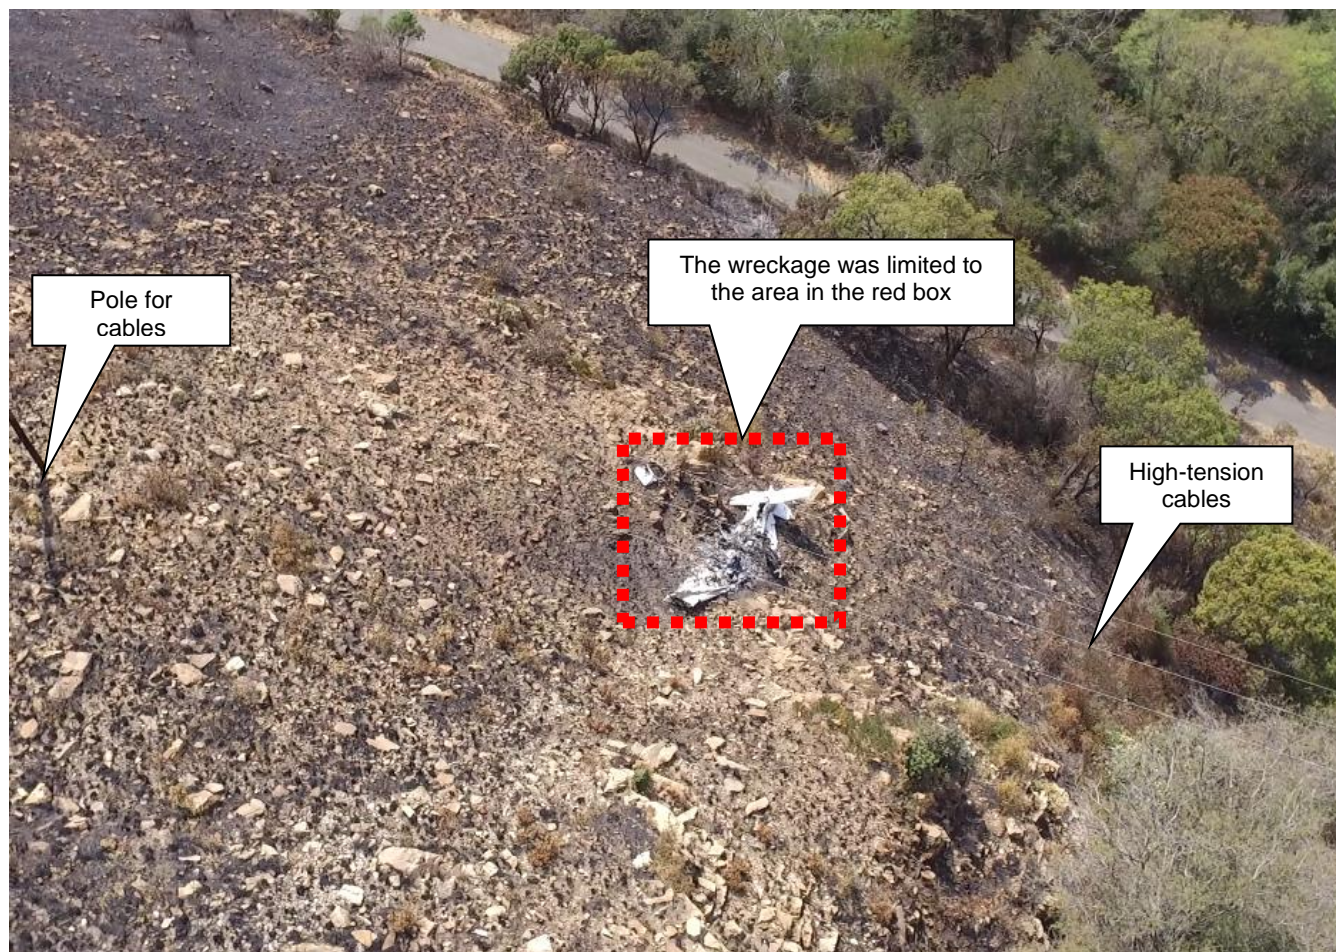
Figure 8: Aerial photograph of the accident site indicating the location of the wreckage

1.12.7 Due to the post-accident fire, the investigation is unable to determine if any components malfunctioned in flight.
