AIRCRAFT ACCIDENT SHORT REPORT

CA18/2/3/9719 ZU-CRF, Mohawk forced landing in Stillbaai River shortly after takeoff

Date and time : 12 June 2018
Location : Stillbaai, Western Cape
Occurrence type : Accident
Aircraft registration : ZU-CRF
Aircraft manufacturer and model : Mohawk
Last Point of departure : Stilbaai Aerodrome, Western Cape (elevation 285 ft)
(GPS co-ordinates: S34°21'3,21" E021°23'36,58")
Next point of intended landing : Stilbaai Aerodrome, Western Cape
Location of accident site with reference to easily defined geographical points (GPS readings if possible) : Stilbaai River (S34°21'14,23" E021°24'56,90", at an elevation of 10 ft)
Meteorological Information : Surface wind: 8 kt/300°, temperature 28°C, dew point: -1°C, pressure altitude: 1019hPa, CAVOK
Type of operation : Private (Part 94)
Persons on board : 1+1
Injuries : None
Damage to aircraft : Substantial

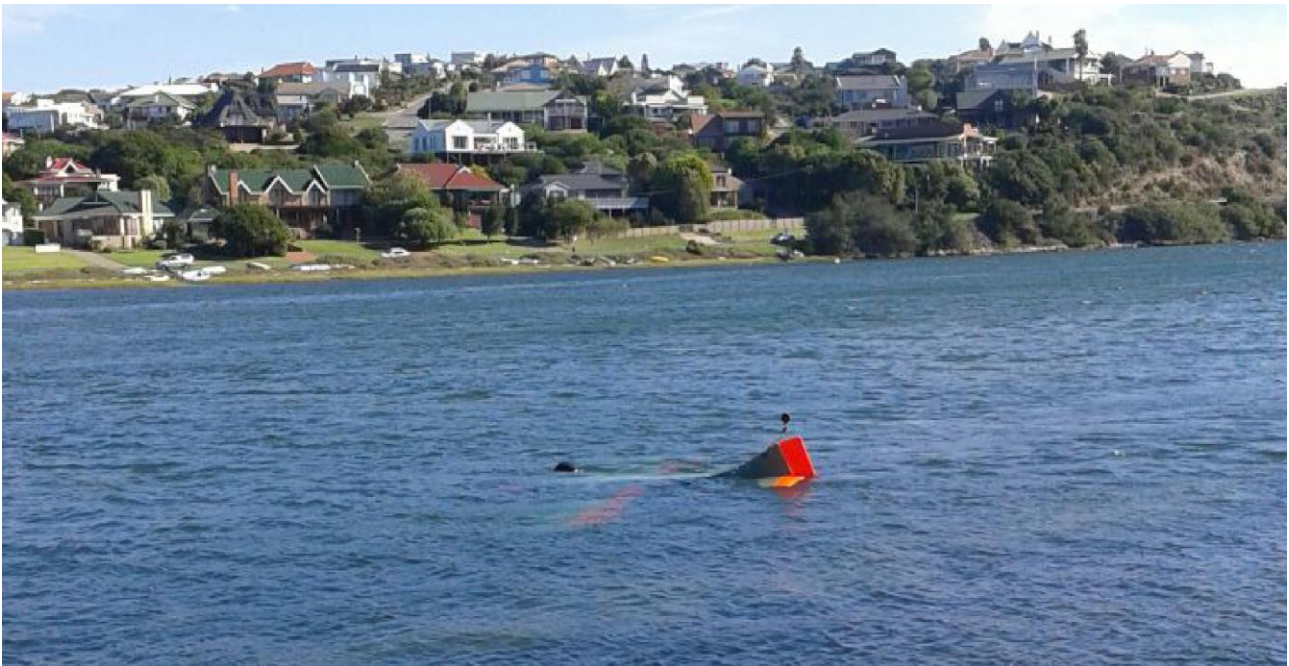
Figure 4: The aircraft as it was positioned after ditching in the Stilbaai River. (image/photograph courtesy of first responder to the crash site)

- 3.6. The pilot opted to perform the forced landing over the Stilbaai River due to the prevalence of wires found after departing FACV runway 27.
- 3.7. The aircraft was substantially damaged. A propeller blade broke off on impact. The airframe bent due to the forces experienced on impact. The aircraft experienced water damage due to ditching.

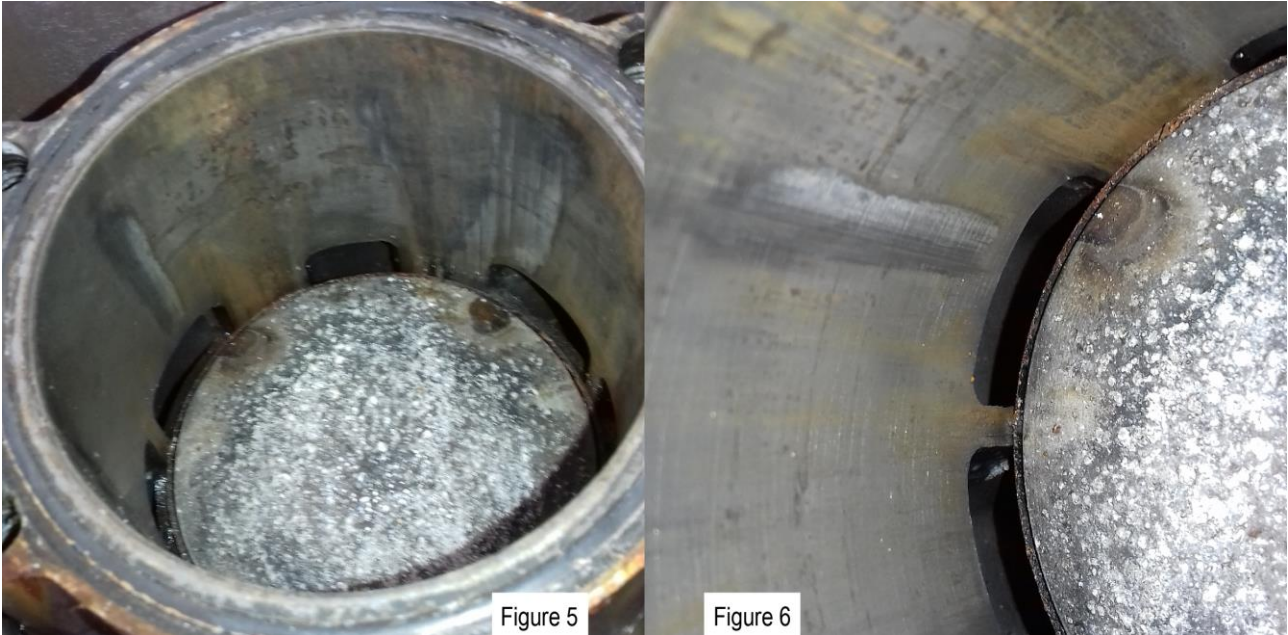
2.2.2 The engine was inspected by an approved person (AP) and no abnormalities were found except for the scaring shown in figure 5 and 6. These abnormalities indicate a cold seizure occurring.

Figures 5 & 6: The damage experienced by the piston with respect to its cylinder.
(image/photograph courtesy of approved person inspecting the engine)

- 3.8. An engine teardown was conducted by the relevant maintenance personnel, and except cold seizure no other abnormalities were found.

5.1 A cold seizure stopped the engine from running due to the restrictions experienced by the piston. This followed with the pilot conducting a forced landing.
