AIRCRAFT ACCIDENT SHORT REPORT

CA CA18/2/3/9766 A gyrocopter was flown at a low height, collided with a tree and fatally injured a spectator.

Date and time : 10 February 2019 ,09:45Z
Aircraft registration : ZU-DXL
Aircraft manufacturer and model : Magni Gyro M 22
Last Point of departure : Sunset Shores, Vaal Marina , Gauteng
Next point of intended landing : Sunset Shores, Vaal Marina , Gauteng
Location of accident site with reference to easily defined geographical points (GPS readings if possible) : 26° 51' 0" South 28° 11' 24" East
Meteorological Information : Wind: 280°/10kts, Temperature: 28°C, Visibility 9999m
Type of operation : Operation of Non-Type Certificated Aircraft (Part 94)
Persons on board : 1+1
Injuries : Both occupants on-board sustained minor injuries and one bystander was fatally injured
Damage to aircraft : Minor damage

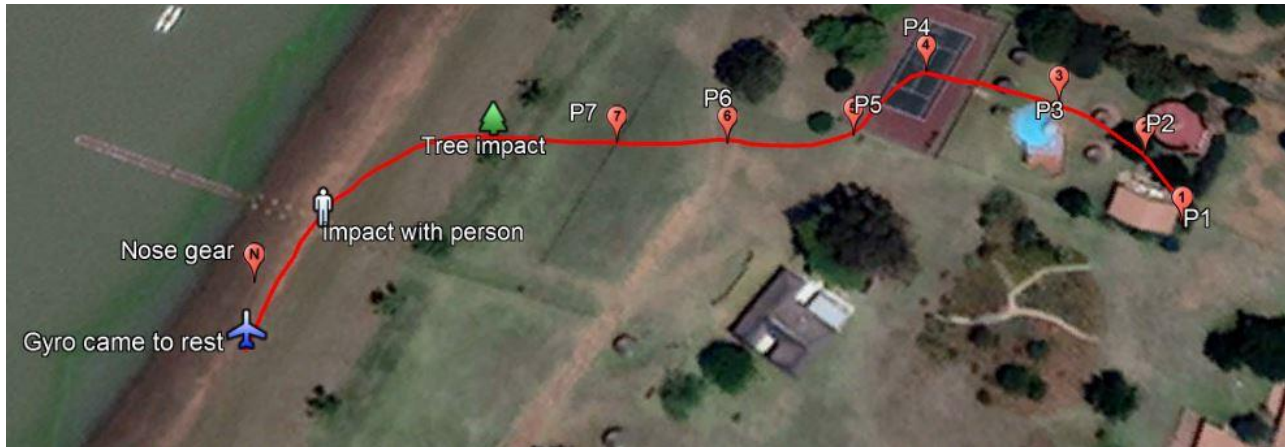
- 2.3 Video evidence showed the gyrocopter flying along the river before going inland and passing over houses. It was seen flying below the treetop prior to impacting one of the trees. After the impact, the gyrocopter became unstable before its rotor struck one of the spectators.

Figure 1: Google Earth image of the final flight path. (Source: Google Earth)

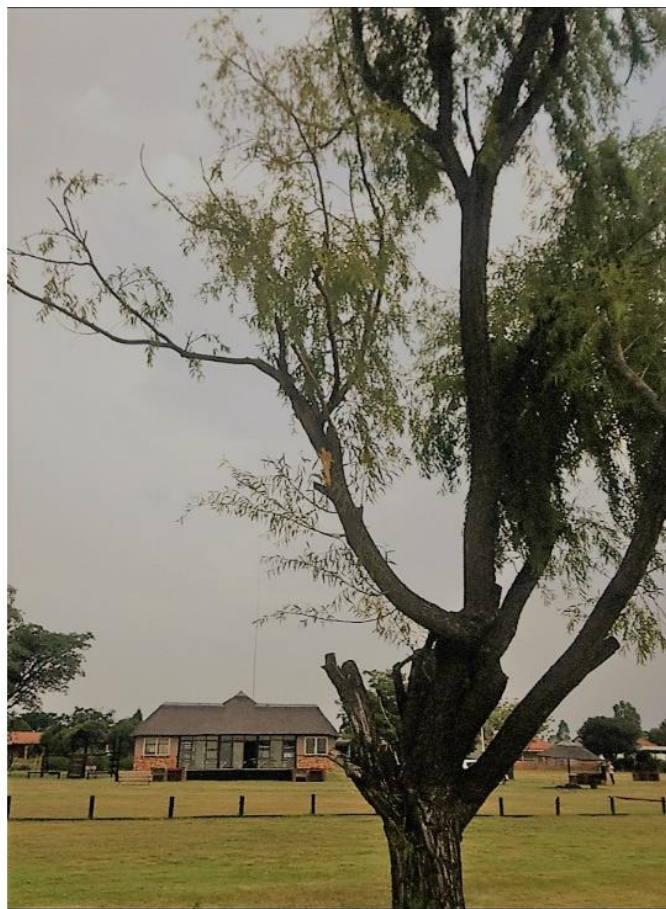
Figure 2: The tree clipped by the gyrocopter.

3.4.5 The investigation revealed that the gyrocopter was operated at a low height and thus, impacted a tree, which rendered it (gyrocopter) unstable while losing height before striking one of the spectators with its rotor blade. The gyrocopter impacted the ground hard and this resulted in the nose gear separating.

4.1 The gyrocopter was operated at a low height and thus, impacted a tree, which rendered it (gyrocopter) unstable while losing height before striking one of the spectators with its rotor blade.

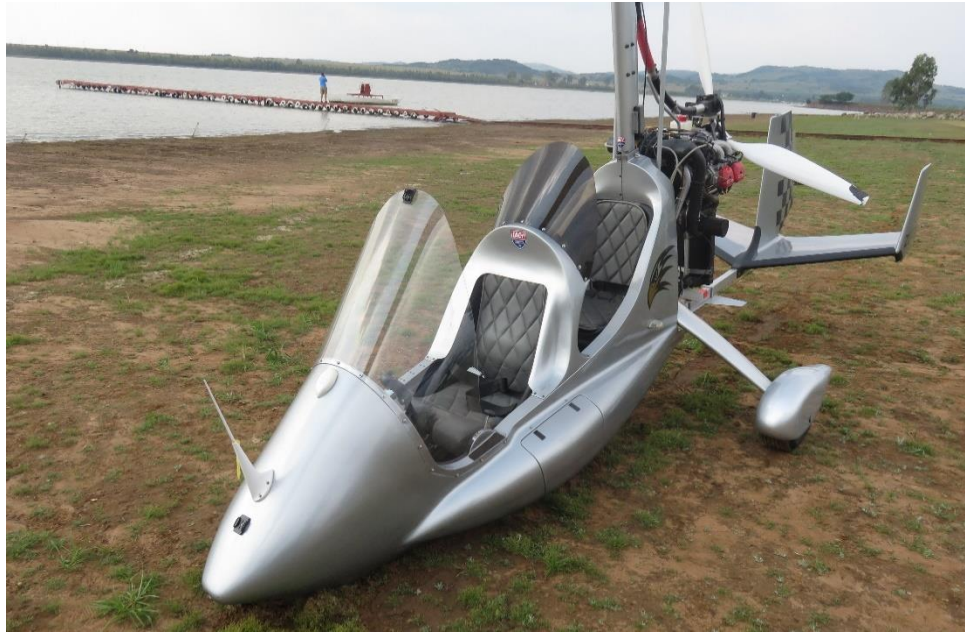
- 2.4 Following the accident, no fault could be found with the engine and the gyrocopter systems and specifically no reason for the alleged degrading of the engine's performance could be established. The damage sustained by the gyrocopter was because of the impact with the ground.

Figure 3: The Gyrocopter as it came to rest.
