LIMITED ACCIDENT INVESTIGATION

Reference Number	CA18/2/3/9995						
Classification	Accident	Date	4 May 2021	Time	0825Z		
Type of Operation	Training (Part 141)						
Location							
Place of Departure	Hoedspruit Civil Airfield (FAHT)			Place of Intended Landing	(FAHT)		
Place Accident	Jejane Private Nature Reserve, Hoedspruit, Limpopo Province						
GPS Co-ordinates	Latitude	24°17'27.5" S	Longitude	30°59'38.1" E	Elevation	1610 ft	
Aircraft Information							
Registration	ZU-LEF						
Model/Make	Jabiru 170						
Damage to Aircraft	Substantial		Total Aircraft Hours	154.3			
Pilot-in-command							
Licence Valid	Yes	Gender	Male	Age	30		
Licence Type	National Pilot Licence (Aeroplane)						
Total Hours on Type	±369.8		Total Flying Hours	1818.9			
People On-board	1+1	Injuries	0	Fatalities	0	Other (On Ground)	0
What Happened	<p>On Tuesday morning, 4 May 2021, an instructor and a student pilot on-board a Jabiru aircraft with registration marking ZU-LEF took off on a training flight from Runway 15 at Hoedspruit Civil Airfield in Limpopo province. The training flight, which was intended to be conducted in the Hoedspruit area, involved effects of controls, and straight and level flight exerc

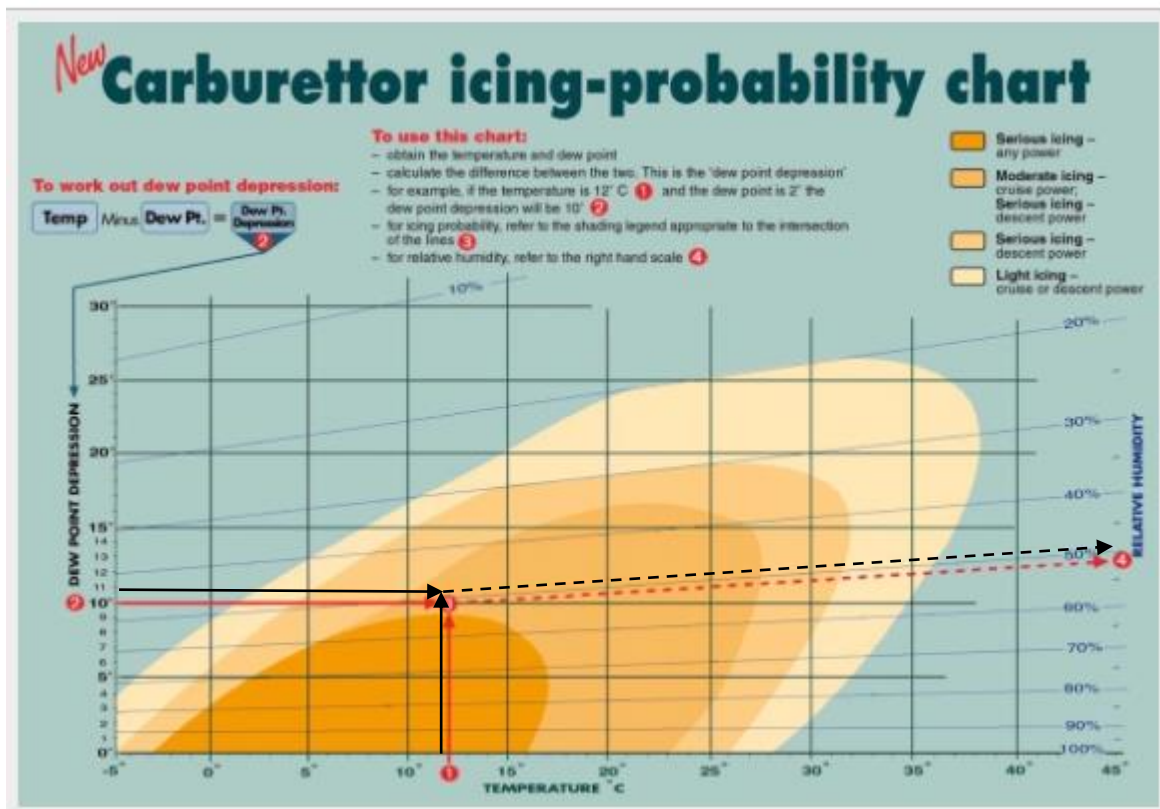
Figure 1: Carb icing chart.

According to the carburettor icing-probability chart below (Figure 1), the relative humidity in the area around FAHS was at approximately 49% with the temperature of 22°C and dew point depreciation of 11°C. When flying in these conditions, the result would be a moderate icing condition at cruise power with serious icing on descent. There would have been a moderate icing probability at cruise power, which is where the aircraft was when the engine lost power.

It is likely that the cause of the engine power loss was due to carburettor icing during cruise power.

Safety message: Pilots are advised to carry out proper flight planning prior to initiating any flight, with emphasis on the weather and calculation of the carburetor icing probability, which could prevent engine power loss or failure, as well as prevent loss of life and damage to property.

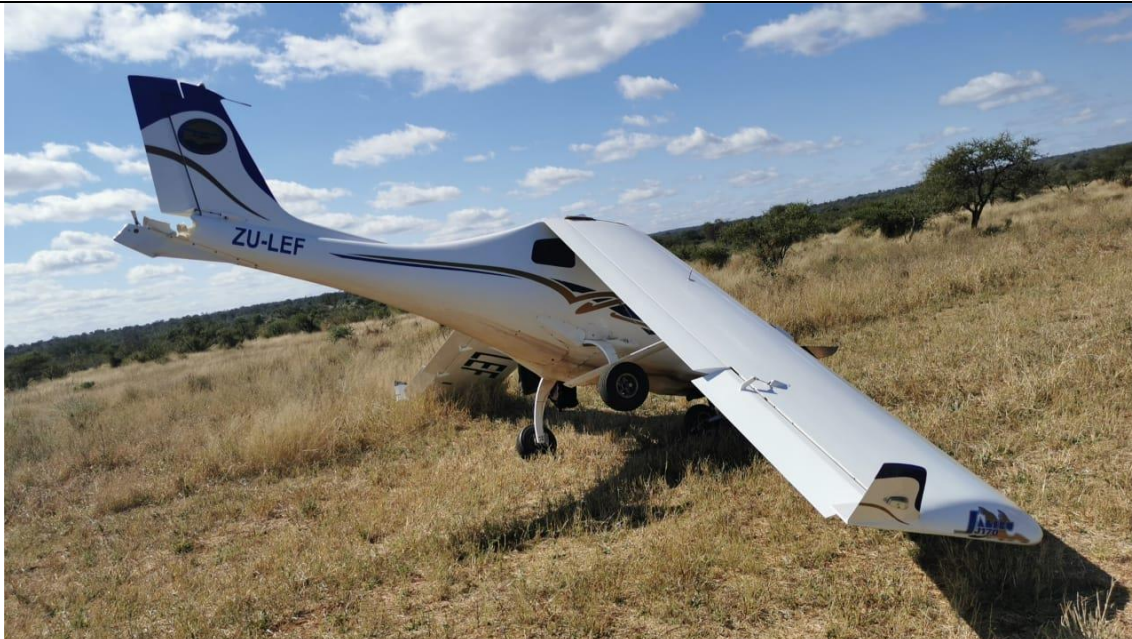
decided to look for a suitable landing spot to execute a forced landing. He elected a gravel road in Jejane Private Nature Reserve to carry out the forced landing. The aircraft touched down hard in a right-wing low attitude, causing damage to the right-side wing (which broke off at the root attachment point), right undercarriage (which cracked/fractured), the right elevator, the nose landing gear and the cone (which broke). The instructor and the student pilot were not injured during the accident sequence.

Figure 2: Jabiru 170 ZU-LEF after the accident. (Source: Pilot)

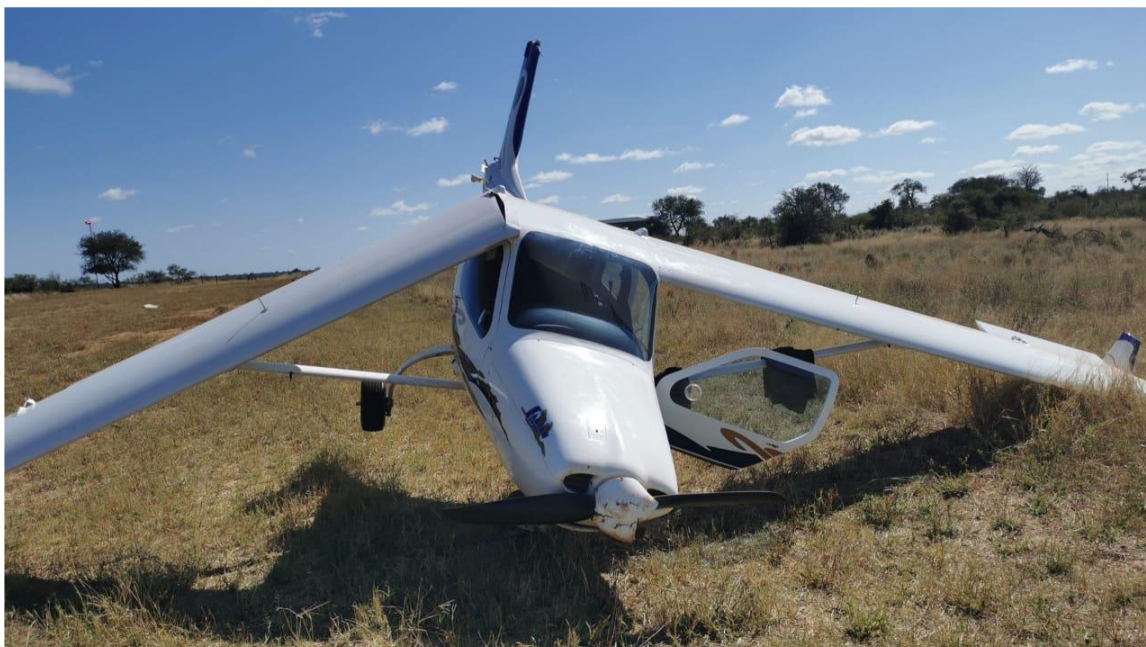
Figure 3: Final resting position of the aircraft.
